Bat Assessment Report

The Old Nursery

**Church Lane
Lodsworth
West Sussex
GU28 9DD**

**22-168
January 2023**

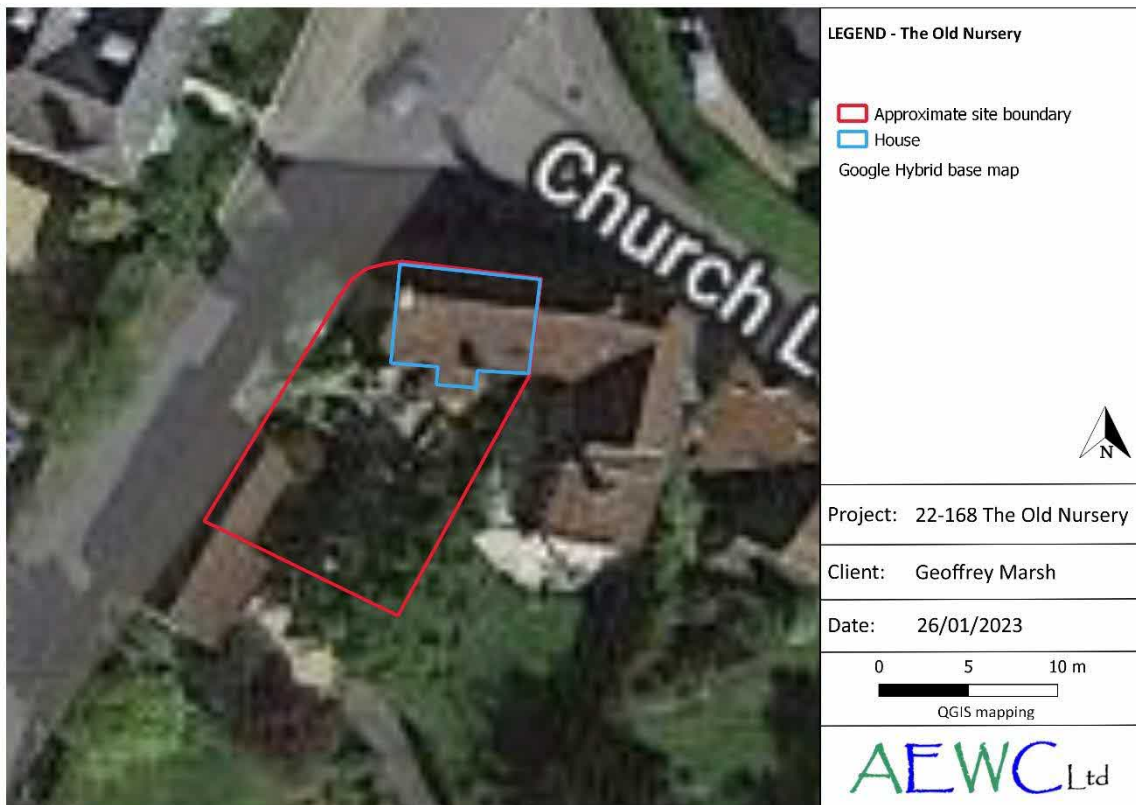
FIGURE 2: SHOWING THE BUILDING SUBJECT TO SURVEY.

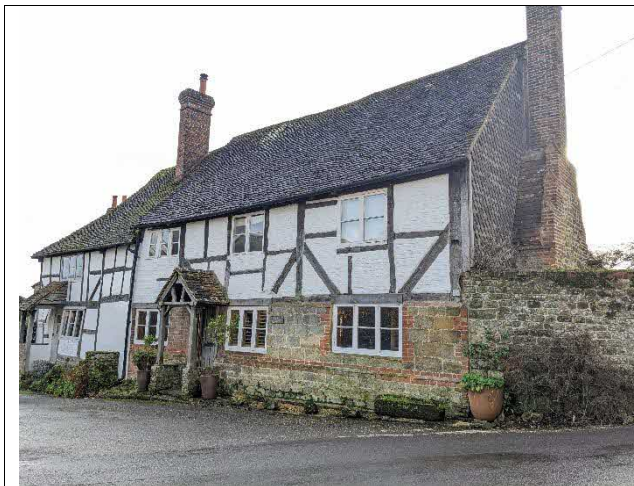
- 4.1 The site comprises a Grade II listed, semi-detached two-storey cottage. The house is timber-framed with brick and stone walls, supporting a pitched roof of clay tiles. The western gable wall is clad in decorative clay hanging tiles either side of the chimney.

Photograph 1: *Northern and western elevations of the house*

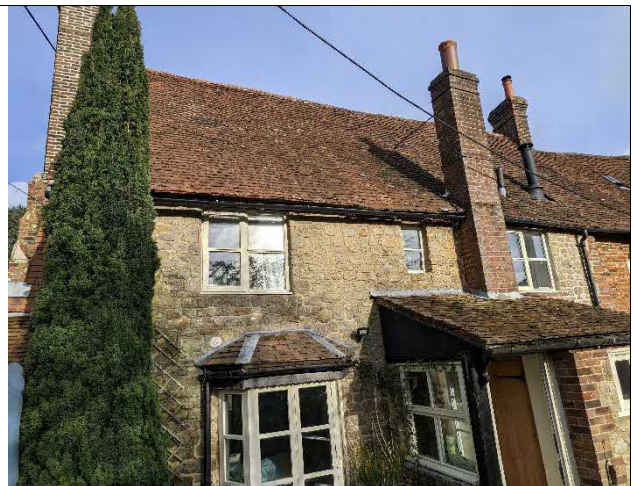
Photograph 2: *Southern elevation of the house*

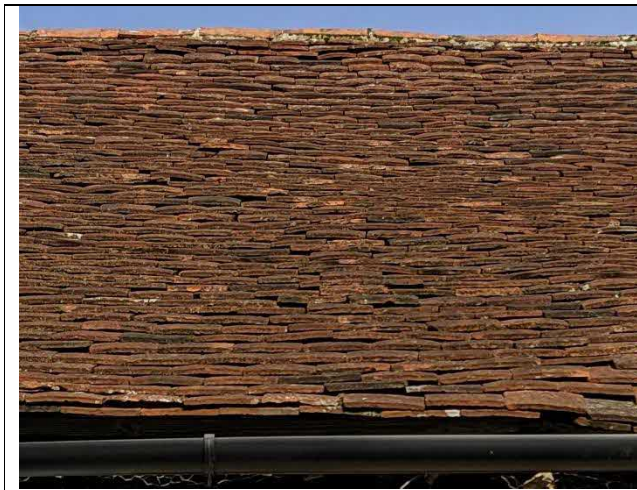
- 4.2 There is a degree of roof sag evident and coupled with the varying camber of the roof tiles, results in numerous gaps beneath slipped or lifted roof tiles on both the northern and southern elevations, providing access for bats into the batten space. Some gaps were also noted present beneath the western gable hanging tiles due to the decorative rounded edges and a slight degree of tile lift in places. The eaves of the house were fitted with wire mesh throughout which would exclude bats from accessing these areas. No evidence of bats was identified around the exterior of the property.

Photograph 3: *Gaps beneath roof tiles*

- 5.2 The daytime assessment identified high potential externally for crevice-dwelling bats within the batten spaces of the roof and the western gable hanging tiles, due to gaps beneath slipped or lifted tiles.

- 6.5 **Should the proposals be extended to include installation of velux windows, full bat survey will be required in order to confirm presence of bat roosts at the property and inform a mitigation strategy and licence application for the site, or to increase confidence in an assessment of likely absence of bats from the property. Further surveys, where required, must be carried out within the active season of May to September with a minimum of three surveys required.**

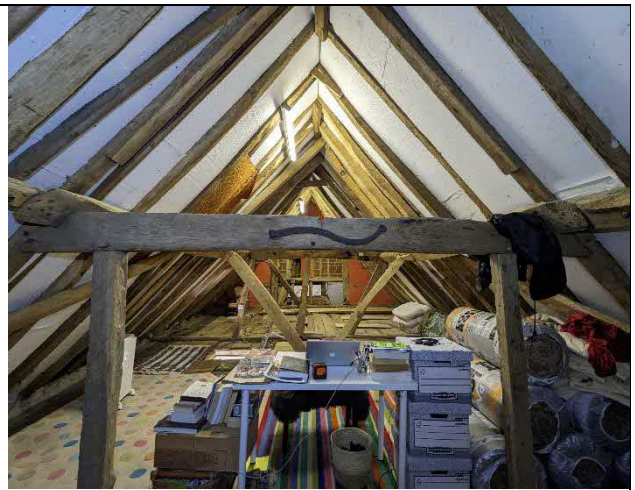
- 4.3 The roof is lined with bituminous felt, with large polystyrene panels fitted between the rafters from eaves to ridge to improve insulation. The floor is boarded out and the void space has been in use as office space for a considerable time, with fluorescent lighting fitted to the underside of the rafters. At the western end, the fireplace is largely bricked off, although one open section allowed inspection of the narrow cavity between the void and chimney stack; this was found to be layered throughout with thick and often dusty cobwebbing. Insect remains such as lacewing could be seen caught in cobwebbing in several areas, however no evidence of bats was noted within this cavity or anywhere within the roof void.

Photograph 4: *Loft space*

- 5.3 While the potential for bats to access the interior roof void from the batten space cannot be ruled out, the presence of the polystyrene panels significantly reduces the available roost provision within the roof void, and the daily use of the space as an office creates high levels of disturbance through light and noise within the void. The roof void is therefore considered to have negligible potential to support void-dwelling species.

- 6.3 **As the areas to be impacted by the confirmed works are assessed as holding negligible suitability for bats, it is considered that there are no likely significant impacts from the proposed works to any bat roosts which may be present elsewhere on the property and therefore no further survey is required at this time.**

- 6.4 **The installation of the paddle staircase will involve hand cutting of a small section out of three floor joists adjacent to the existing loft hatch. In the unlikely event a bat is found present during these works, work must stop and the procedure detailed in Section 7 below must be followed.**
