VISUAL TREE ASSESSMENT AT SILVERWOOD LONDON ROAD ASCOT

**Prepared for:
Mr P Robinson
Silverwood
London Road
Ascot
SL5 7EQ**

Ref: SPH/VTA-23/28.11

7 December 2023

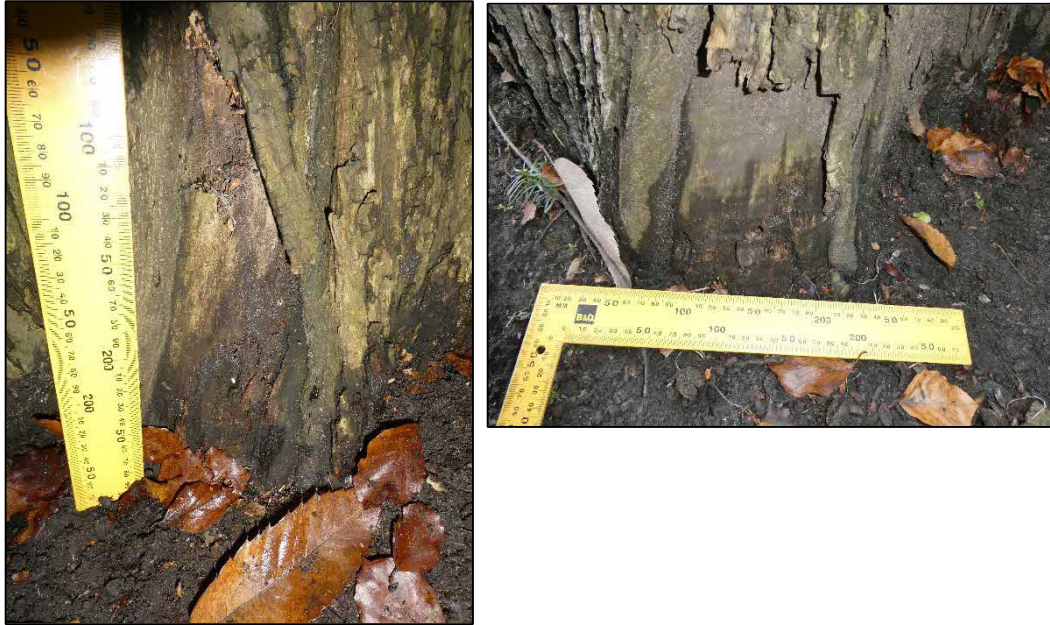
3.2.4 After clearing away leaf litter at the base we observed two areas of damage bark both at ground level and both on buttress roots on the northeast and northwest sides, see examples at Figure 1 on page 6.

- 4.1.4 The site redevelopment in 2012 when two new properties (Redwood and Silverwood) were constructed most probably resulted in some form of root damage. The damage at the base of the stem shown in Figure 1 may also have occurred at this time. The root protection area (RPA) calculation undertaken prior to the planning application indicated tree (T)8 (sweet chestnut) had a 10.6 metres radius and the existing car parking and access road are all within 10.6 metres. It is unknown if there was an existing access or car park where it now exists. There is a slight change in levels where the block paving (parking area) has been constructed and it is highly probable that root severance, soil compaction and levels changes occurred at the time of development. The trees decline is most probably a combination of root damage, (post development stress) and fungal infection.

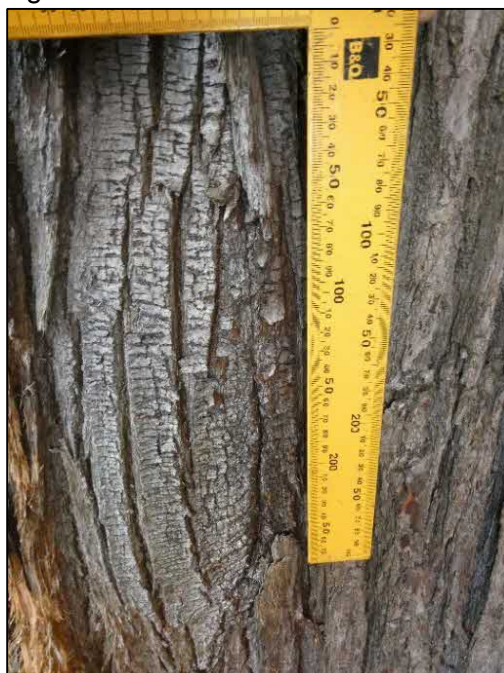
- 3.2.5 The main stem has a natural taper and the bark, with one exception, is true to type and firmly attached. A small area of abnormal bark, lacking the deep fissuring normally associated with mature species, was observed on the southeast side and when tapped with a mallet it sounded hollow, see Figure 2 below. The main stem is co-dominant at approximately 16 metres and has an open union with no obvious structural defects of the main stem.
- 3.2.6 The tree was included in a tree survey for the redevelopment of the site in 2012 and the inspector noted that there was “major deadwood to NE forming extended latera to road with former branch stubs”. Pruning was undertaken in 2016 (crown lifted by 3 metres) and crown reduction (by removal of deadwood) in 2017.

- 4.1.6 The bark anomaly may have been due to mechanical damage during development and as the bark is thin it should not produce a hollow intonation. The hollow sounding from this area is most probably due to delamination of the bark.

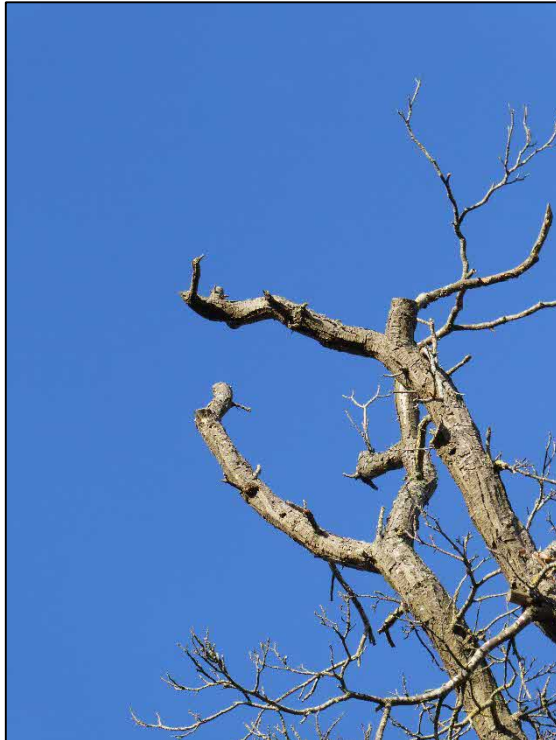
- 3.2.7 The physiological appearance, for the time of year, was abnormal for the species. As leaf cover had fallen revealing the lateral and secondary branches together with the twigs and buds. The canopy is biased having been suppressed by an adjacent mature beech tree and it is also evident that it has been reduced, this can be seen in Figure 3 below. A search of the Royal Borough of Windsor & Maidenhead website revealed an exchange of emails between Tree Officer Alastair Barnes and Tree Works Contractors, Out There Trees Ltd, between 24 and 28 February 2017 that resulted in a crown reduction by removal of dead wood.

- 3.2.8 The upper canopy has extensive die back and significant deadwood, this can be seen in Figure 3 above and Figure 4 below, the deadwood having occurred since the last reduction in 2017. Extension growth, secondary branching and bud structure in the upper canopy is very limited and the overall physical and structural appearance is very poor, see Figure 5 on page 8.

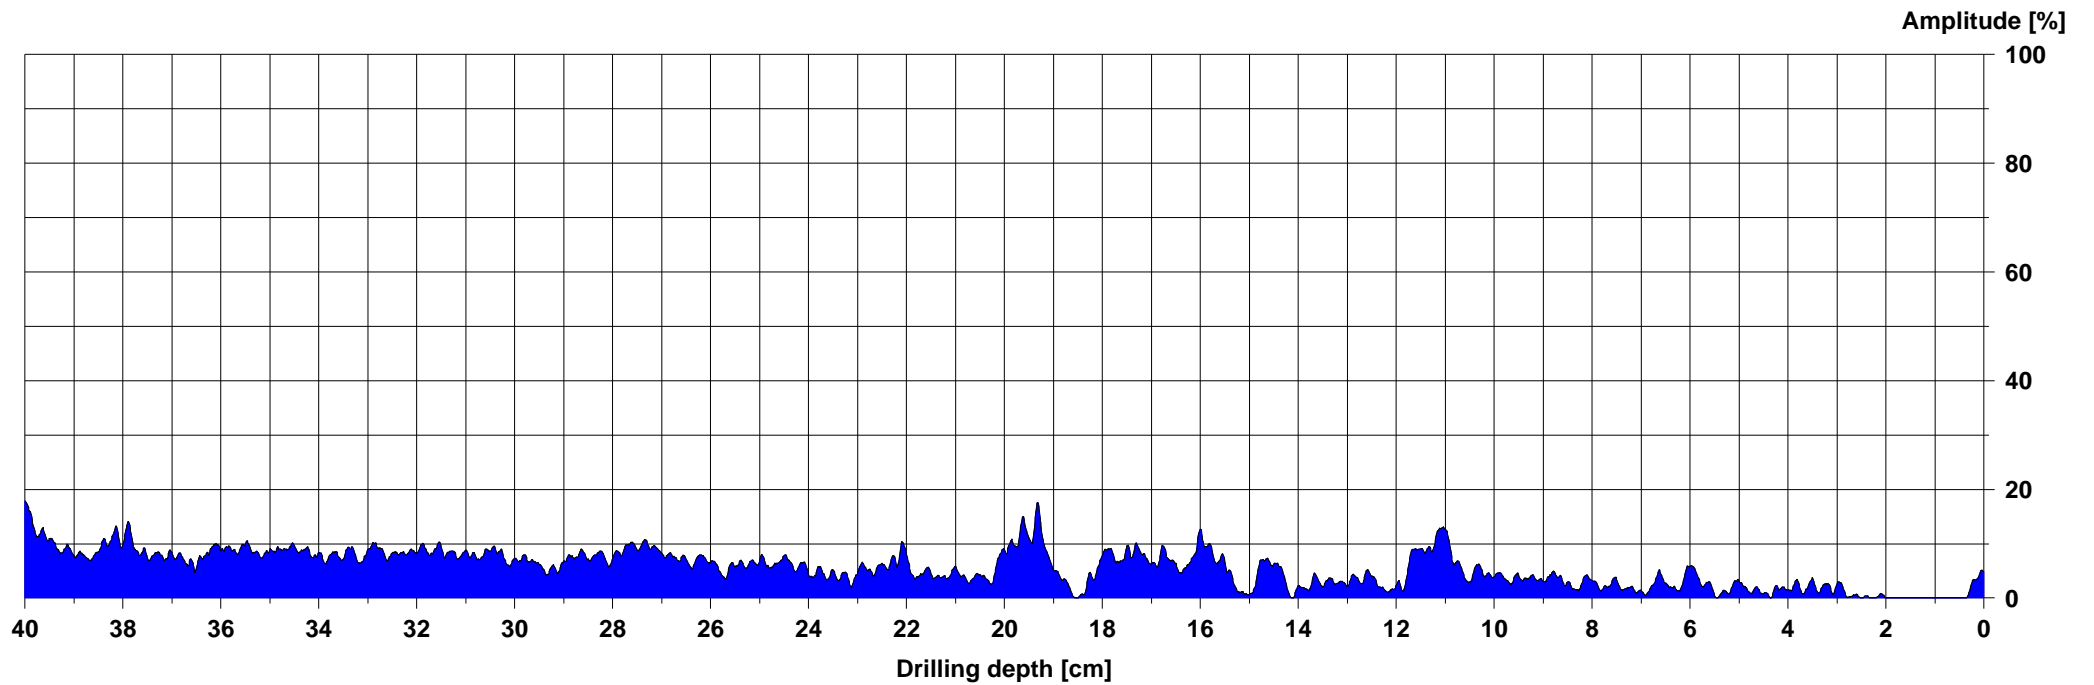
Ground level North. Poor amplitude between 0 and 26cm indicates incipient decay at the test location

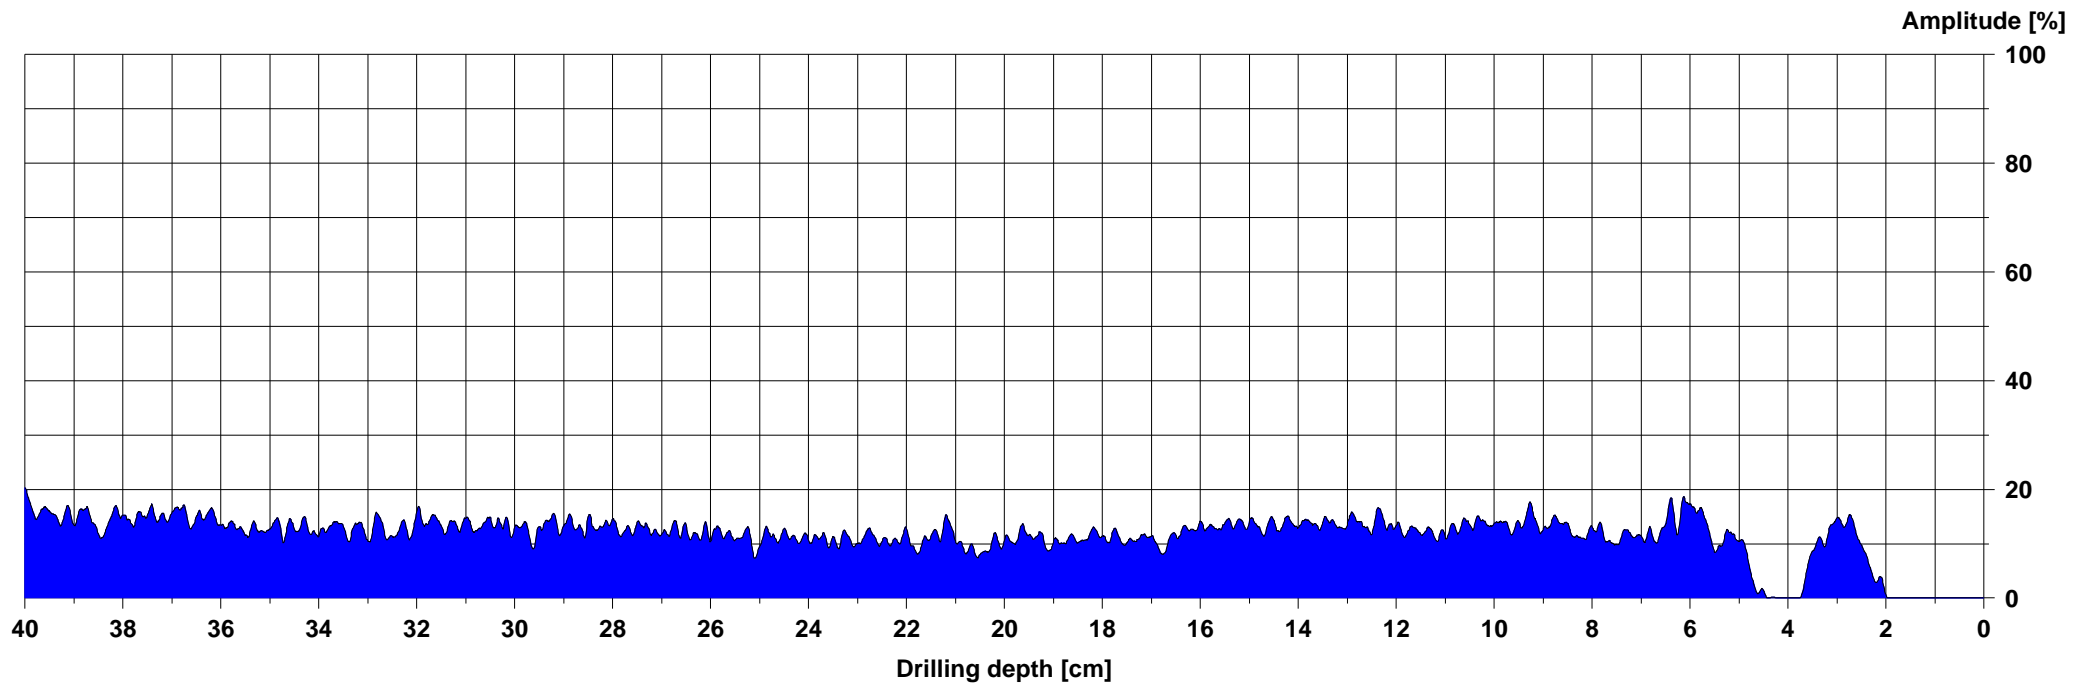
Ground level East. No decay detected at the test location

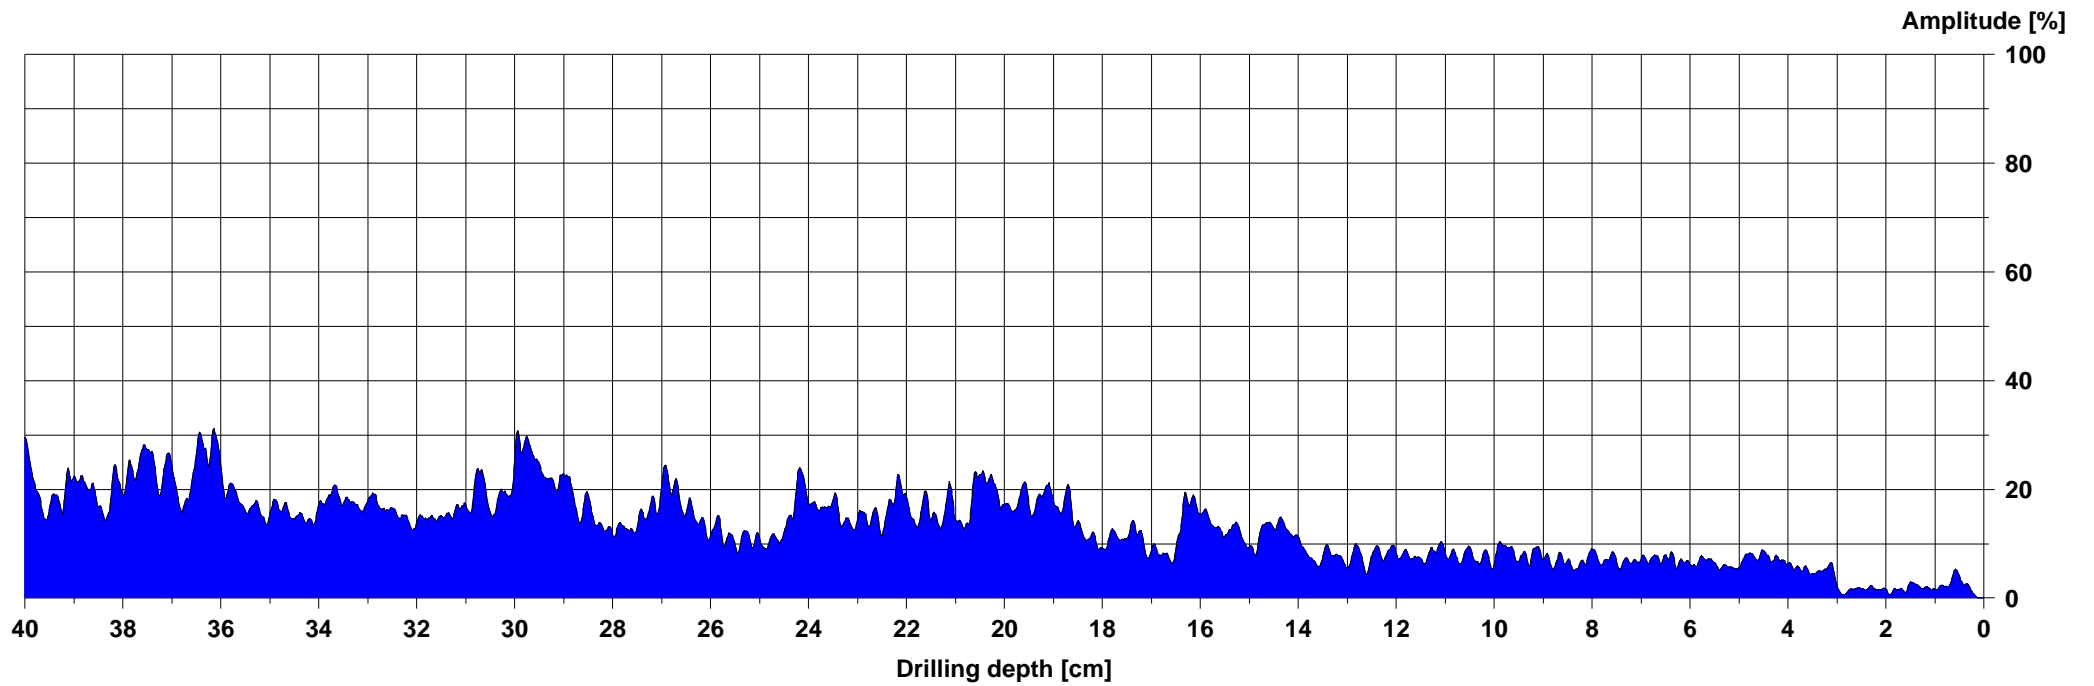
Ground Level South. No significant decay at the test location.

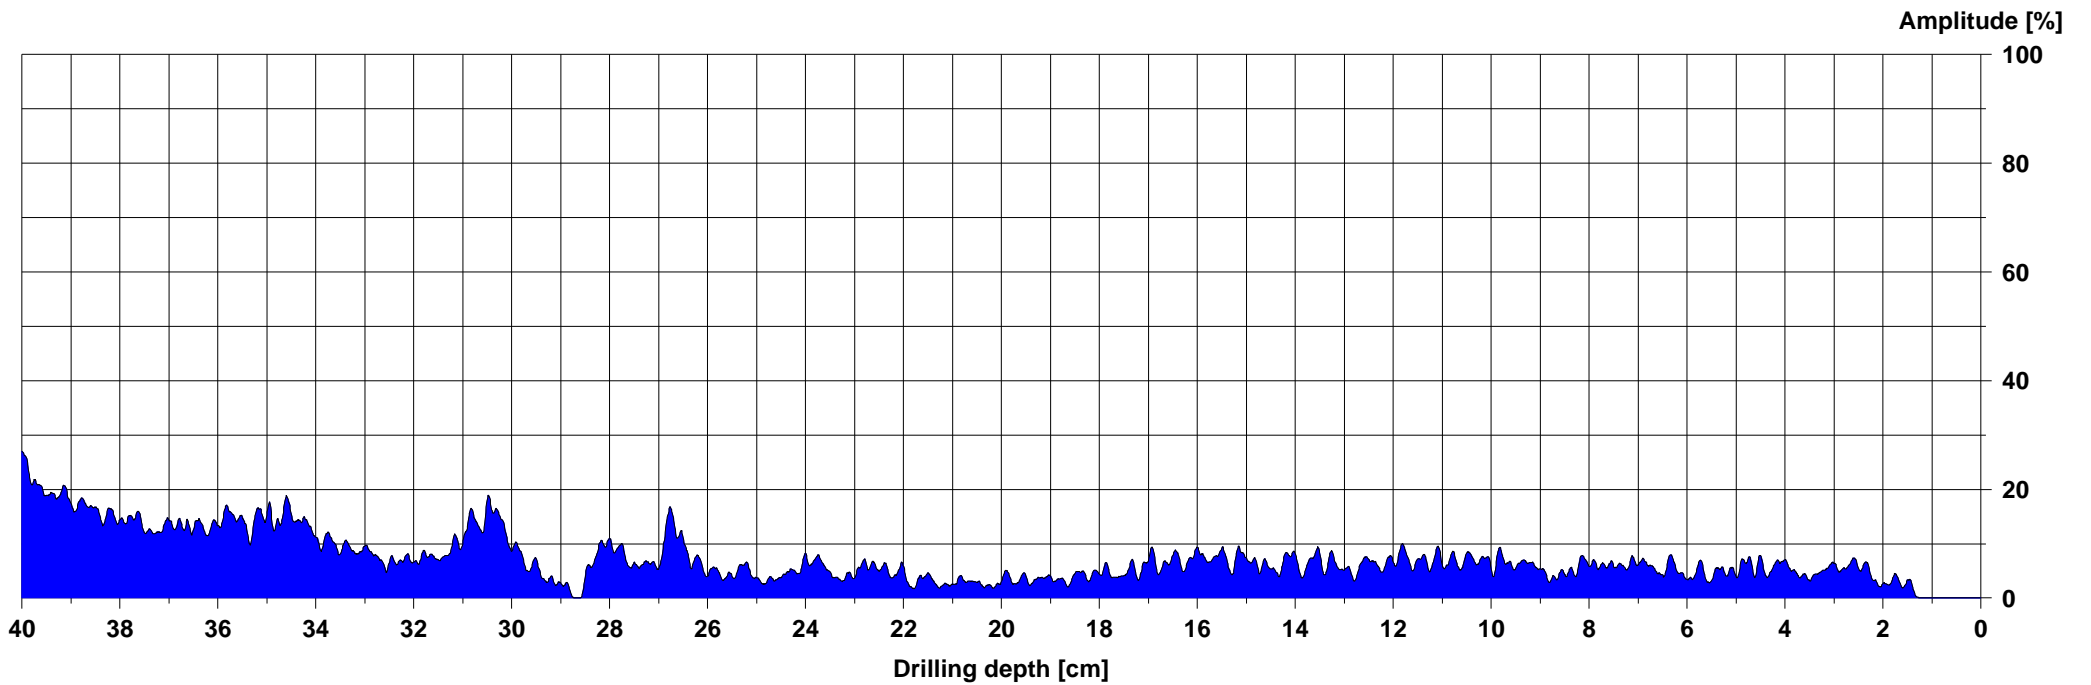
Ground Level West. Poor amplitude between 0 and 30cm indicates incipient decay at the test location

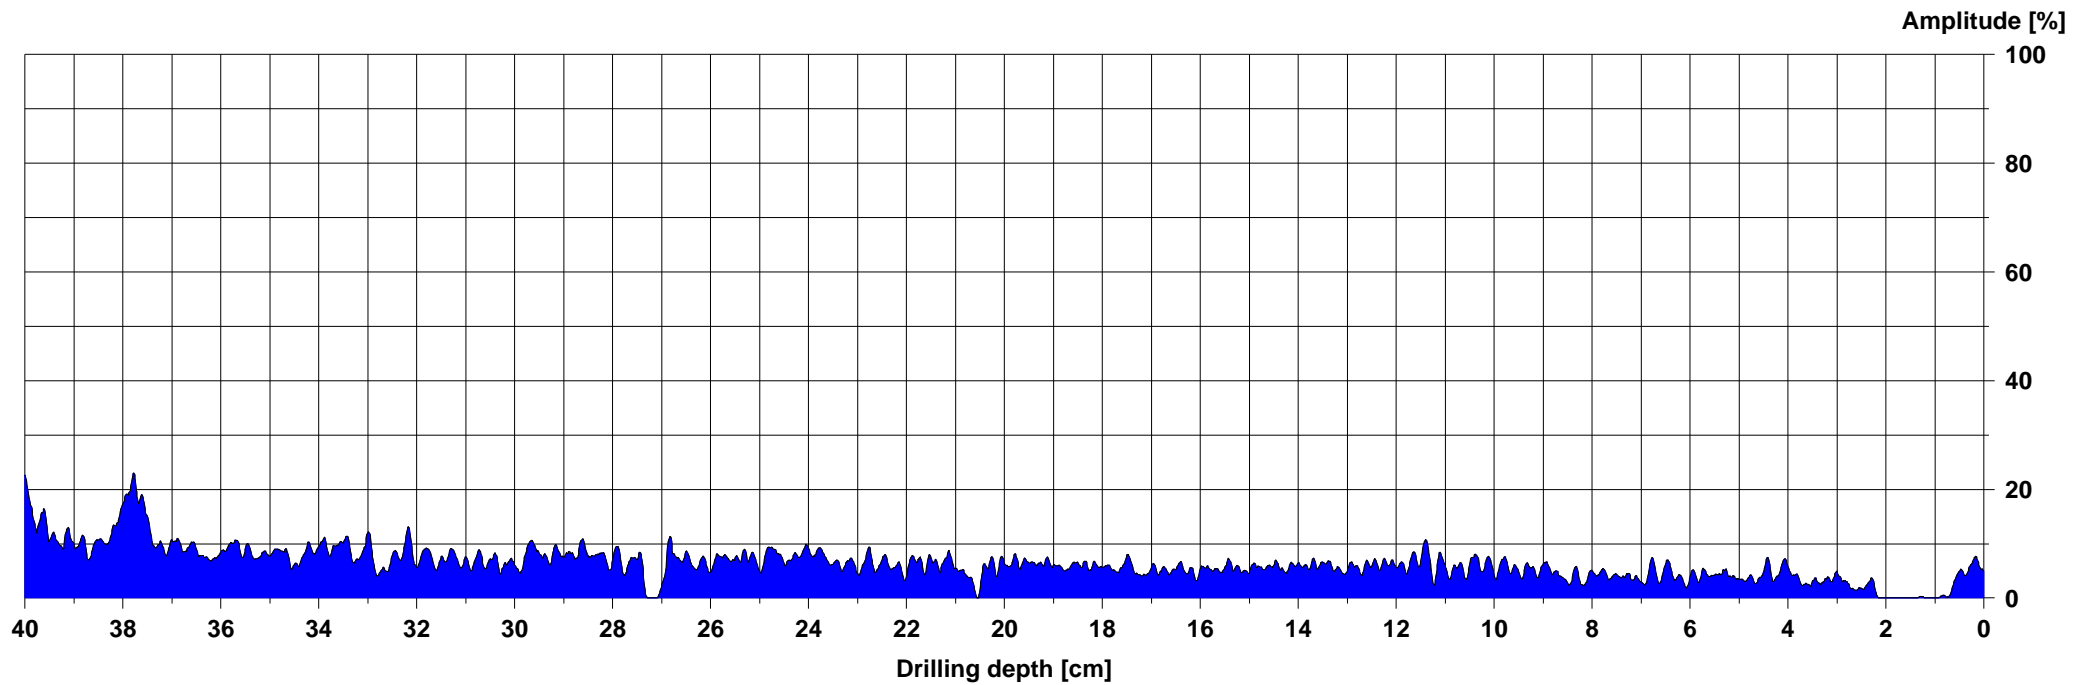
Control test at 1.5 metres AGL. Low amplitude over most of the reading indicating incipient decay at the test location.
