21st December 2023

Our Ref: DWS/11479
Your Ref: N/A

Re: Visual Structural Inspection in Relation to Proposed Conversion of Existing Barn for Residential Use Adjacent to Cobbold, West Street, Walsham-le-Willows.

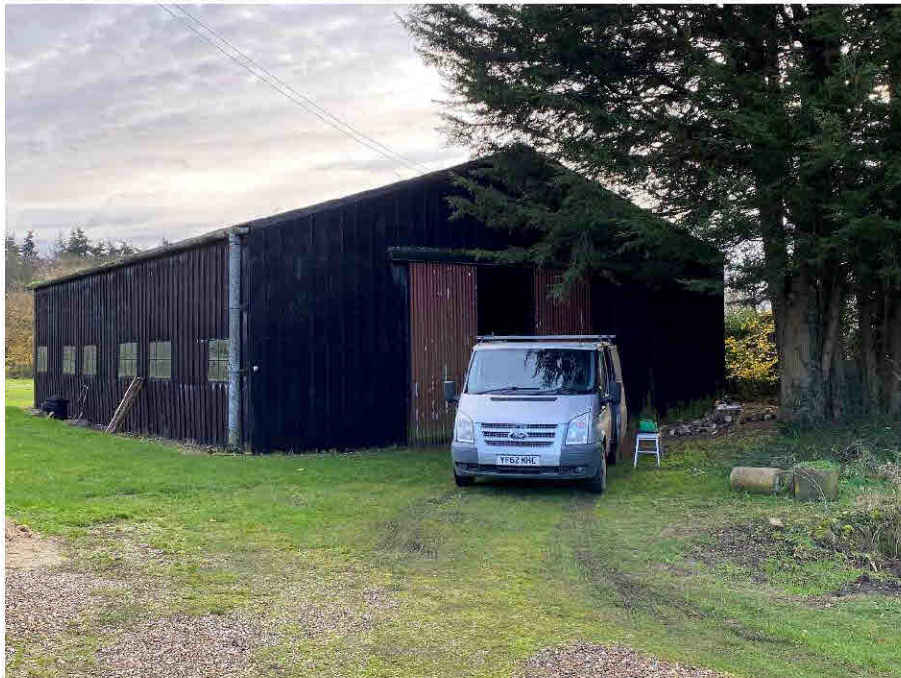
Photograph 1: West Gable Elevation and North Flanking Wall, Note Proximity of Mature Fir Trees.

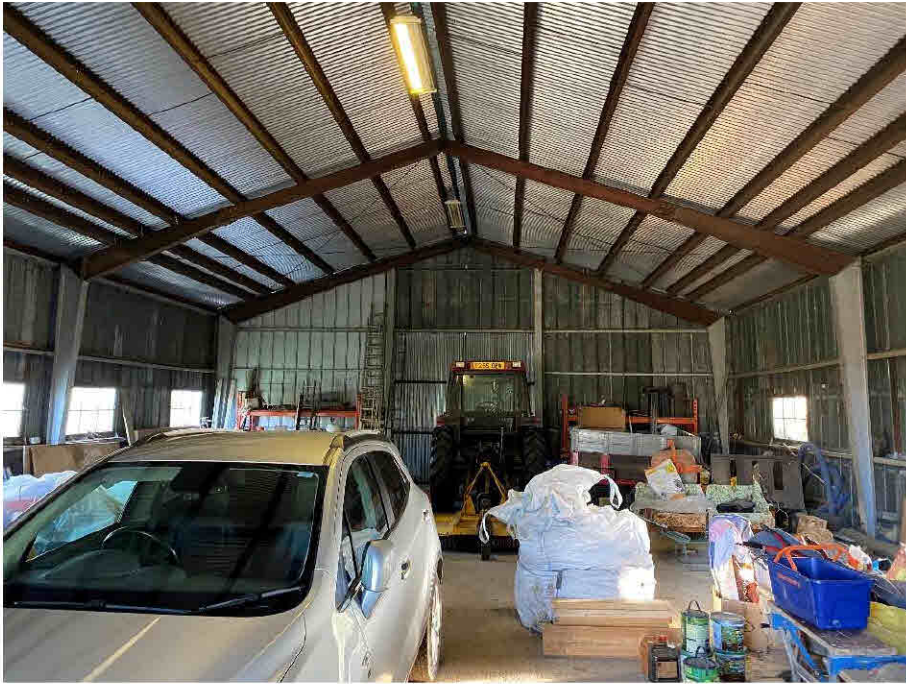
Some nominal bracing has been provided to the end bay between the rafters. This takes the form of crossed steel tie rods. These perhaps help to transfer wind loading on the gable end to the flank walls, however, there is no apparent bracing to the flank walls other than the diaphragm action of the profiles steel cladding. Despite this, there is no indication that the building has listed over.

Photograph 2: Internal View Looking East Showing Steel Portal Frames and Purlins etc. Note Threaded Rod Cross Bracing to End Bay.

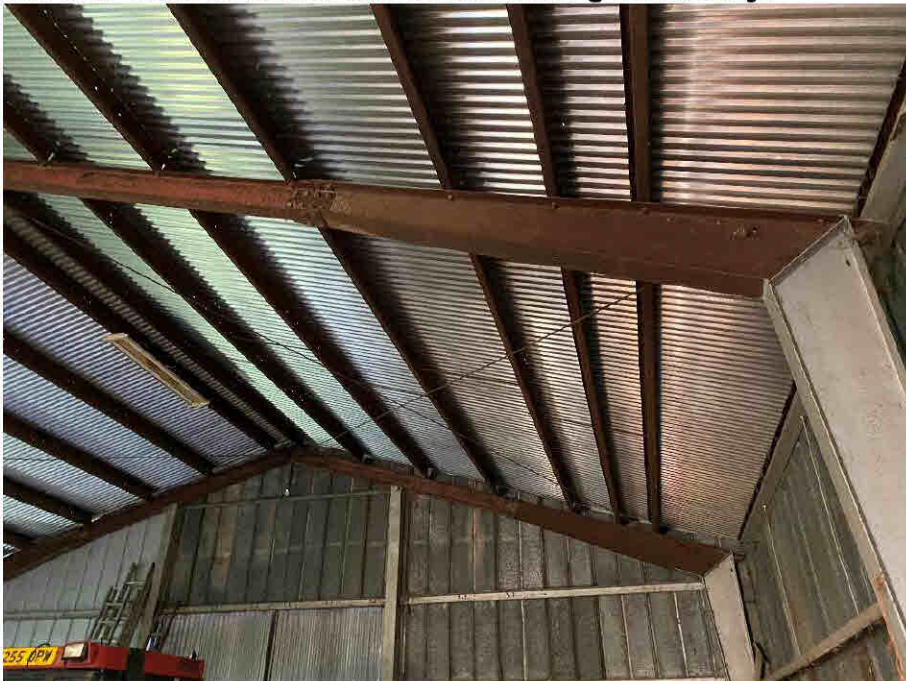
The eaves connection appears to be a fully welded mitred joint between the rafter and column. There is therefore a bolted cover plate moment splice connection around the mid-span of the rafter (slightly closer to the eaves) to allow the frame to be transported and erected in manageable sections.

Photograph 3: Typical Portal Frame, Note Welded Mitre Joint at Eaves and Cover Plate Splice Connection Further up Rafter.

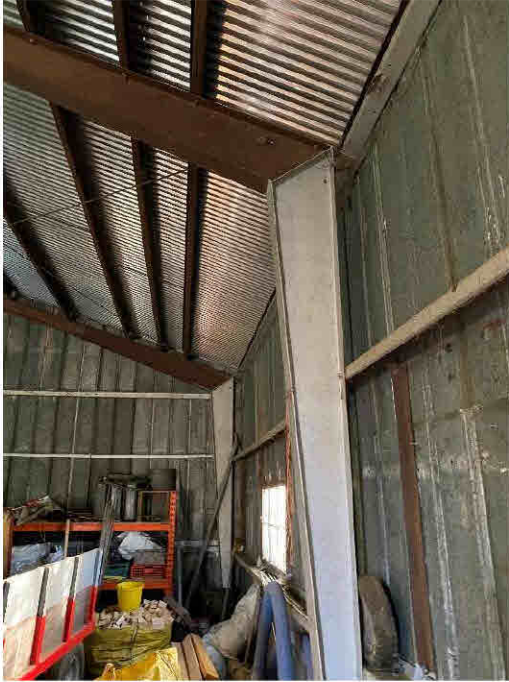
The steel portal frames are slightly unusual in that both columns and rafters are tapered. The columns are approximately 125mm deep at floor level tapering out to approximately 400mm deep at eaves level. The rafters also taper by what appears to be a similar amount.

Photograph 4: Typical Portal Frame Column, Note Tapering Profile.

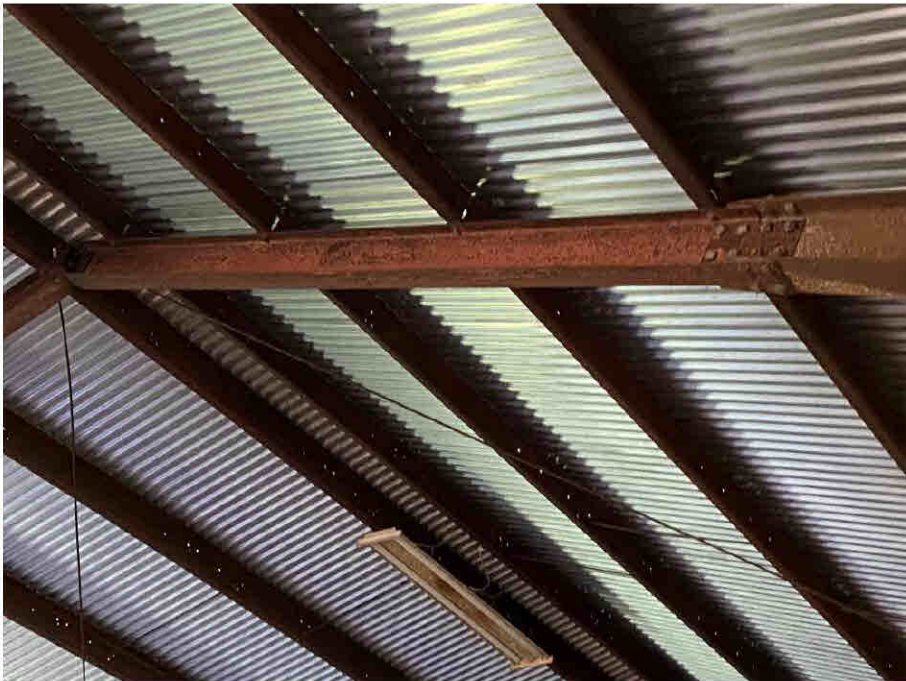
Photograph 5: Typical Portal Frame Rafter. Note Apex Section of Rafter is Not Tapered.

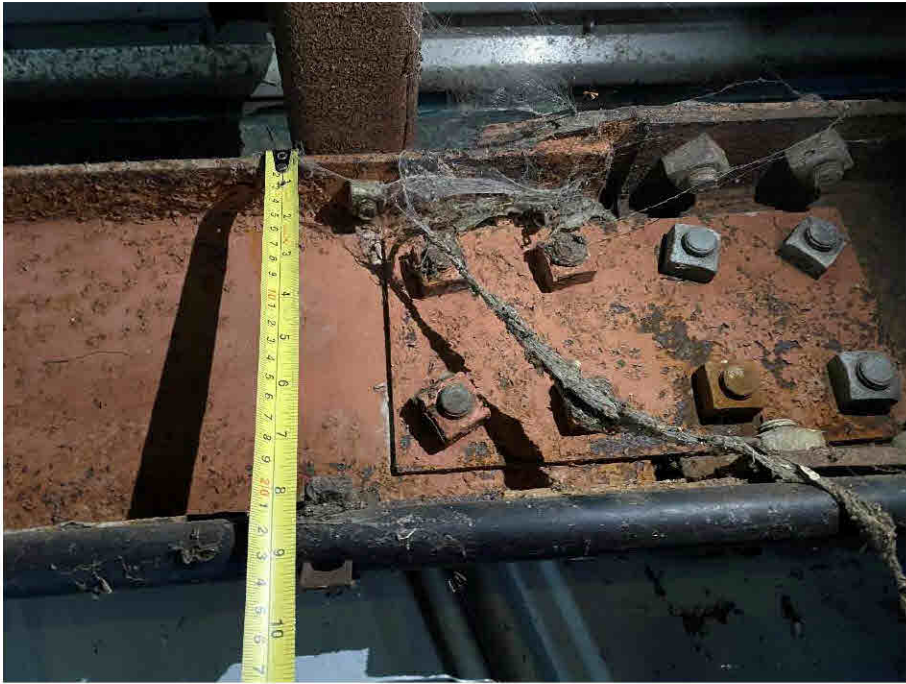
The portal frames appear to have suffered from surface corrosion which will require some attention however, other than this the frames appear to be well aligned and upright with no indication of bowing or sagging.

Photograph 6: Close Up of Cover Plate Splice Connection to Rafter. Note Surface Corrosion to Steelwork. Rafter Depth Approx. 200mm.

It should be possible to remove the mild surface corrosion by wire brushing. We would also recommend that any corroded bolts/fixings also be replaced as a matter of maintenance rather than as part of any proposed conversion works.

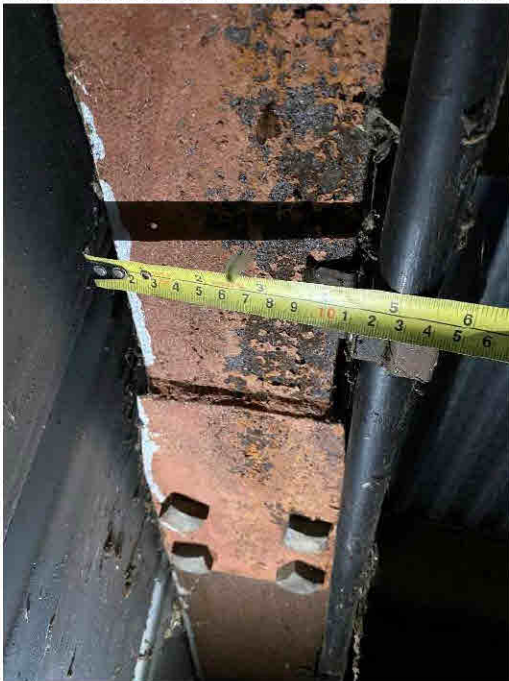
Photograph 7: Close Up of Underside of Cover Plate Splice Connection. Rafter Width Approximately 100mm.

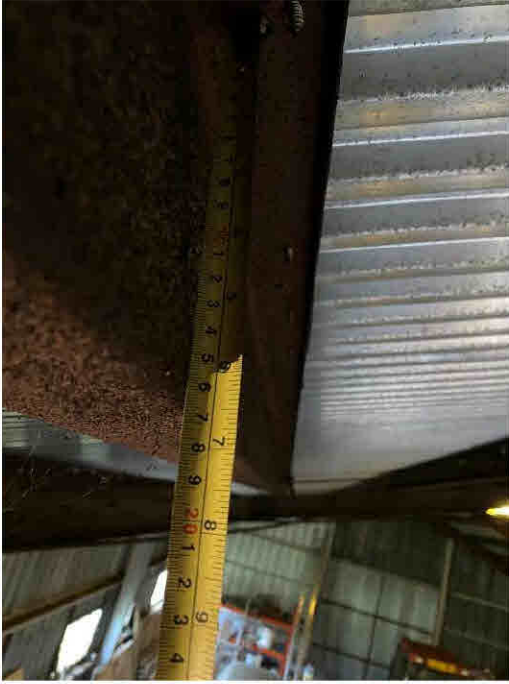
The galvanised Z-purlins are approximately 150mm deep at maximum 1050mm centres and appear to be appropriately sized for the span and in generally reasonable condition but with extensive surface corrosion which, whilst we would not consider to be at a stage which would affect structural performance, will require some future attention.

Photograph 8: Purlin Depth Recorded as Approximately 150mm. Note Surface Corrosion to Purlin.

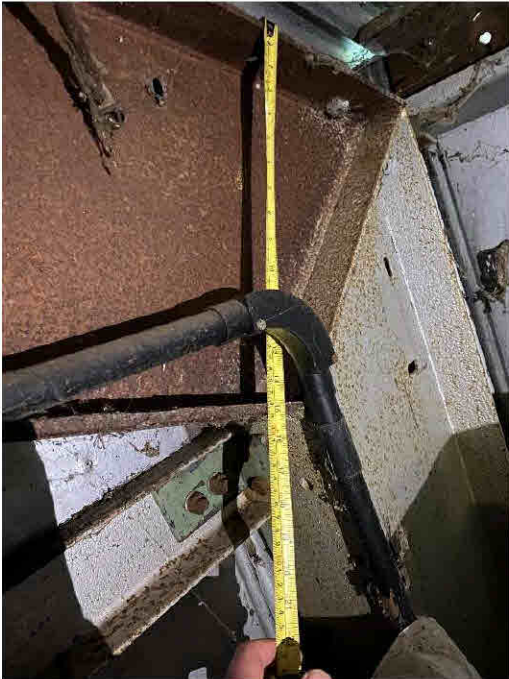
Photograph 9: Depth of Tapered Rafter at Eaves Approximately 380mm.

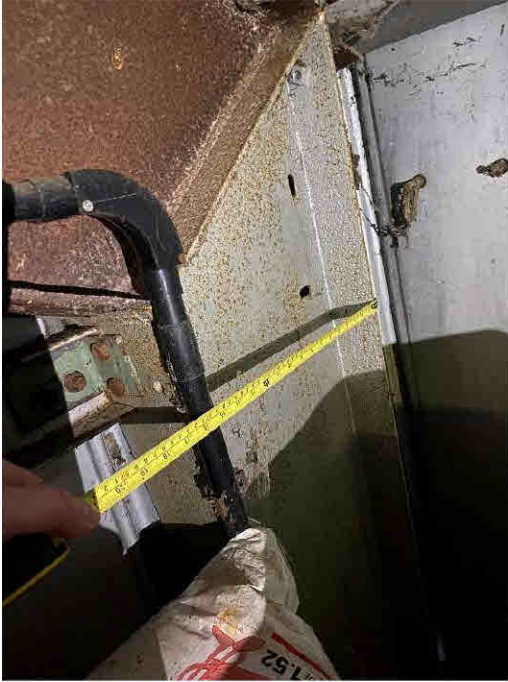
Photograph 10: Depth of Tapered Column at Eaves Approximately 380mm.

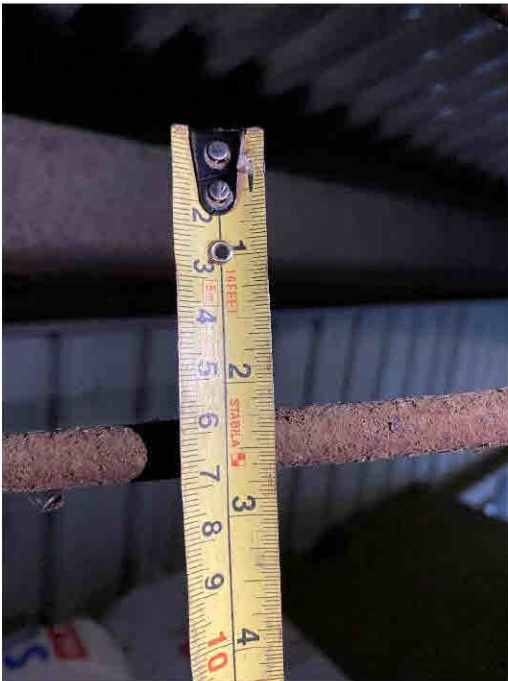
Photograph 11: Crossed Steel Rod Bracing Approximately 10mm Diameter.

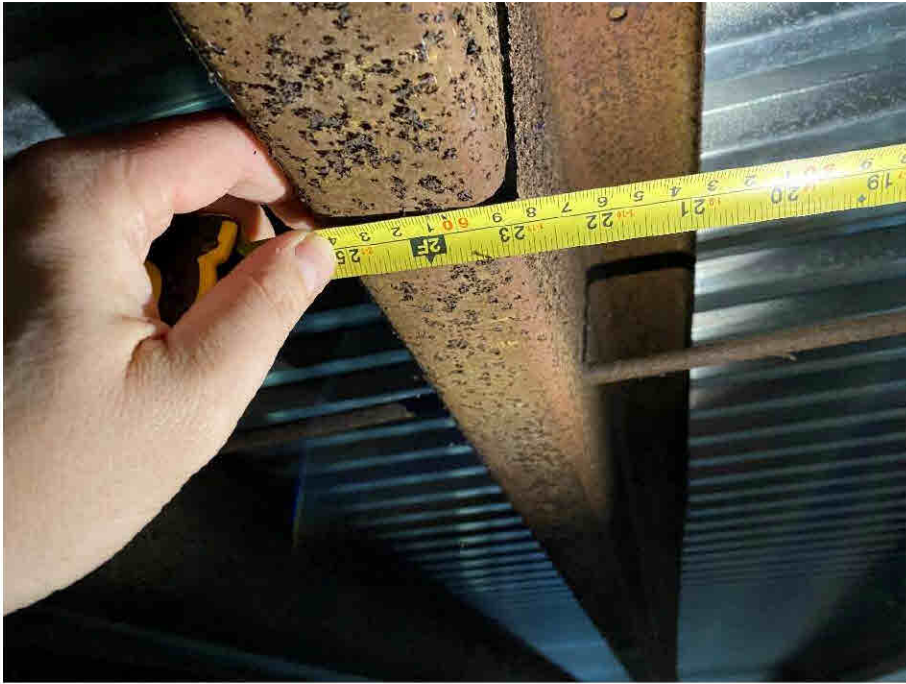
Photograph 12: Purlin Centres Closed up to 600mm. Note Surface Corrosion.

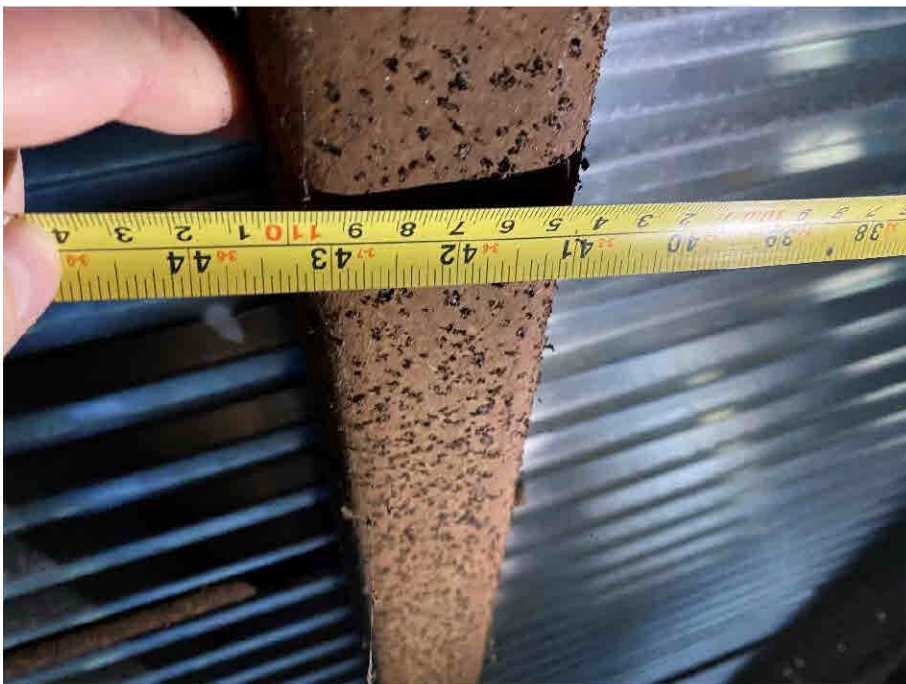
Photograph 13: Purlins Generally at 1050mm Centres.

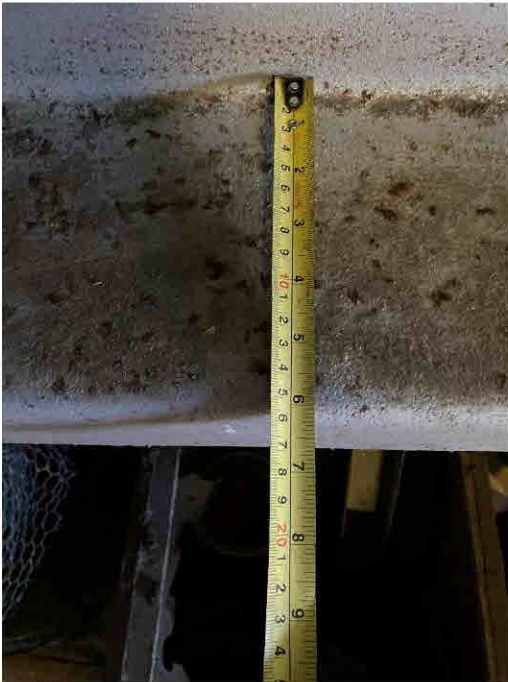
Photograph 14: Cladding Rail Depth Measured as Approximately 150mm.

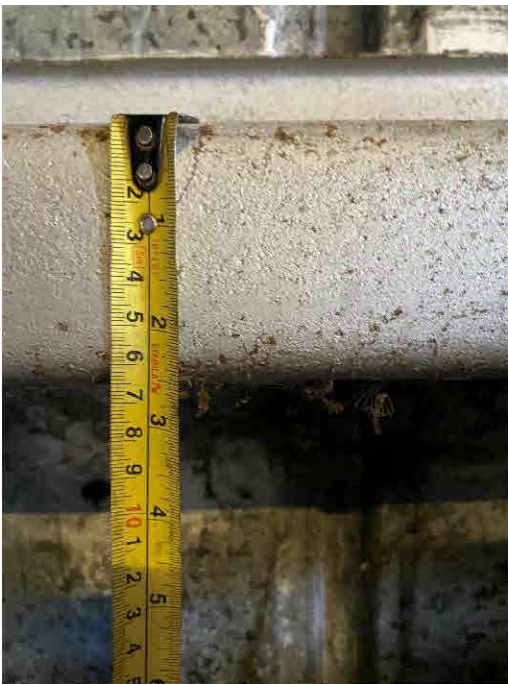
Photograph 15: Cladding Rail Flange Width Measured at Approximately 65mm.

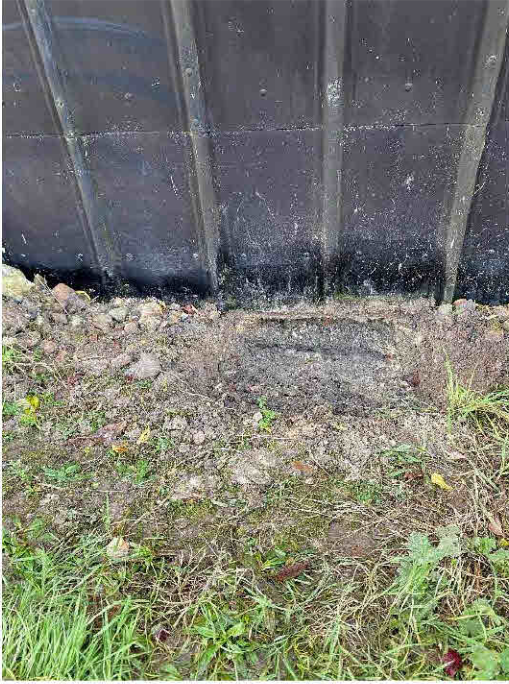
A trial hole was undertaken on the foundations to one of the steel columns. The trial hole indicates the columns to have mass concrete pad foundations approximately 900mm square x 300mm thick (approximately 450mm below ground level).

Photograph 16: Trial Hole on Column Foundation, North Elevation.

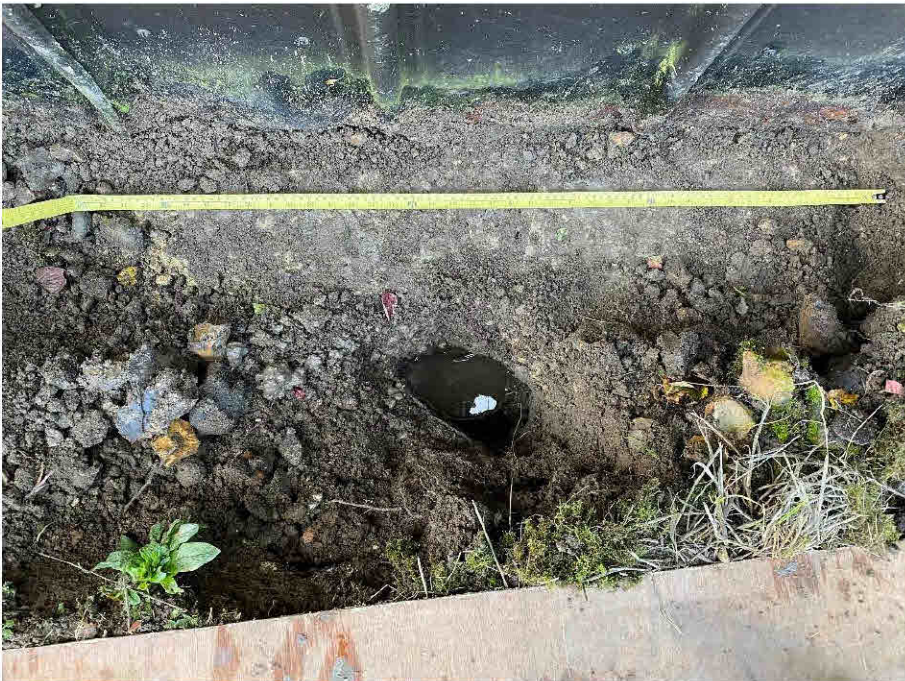
Photograph 17: Trial Hole Exposing Edge of Concrete Pad Foundation. Pad Width Measured at Approximately 900mm.

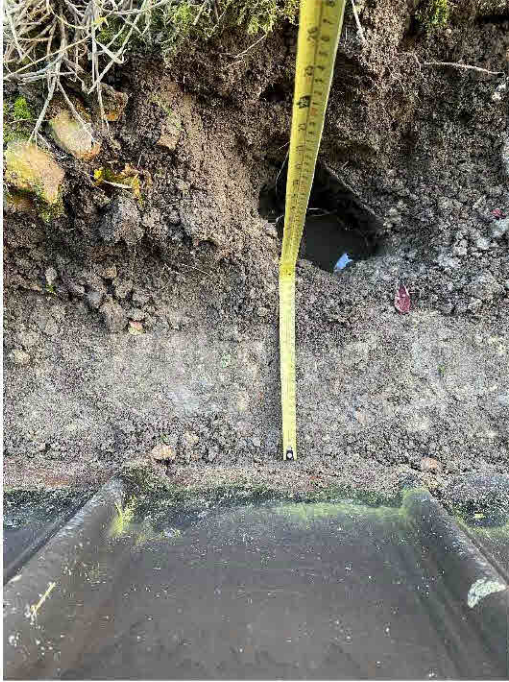
Photograph 18: Pad Foundation Projects Approximately 250mm From Face of Cladding Indicating 900mm Square Pad.

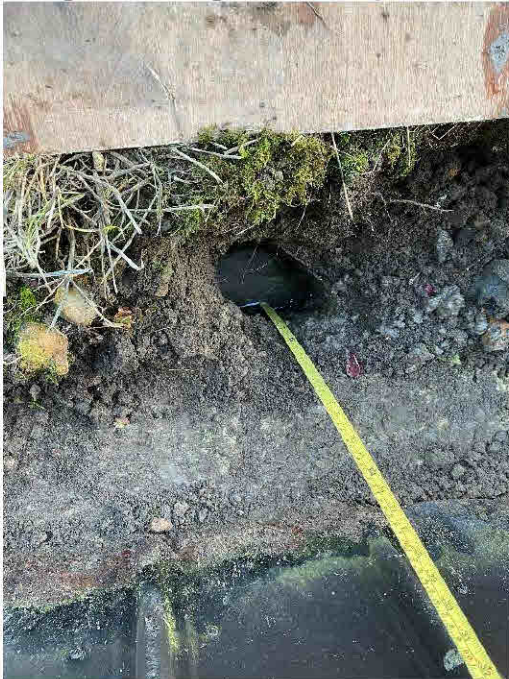
Photograph 19: Concrete Thickness to Pad Foundation Approximately 300mm.

We note that the existing mass concrete pad foundations may perhaps be shallow by modern Standards, however, the plan area is appropriate for the anticipated loading and the allowable bearing pressure of the ground and there is no evidence of significant foundation movement.
