**CCTV REPORT FOR: 1a DURLEY AVENUE  
WATERLOOVILLE  
PO8 8XA**

**Insured:** Mr Reynolds  
**Reference:** LIV-SN-22-005818

**Site Visit:** 15-Feb-23  
**Report Date:** 27-Apr-23

Address: **1a DURLEY AVENUE, WATERLOOVILLE, PO8 8XA**

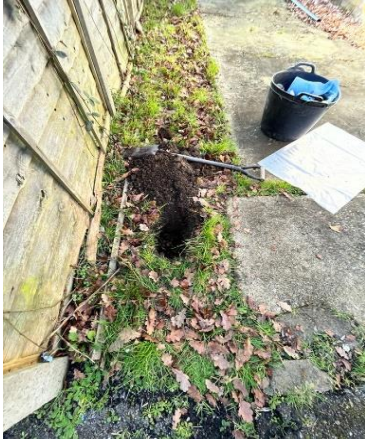
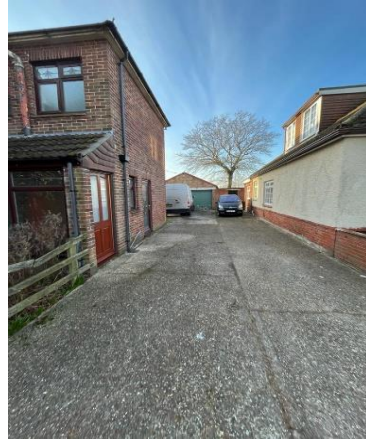
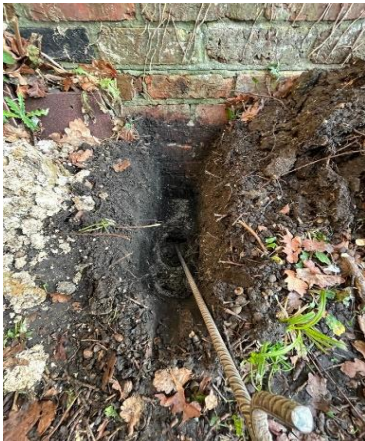
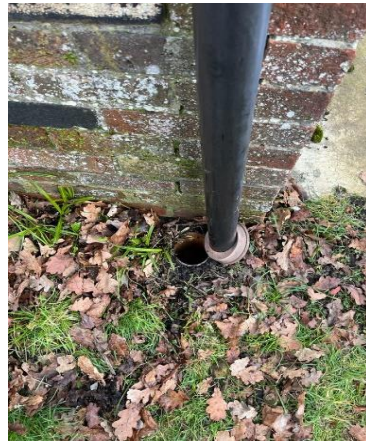
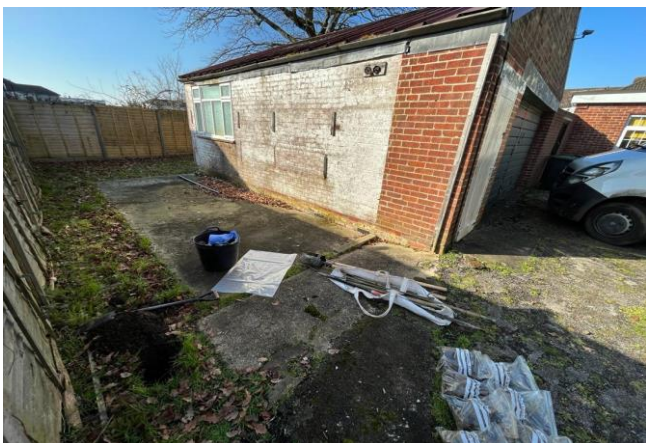
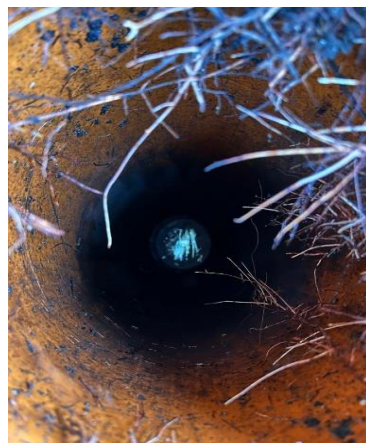
Metres	Faults / Defects	Remarks
0.00		At RWP1
1.90	Debris (Silt) 25%	
	Root Ingress	
3.20		At Soakaway
		End of survey

Some debris in the pipe and slight root ingress.  
Water flowing well from RWP

No recommendations are required.
