Engineers Report

Risk Address 1a Durley Avenue
Waterlooville
PO8 8XA

360 Reference LIV SN 22 005818
Insurer Reference 100 50 200742
Policy Holder Mr John Reynolds

Date Notified 17 October 2022
Date Instructed 17 October 2022
Report Date 21 December 2022

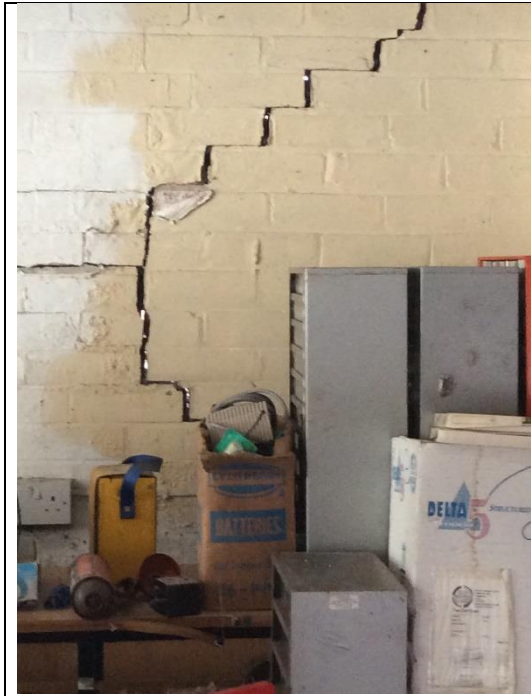
There is stepped cracking to the bed joints of the rear wall and the right hand flank wall. The cracks are between 10mm and 15mm and are visible internally and externally. Several bricks are also cracked.

Cracks to right flank wall

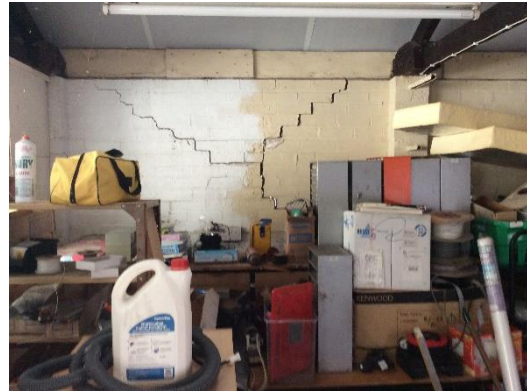
Cracks to right flank wall

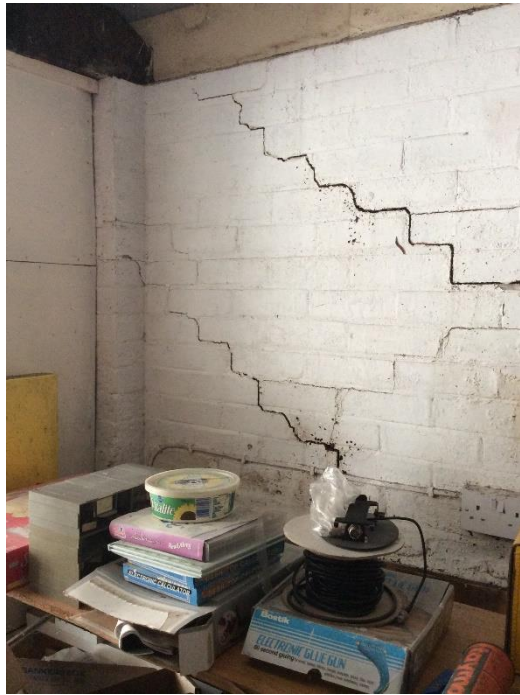
Cracks to right flank wall

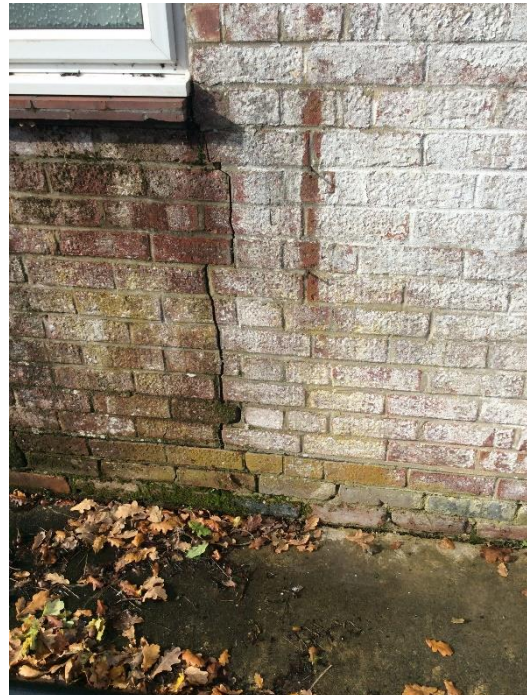
Crack to rear wall

The pattern and orientation of damage noted to the property is indicative of localised subsidence of the garage down towards the rear right hand corner.

The cause of the localised subsidence, appears to be clay shrinkage, exacerbated by the water demand of the nearby vegetation.

In order to mitigate further subsidence damage occurring, it will be necessary to remove the cause of the problem, and this may include any implicated vegetation. This should allow the ground to stabilise.

Following completion of the mitigation works described above, and a period to allow the ground to rehydrate, crack repairs and redecoration to the affected areas of the property can proceed. A repair schedule will be drawn up and agreed in due course.
