Monitoring visit 3 of 7

### Monitoring Plus Report

Owners name	Mr Reynolds	Suspected cause	to be advised	Monitoring type	levels & cracks
Address	1a Durley Avenue Waterlooville  PO8 8XA	Principal area of damage	to be advised	Installed	24/05/2023
Comment		Damage category	to be advised	Frequency (weeks)	8.7
Max movement	27.7 mm	Surface geology	to be advised	Completion date	tbc
Focal area	Pts 5, 6, 7, 8,	Feedback from last visit		Status	open
0		Feedback from this visit	no feedback for this visit		
		Sketch showing location of monitoring points

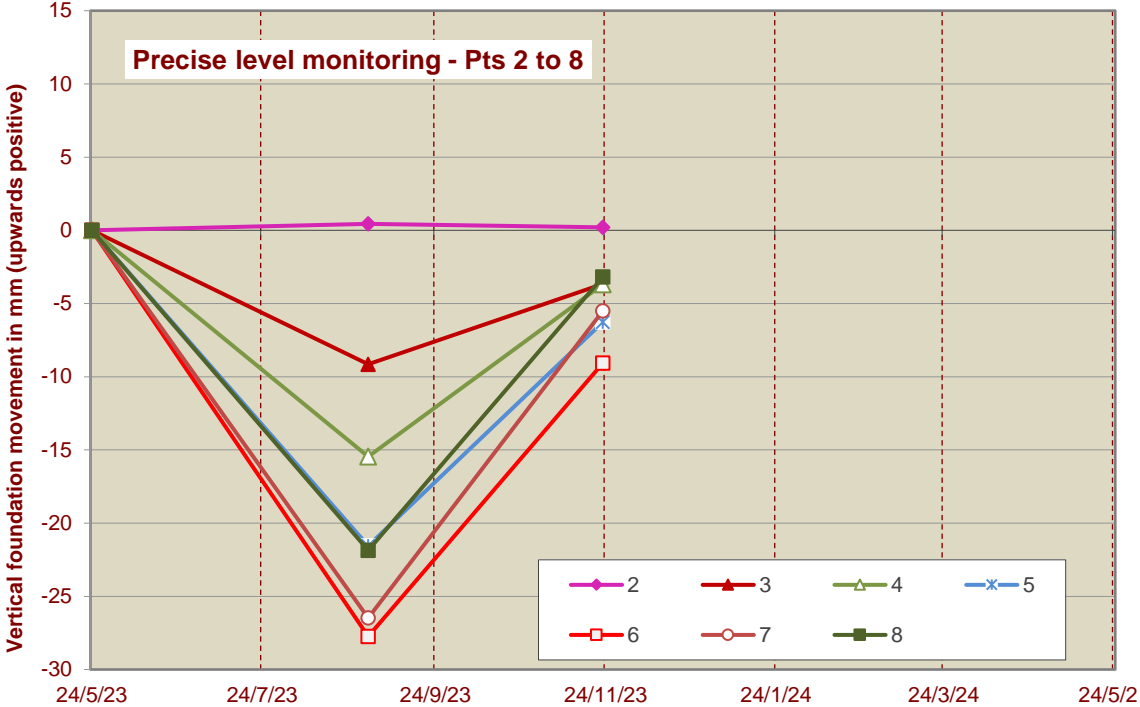
# Precise level monitoring related to Point 1

Survey:	1		2		3		4		5	
By:	VV		VV		VV		#N/A		#N/A	
Date:	24/05/2023		31/08/2023		23/11/2023		#N/A		#N/A	
Point ID	levels mm	<i>chngs</i> <i>mm</i>	levels mm	<i>chngs</i> <i>mm</i>	levels mm	<i>chngs</i> <i>mm</i>	levels mm	<i>chngs</i> <i>mm</i>	levels mm	<i>chngs</i> <i>mm</i>
1	<b>1000.00</b>	<b>0.0</b>	<b>1000.00</b>	<b>0.0</b>	<b>1000.00</b>	<b>0.0</b>		#N/A		#N/A
2	1094.38	<b>0.0</b>	1094.82	<b>0.4</b>	1094.58	<b>0.2</b>		#N/A		#N/A
3	1065.60	<b>0.0</b>	1056.45	<b>-9.2</b>	1061.94	<b>-3.7</b>		#N/A		#N/A
4	1068.28	<b>0.0</b>	1052.82	<b>-15.5</b>	1064.59	<b>-3.7</b>		#N/A		#N/A
5	1079.18	<b>0.0</b>	1057.63	<b>-21.6</b>	1072.90	<b>-6.3</b>		#N/A		#N/A
6	1112.23	<b>0.0</b>	1084.49	<b>-27.7</b>	1103.17	<b>-9.1</b>		#N/A		#N/A
7	1093.92	<b>0.0</b>	1067.44	<b>-26.5</b>	1088.42	<b>-5.5</b>		#N/A		#N/A
8	1070.62	<b>0.0</b>	1048.76	<b>-21.9</b>	1067.44	<b>-3.2</b>		#N/A		#N/A

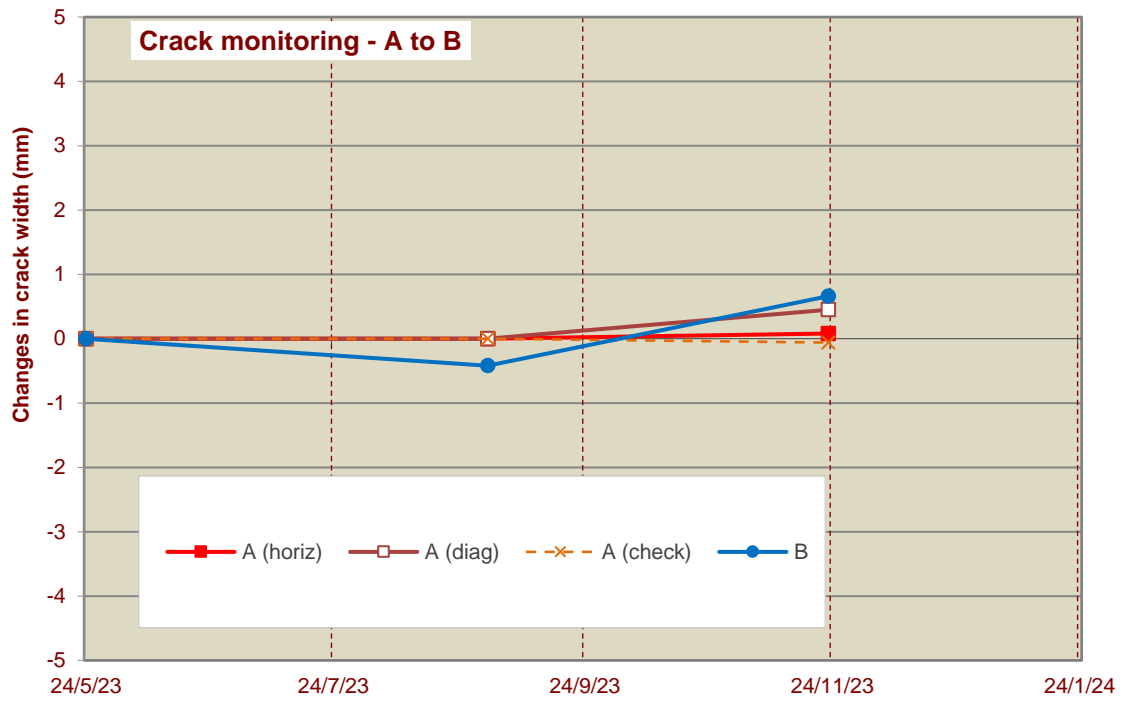
# Crack monitoring

Survey:		1		2		3		4		5	
By:		VV		VV		VV					
Date:	initial	24/05/2023		31/08/2023		23/11/2023		#N/A		#N/A	
Crack ID	width mm	sprtn mm	chngs mm	sprtn mm	chngs mm	sprtn mm	chngs mm	sprtn mm	chngs mm	levels mm	chngs mm
A (horiz)	4.10	60.27	0.0	49.68		49.76	0.1		#N/A		#N/A
A (diag)		71.93	0.0	58.11	new	58.56	0.5		#N/A		#N/A
A (check)		40.85	0.0	41.06		41.00	-0.1		#N/A		#N/A
B	3.00	54.37	0.0	53.95	-0.4	55.03	0.7		#N/A		#N/A

A (horiz)	Demec triplet, external, garage LHS wall
B	Demec pair, external, garage rear wall
