Structural Report: An Teachin, Hawley Road, Dartford – Condition Report on Existing Stable Structure

Engineer: JGS Date: 08.03.21 Revision: 001

Structural condition report on existing period stable for conversion into permanent living accommodation.

Project Address(s):
An Teachin, Hawley Road, Dartford

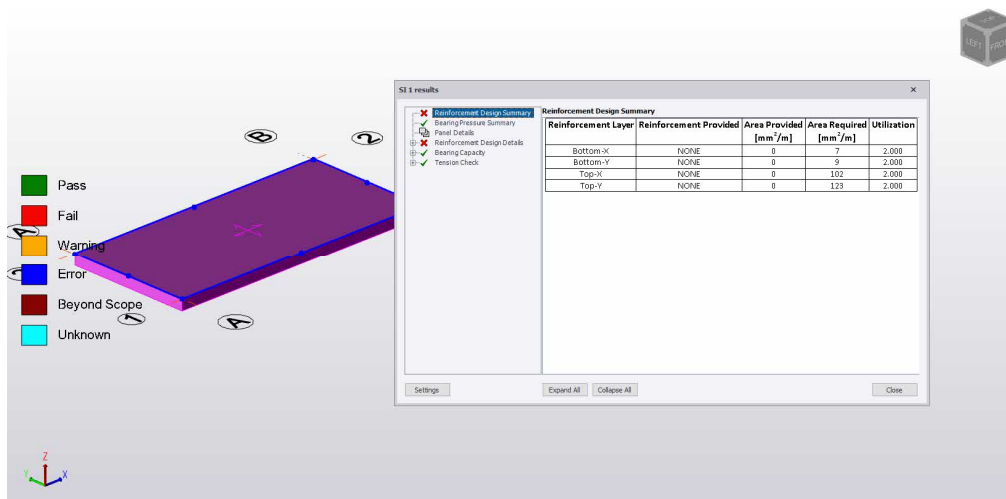
Existing slab failure:

The 300mm thk (+) ground bearing slab has been assumed to not include any reinforcement due to its age. Due to the depth of the raft and the period of soil consolidation that it will have been subjected to, an allowable ground pressure of 50 kN/m² has been considered. Preliminary bearing pressure calculation indicates a bearing pressure of 43 kN/m² for the proposed scheme and therefore the soil is suitable for the proposed scheme. Preliminary design indicates that the current slab fails under the minimum reinforcing and spacing required to Eurocode – requires H10 bars minimum, and for a 300mm slab @ 200mm centres (A393 mesh) top and bottom. In the proposed scheme, an FFL equal to the existing SSL has been given and consequently the proposed SSL will need to decrease to compensate for this change, effectively decreasing the depth of the slab. To do so, the slab will be broken out internally, reinforcing bars will be placed in the perimeter foundation in order to lap with the new thinner in-situ slab that will be recast. Decreasing the depth of the slab, speculatively to say 150mm, would allow the H10 bars to be placed at 250mm centres.
