ARBORICULTURAL ASSESSMENT REPORT

Lychgate, Church Side, Bishop Burton, Beverley, HU17 8QB

**PRI Ref:** 273767

**Survey Date:** 11/10/2023

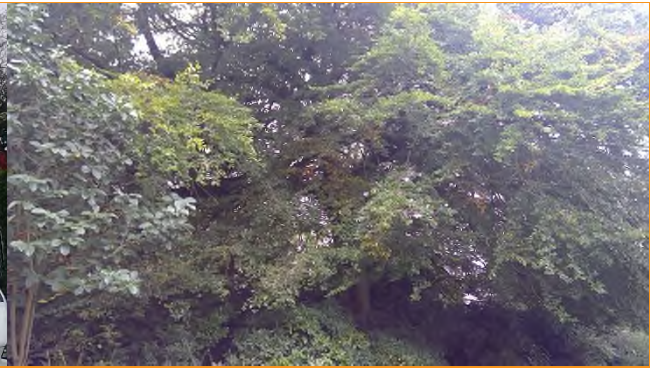
T1 - Beech (Common)

Tree No	Common Name	Age Class	Condition	Height (m)	Crown Spread (m)	Stem diam. (mm)	Dist to bldg. (m)	Roots Implicated	Pruning history	Recommendation	Tree work constraints	Notes	Owner address	Owner
G1	Rose	Young	Fair	1.5*	2*	10*	0*	Y	Subject to recent management.	No work required.		Roots have been identified but the pit was dug adjacent to the Roses. If problem persists this may be a factor.	Lychgate Church Side Bishop Burton Beverley HU17 8QB	PH
S1	Wisteria	Early Mature	Fair	3*	2	40	0	Y	Subject to past management.	Fell and treat stump with eco plugs (broadleaved).	Access through side gate.	Roots identified in the trial pit, remove and treat.	Lychgate Church Side Bishop Burton Beverley HU17 8QB	PH
T1	Beech (Common)	Over Mature	Fair	22*	18*	1013	2*	Y	Subject to past management.	Fell and treat stump with eco plugs (broadleaved).	Access through side gate.	Roots have been identified in the trial pit, Closest Beech to the property.	Lychgate Church Side Bishop Burton Beverley HU17 8QB	PH

Tree No:	Species	Works Required	CA	TPO	Ownership
S1	Wisteria	Fell and treat stump with eco plugs (broadleaved)	No	No	PH
T1	Beech (Common)	Fell and treat stump with eco plugs (broadleaved)	Yes	No	PH
T2	Apple	Fell and treat stump with eco plugs (broadleaved)	Yes	No	PH
T3	Apple	Fell and treat stump with eco plugs (broadleaved)	Yes	No	PH
T4	Oak	Fell and treat stump with eco plugs (broadleaved)	Yes	No	PH
T8	Apple	Fell and treat stump with eco plugs (broadleaved)	Yes	No	PH
T9	Whitebeam (Swedish)	Fell and treat stump with eco plugs (broadleaved)	Yes	No	PH
T10	Plum	Fell and treat stump with eco plugs (broadleaved)	Yes	No	PH
T11	Apple (Crab)	Fell and treat stump with eco plugs (broadleaved)	Yes	No	PH
T12	Pine	Fell close to ground level (approx. 50mm) (conifer)	Yes	No	PH

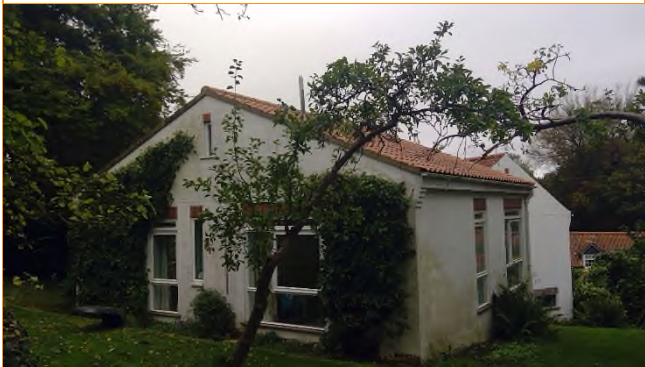
T2 - Apple

Tree No	Common Name	Age Class	Condition	Height (m)	Crown Spread (m)	Stem diam. (mm)	Dist to bldg. (m)	Roots Implicated	Pruning history	Recommendation	Tree work constraints	Notes	Owner address	Owner
T2	Apple	Semi-Mature	Poor	5*	3.0*	120	0.5*	Y	Subject to past management.	Fell and treat stump with eco plugs (broadleaved).	Access through side gate.	Roots have been identified in the trial pit.	Lychgate Church Side Bishop Burton Beverley HU17 8QB	PH
T3	Apple	Mature	Poor	12*	10*	320*	3*	Y	Subject to past management.	Fell and treat stump with eco plugs (broadleaved).	Access through side gate.	Roots identified in the trial pit.	Lychgate Church Side Bishop Burton Beverley HU17 8QB	PH
T4	Oak (English)	Semi-Mature	Good	17*	10*	440	7*	N	Subject to past management.	Fell and treat stump with eco plugs (broadleaved)..			Lychgate Church Side Bishop Burton Beverley HU17 8QB	PH
T5	Beech (Common)	Over Mature	Fair	22*	18*	1020	19*	N	Subject to past management.	No work required.		Closest growth to property is approximately 19 metres away. Tree is far enough away.	Lychgate Church Side Bishop Burton Beverley HU17 8QB	PH

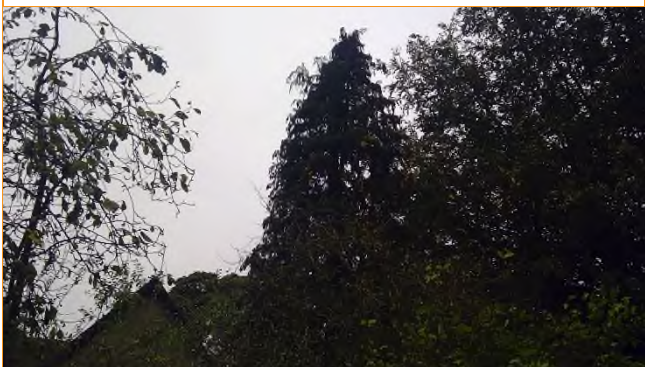
T6 - Cypress (Lawson)

Tree No	Common Name	Age Class	Condition	Height (m)	Crown Spread (m)	Stem diam. (mm)	Dist to bldg. (m)	Roots Implicated	Pruning history	Recommendation	Tree work constraints	Notes	Owner address	Owner
T6	Cypress (Lawson)	Mature	Good	16*	6*	300	15*	N	No significant past tree works.	No work required.		Tree far enough away from property.	Lychgate Church Side Bishop Burton Beverley HU17 8QB	PH
T7	Plum	Semi-Mature	Fair	7*	6*	120	8*	N	Subject to past management.	No work required.			Lychgate Church Side Bishop Burton Beverley HU17 8QB	PH
T8	Apple	Semi-Mature	Poor	5*	4*	320	0.3*	Y	Subject to past management.	Fell and treat stump with eco plugs (broadleaved).	Access through side gate.	Roots have been identified in the trial pit.	Lychgate Church Side Bishop Burton Beverley HU17 8QB	PH
T9	Whitebeam (Swedish)	Semi-Mature	Good	12*	6*	180	5.5*	Y	Subject to past management.	Fell and treat stump with eco plugs (broadleaved).	Access through side gate.	Roots have been identified in the trial pit.	Lychgate Church Side Bishop Burton Beverley HU17 8QB	PH

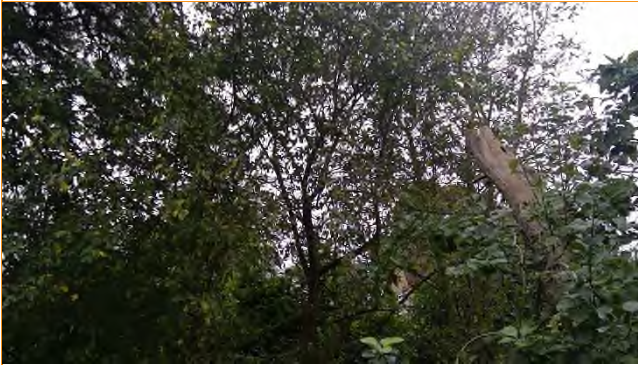
T10 - Plum

Tree No	Common Name	Age Class	Condition	Height (m)	Crown Spread (m)	Stem diam. (mm)	Dist to bldg. (m)	Roots Implicated	Pruning history	Recommendation	Tree work constraints	Notes	Owner address	Owner
T10	Plum	Semi-Mature	Fair	7*	6*	120	4*	N	Subject to past management.	Fell and treat stump with eco plugs (broadleaved).			Lychgate Church Side Bishop Burton Beverley HU17 8QB	PH
T11	Apple (Crab)	Young	Fair	5*	3.0*	90	4	Y	Subject to past management.	Fell and treat stump with eco plugs (broadleaved).	Access through side gate.	Roots identified in the trial pit.	Lychgate Church Side Bishop Burton Beverley HU17 8QB	PH
T12	Pine	Semi-Mature	Fair	16*	8	480	2*	Y	Subject to past management.	Fell close to ground level (approx. 50mm) (conifer).	Access through side gate.	Roots identified in the trial pit.	Lychgate Church Side Bishop Burton Beverley HU17 8QB	PH
T13	Apple (Crab)	Young	Fair	4*	5.0*	110	3	Y	Subject to past management.	Fell and treat stump with eco plugs (broadleaved).	Access through side gate.	Roots identified in the trial pit.	Lychgate Church Side Bishop Burton Beverley HU17 8QB	PH

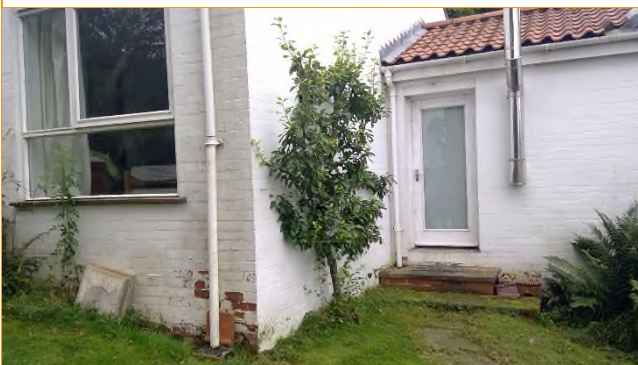
T14 - Pear

Tree No	Common Name	Age Class	Condition	Height (m)	Crown Spread (m)	Stem diam. (mm)	Dist to bldg. (m)	Roots Implicated	Pruning history	Recommendation	Tree work constraints	Notes	Owner address	Owner
T14	Pear	Young	Fair	3	2*	90	0	Y	Subject to past management.	Fell and treat stump with eco plugs (broadleaved).	Access through side gate.	Roots identified in trial pit.	Lychgate Church Side Bishop Burton Beverley HU17 8QB	PH

Tree No:	Species	Works Required	CA	TPO	Ownership
T13	Apple (Crab)	Fell and treat stump with eco plugs (broadleaved)	yes	No	PH
T14	Pear	Fell and treat stump with eco plugs (broadleaved)	Yes	No	PH
