30th November 2023

Our Reference: 16039 / 71634

TREE CONDITION SURVEY – OAK to the REAR OF 24 NASSE COURT, CAM

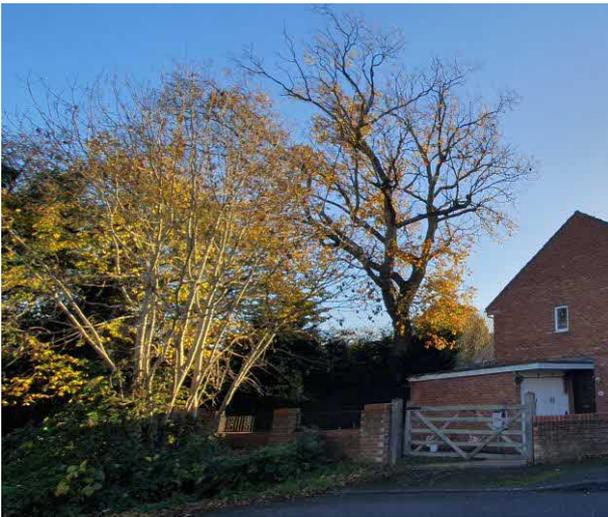
- 5.1 The tree is a large boundary specimen growing on the edge of an open culvert. Due to the hedge and steep bank, the rear and base of the tree could not be accessed or surveyed. The shed also prevented access to the lower trunk (see Photograph 1)

Photograph 1. Oak, overhanging rear garden

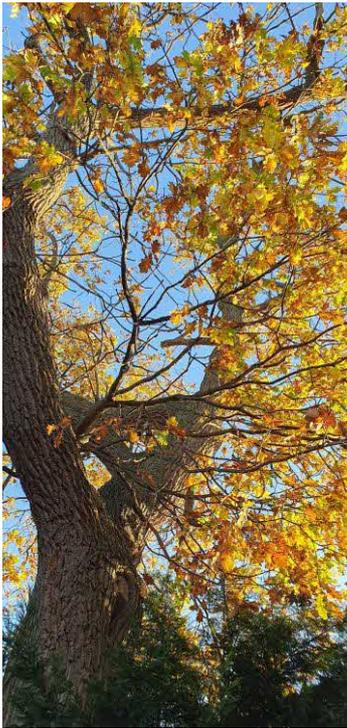
Photograph 2. Regenerating growth from reduction points and now in decline.

- 5.5 Large limbs extending over the garden which were previously reduced (see Photograph 2) had started to regrow, but are now showing evidence of reduced vitality, apical dieback and crown decline with limited epicormic growth evident on smaller upper branches.

- 5.7 The tree is in gradual decline, probably as a result of past garden, culvert and construction works resulting in root and soil damage. Previous pruning may have also contributed to the tree's loss of vitality. The extensive dead wood poses a risk to residents and visitors to the property and may pose a risk to the property from to large limb failure as the tree continues to decline.

- 6.2 Given the tree's ongoing decline, I recommend that consideration is given to reducing the tree to a 6-8 metre high pollard, retaining all lower epicormic growth and the larger stubs of main limbs. Larger branch stubs should be cut to leave natural looking fracture surfaces for habitat creation. The stress response from the pruning may stimulate the production of more epicormic growth creating a smaller compact crown, alternatively the tree may go into further decline and die but would pose a lower risk due to its reduced size.

- 6.3 This work would be best completed from a mobile elevated work platform which will allow small sections to be removed and safely dropped into the rear garden. These works should be completed within 6 months of survey.

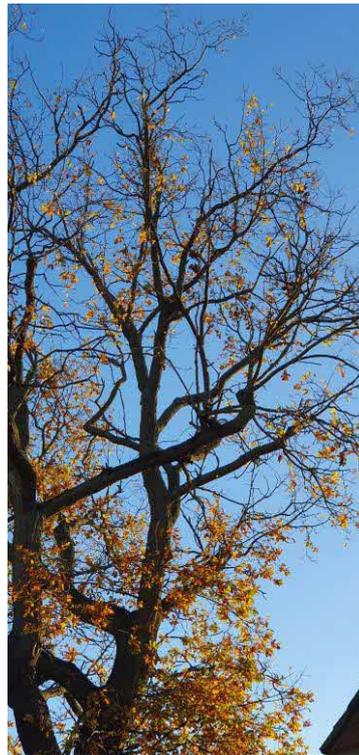
Photograph 3. Epicormic growth forming on upper trunk.

- 5.6 The tree has large dead wood present, together with extensive small twig and branch shedding. The tree has limited epicormic growth development on higher branches but some more prominent growth at around 3-4 metres from where the epicormic growth is starting to form (see Photograph 3).
