BS5837:2012 Tree Survey

**Land at Old Manse Stud
Station Road
Balfron
G63 0SX**

Survey Reference: BS_231206

Document Reference: BS_231206_SR

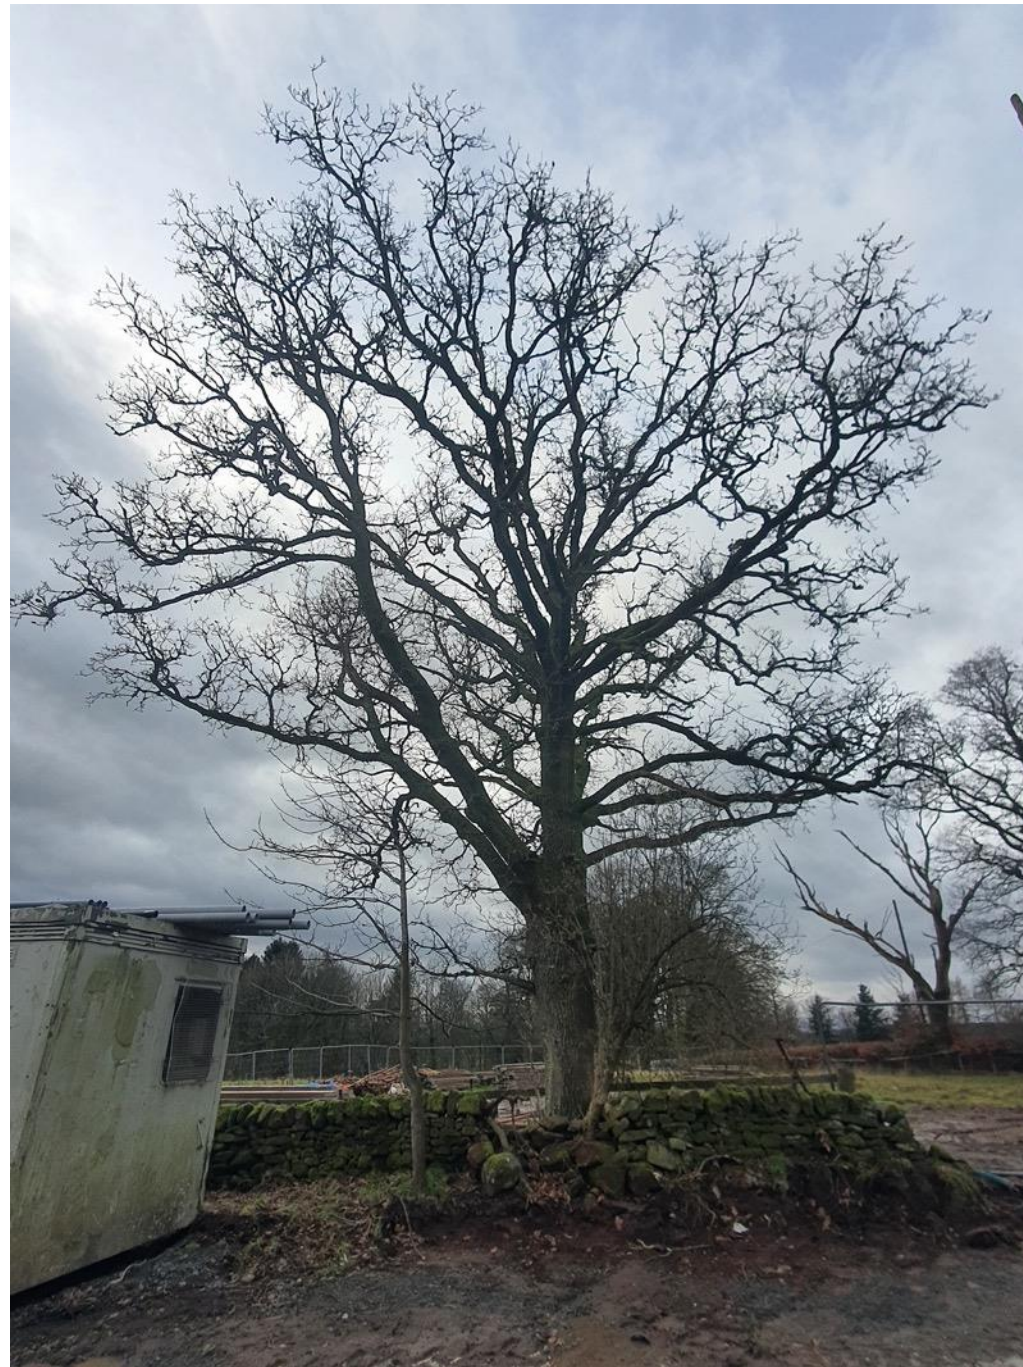
BS_231206 Land at Old Manse Stud, Balfroon Image No 01

6.2.1 Fairly substantial mature Oak specimens in reasonably good condition, constituting a significant feature on the local landscape. See Images No 01, 02 & 03 at Appendix 1, below.

Oak No 9719

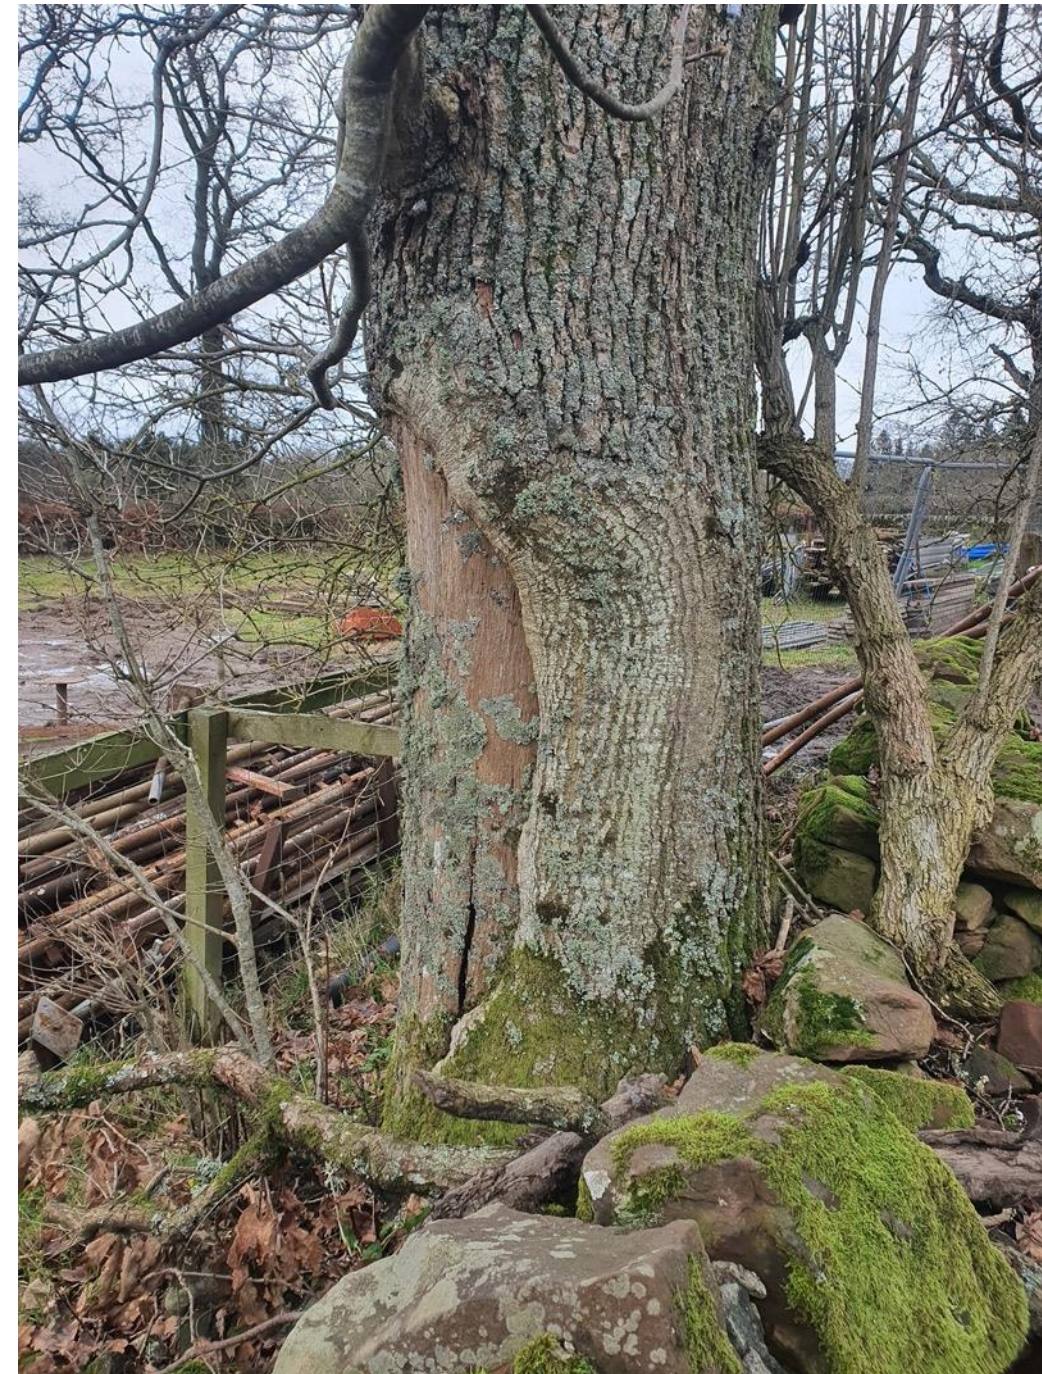
BS_231206 Land at Old Manse Stud, Balfroon Image No 02

6.2.2 Both indicate a range of deadwoods and fracture sites partly indicative of the exposed location, and No 9719 features a substantial trunk wound, currently undergoing effective compartmentalisation. See Image No 02 at Appendix 1, below. The Oaks are recorded in the survey at BS5837 Retention Category B2.

Oak No 9719, showing trunk wound with vigorous wound-wood developing

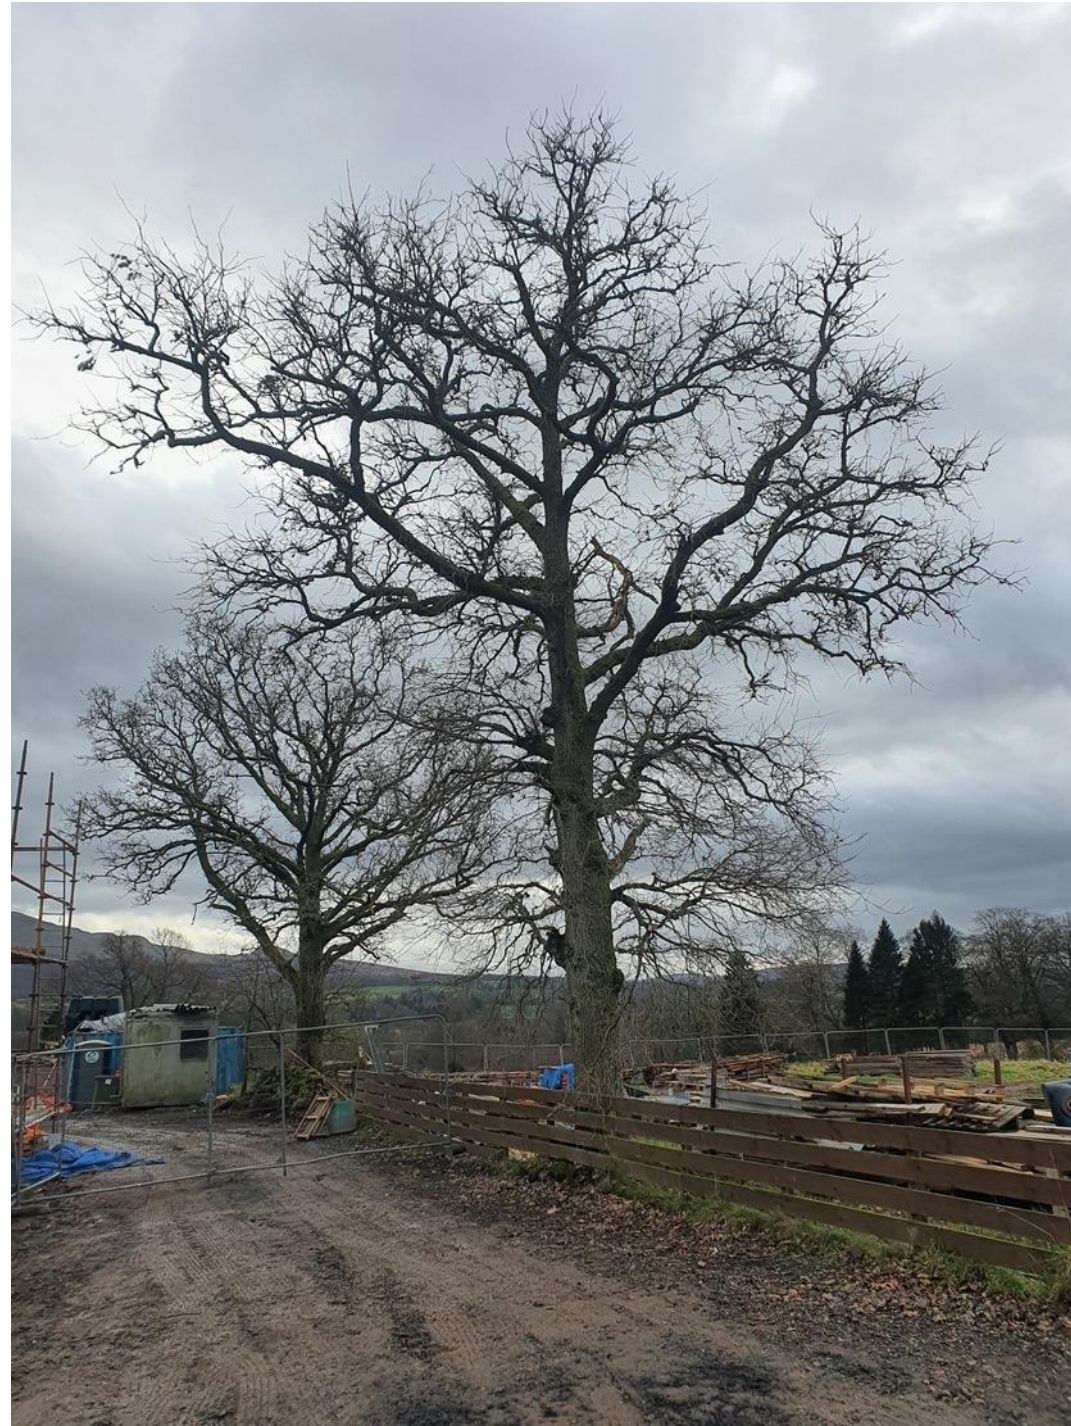
BS_231206 Land at Old Manse Stud, Balfron Image No 03
Oak No 9720 (In foreground)

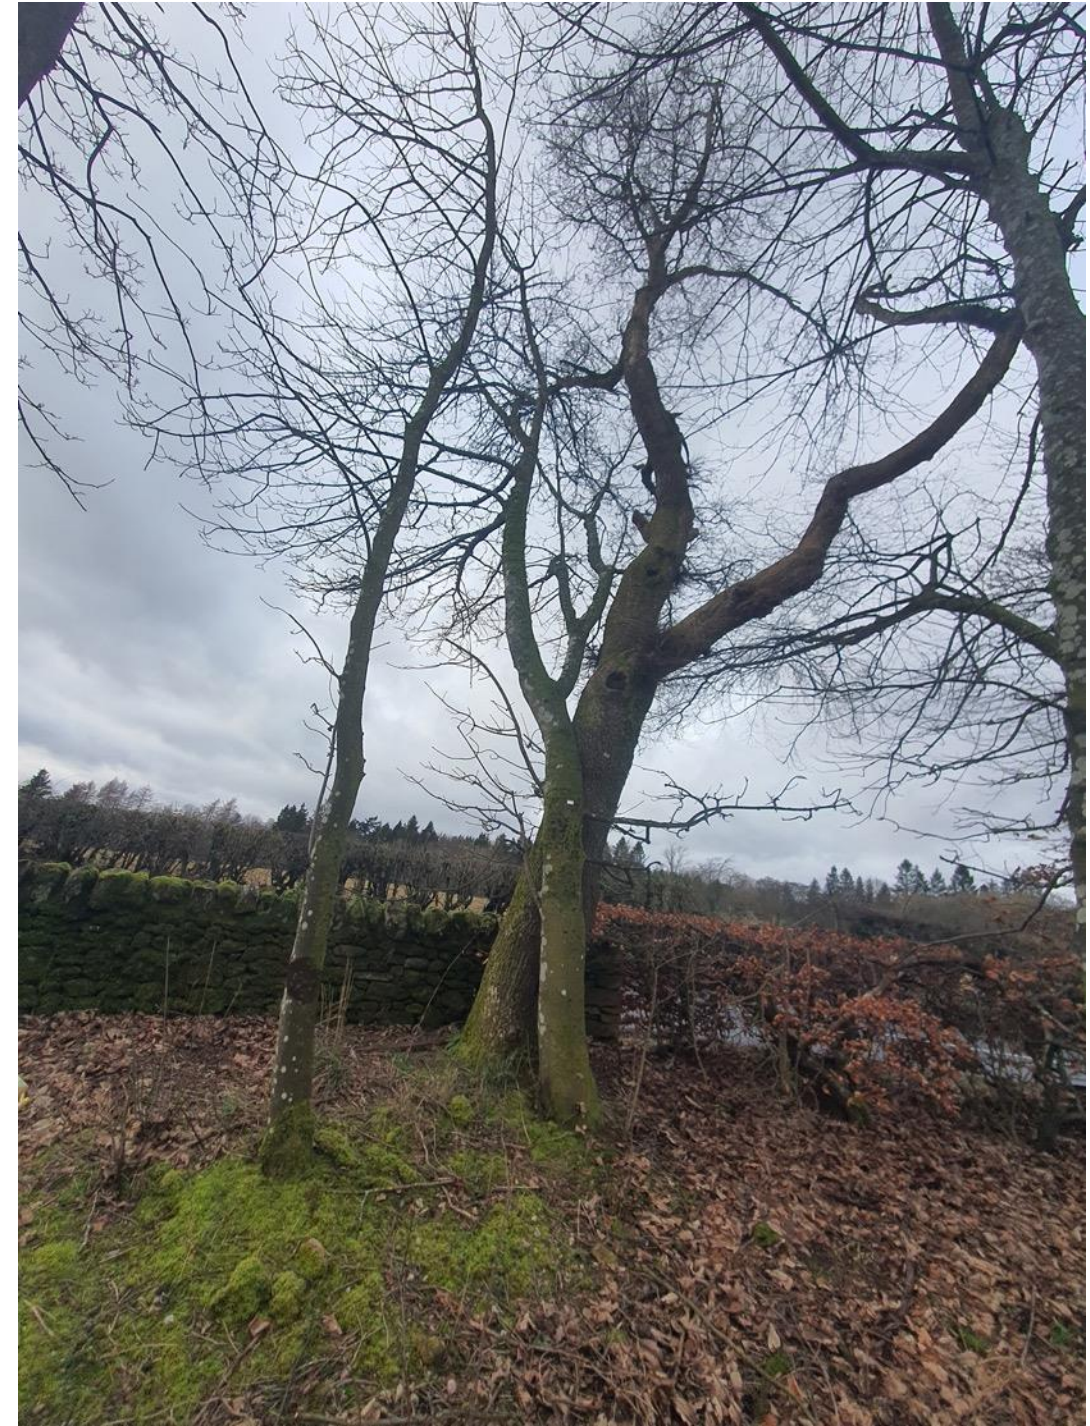
6.3.3 Oak 9725 is a less well-structured mature specimen indicating significant developmental suppression. See Image No 04 at Appendix 1, below. Both of these trees are recorded in the survey at BS5837 Retention Category B2.

BS_231206 Land at Old Manse Stud, Balfron Image No 04
Oak No 9725 on NE edge of site, showing suppressed development and smaller Sycamore impacting on trunk

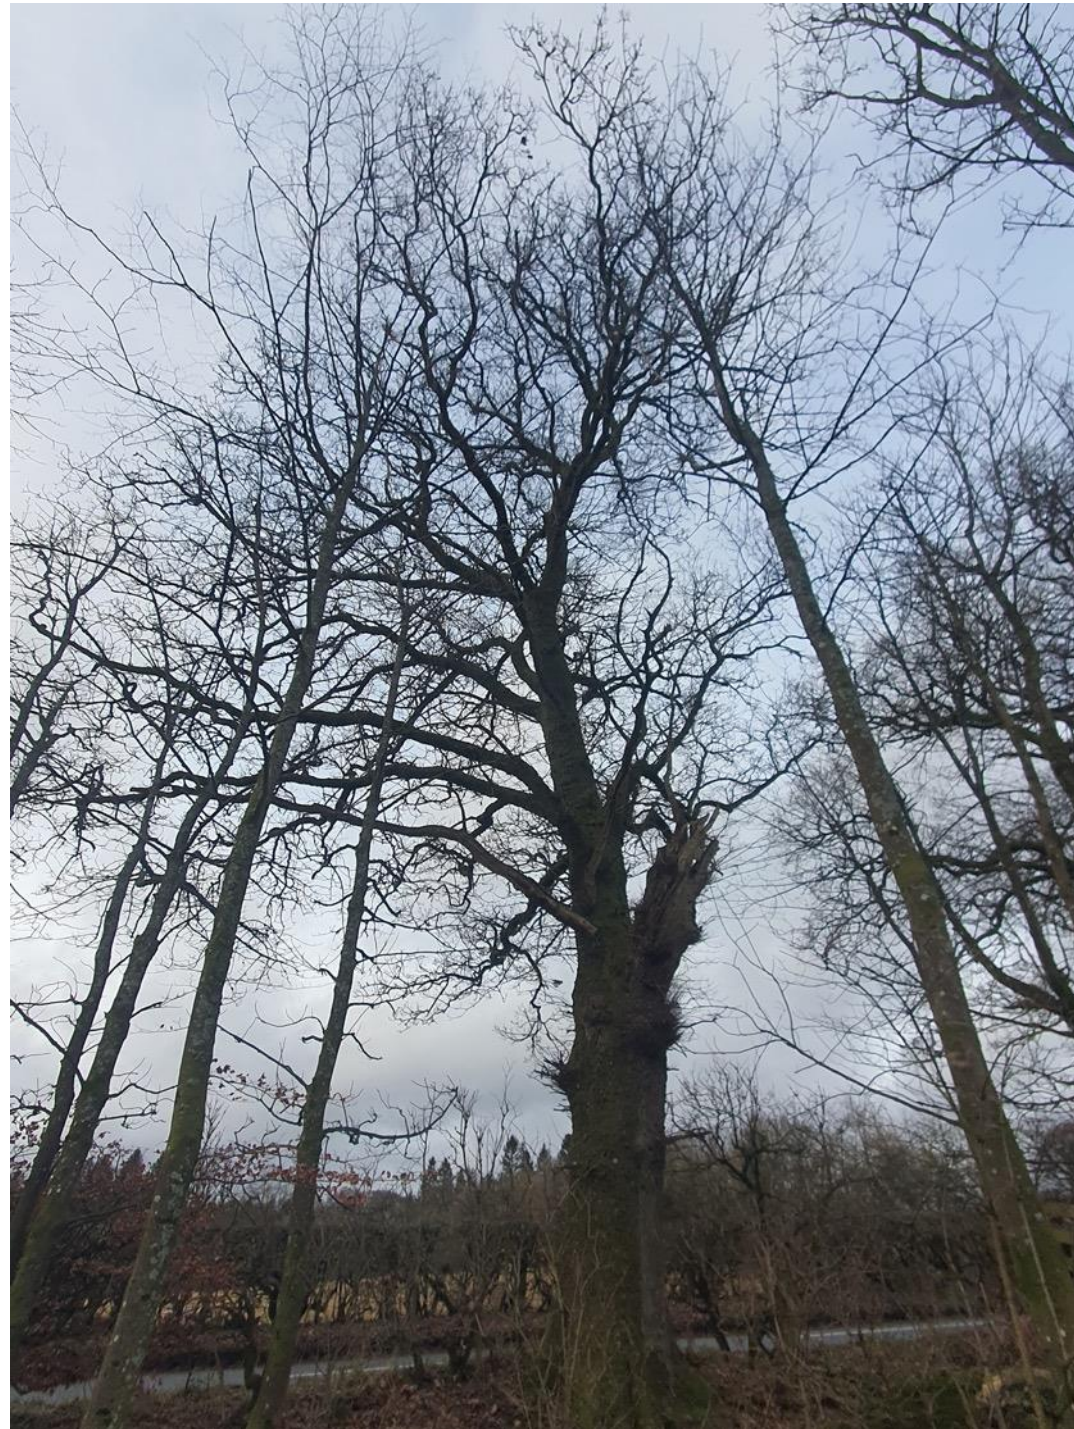
6.3.2 Oak No 9729 is a substantial tree, historically well-structured, but now featuring a large wound from the loss of a co-leader and with a decay cavity forming at the open fracture site. See Image No 05 at Appendix 1, below.

BS_231206 Land at Old Manse Stud, Balfron Image No 05
Oak No 9729 showing major fracture wound from loss of co-leader

9729	NS 54090.49 89085.72	Pedunculate Oak, <i>Quercus robur</i>	Mature	20	970	N:7 E:6 S:7 W:8	5(SW)	5	Radius: 11.6m. Area: 423 sq m.	Fair to Good	Fair	Substantial mature roadside specimen SE co-leader fractured at 4.0m leaving open tear wound on stump Multiple deadwoods and historic branch fracture points	—	—	20+ Years	B2	Image No 05
9730	NS 54091.81 89081.28	Sycamore, <i>Acer pseudoplatanus</i>	Early Mature	9	210	N:1 E:2 S:2 W:2	2(NW)	2	Radius: 2.5m. Area: 20 sq m.	Fair	Fair	Minor specimen on S side of roadside grouping Crown development substantially suppressed from N Specimen indicating generally depleted vigour	—	—	10+ Years	C2	—

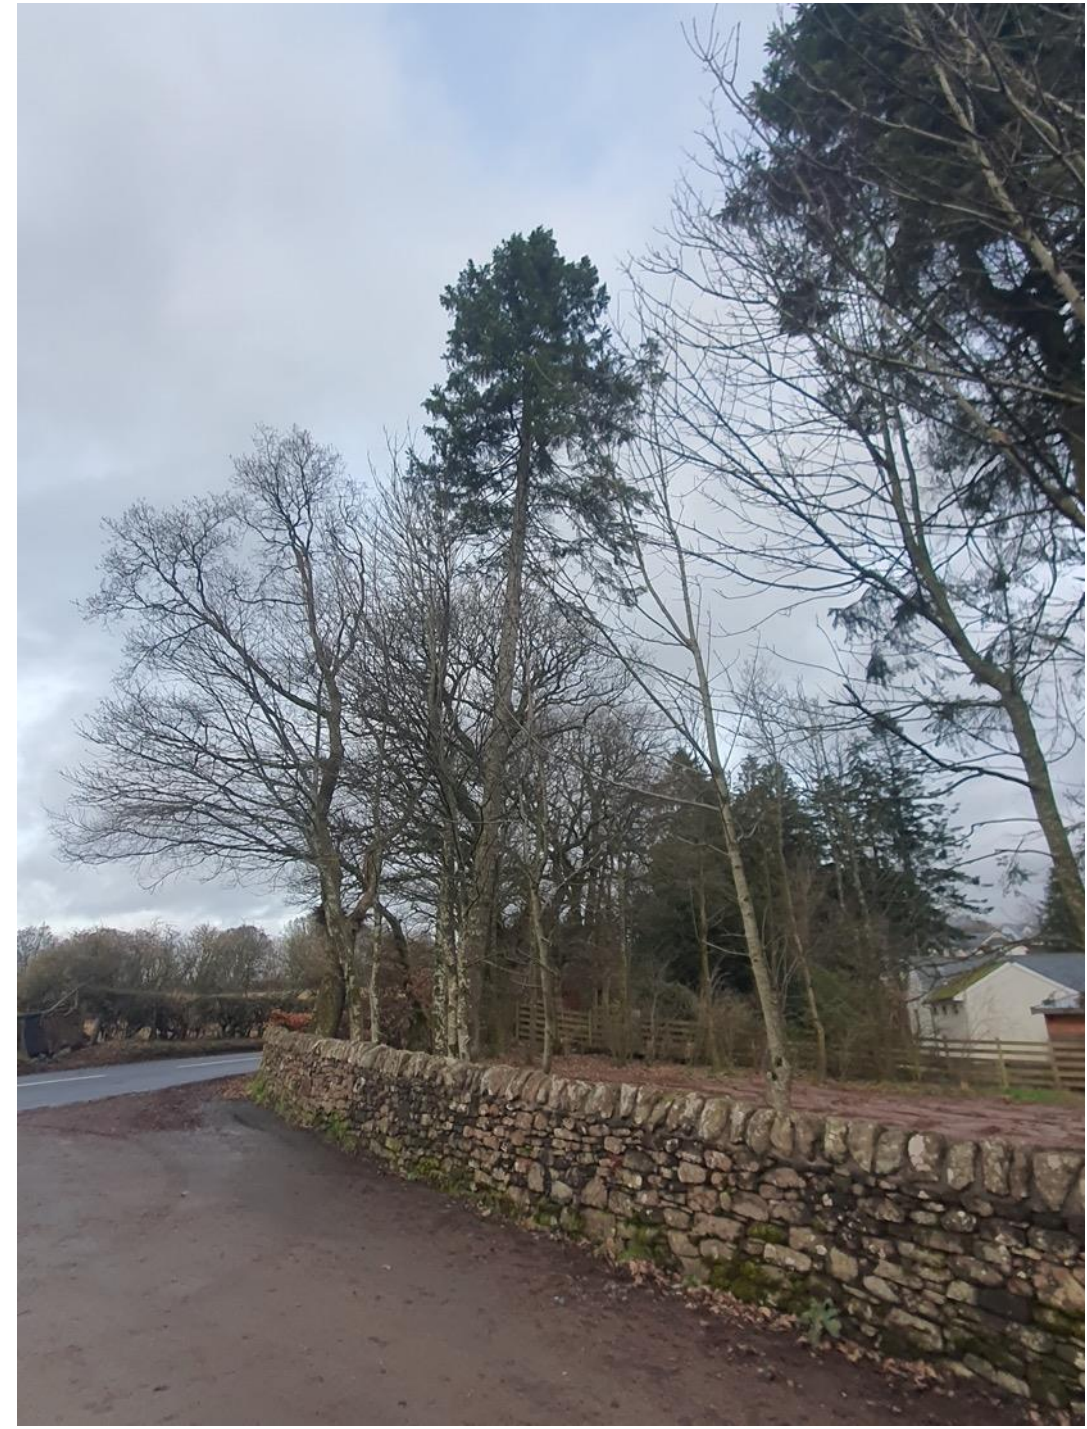
6.3.1 The site perimeter to the north of the current development area features a small mixed-species wooded group, generally populated by self-seeded trees of modest stature but featuring occasional older, more substantial specimens. See Image No 06 at Appendix 1, below.

BS_231206 Land at Old Manse Stud, Balfron Image No 06
Tree group G1 (and individually recorded constituent specimens), from SW

Tree Groups																	
G1	NS 54084.04 89071.89	Sycamore, <i>Acer pseudoplatanus</i>	Early Mature	10	130	N:1 E:1 S:1 W:1	1(N)	1	Area: 545 sq m.	Fair	Fair	Background canopy of minor self-generated trees within loosely-structured group Compromised predominantly of low-quality stretched Sycamores offering limited development potential	—	—	10+ Years	C2	Image No 06
