JACKDAWS CASTLE

HIGHCLERE CASTLE

Scope of Works and Heritage Impact Assessment

Job No: 3878
January 2024

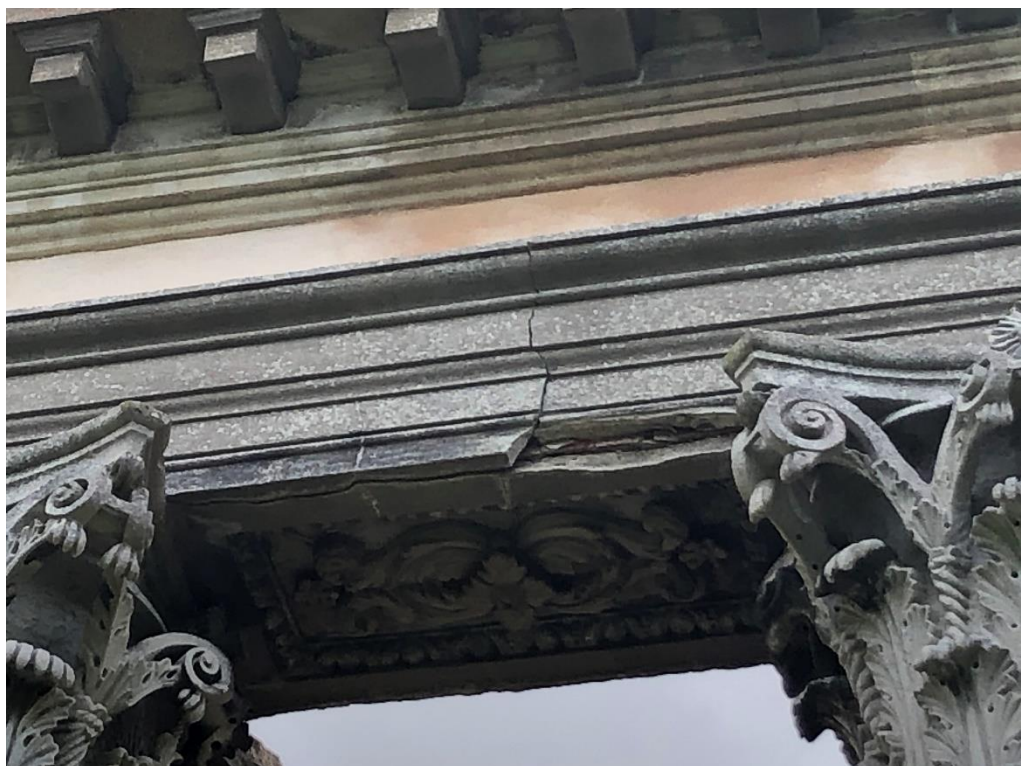
The section of render has been stored at the base of the structure below where it has fallen. This is the banded frieze directly above the colonnade to the western elevation (facing the castle). Cracking is noted to the remaining sections both to the underside between the columns and through the height of the rendered panel. The brickwork to the masonry wall beneath is evident, the render is approximately 30mm thick at its thinnest.

Fallen section of render, note cracking. Sound render above

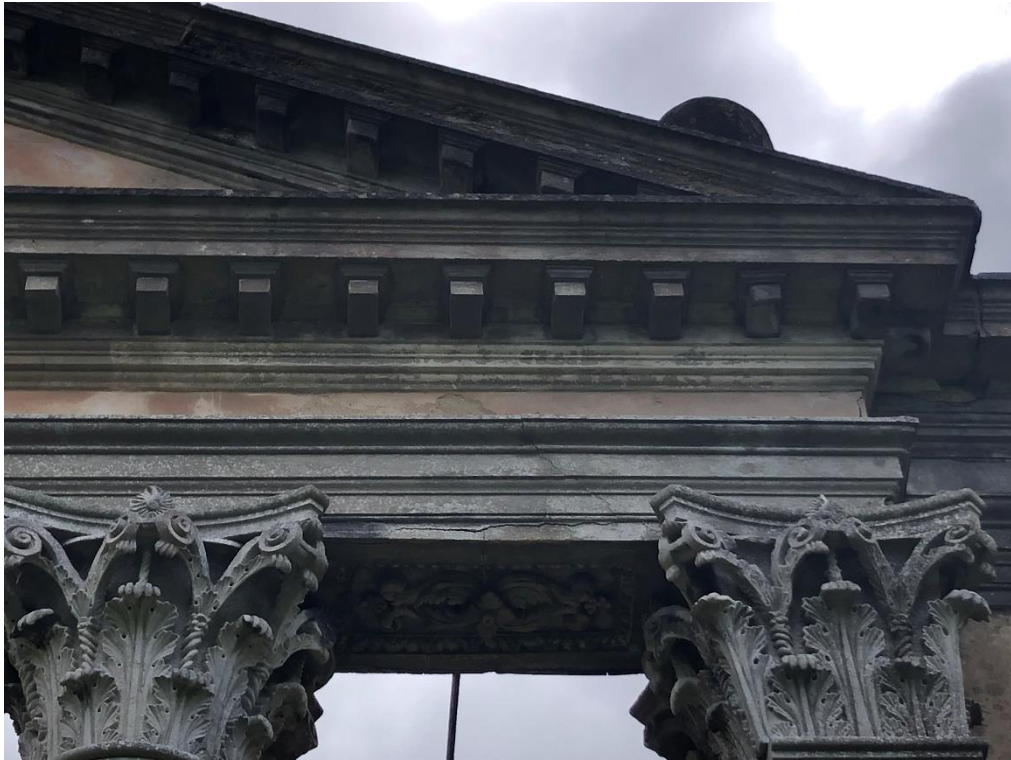
Adjacent cracking to render

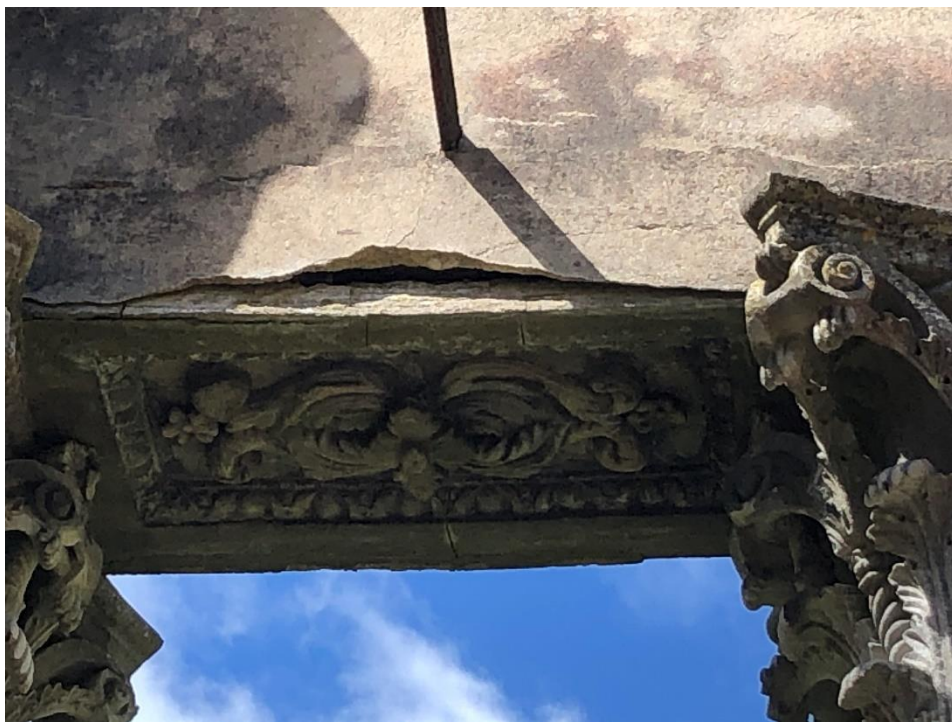
Cracking to base of internal render lining

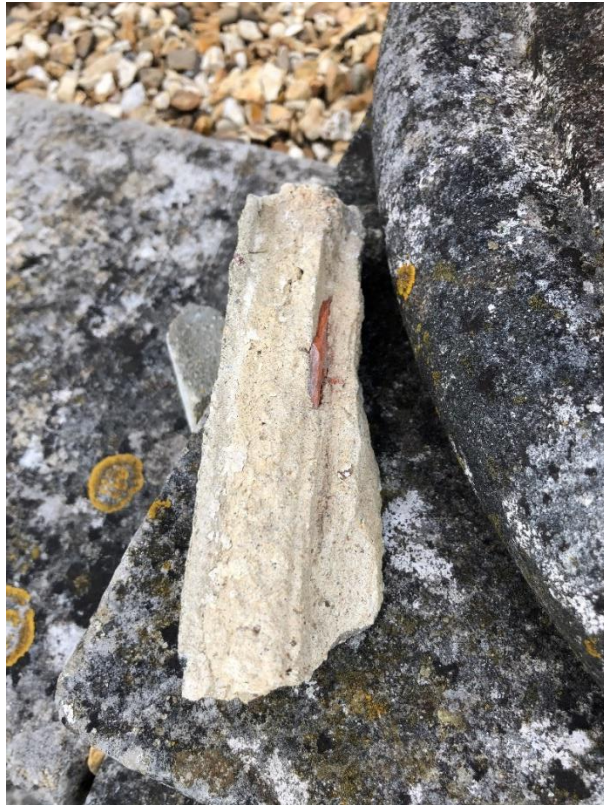
Fallen piece of render and brick substrate at ground level

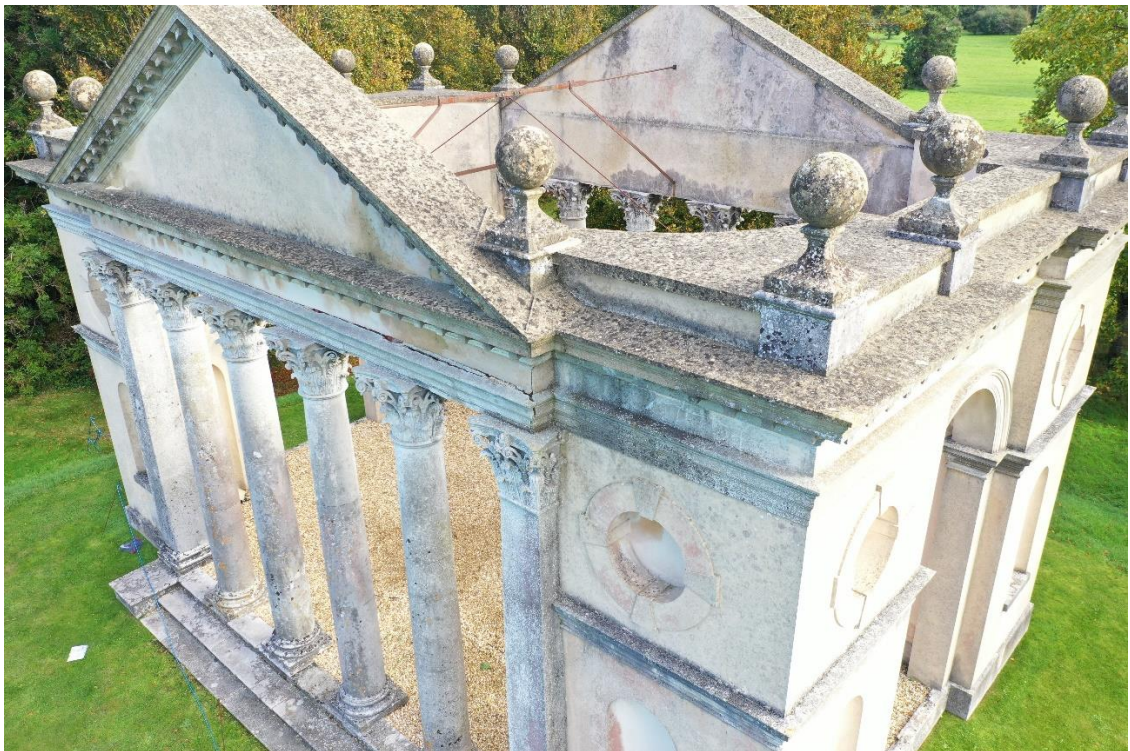
The cracking continues along the full length of the string course to the west elevation. Similar cracking is not visible on the drone photographs to remaining elevations, however this will need to be verified off scaffold.

Full length crack above string course from south-west corner

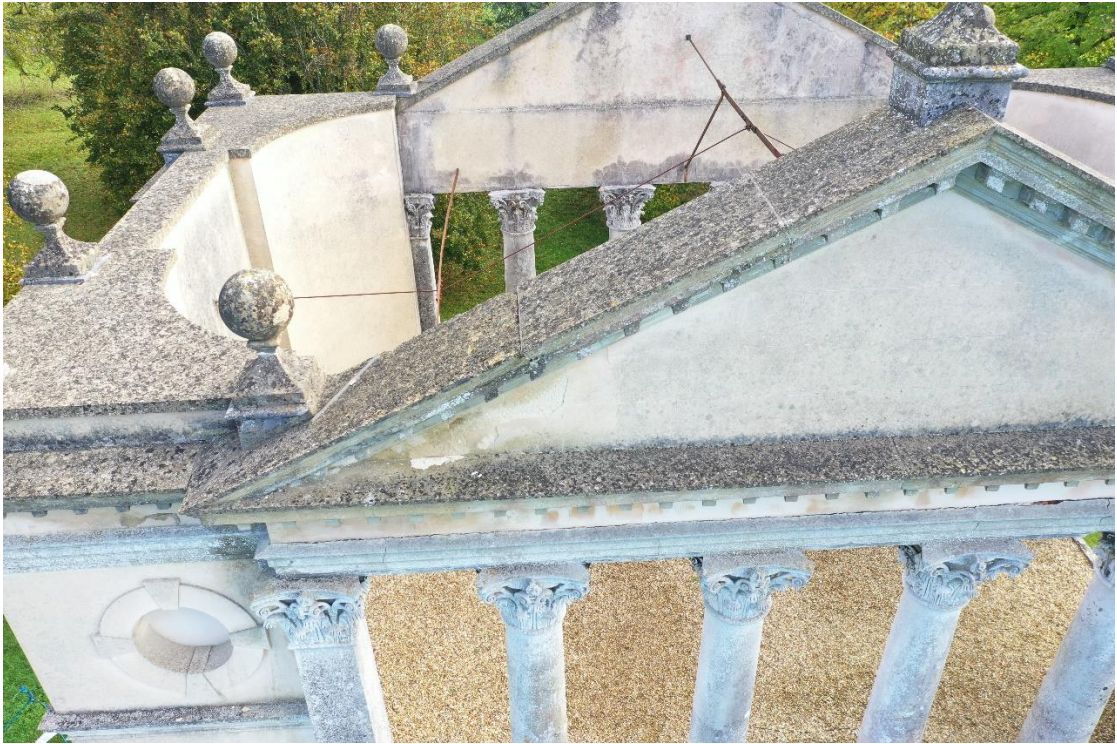
Finer crack to north-west end of west string course – full length

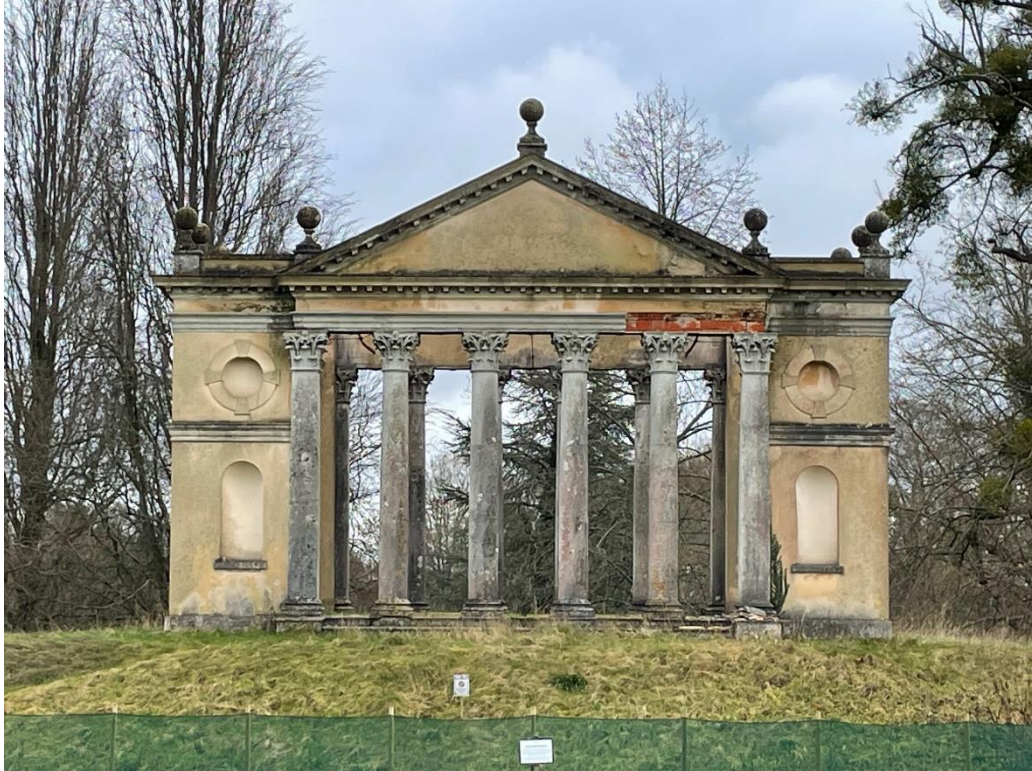
Since the original LB application for repair of the string course, the condition of the render has deteriorated and a large section of profiled string has collapsed. This will now require repair in new 3 coat render work mixed and profiled to match.

General view December 2023 showing collapsed section of string

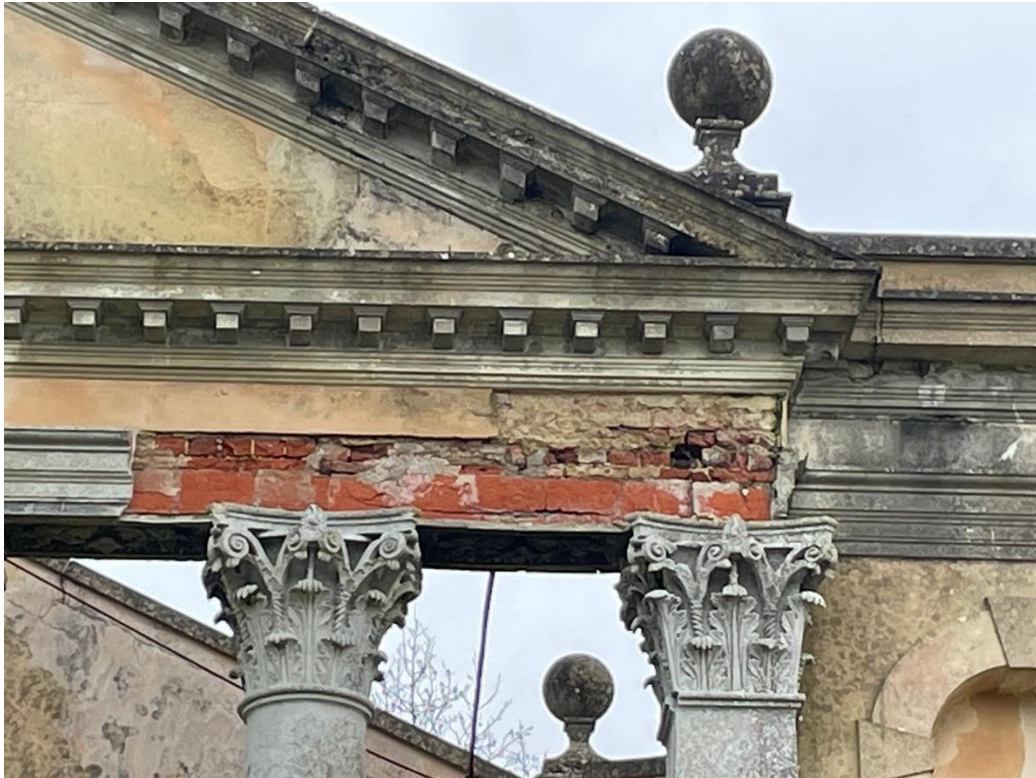
Close up of collapsed string and brick substrate
