2 North Lane

Asbestos Refurbishment Survey

2 North Lane BS23 1QR

Surveyed On: 9 Nov 2023

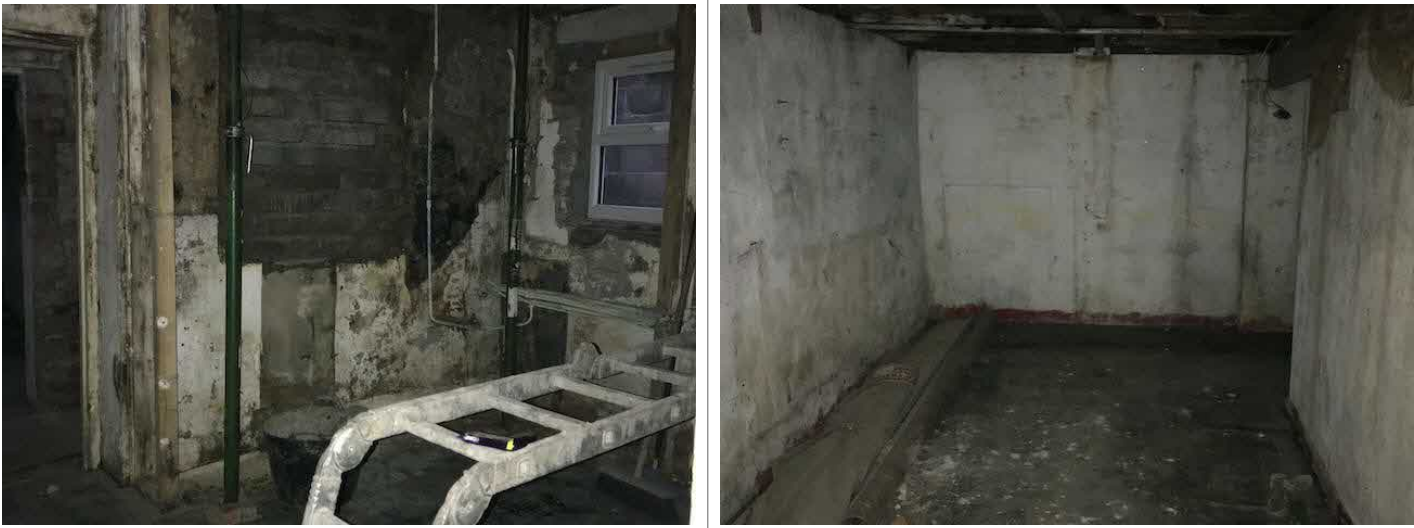
Main Building > 0 > Back Rooms > Location Notes

Location Notes	No suspected Asbestos Containing Materials (ACM's) located during inspection

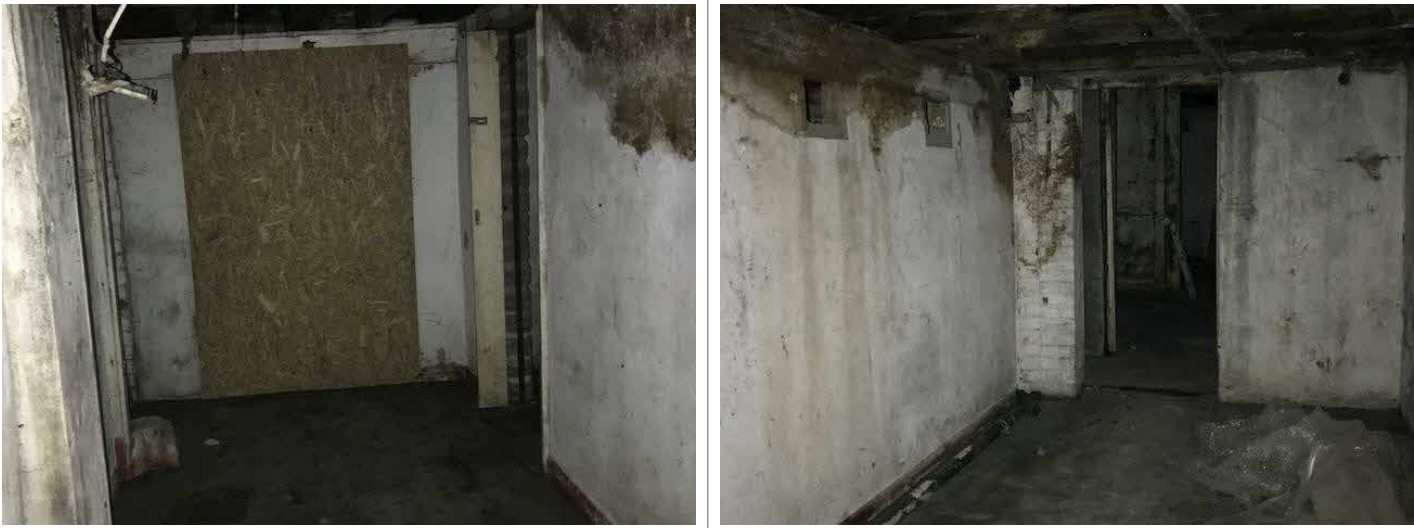
Main Building > 0 > Back Rooms > Location Notes

Location Notes	No suspected Asbestos Containing Materials (ACM's) located during inspection

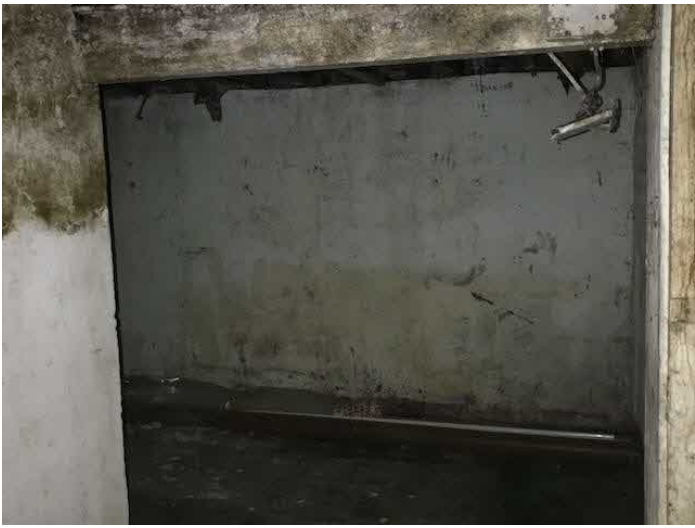
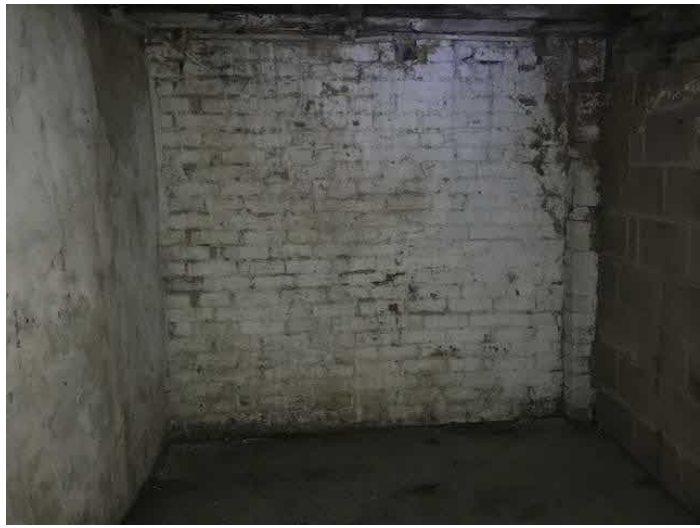
Main Building > 0 > Back Rooms > Location Notes

Location Notes	No suspected Asbestos Containing Materials (ACM's) located during inspection

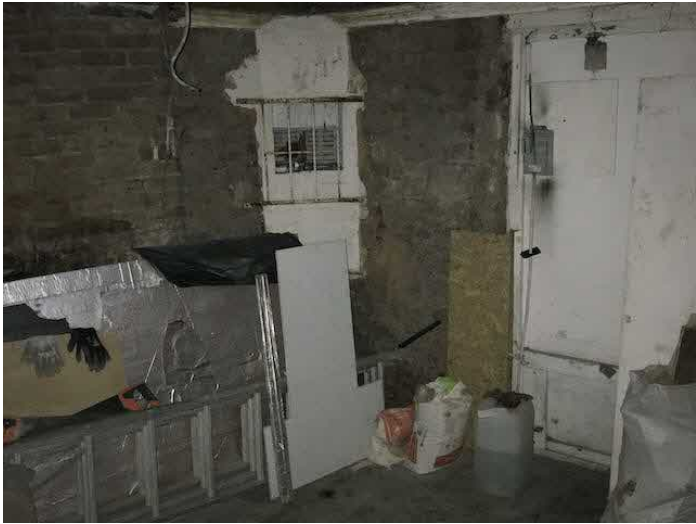
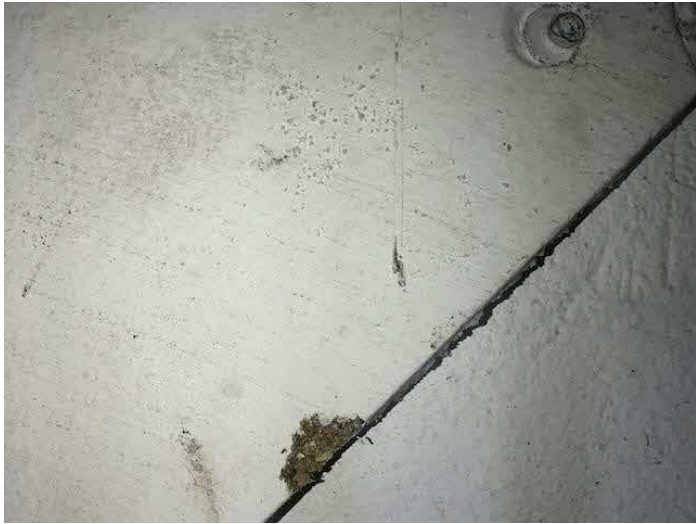
Main Building > 0 > Entrance Room > 1

Building	Main Building	Level	0
Location	Entrance Room	Item	1
Material	Insulation Board	Extent	600 x 600

Strategy / Sample Id	Sample / 11	Fibre Type	NADIS
General Comments	<p>Upon Sampling, it was apparent that the material was actually chipboard. However, where the previous identification of the area's presumption was to be containing ACM's was insufficient, a sample "no 11" was generated to confirm the presence of ACM's or not.</p> <p>The reason the sample is called Number 11 is to clearly separate it from the other 4 samples that were taken on the previous visit. There are no missing samples numbered between this sample and the previous samples taken separately</p>

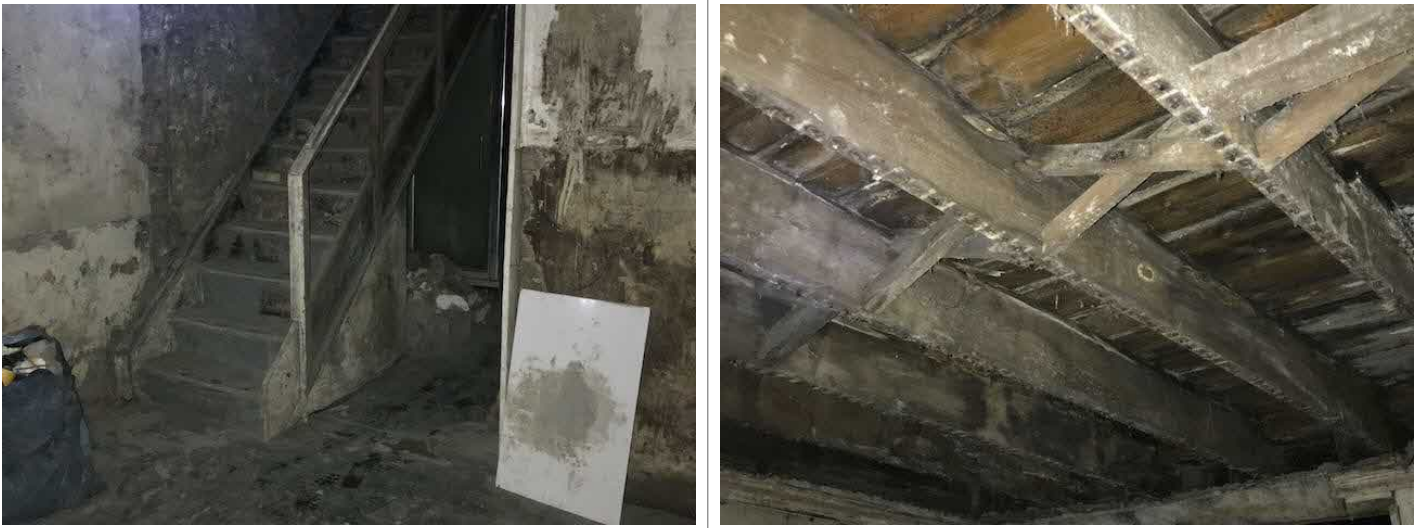
Main Building > 0 > Entrance Room > Location Notes

Location Notes	No suspected Asbestos Containing Materials (ACM's) located during inspection

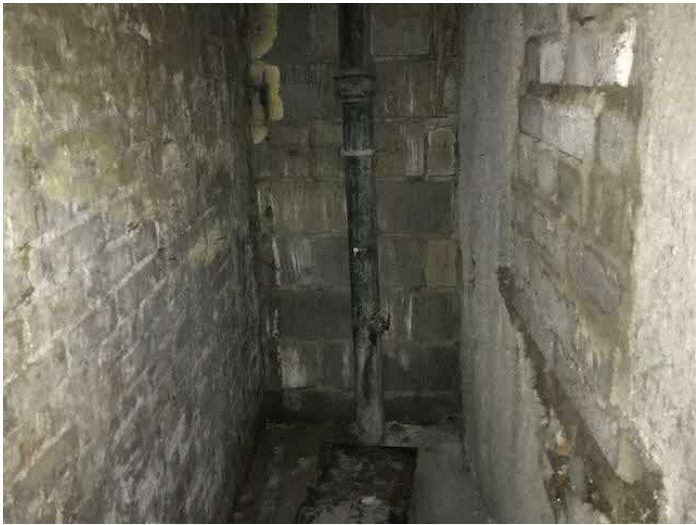
Main Building > 0 > Storage Area (VERTICAL PIPE) located on right between front and back rooms. > 2

Building / Level / Location	Item	Material	Material Score	Recommendation	Page
Main Building / 0 / Storage Area (VERTICAL PIPE) located on right between front and back rooms.	2	Cement	5 Low	Remove	15

Building	Main Building	Level	0
Location	Storage Area (VERTICAL PIPE) located on right between front and back rooms.	Item	2
Material	Cement	Extent	2 to 4 Lm Visible during inspection

Strategy / Sample Id	Sample / 1	Fibre Type	Amosite and Chrysotile
Recommendation	Remove		
General Comments	Removals quotation to follow.

Product Type (or Debris from Product)	1	Extent of Damage / Deterioration	1
Surface Type / Treatment	1	Asbestos Type	2
Material Score	5 / Low

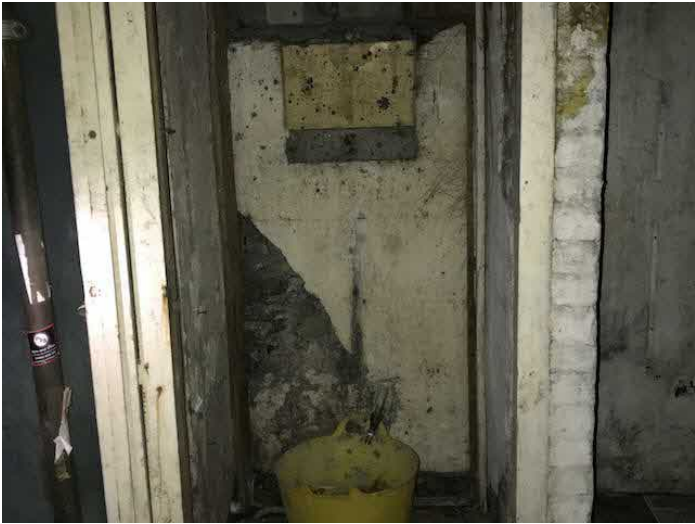
Main Building > 0 > Storage Area between front and back rooms > Location Notes

Location Notes	No suspected Asbestos Containing Materials (ACM's) located during inspection

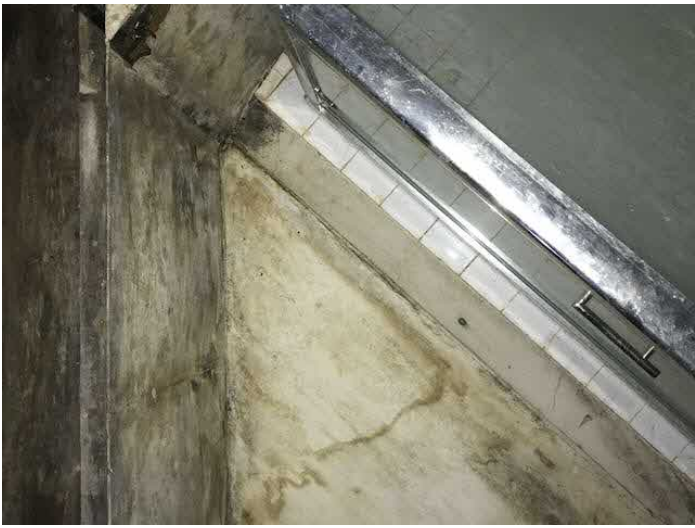
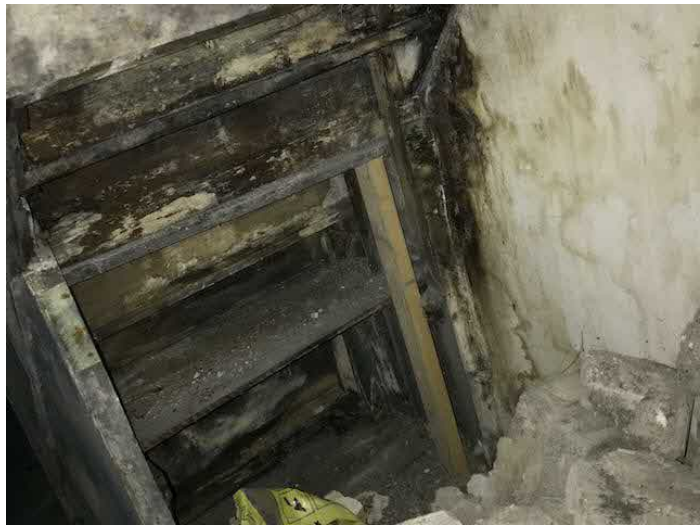
Main Building > 0 > Under Staircase > Location Notes

Location Notes	No suspected Asbestos Containing Materials (ACM's) located during inspection

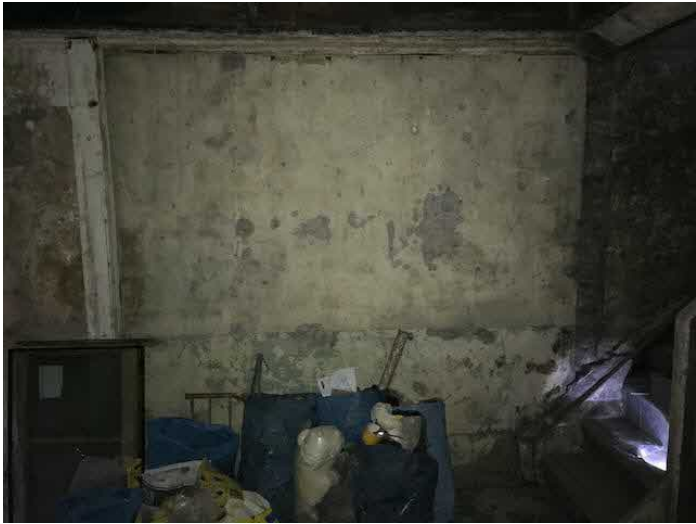
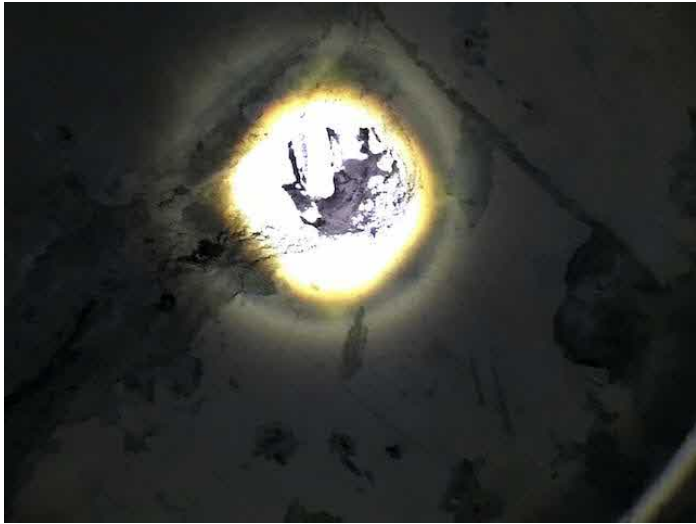
Main Building > 0 > Walls > 6

Building	Main Building	Level	0
Location	Walls	Item	6
Material	Brick and Mortar	Extent	Throughout

Strategy / Sample Id	Sample / 21	Fibre Type	NADIS
General Comments	<p>The previous identification of the area's presumption was to be not containing ACM's. However this was insufficient, so sample "no 21" was generated to confirm the presence of ACM's or not.</p> <p>The reason the sample is called Number 21 is to clearly separate it from the other 4 samples that were taken on the previous visit and to separate the sample from Sample 11. There are no missing samples numbered between this sample and the previous samples taken separately.</p>

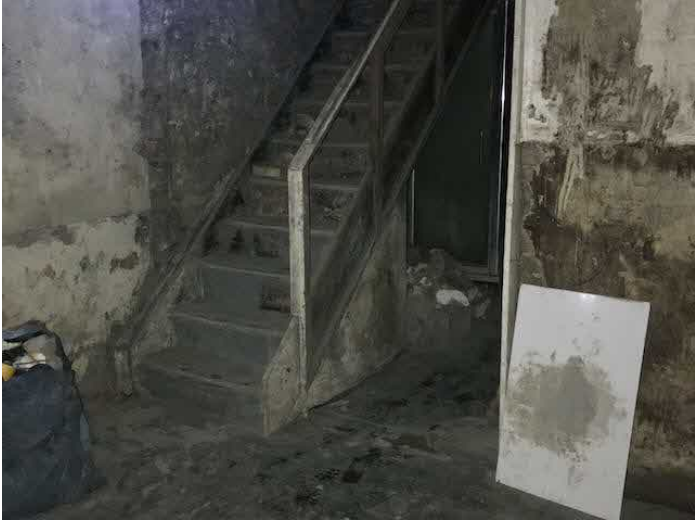
Main Building > 0 / 1 > Stairs > 4

Building	Main Building	Level	0 / 1
Location	Stairs	Item	4
Material	Thermoplastic Floor Tile Light In Colour	Extent	3 m2

Strategy / Sample Id	Sample / 2	Fibre Type	NADIS

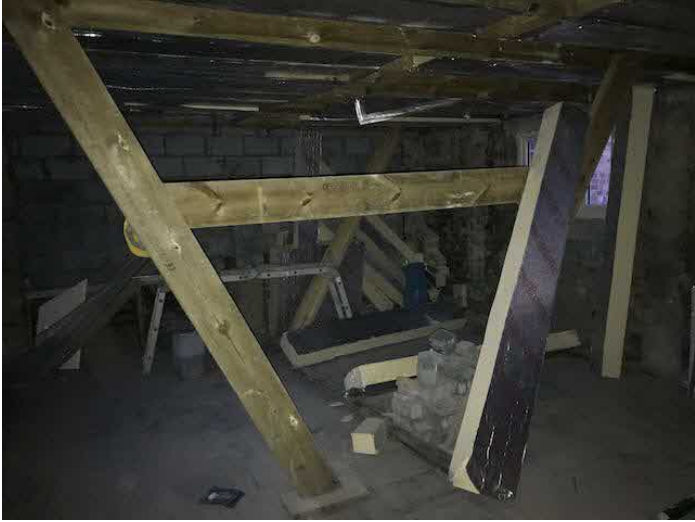
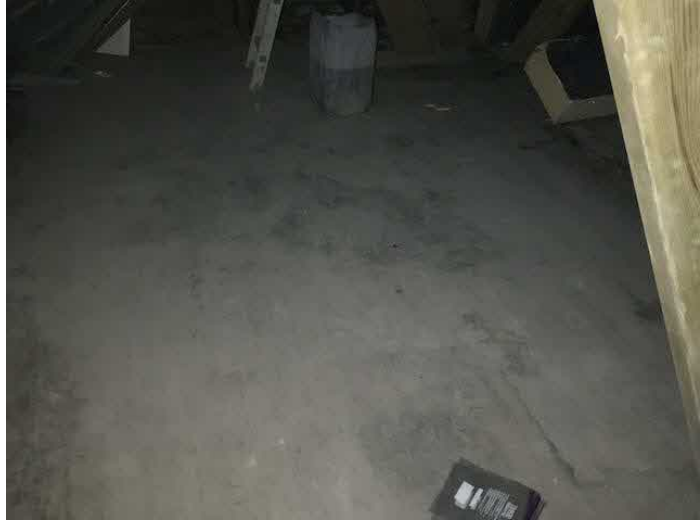
Main Building > 1 > Back Room Laminate / Wood Flooring > 4

Building	Main Building	Level	1
Location	Back Room Laminate / Wood Flooring	Item	4
Material	Adhesive	Extent	6 m2

Strategy / Sample Id	Sample / 4	Fibre Type	NADIS

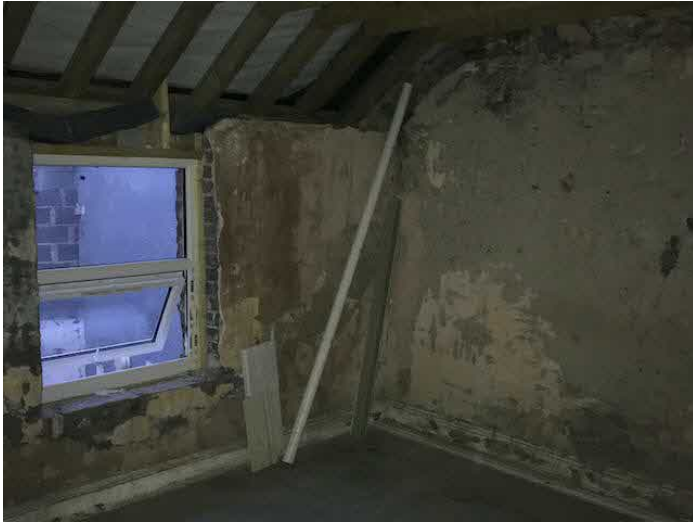
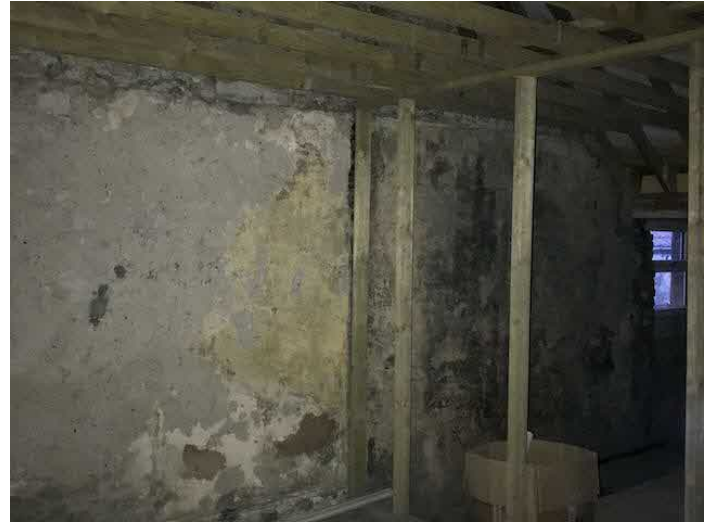
Main Building > 1 > Front Room > 3

Building	Main Building	Level	1
Location	Front Room	Item	3
Material	Thermoplastic Floor Tile Light In Colour	Extent	40 m2

Strategy / Sample Id	Strongly Presume / 2	Presumed Fibre Type	NADIS
----------------------	----------------------	---------------------	-------

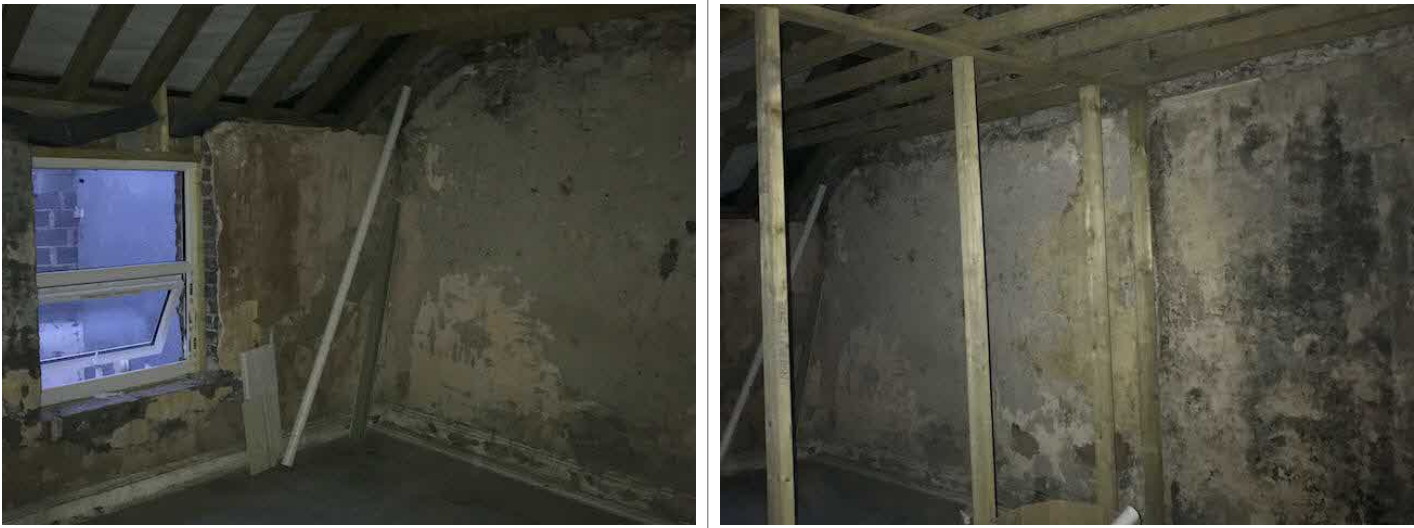
Main Building > 1 > Roof > Location Notes

Location Notes	Newly installed Roof. No suspected Asbestos Containing Materials (ACM's) located during inspection

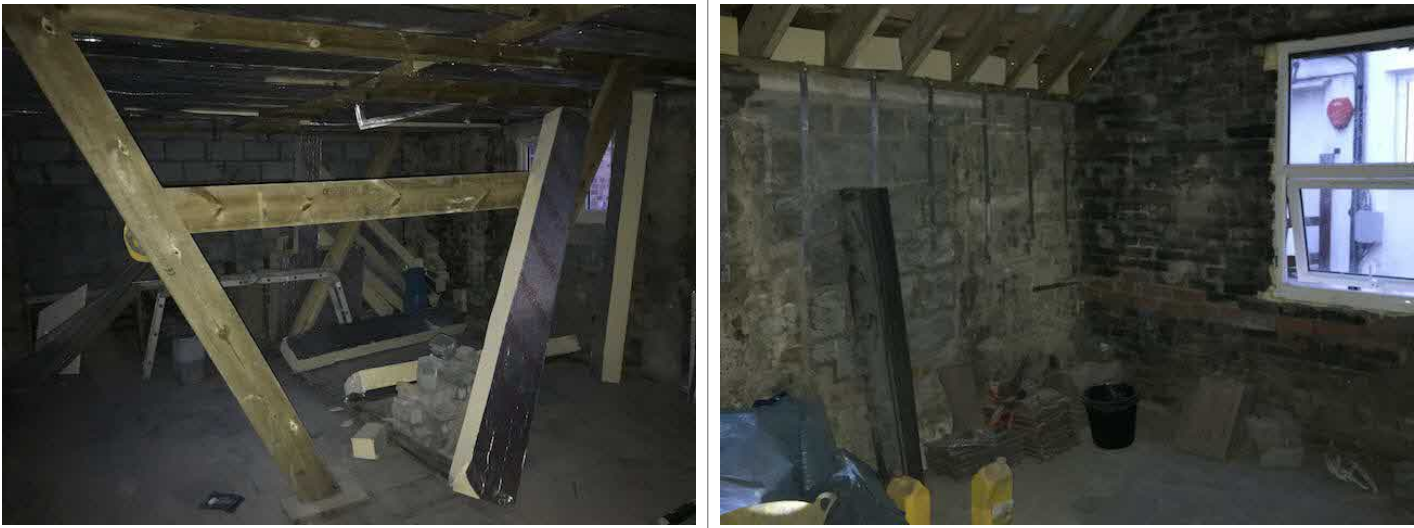
Main Building > 1 > Roof > Location Notes

Location Notes	New Roof Installation No suspected Asbestos Containing Materials (ACM's) located during inspection
