Tree Hazard Evaluation

For Mr. R. D'Costa

85 Sutherland Close, Ascot, SL5 8TE

Job Reference: 03373R

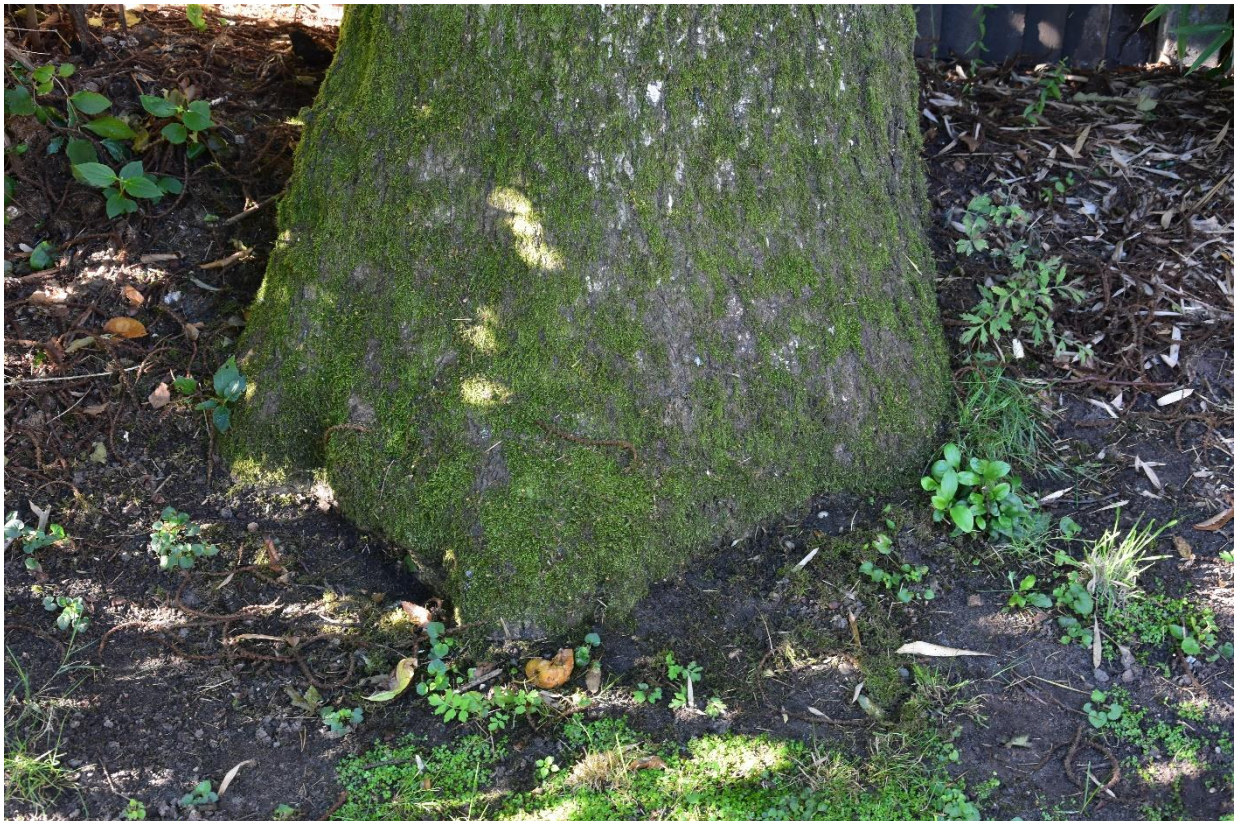
- 6.1 The tree is a mature example and space inhibited the use of a hypsometer to measure the tree but it appears approximately 18m in height. The tree is located within the rear garden close to the boundary fence.
- 6.2 The basal area has a minor deformity of bark formation at its base but nylon headed hammer soundings suggested there is not decay in this area and there were no open cavities on the lower stem.

Fig 1 – The lower stem area of T1 showed no sign of established decay or evidence the tree is moving on the root plate.

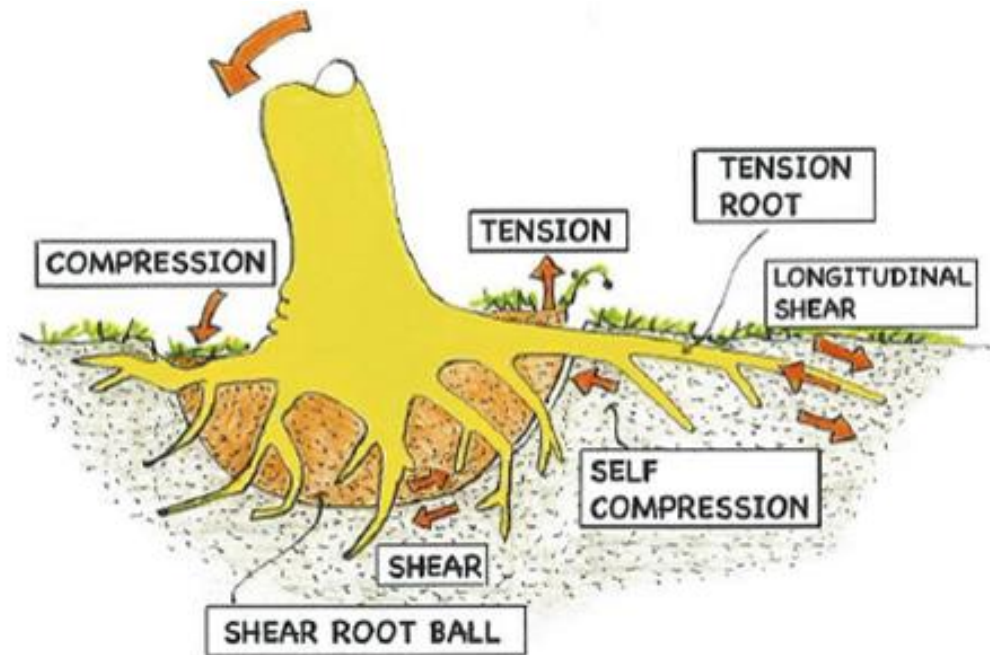
- 6.3 There is a minor pruning wound visible at approximately 3m above ground level and whilst decay will be developing in this area there was no evidence to suggest this was an issue for the tree. We would recommend being vigilant to the potential emergence of any decay fungi around such pruning wounds.

Fig 2 – The root plate of T1 appears normal with the above diagram (Mattheck) showing the likely forces.

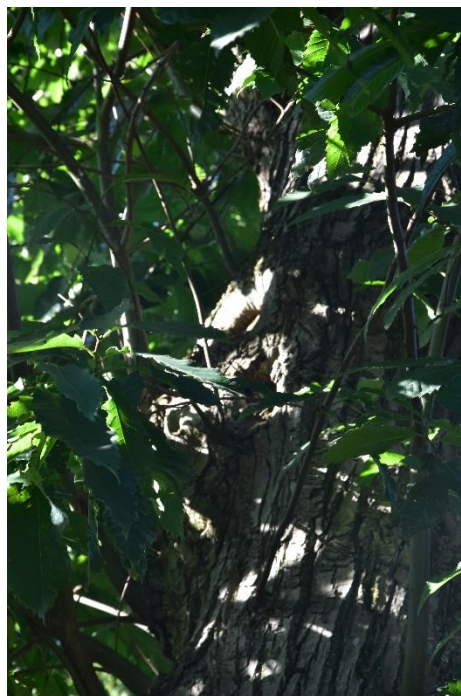
- 6.4 The size of the tree and its high-risk location is such that we would recommend the area at the base of the tree be maintained clear of all visual obstructions as this will more readily allow identification of any decay fungi that may appear at the base of the stem.
- 6.5 The tree has been crown lifted previously and as is normal of the species regrowth has occurred. It would be advisable to repeat these works to limit the wound size (as the longer they are left the larger the regrowth branches will become increasing the impact of future works).

Fig 3 – Image showing previous branch removal wound and associated stem regrowth from prior crown lifting works.

6.16 It would be advisable to include the crown lifting and removal of deadwood to T1 in any forthcoming application as indicated within Appendix 2 (Tree Works).

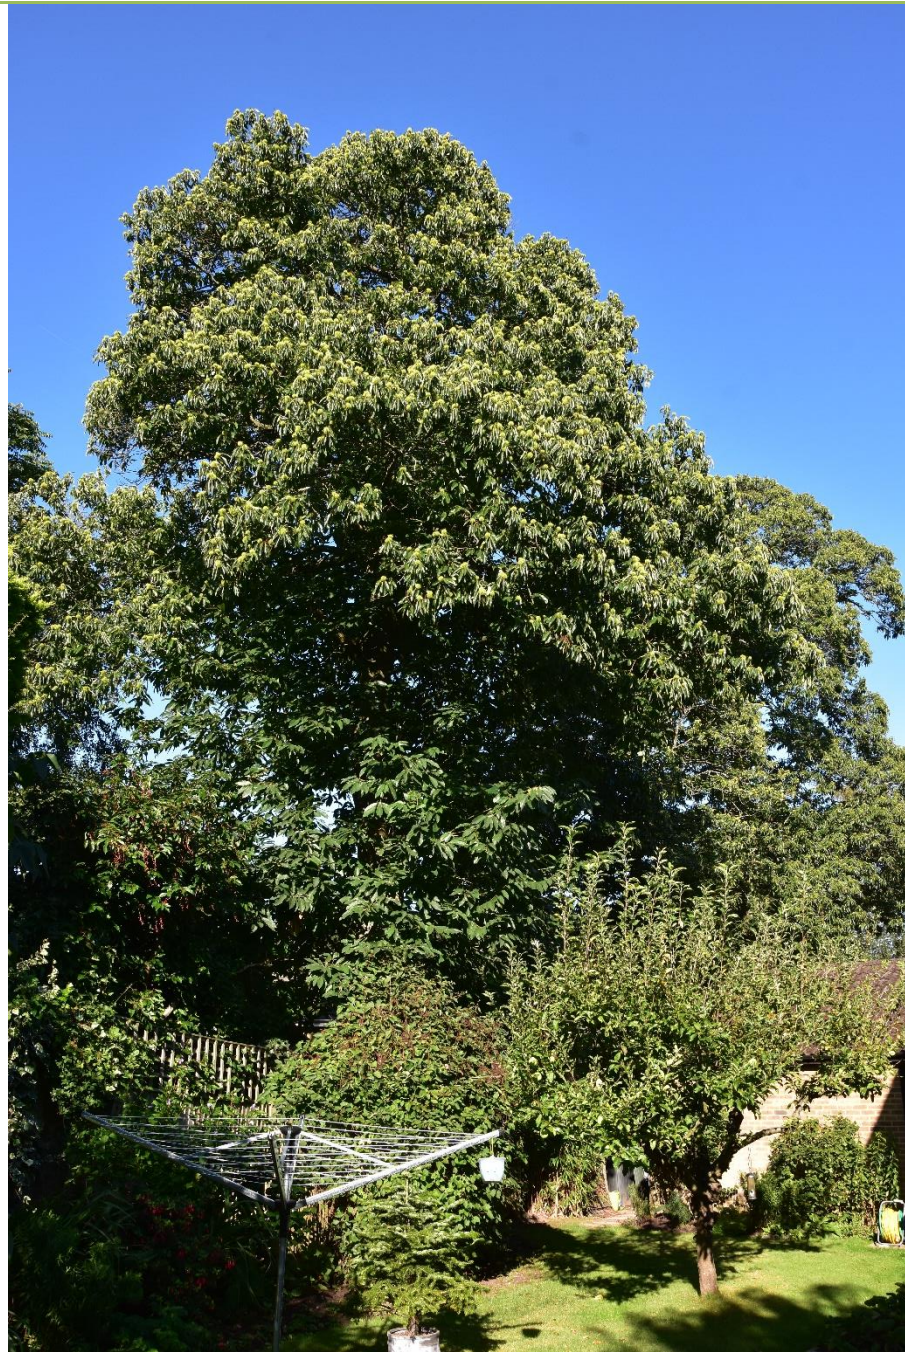
Image 1 – T1 Sweet Chestnut viewed from the rear garden

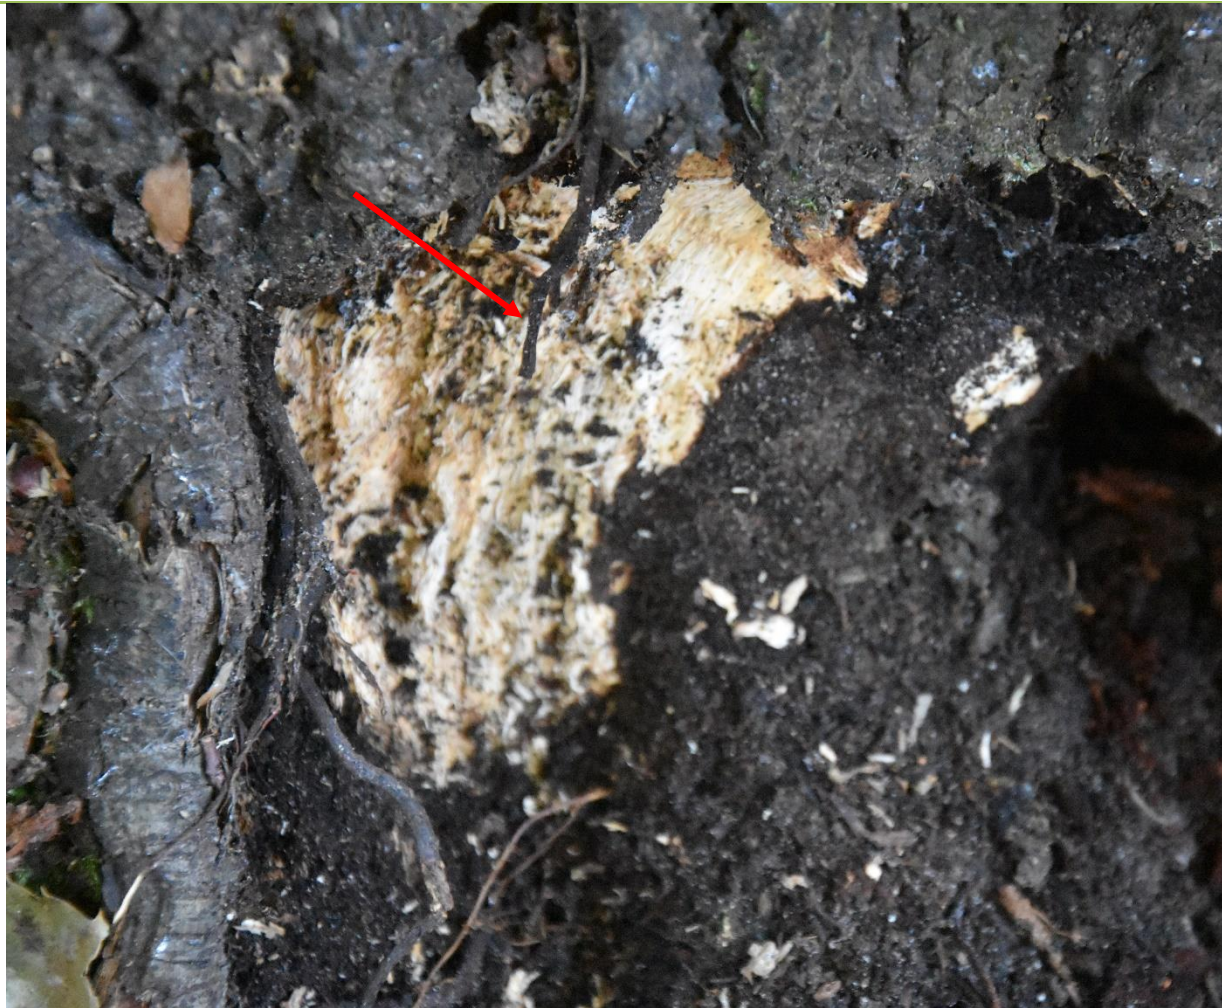
- 6.7 The lower stem was not fully accessible for inspection but soundings indicate areas of decay and dead bark could easily be removed in places to reveal a white mycelial mat and the presence of rhizomorphs below the bark. This confirms the tree to be infected by Honey Fungus (*Armillaria* spp).

- 6.9 No fungal fruiting bodies of *Armillaria* spp were evident at the base of the tree during my inspection but the exposed decayed wood suggests the extent of decay in this area was likely well established. The significance of *Armillaria* spp infection is such that should decay be extensive in a root system there is a high chance of wind throw (Lonsdale 1999). The nature of *Armillaria* spp infection is that it usually begins in the cambium of the roots and this can lead to above ground symptoms often manifesting themselves as a thinning of the upper canopy of the infected tree. Given the location of the tree relative to people and property and the propensity for failure of infected trees we recommend the removal of T2.

Image 2 – Decay evident at the base of T2 with rhizomorphs of Honey Fungus visible

6.15 We recommend the removal and replacement of T2. Ginkgo and Catalpa are both widely available ornamental trees and are known to show a level of resistance to Honey Fungus. Scope to replant in the location of T2 is limited but during our visit a further Willow in decline as discussed and in the event this tree (not the subject of the TPO) is also removed this would offer a suitable location for either replacement tree species suggested. RBWM will likely condition the replacement in any decision notice relating to the forthcoming application to remove T2.

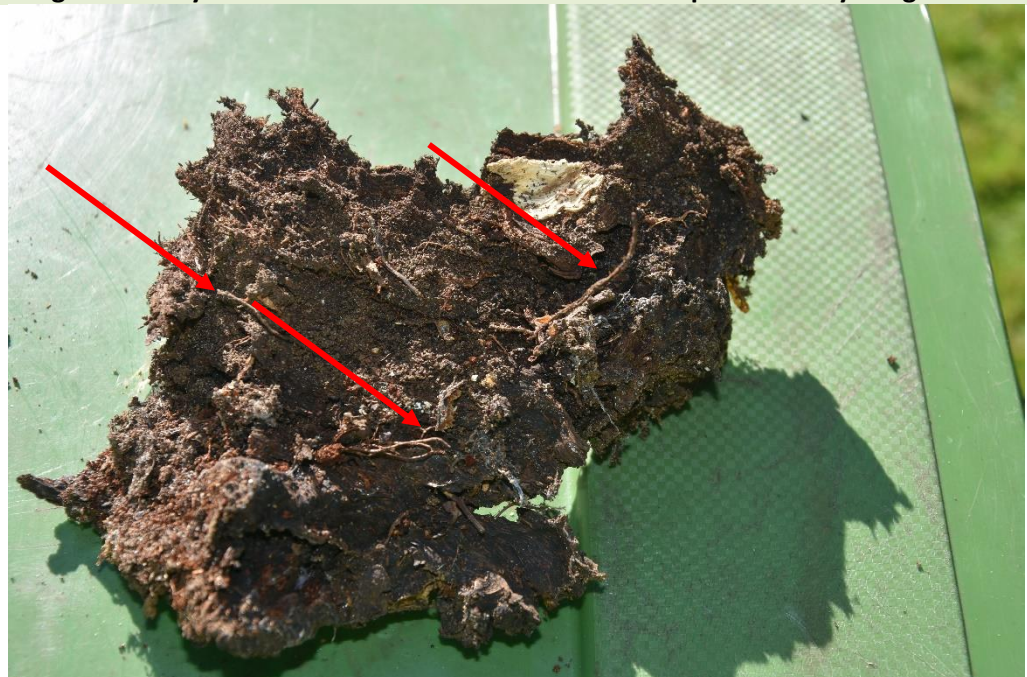
Image 3 – Section of removed bark from T2 showing rhizomorphs of Honey Fungus

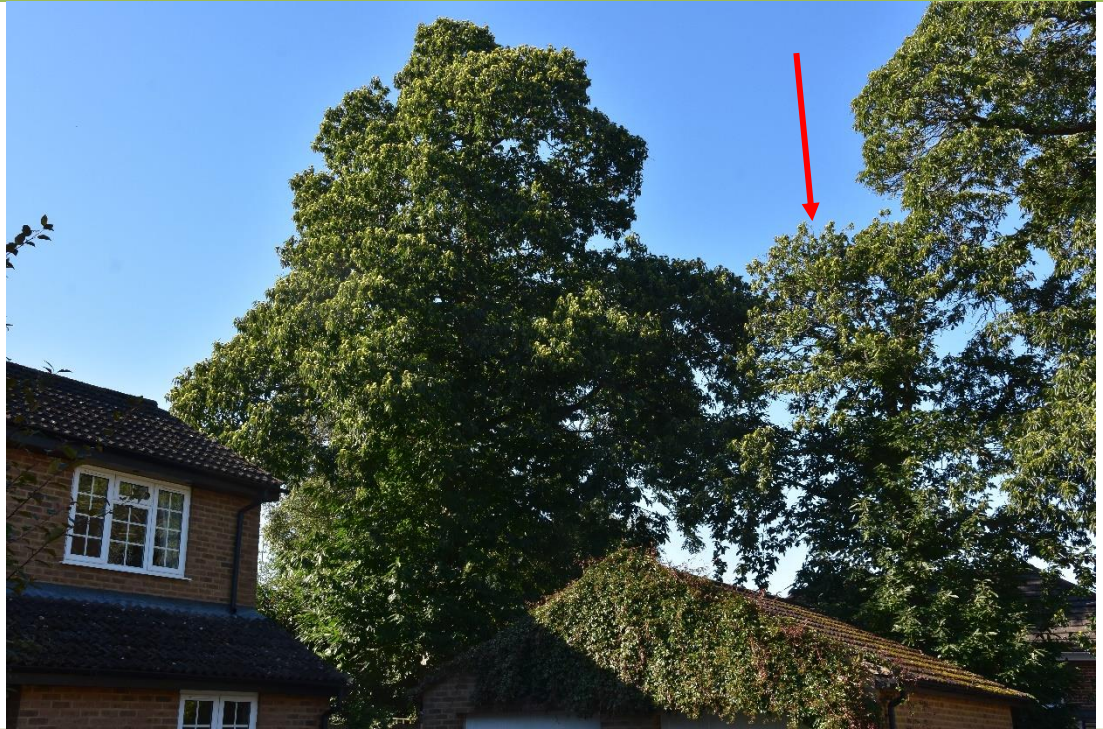
- 6.6 This tree is close to a garage that has been constructed in an area where root damage will have occurred at the time of construction. The tree is smaller in size (12m) and has evidence of stress within the canopy as demonstrated by the presence of smaller leaves, excessive dead wood and in places tip die back and canopy thinning.

Image 4 – The relative significance of T2 (highlighted) is less given its smaller size and suppression by adjacent trees with T1 shown left
