Our Reference: AM/AR/3277_022/R24-2188

30th January 2024

Structural Engineer's Inspection – Garage & Office Structures at 8 Manchester Rd Burnley

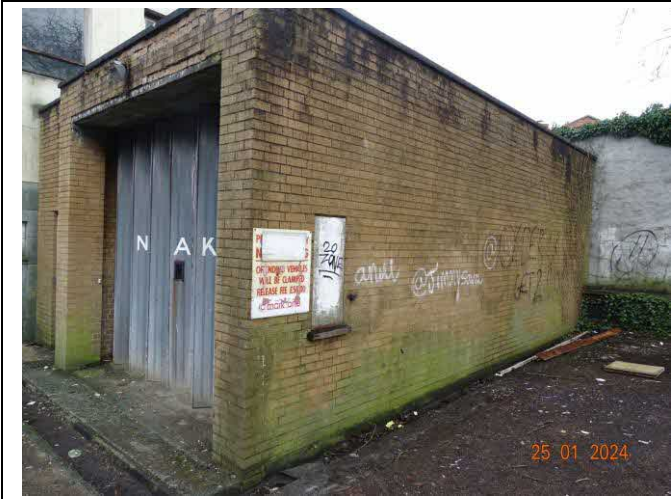
- 9" solid brick wall using 'English Bond' with headers every other course, with small (boarded-up) slot window near front elevation corner.
- No significant cracking but extensive mortar joint degradation around the (assumed) damp proof course, with green staining (assumed to arise from rainwater bouncing up from the surrounding hard surface) up to around 1m above outside ground level.

- Damp proof course material (bitumen felt) folded down on the outside to cover 2no brick courses below and then into open drain – fractured towards the front elevation corner exposing brick.

- Dark staining to around 50% of the top area, down to around 1m below copings (assumed to be associated with continual moisture entry from the roof behind) with light vegetation growth.

- Copings relatively level with consistent but minimal overhang; some minor gaps between copings.
- Approx 3.8m high, 9" / 225mm thick side wall has an outwards lean at the top from vertical – by approx 40mm near the front and rear junctions, and by approx 50mm at the centre of the side wall.

- Side wall butts up to the white-painted retaining wall at the rear edge with a max 2mm to 3mm gap and no visible form of connection (some embedded fixing may not be visible). This retaining wall leans back from vertical – measured as 50mm over the height of a 1.8m spirit level.

- The open surface water drainage channel running in front of the wall was blocked with debris in many places and did not appear to have an obvious fall to any drainage gully.

Photo 1 – Right hand side wall with front pier.

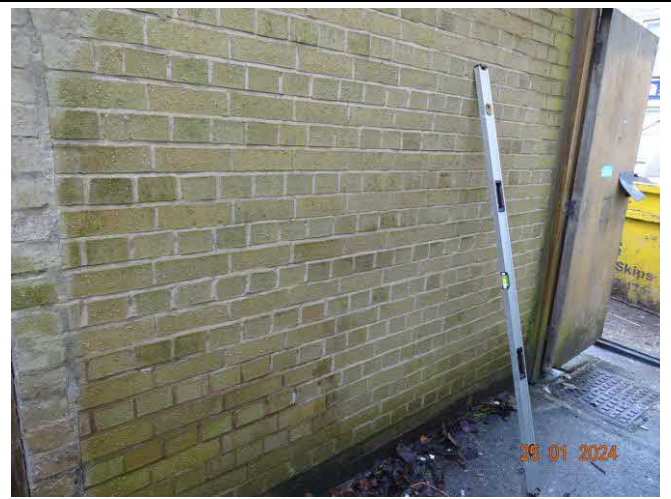
- Forward section - 9” solid brick wall using ‘English Bond’ with headers every other course, with external door to enclosed open space.
- Door-surround brickwork with uneven, degraded mortar joints, and corroded lintel.
- Rearward section - overall 250mm thick, narrow cavity wall shared with attached Office structure.
- No significant cracking observed but some mortar joint degradation around the (assumed) damp proof course.
- Copings relatively level with consistent but minimal overhang; some minor gaps between copings.
- Approx 3.8m high, 9” / 225mm thick frontwards section of the side wall has an approx 25mm inwards lean at the top from vertical, along its full length, up to the junction with the rearwards cavity wall section.
- Brickwork projects forward over the damp proof course to the bottom right hand side of the external door.

Photo 2 – Left hand side wall – front solid wall area.

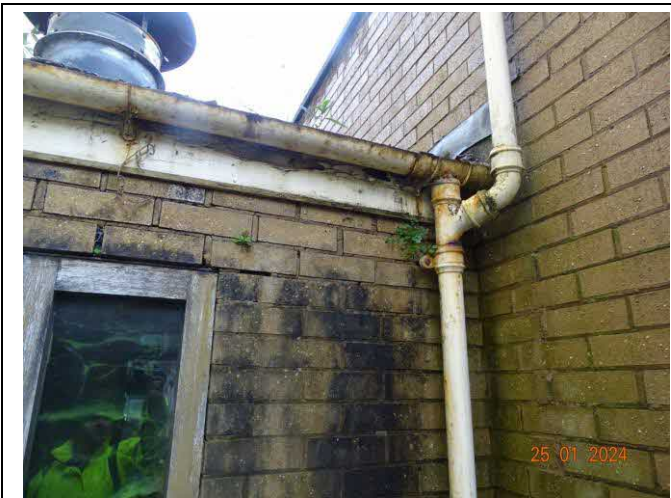
Photo 3 – Left hand side wall – rear cavity wall showing attached Office structure front wall (with window).

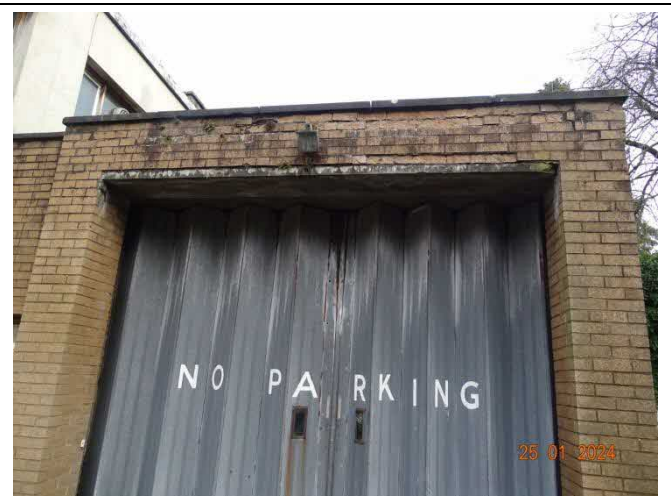
- 450mm square brick piers either side of folding steel vehicle door – approx plumb to vertical on front face but leaning, to a degree consistent with the side walls (see above), to the right hand side at top (viewed facing Front Elevation).

- 450mm wide x 75mm deep concrete lintel spanning across corner piers with concrete padstone towards inner face each side. Small spalled patch towards the centre of the lintel underside reveals corroded steel reinforcement – indicating (not surprisingly given the shallow depth of the concrete) very little cover to the reinforcement.

- 6no courses of brick above the lintel to the underside of the copings – these are in very poor condition with extensive spalling, degraded mortar joints, displacement both forward and backwards, vegetation penetration from behind, dark staining (assumed to be associated with continual moisture entry from the roof behind), and white staining (which could be efflorescence or other chemical seepage from the masonry or from penetrating moisture from the roof behind).

- Copings with minimal overhang and some minor gaps between.
- The open surface water drainage channel running in front of the wall was blocked with debris in many places and did not appear to have an obvious fall to any drainage gully.

Photo 4 – Front elevation showing piers to side of vehicle door & masonry over shallow r.c. lintel.

We conclude that the Garage structure, possibly even from its original construction, but certainly in its current condition, has now reached, or is near to reaching, structural instability and will remain so without extensive remedial works (e.g. substantial propping to the side walls, complete re-roofing, robust securing to the rear retaining wall, and repairs to, or replacement of, the front lintel).

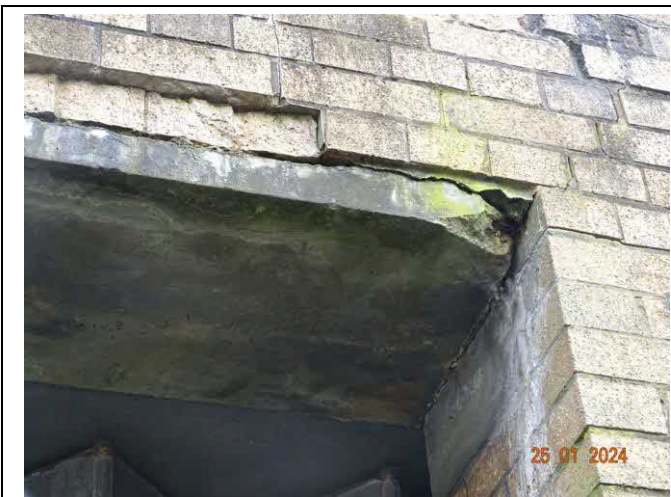
- Bearing of the lintel on the right hand side pier appears fractured with visible gaps across approx 30% of the width of the bearing surface, indicating a potentially dangerous failure of support for the masonry above and roof structure.

Photo 5 – Partially failed bearing of vehicle door lintel at right hand side pier.

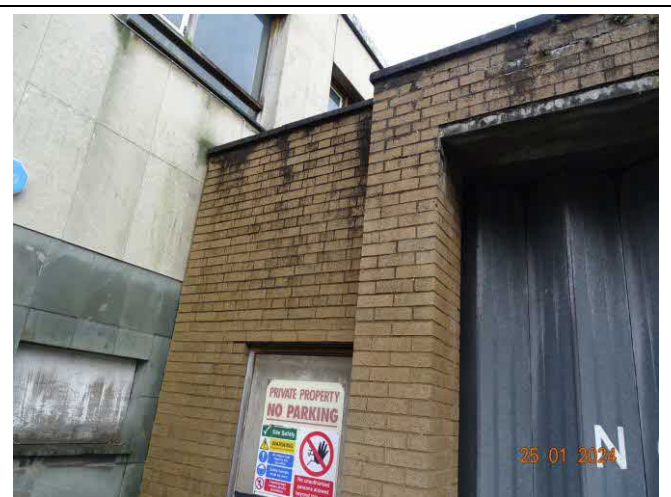
- 9” solid brick wall using ‘English Bond’ with headers every other course, with door from external parking area to enclosed open space between Garage and Bank building, corroded lintel over door.
- Copings with minimal overhang and some minor gaps between.
- No significant cracking observed but with green staining (assumed to arise from rainwater bouncing up from the surrounding hard surface) up to around 1m above outside ground level.
- Corroded steel angle bracket mounted with a single bolt to the inside of the Link wall at high level with an estimated approx 30mm gap between the second angle leg and the Garage left side wall, suggesting movement of the Garage side wall away from the original constructed position, though the mortar joints at the junction did not necessarily echo this potential historic movement.

Photo 6 – Link wall viewed externally showing door to enclosed area and dark staining below copings.

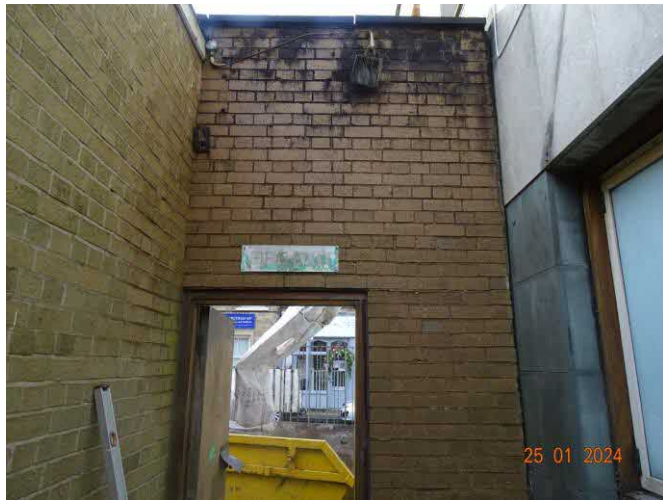
Photo 7 – Link wall viewed internally with corroded bracket near junction to Garage left side wall and gap to Bank main building on right hand edge.

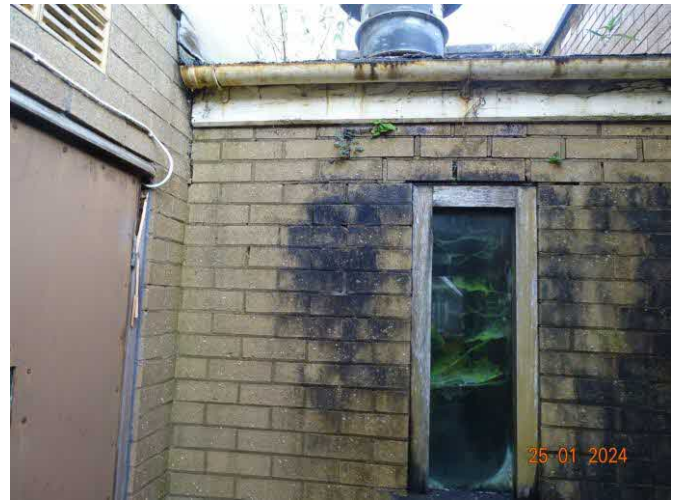
- Overall 250mm thick, narrow cavity wall with central window – all in very poor condition with extensive dark staining (from assumed moisture penetration) near rainwater downpipe, degraded mortar joints above window level, rotten timber window frame, peeling paint from rotten barge boards, stepped hairline crack from bottom left hand side of window sill down to ground level..
- Assumed flat roof with metal vent structure above, extensive vegetation growth, blocked and corroded gutters, corroded rainwater downpipe and blocked gully below.

Photo 8 – Office structure front elevation showing rotten window, dark staining, corroded gutters, vegetation above – door to Bank main building on the left hand side.

To restore usability of the Office structure, a completely new roof would be required, with appropriate sealing to surrounding structures and new drainage facilities. After a period of drying out, masonry crack stitch repairs, lintel replacement, window & door frame replacements, plumbing, electrics, heating, decoration, etc would all appear to be necessary.

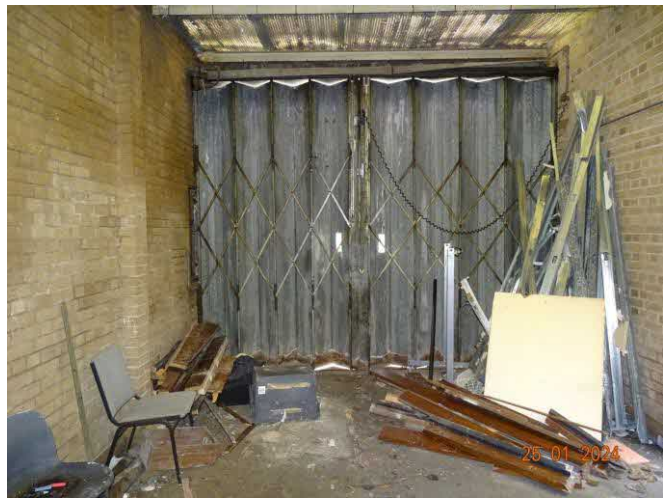
- Interior cluttered with building materials restricting access – especially to the Office structure side.
- Folding steel vehicle door and support frame inset from Front Elevation brick piers.

- Corrugated translucent plastic sheeting material supported on 4no (estimated) 75 x 75 steel angle purlins and a central gutter (unknown form) spanning between the side walls forming the shallow duo-pitched roof. Purlins appeared simply mortared into masonry at bearings (with some corrosion visible) at approx 1350mm horizontal spacing.

- Some form of steel mesh fixed to the roof material underside (presumably for security).
- Right hand side wall with 3no full-height 9” brick buttressing piers toothed into the inside face.

- Water penetrating (dripping) from the roof structure in multiple places throughout the Garage.
- Door-surround brickwork with uneven, degraded mortar joints, and surface cement coating.

Photo 9 – Garage structure interior – front area showing folding steel vehicle door & steel angle purlins spanning across.

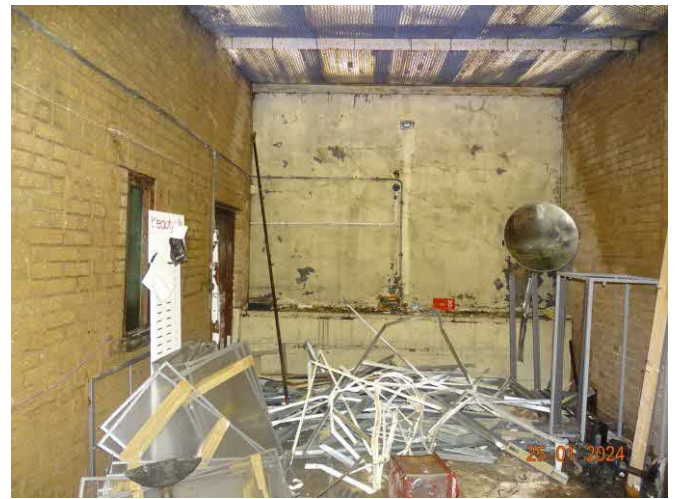
- Unmeasured sag towards centre of rear purlin near retaining wall.
- Previously filled horizontal / stepped cracks in mortar joints of wall to Office structure, to left side of internal door to Office, and from right hand end of internal window sill down to bottom left hand corner of internal door.

- Various horizontal cracks and flaking of the render / paint finish to the upper and lower sections of the rear retaining wall, with dark staining (assumed from damp penetration through wall).

Photo 10 – Garage structure interior – rear area showing upper & lower rear retaining wall – internal door & window to Office structure on left hand side.

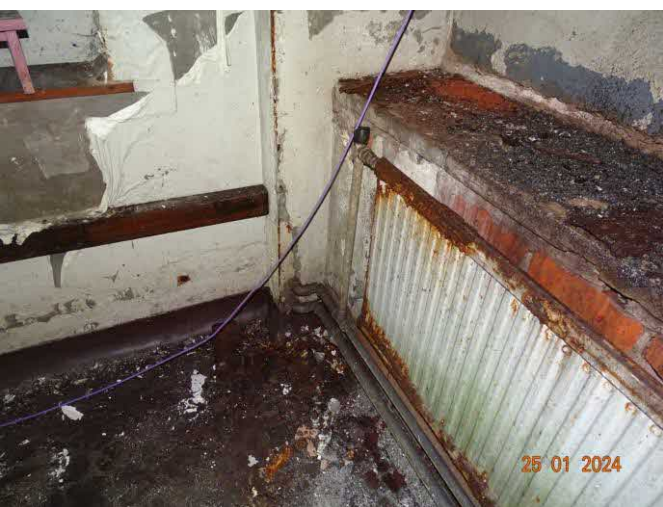
- One-roomed structure completely derelict – roof structure soaking, rotten and with ceiling board fallen down in many places – water penetration has caused extensive damage.
- Brick-built lower plinth to the rear retaining wall, with stone or concrete slab shelf, covered with debris and damp – badly rusting radiator mounted to front of plinth. Painted render to the upper retaining wall face badly cracked and spalled.
- Front wall (to enclosed external area) and internal wall to Garage with diagonal cracks from bottom corners of each window sill, and to top left hand corner of the external window.
- Concrete? lintel over door to Garage appears to be delaminated (not accessible for closer examination).

Photo 11 – Office structure interior showing rear retaining wall lower plinth and radiator.

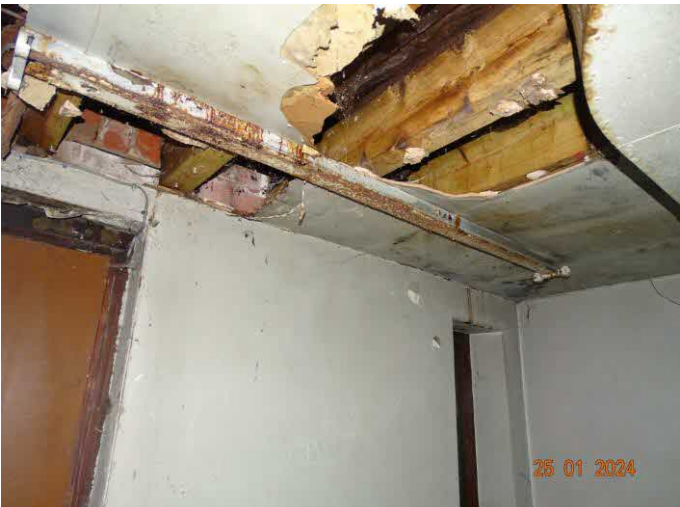
Photo 12 – Office structure interior showing failed roof structure.
