Heritage, Design and Access Statement

Address: The Old Rectory, Wraxall Hill, Wraxall, BS48 1NA

Proposal: Replacement of failed structural beam and associated repairs.

Date: January 2024

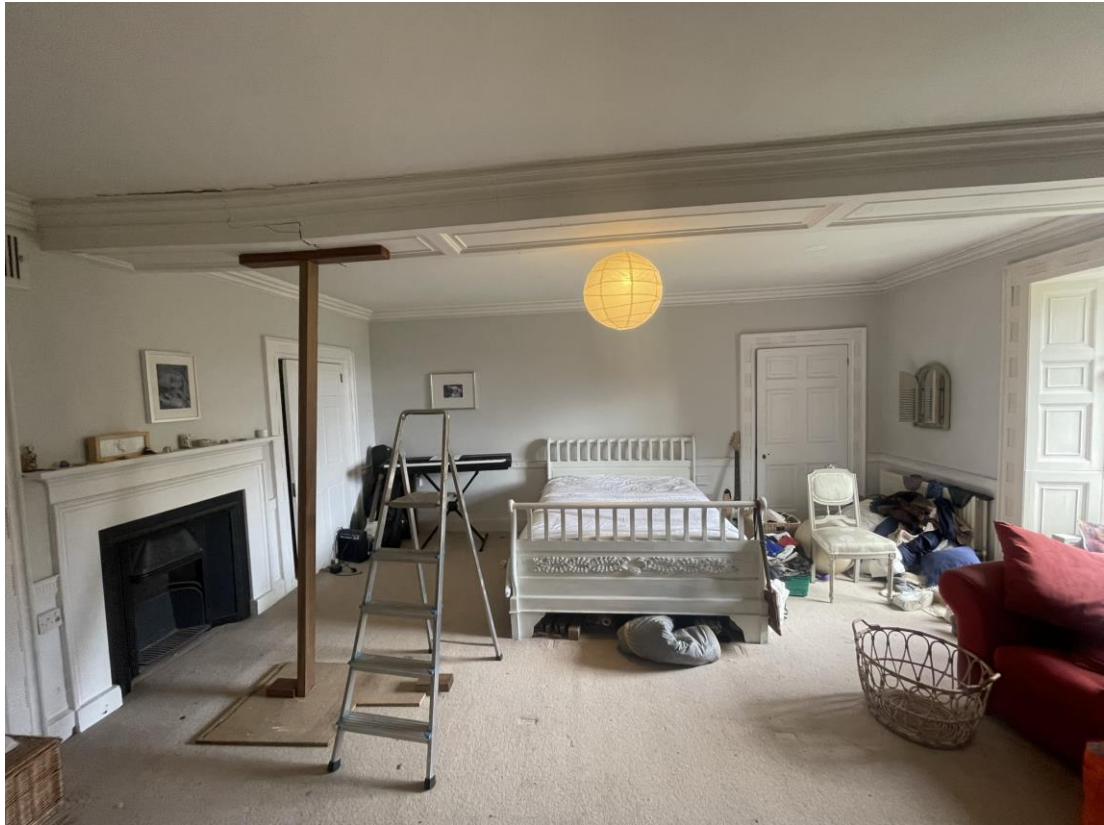
The original timber beam is located within the second floor with a visible downstand in the first floor room below. The beam is sagging and is being temporarily propped after it caused cracking to the plasterwork encasing the beam.

Fig. 6: First Floor bedroom showing temporary propping

It is proposed to remove the timber beam that is now in a state of disrepair and to provide support to the existing floor structure with new C section steel beams. There will be no change to the floor level or existing timber joists.

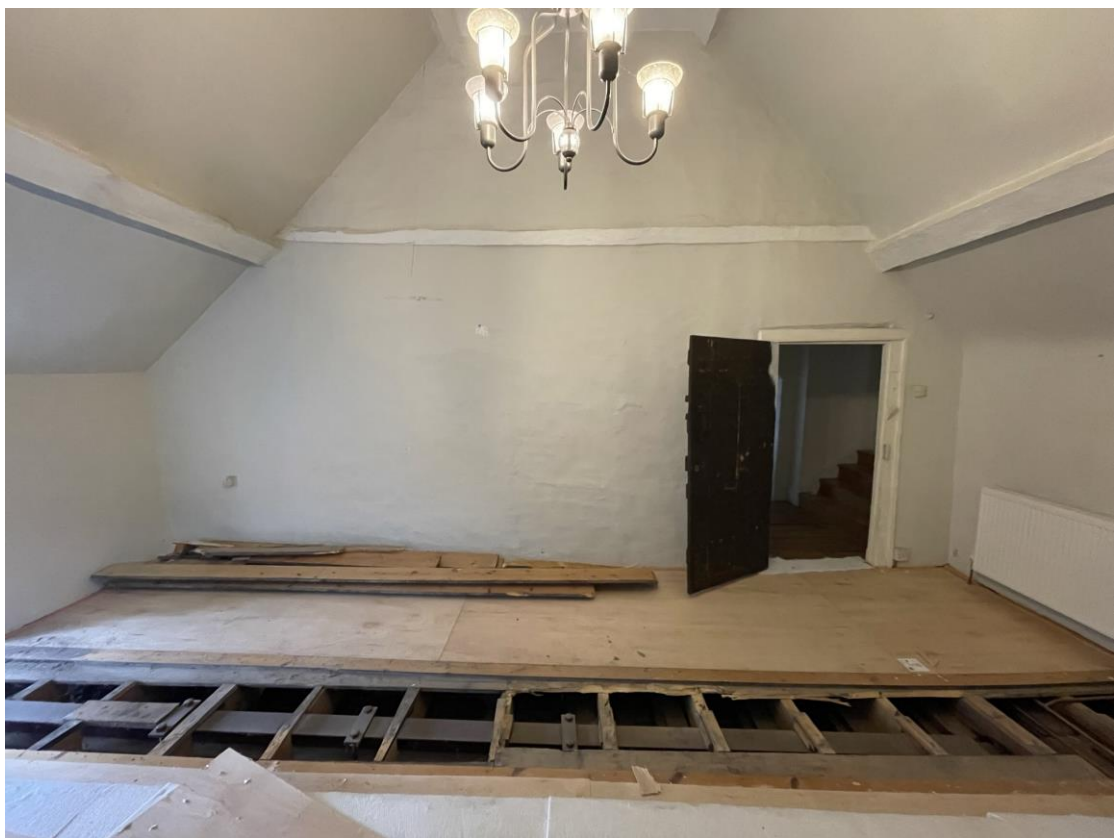
Fig. 7: Second floor with exposed beam

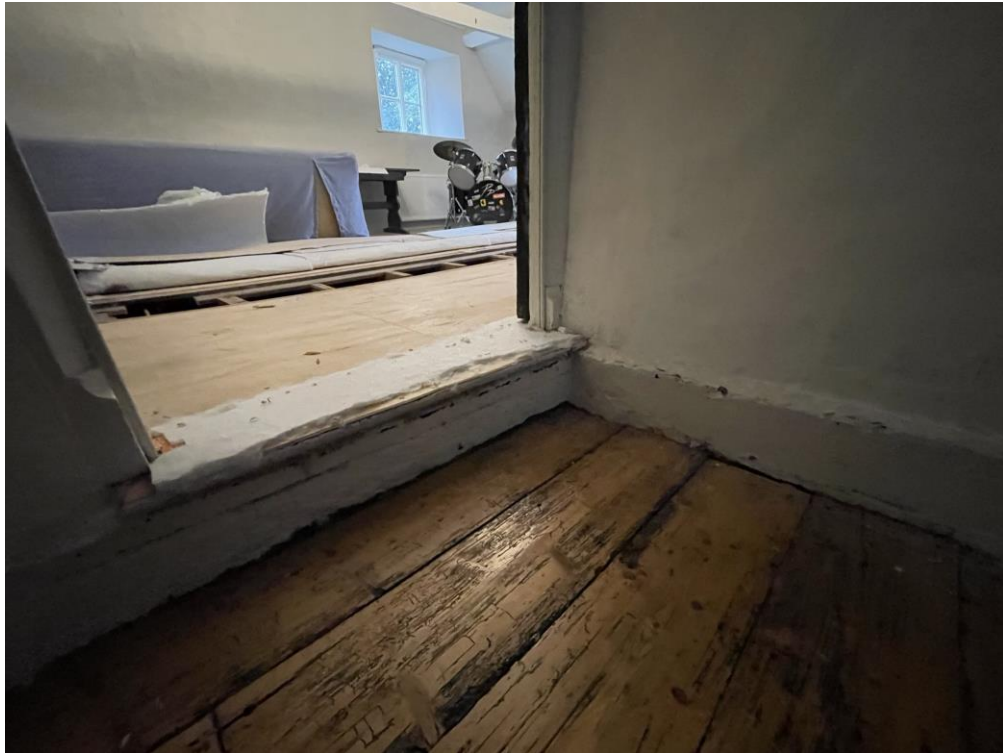
It has been speculated that repairs to the original beam were carried out in the 1980s. The previous repair approach aimed to retain the historic fabric of the beam in-situ and in doing so has required a lot of alteration around this area including the introduction of a steel beam bolted on top of the historic timber. Due to the additional height of the steel beam, the floor level in this room was raised and modern timber joists were installed over the original. The change in height can be seen in the step at the door threshold (figure 8). The timber beam was covered in a timber framing for a plaster moulding finish.

Fig. 8: Second floor door threshold showing change in floor level

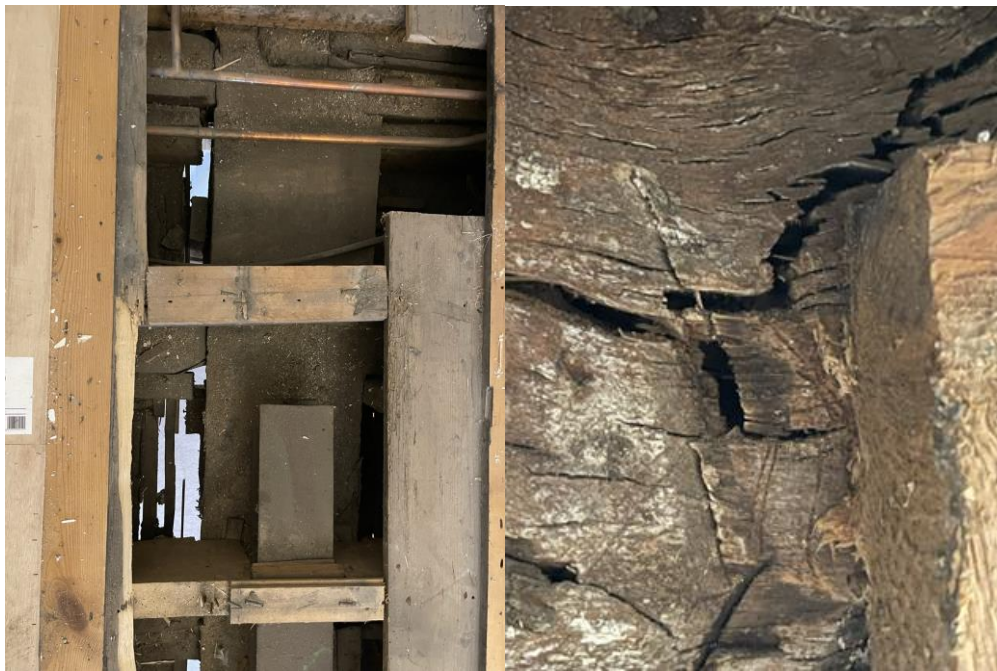
Due to the urgent need for repair, the 1980s plaster mouldings have been removed to expose the beam in order to reveal its condition and extent of previous repairs. Figure 10 shows diagonal cracking in the beam itself.

Fig. 9: Exposed structural beam showing previous repair

Fig. 10: Cracking in timber beam

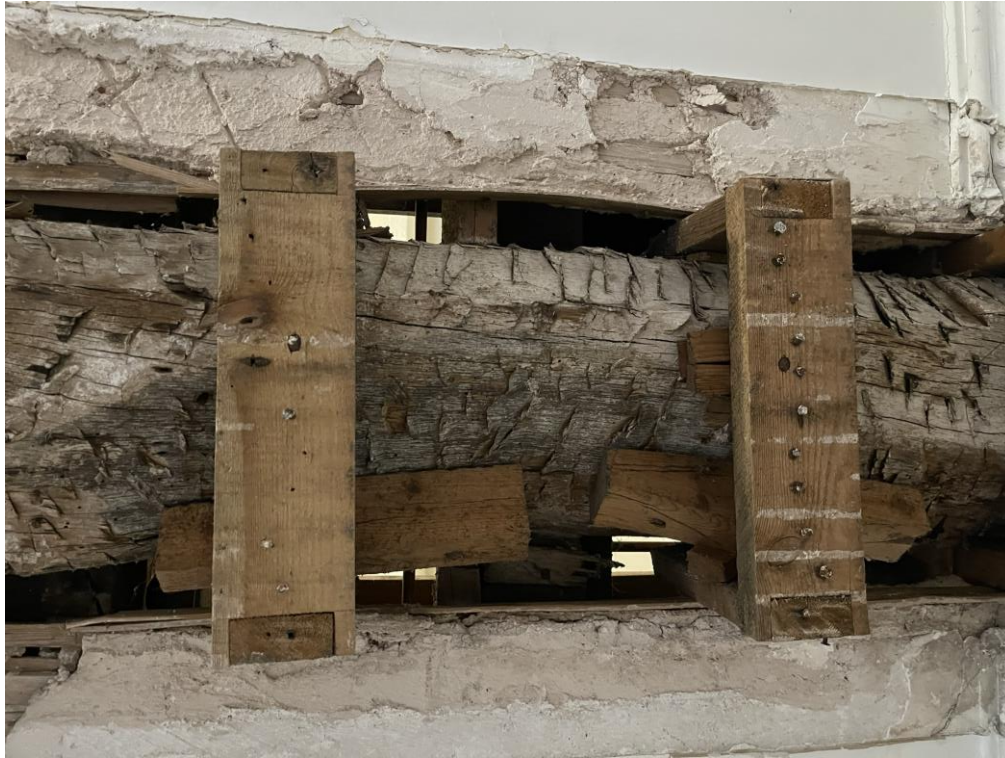
Fig. 11: Exposed timber beam underside

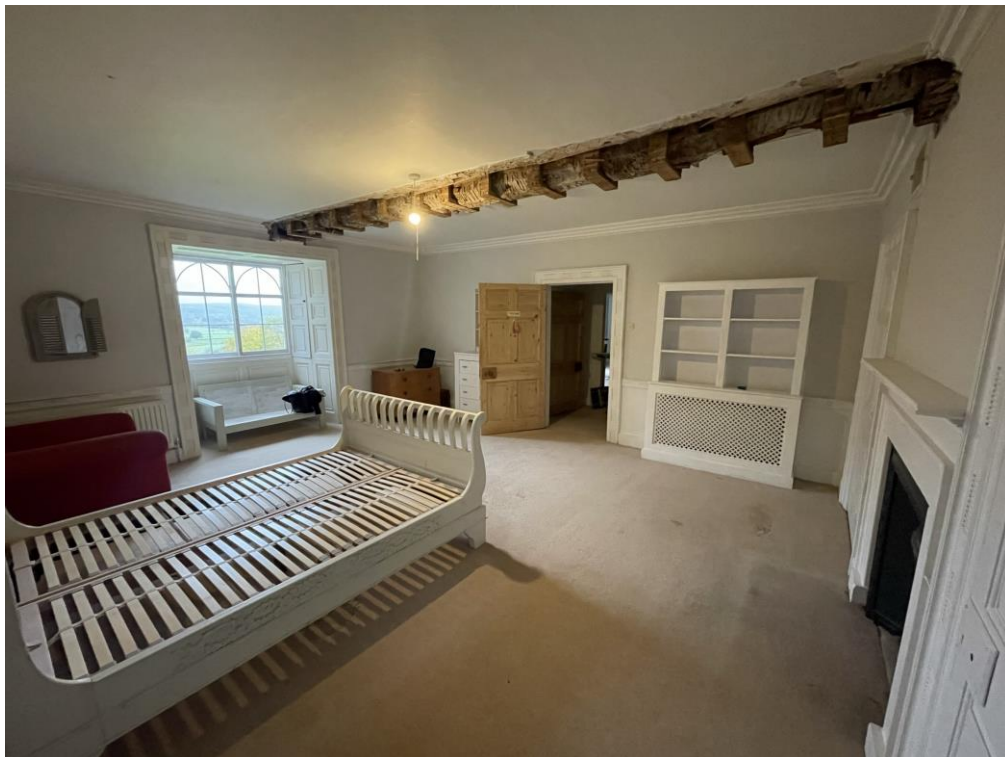
Fig. 12: Exposed timber beam first floor
