MR E RUDDOCK  
SURVEY: BARN AT  
MANOR FARM HOUSE  
WETHERBY ROAD  
RUFFORTH  
YORK  
YO23 3QF

REPORT NO. 22040-RP-001

**Survey: Barn at Manor Farm House Rufforth**

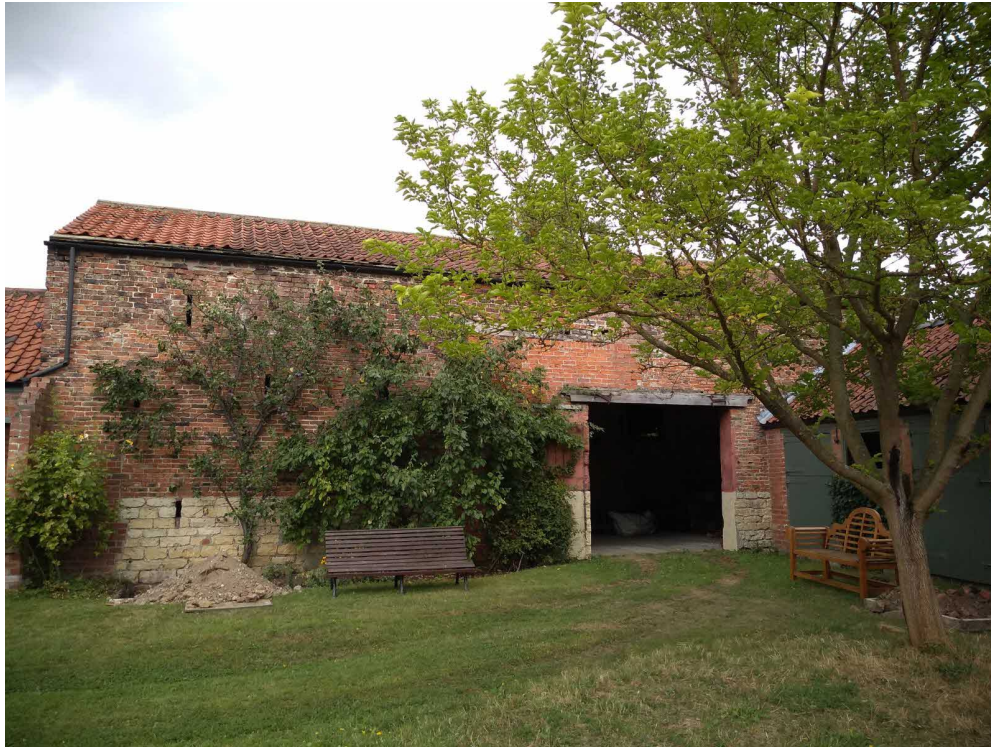
Photo 1 –Front Elevation

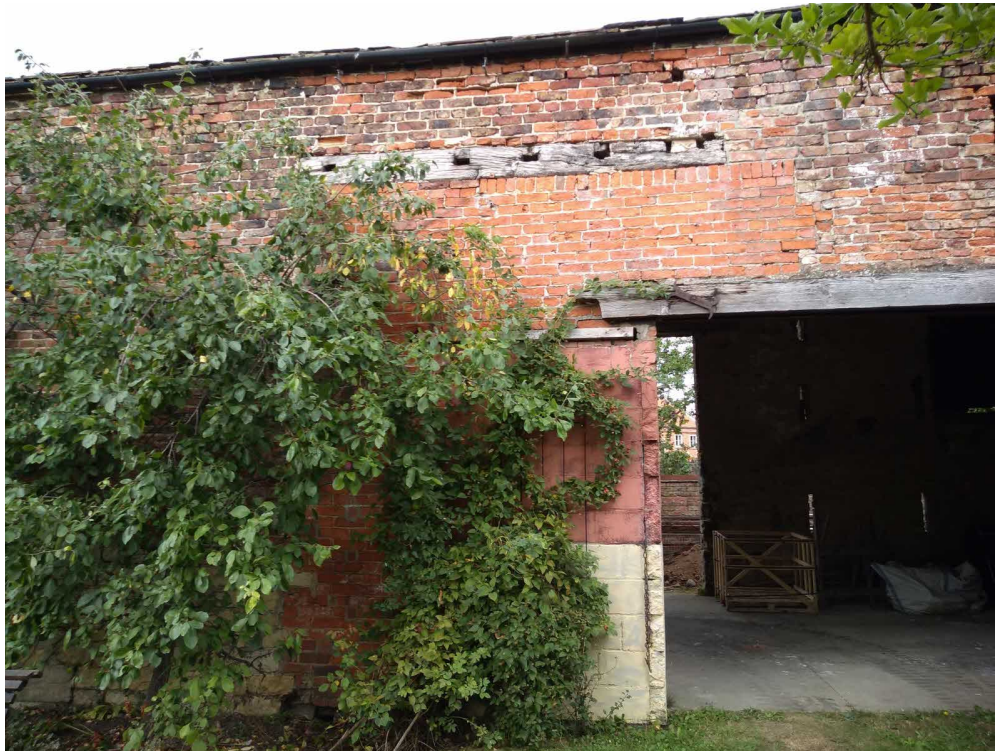
Photo 2 –Front Elevation Doorway alterations

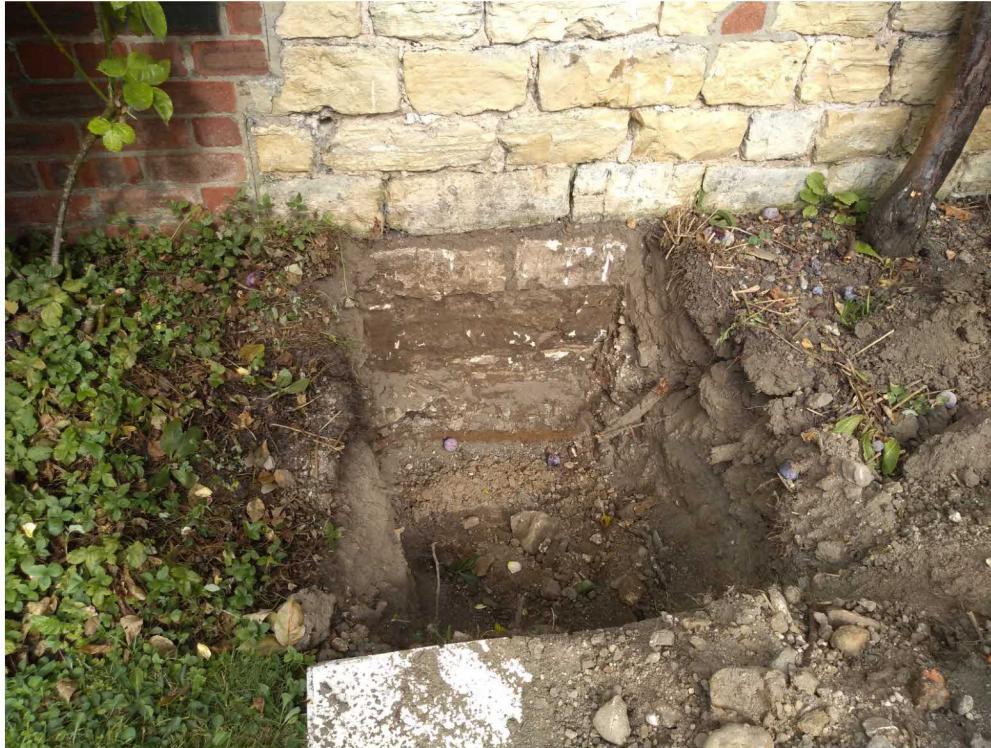
- 2.1 The front elevation is a solid stone wall up to a height of 1200mm and then solid brickwork above this level with brick headers every six courses. The brick and stone coursing are level, and the wall is vertically plumb. The stonework thickness is 420mm at the base of the wall, tapering to 380mm where it meets the brickwork. Photo 1
- 2.2 The central main door opening position has been modified in the past leading to two timber lintels being built into the existing brickwork and a section of blockwork masonry to the left of the doorway. Photo 2
- 2.3 At eaves level there is local weathering to the brickwork.
- 2.4 The clay pantile roof discharges into an eaves gutter.
- 2.5 A trial hole on the left-hand side of the front elevation revealed a corbelled stone foundation at 675mm depth projecting 125mm from the face of the wall founded on a firm light brown sand. Photo 3

Photo 3 – Trial hole 1 Front elevation

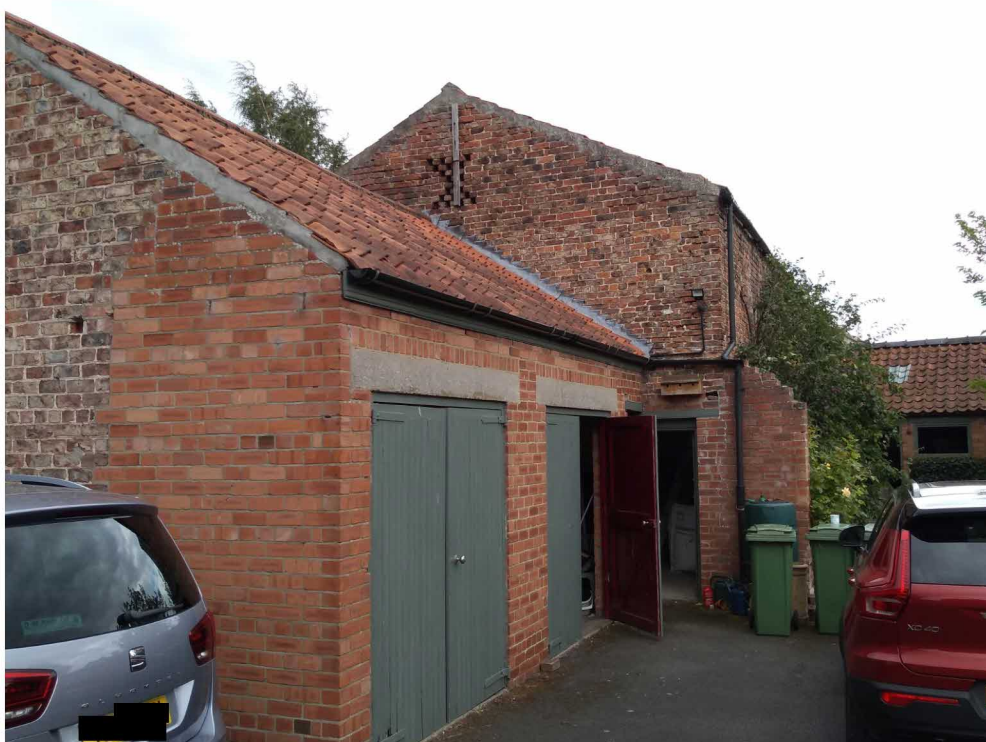
- 2.6 This elevation forms the end gable wall and is abutted by a lower-level brick-built garage structure. The gable wall is constructed from solid 9" brickwork and is a plain wall apart from ventilation bricks at high level. The brick coursing is level and the wall plumb. Photo 4

Photo 4 – Left-hand gable elevation

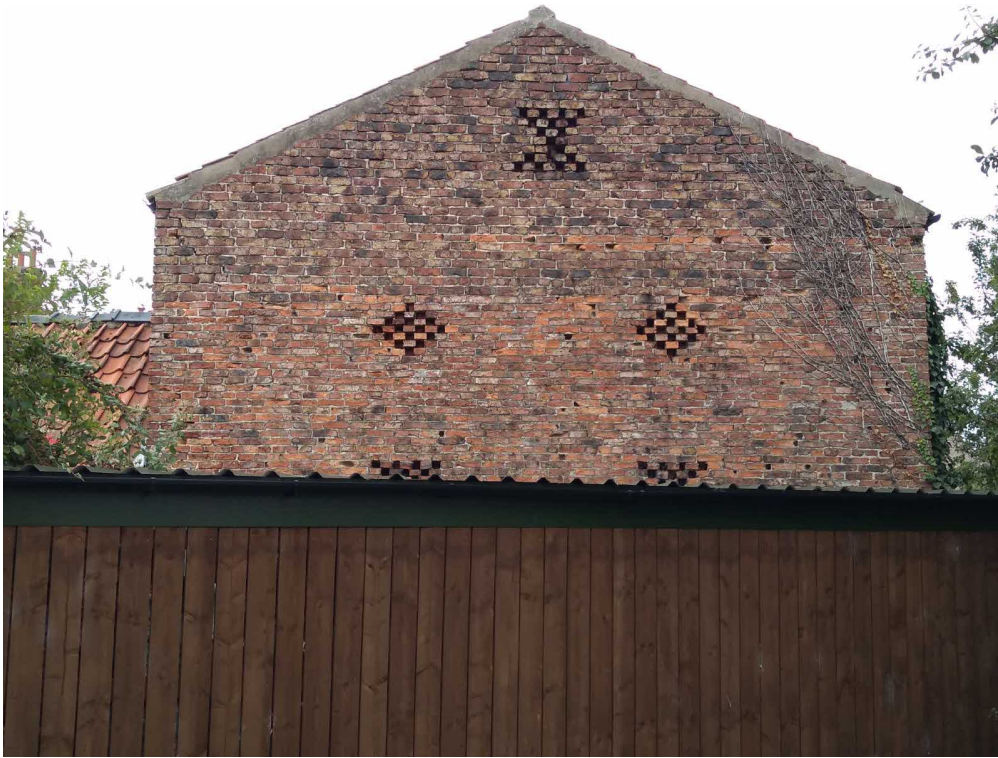
- 2.7 This elevation is also constructed from solid 9" brickwork with headers every sixth to eighth course. The wall is plumb and the brick coursing level. There is stepped diagonal cracking down and to the right from the left-hand eaves level. Photo 5

- 2.8 There is localised weathering to some of the small number of softer lighter coloured bricks used on this elevation.

**3.2** The local defects noted in the brickwork due to natural weathering and cracked joints in the right-hand gable brick bonding can be repaired using conventional building techniques.

Photo 5 –Right-hand gable elevation

**4.1** The diagonal cracking on the right-hand gable at high level is repaired incorporating of Helibar bed joint reinforcement across the vertical crack.

**4.5** Localised weathered brickwork is repaired.

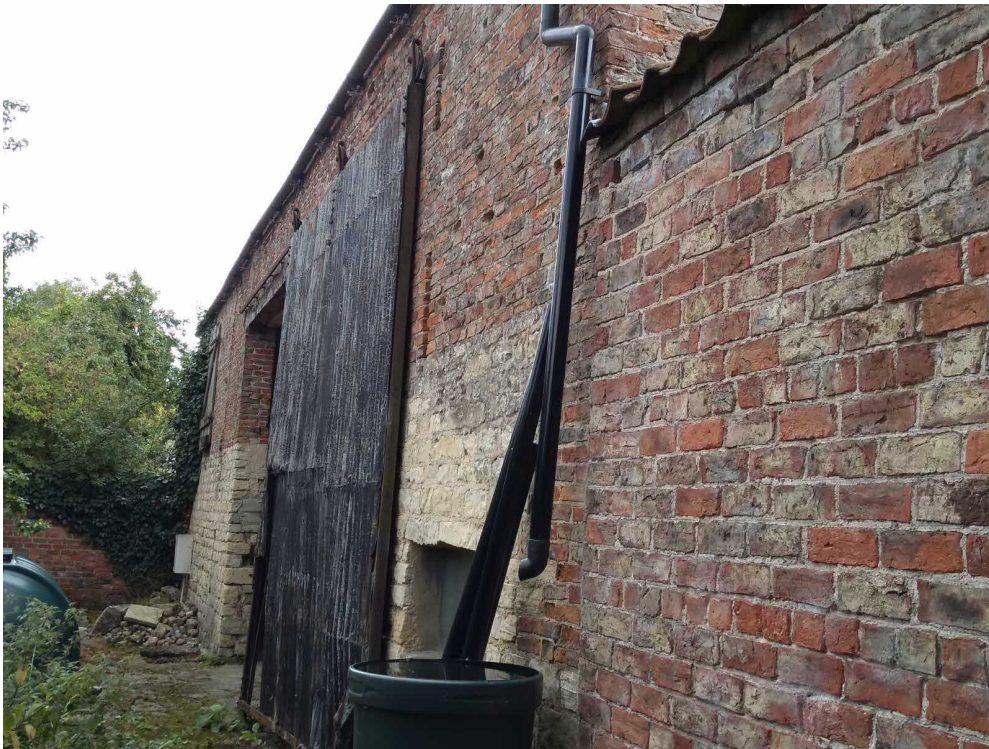
- 2.9 This elevation is constructed from part brick part stone with the stone up to a height of 2500mm. The stone thickness of 400mm at the base of the wall tapers to 370mm at the junction with the brickwork. The brick and stone coursings are level and the wall is plumb. Photo 6

Photo 6 –Rear elevation

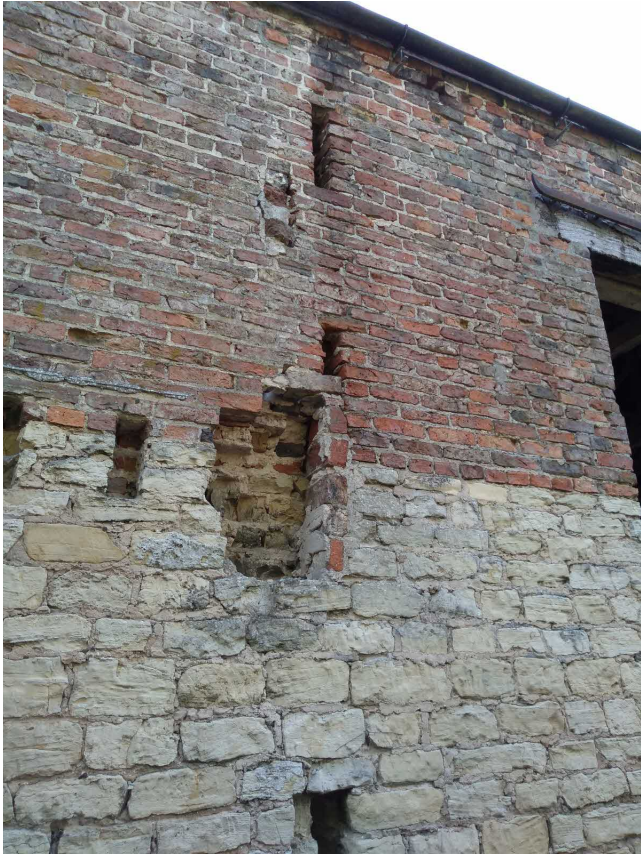
- 2.10 A large central door opening with sliding door to the right is the main feature of the elevation. To the right of the door at low level in the stonework is an infilled window opening. To the left of the doorway is a high-level shuttered window opening. Between the two openings there is localised damage to the stone masonry. Photo 7

Photo 7 –Local damage rear elevation

**4.2** Local damage to the stonework on the rear elevation is repaired.

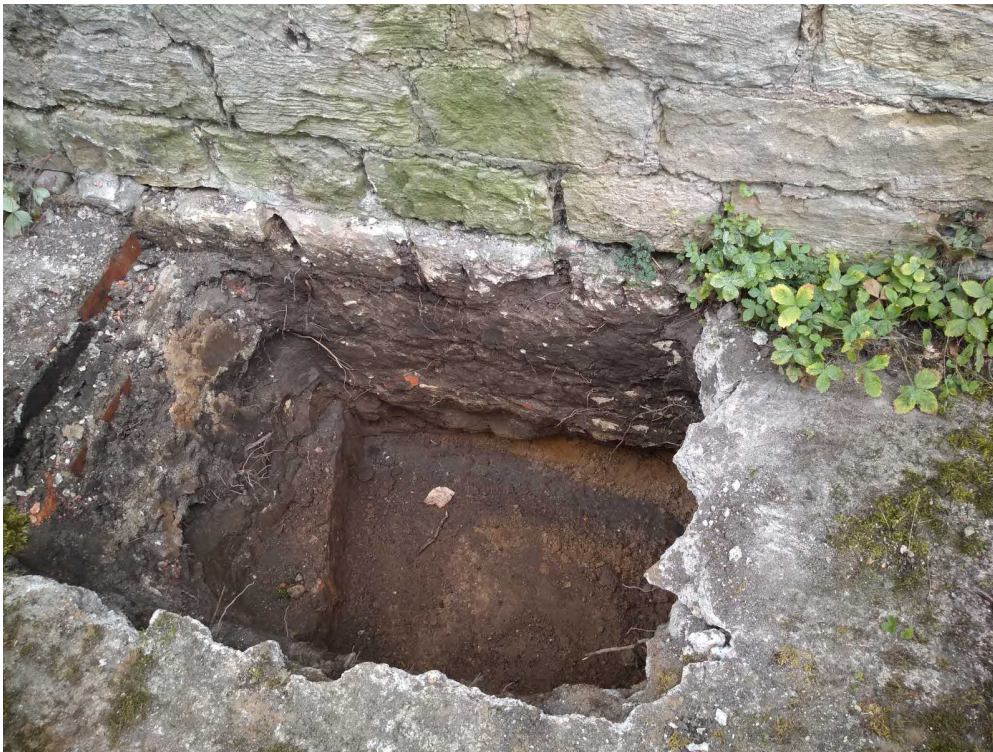
- 2.11 A trial hole to the left of the central doorway revealed a stone corbelled foundation at 780mm depth projecting 45mm from the face of the wall founded on firm light brown sand. Photo 8

Photo 8 –Trial hole 2 rear elevation

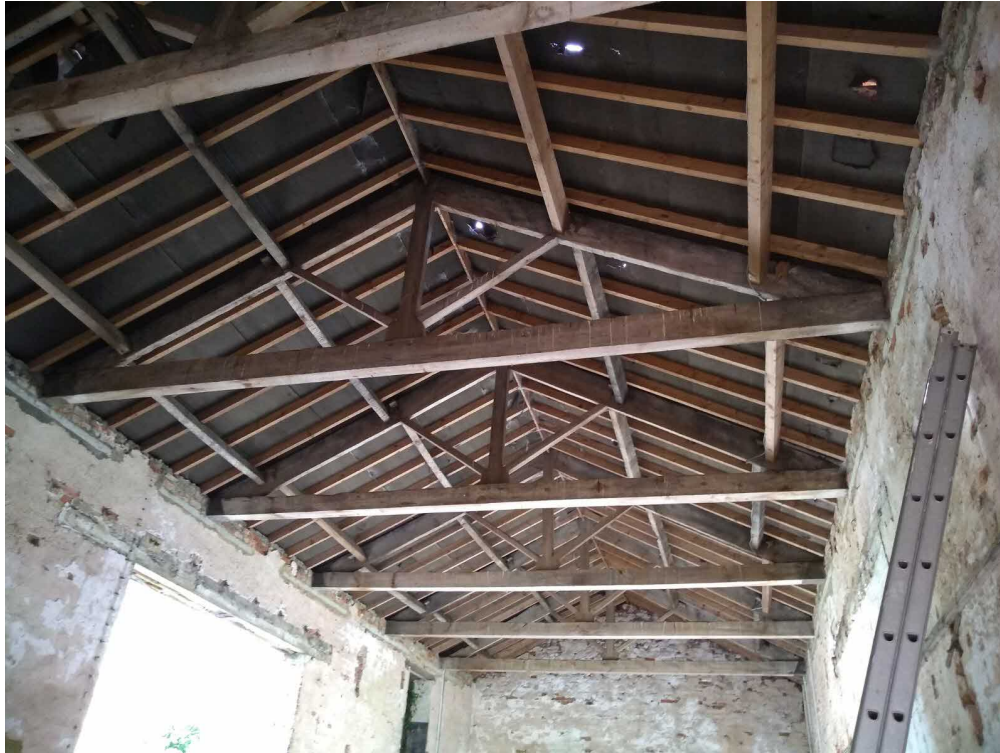
- 2.13 Six traditional king post trusses, purlins and rafters supports a pitched pantile roof covering. Photo 9
- 2.14 Several of the trusses have been strengthened at their end bearing with metal shoes. Original timber bearing plates in the brickwork have been replaced with concrete lintels. Photo 10

Photo 9 –King post roof trusses

**4.4** Existing timber rafter and truss ends are carefully inspected prior to re-roofing.

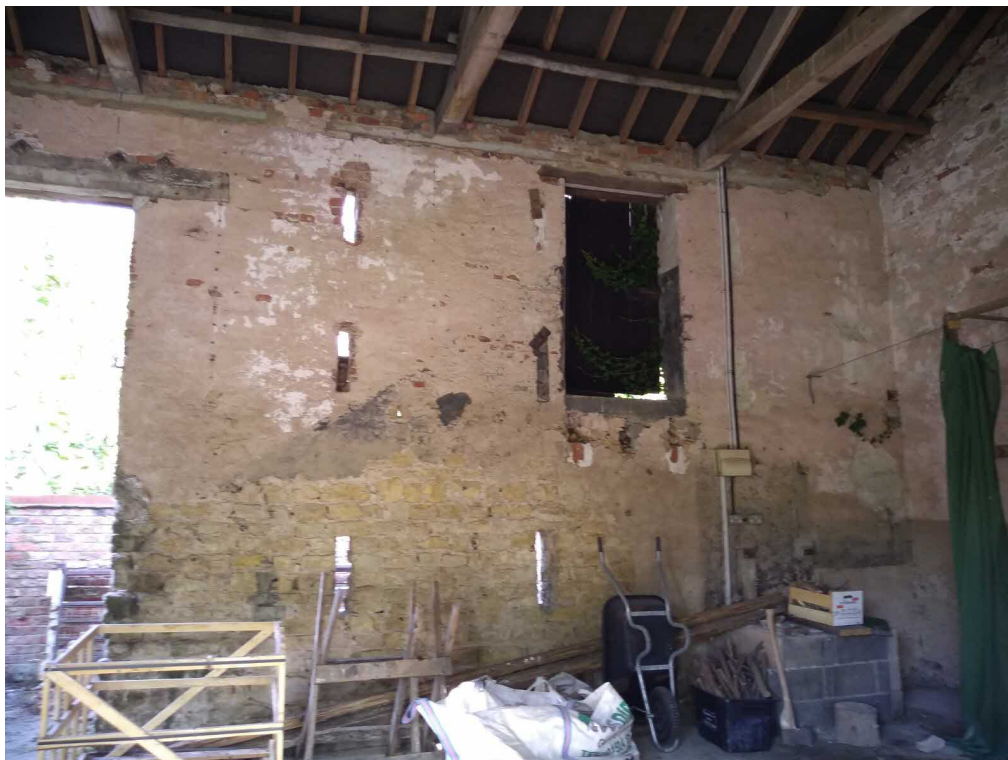
Photo 10 –Internal of rear elevation showing truss bearing

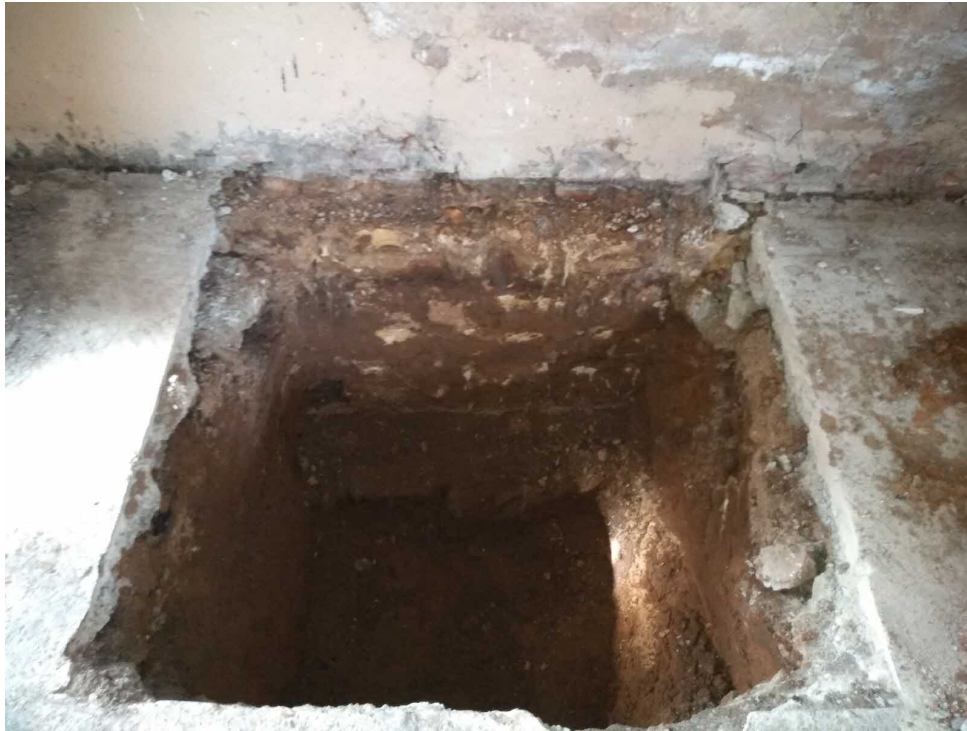
- 2.15 A trial hole next to the left-hand gable wall revealed a stone foundation at 700mm depth projecting 200mm from the face of the wall founded on firm brown sand. Photo 11
- 2.16 At the bottom left of the gable is a pedestrian entrance door to the barn. Photo 12

Photo 11 –Trial hole 3 left-hand gable

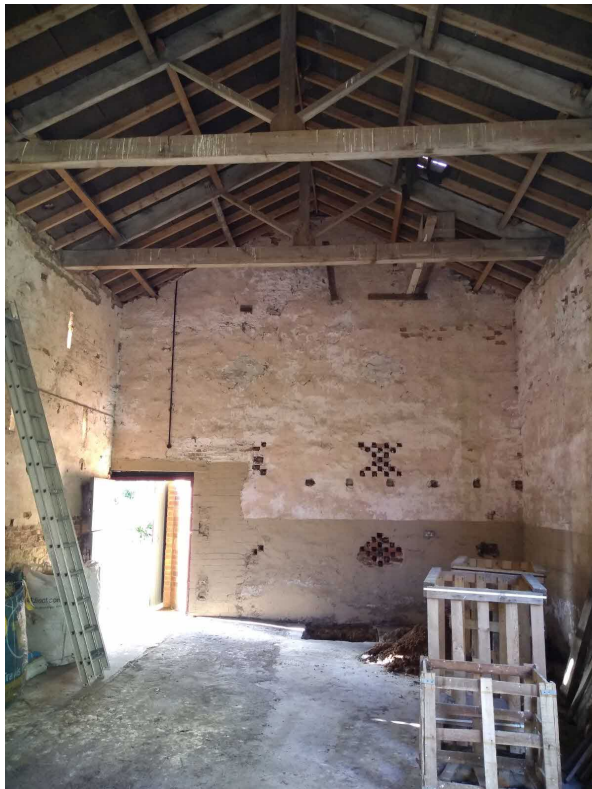
Photo 12 –Left-hand gable wall

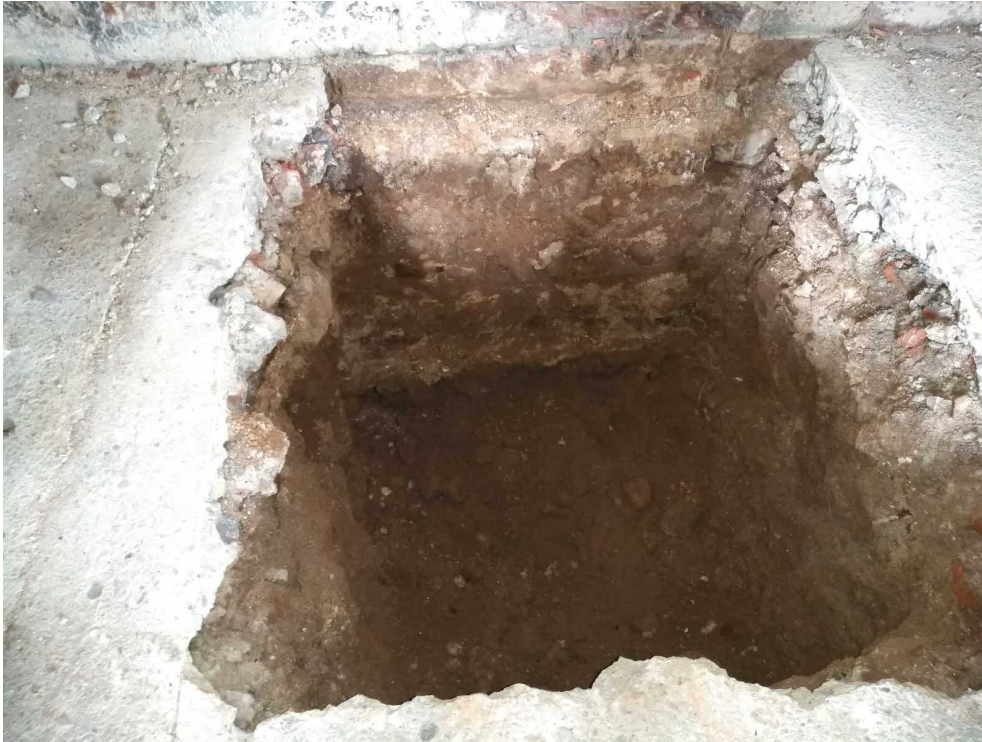
- 2.17 A trial hole next to the right-hand gable wall revealed a stone foundation at 790mm depth projecting 150mm from the face of the brickwork wall above founded on firm brown sand. Photo 13

Photo 13 –Trial hole 4 right-hand gable

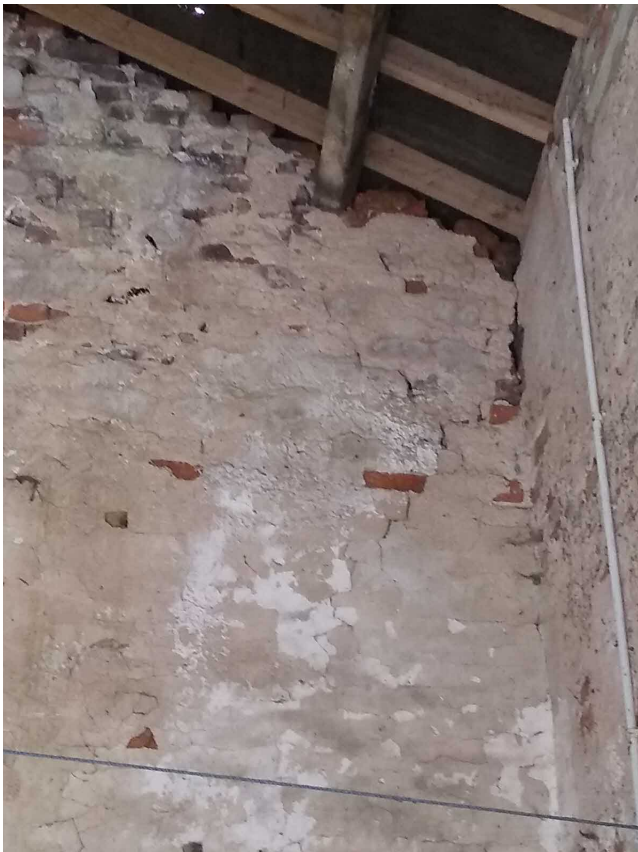
**2.18** At the top right of the gable is slight diagonal cracking in the brickwork corresponding with the cracking viewed externally. Photo 14

Photo 14 –Right-hand gable at high level
