Slates Farm
Structural Engineering
Condition report
Rev A – 10th January 2024

Prepared by: _____
Mark Sinclair
BEng(Hons) MSc CEng MICE
Structural Engineer | Founder

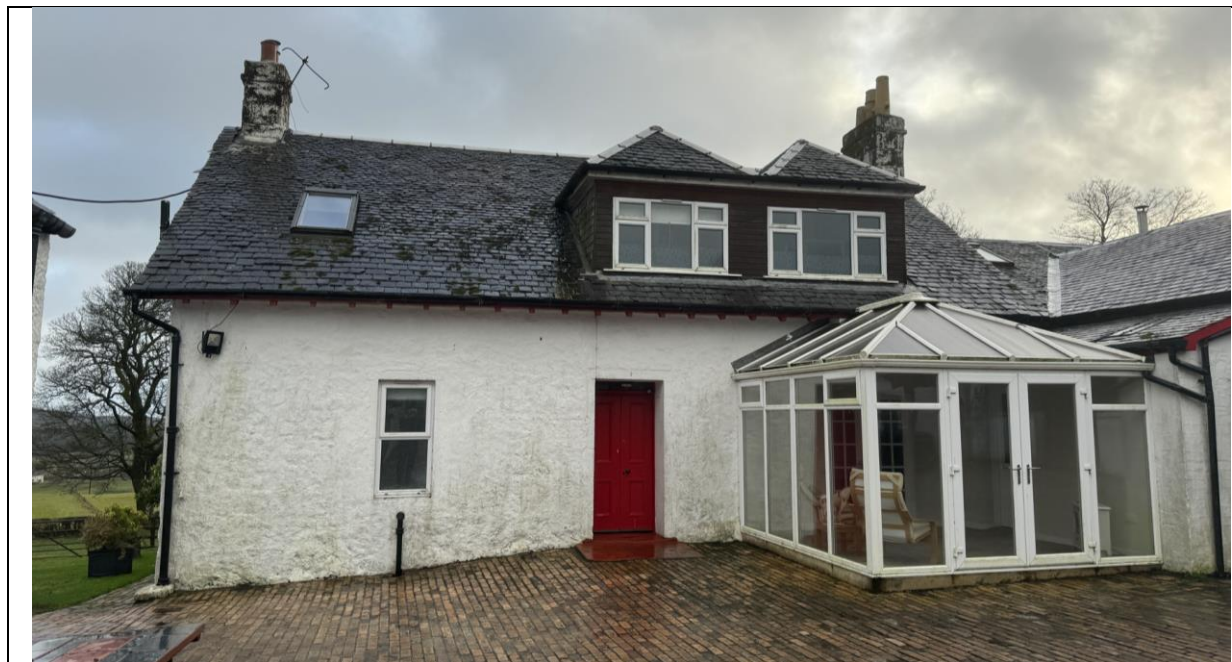
Figure 2 Image of elevation facing courtyard

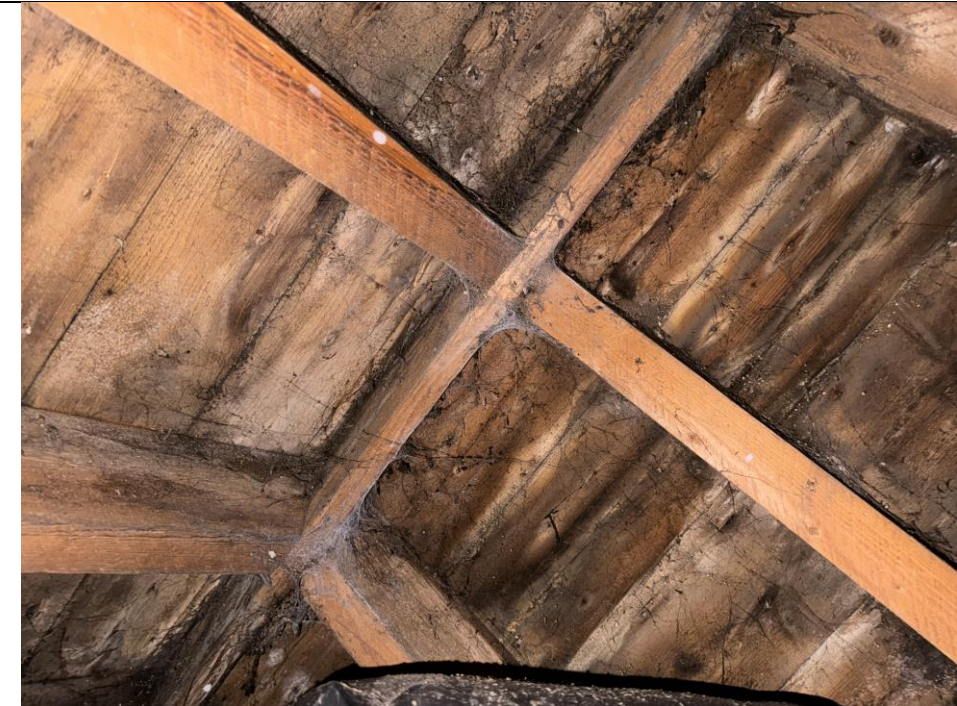
Figure 9 Inside main farm building roof space. Showing signs of water ingress and rot

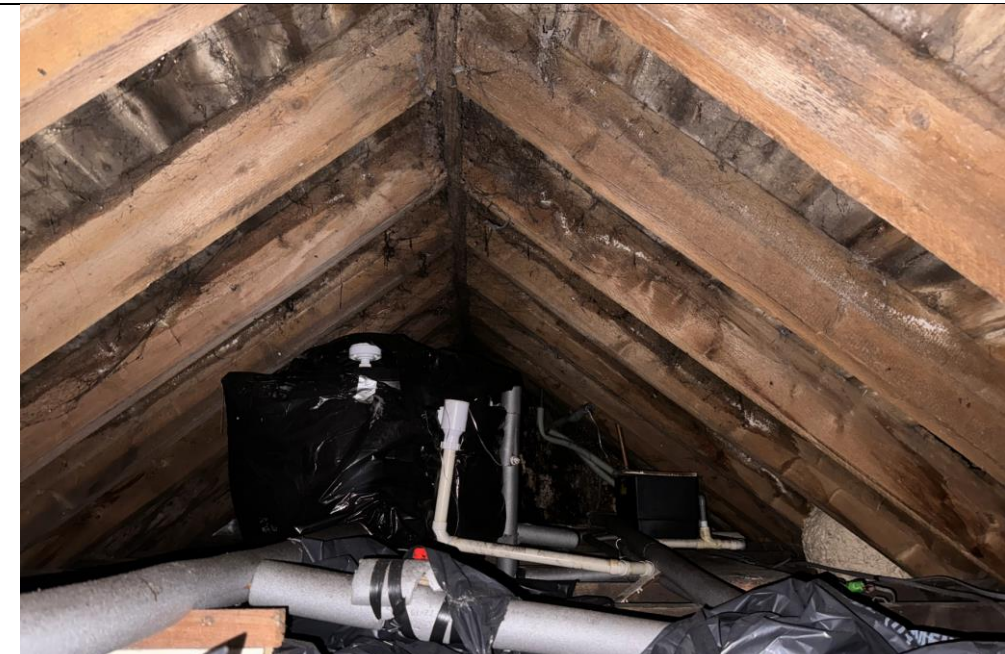
Figure 10 Inside main farm building roof space. Showing signs of water ingress and rot

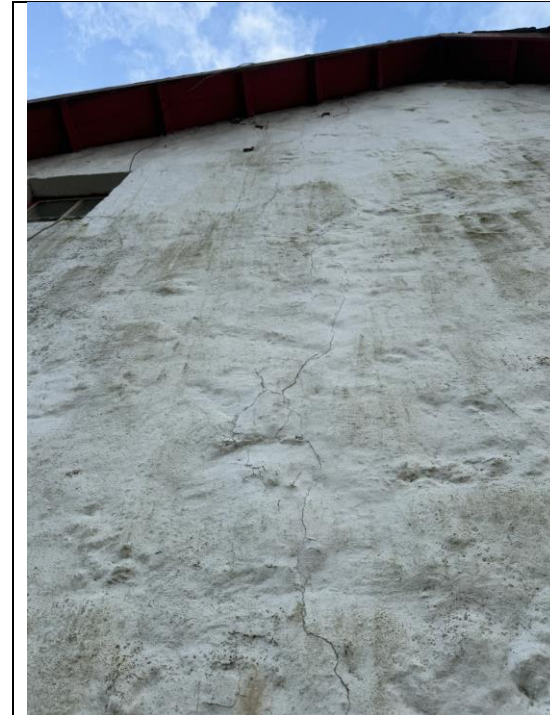
Figure 24 External gable wall showing evidence of minor cracking to the external finishes.

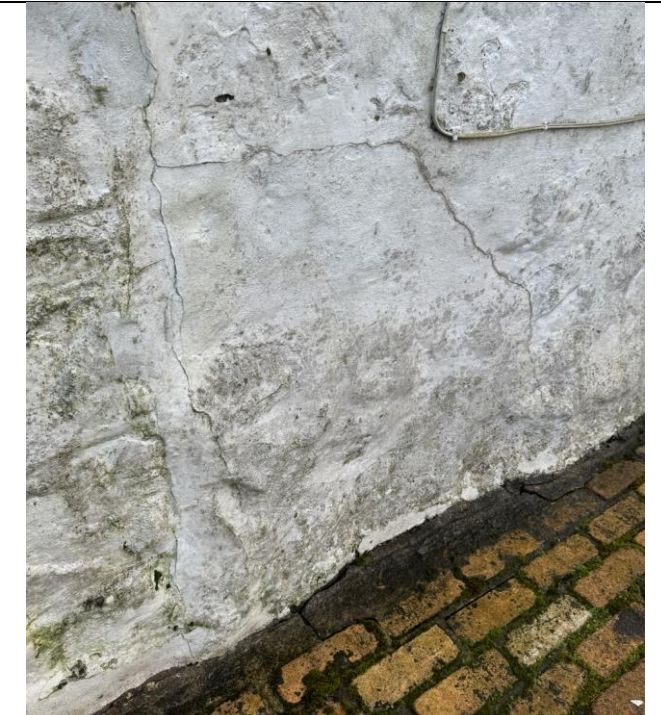
Figure 25 External gable wall showing evidence of minor cracking to the external finishes.

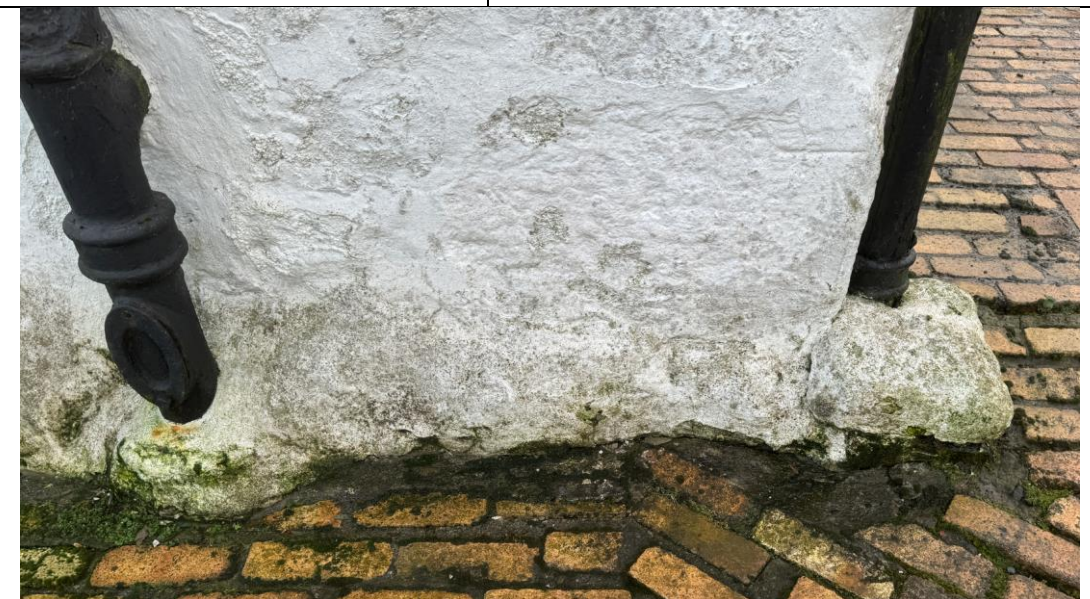
Figure 26 external gable wall with rocks in the wall build-up at the base

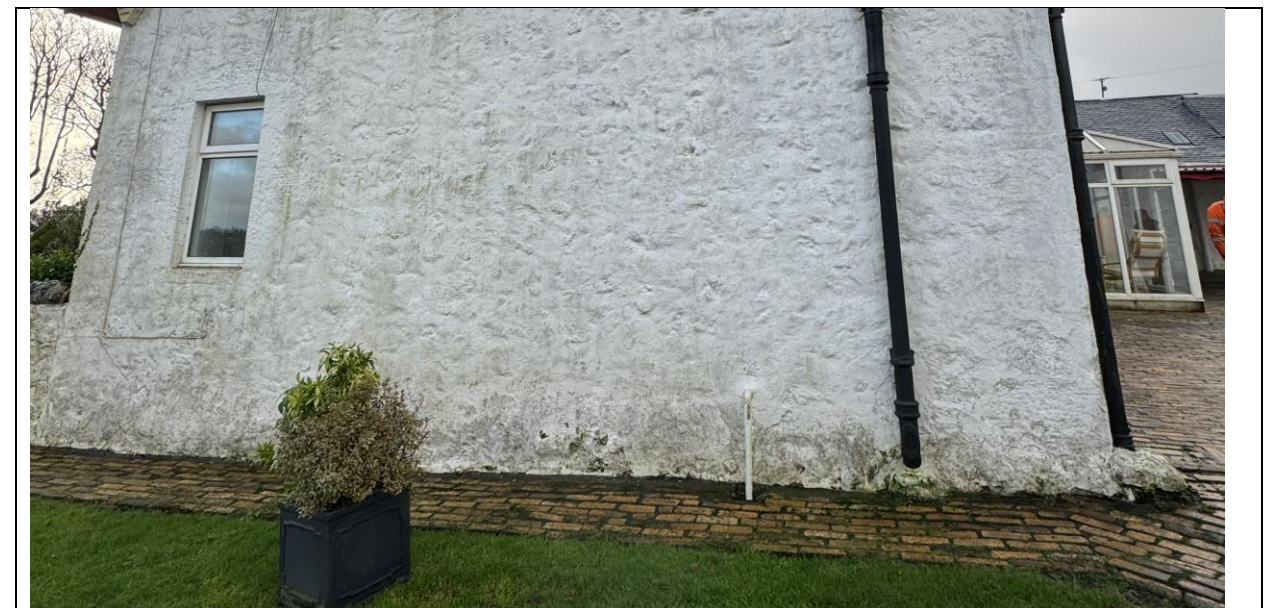
Figure 27 image of side elevation showing what appears to be rock forming the exposed foundation

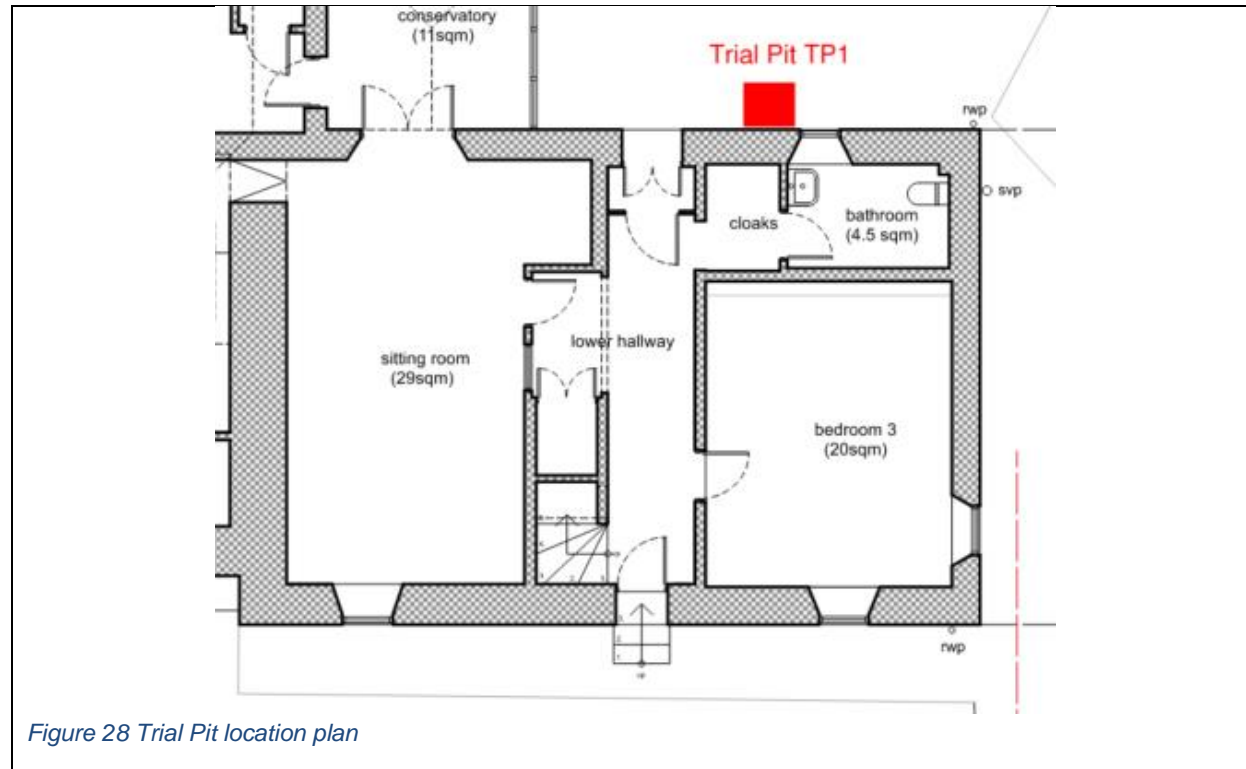
Figure 28 Trial Pit location plan

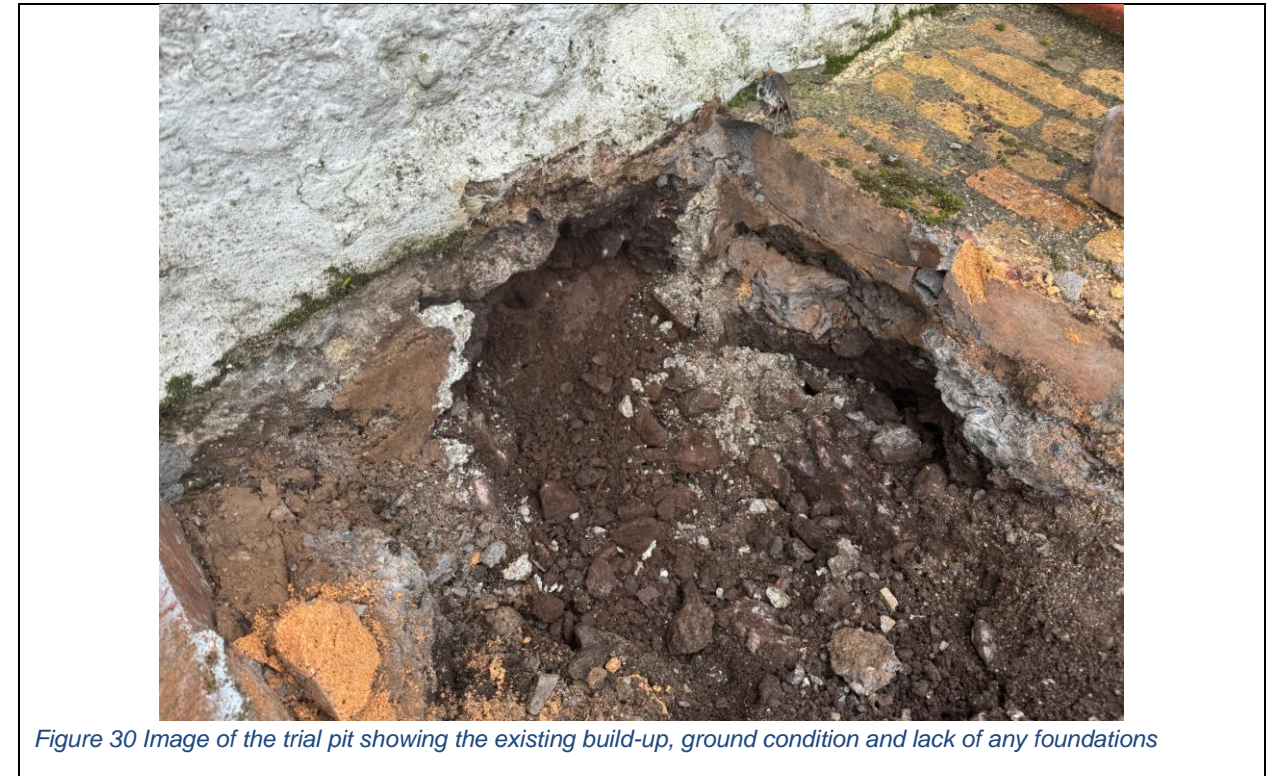
Figure 30 Image of the trial pit showing the existing build-up, ground condition and lack of any foundations

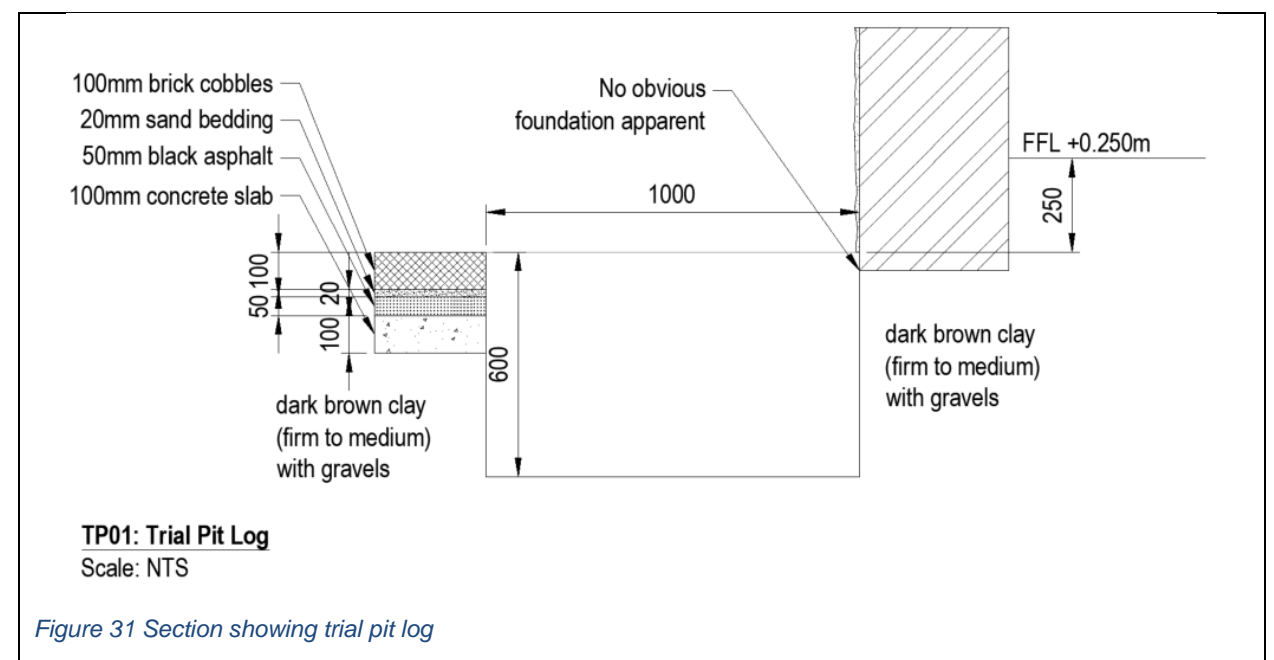
Figure 31 Section showing trial pit log
