Building Survey Report

The Property: Perseverance House
47 High Street
Lavenham
Suffolk
CO10 9PY

Inspected on: 14 September 2023

Survey Carried out by: Kevin R Hurley BSc MRICS

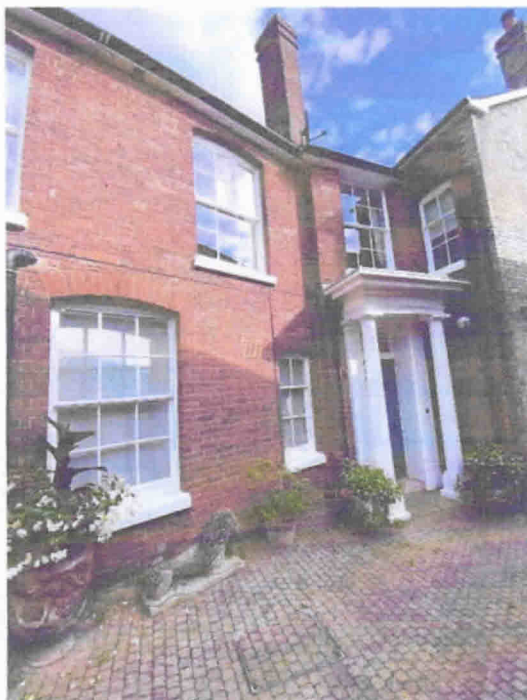
The chimney to the central section, left hand side (over front entrance) appear to serve the fireplace in the bedroom below. One would normally expect the chimney to extend down to ground floor level unless it has been subsequently removed.

However, below this at ground floor level, there is a window that appears original and no fireplace in the room corner. Accordingly, it appears likely that this chimney was *originally built to serve the first floor room only*.

The chimney appears plumb and there were no indications of any structural stress to the walls or floors, although some slope was noted to the bedroom floor in the direction of the fireplace which is most likely historic.

mid section LH side chimney (note window below)

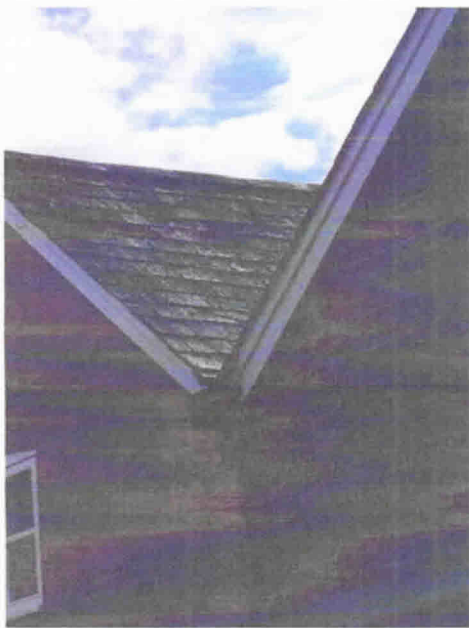
Valleys are a weak spot on a roof and are subject to leakage, due to their lining

and that they also are prone to becoming blocked. This causes a build up of water that can overflow the gutter lining and result in water ingress internally.

No access is provided to the roof spaces in this area and therefore we were unable to inspect these areas to assess whether the roof timber were damp. We would advise that such access is provided to enable future maintenance and inspection.

stable valley gutters

Also, we would recommend that the valley gutters to both this section and the main roof are inspected and cleared, prior to the onset of winter. At this time any maintenance repairs should be carried out.

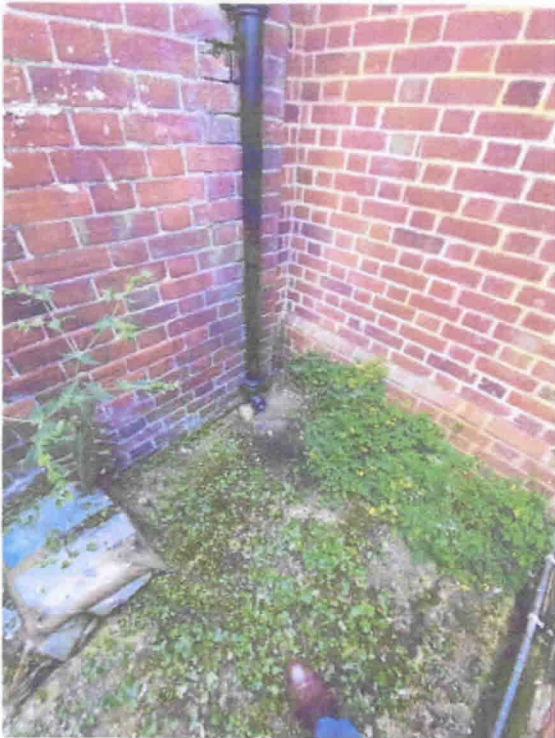
One area that could however be improved upon is to the rear right hand side, where a downpipe discharges onto the ground. This is making the area quite dank and ideally this should be connected to the underground drains.

right hand side small courtyard

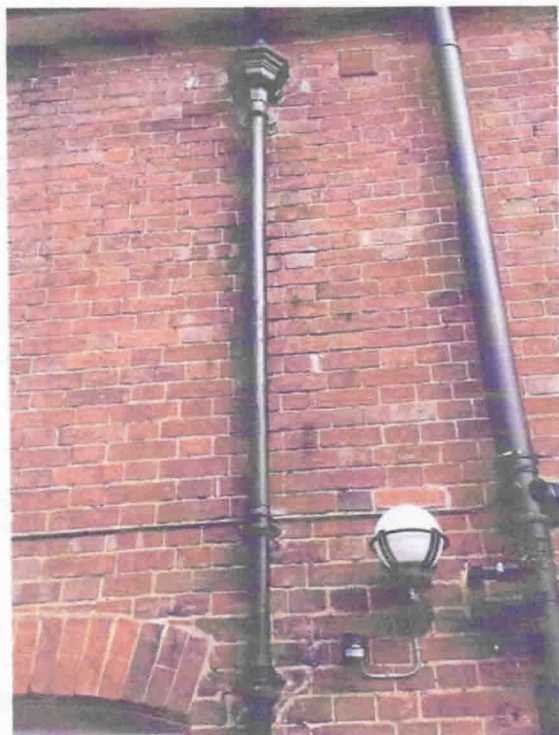
To the left hand side wall to the mid section of the main house, the lime mortar pointing was however noted to be eroded in areas and this will require attention in the short to medium term to prevent further deterioration.

erosion of lime mortar around downpipe

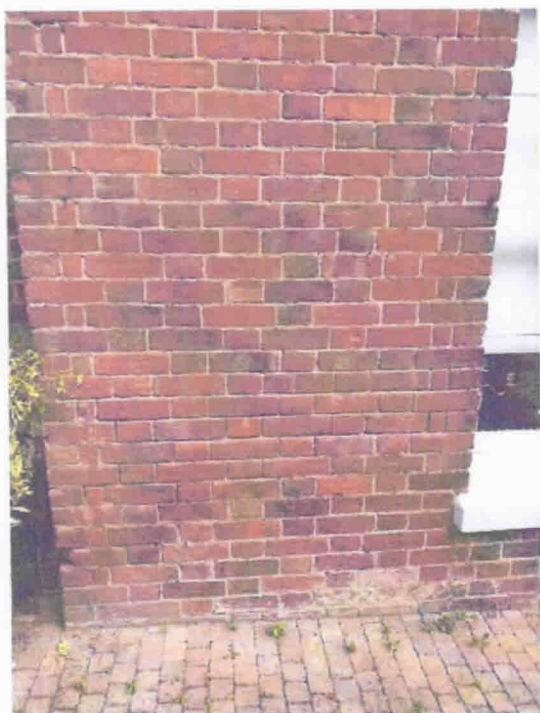
section of eroded mortar to LH side wall.

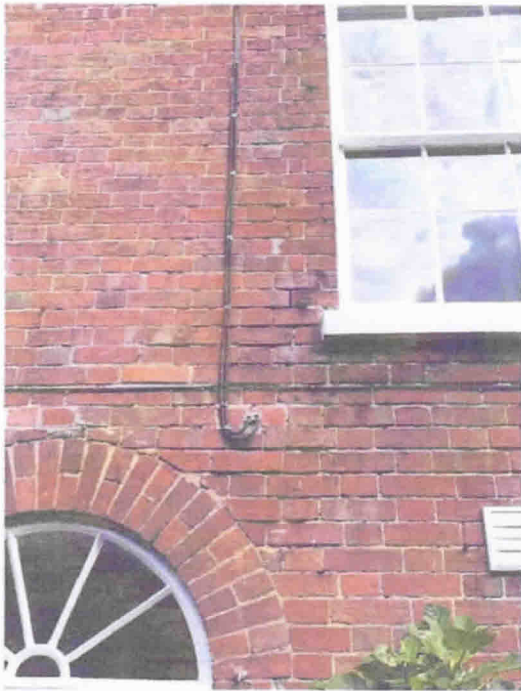
eroded mortar around side doorway

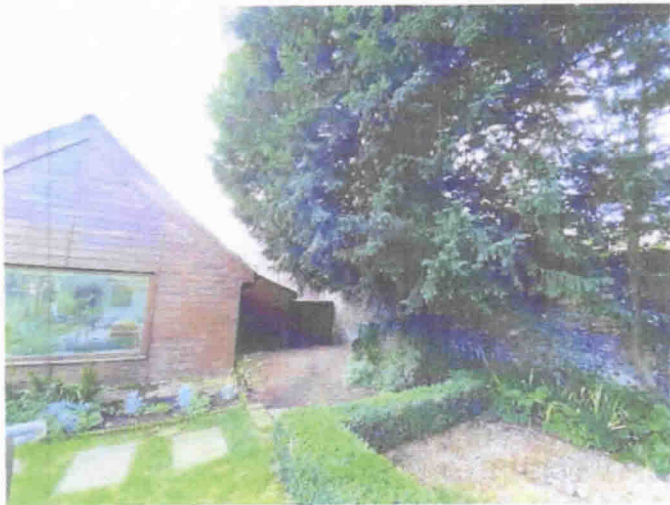
The timber cladding is finished with wood stain and this will require re-applying in the short term to maintain the protection to the timber.

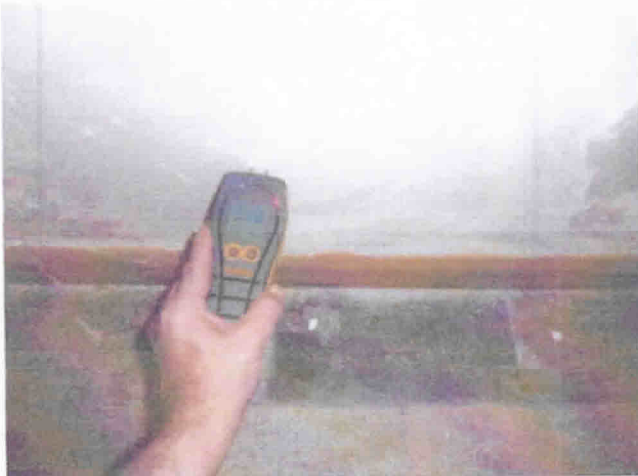
These areas have not been modernised or upgraded and the walls and floor are noticeably damp.

Access to the first floor flat is also provided with a lobby / stairwell area. The walls to this area are also damp affected and this is resulting in a damp / musty smell within the flat.

dampness to flat stairwell wall

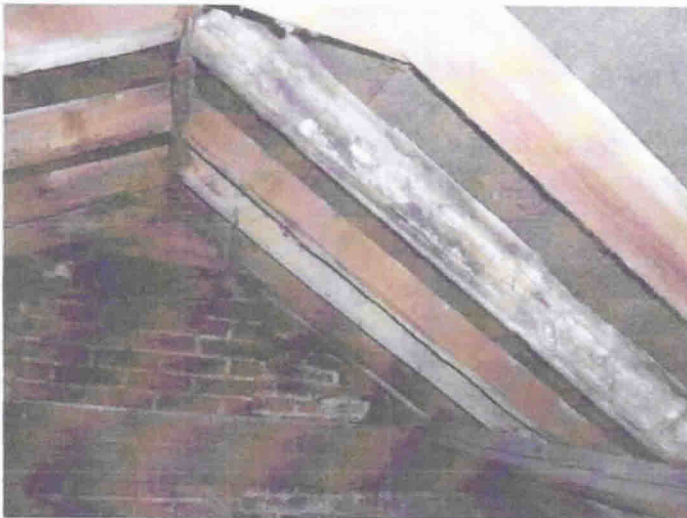
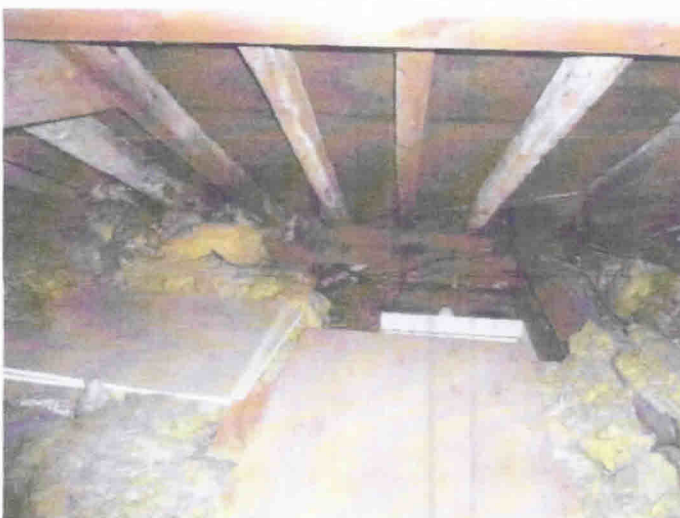
As is to be expected, there are signs of historic beetle attack and some deterioration to the outer surface of some timbers but they appear to remain sound and structurally stable.

Some staining was evident to the underfelt, indicating that condensation had occurred. Accordingly, we do advise that the ventilation to the roof spaces is improved.
