**Site Investigation including
Quantitative Risk Assessment
Pine House
Stowlangtoft
Suffolk
104909
December 2023**

Client:
HLD Developments Ltd
Old Hall Green Farm Barn
Old Hall Lane
Cockfield
Bury St Edmunds
Suffolk
IP30 0LQ

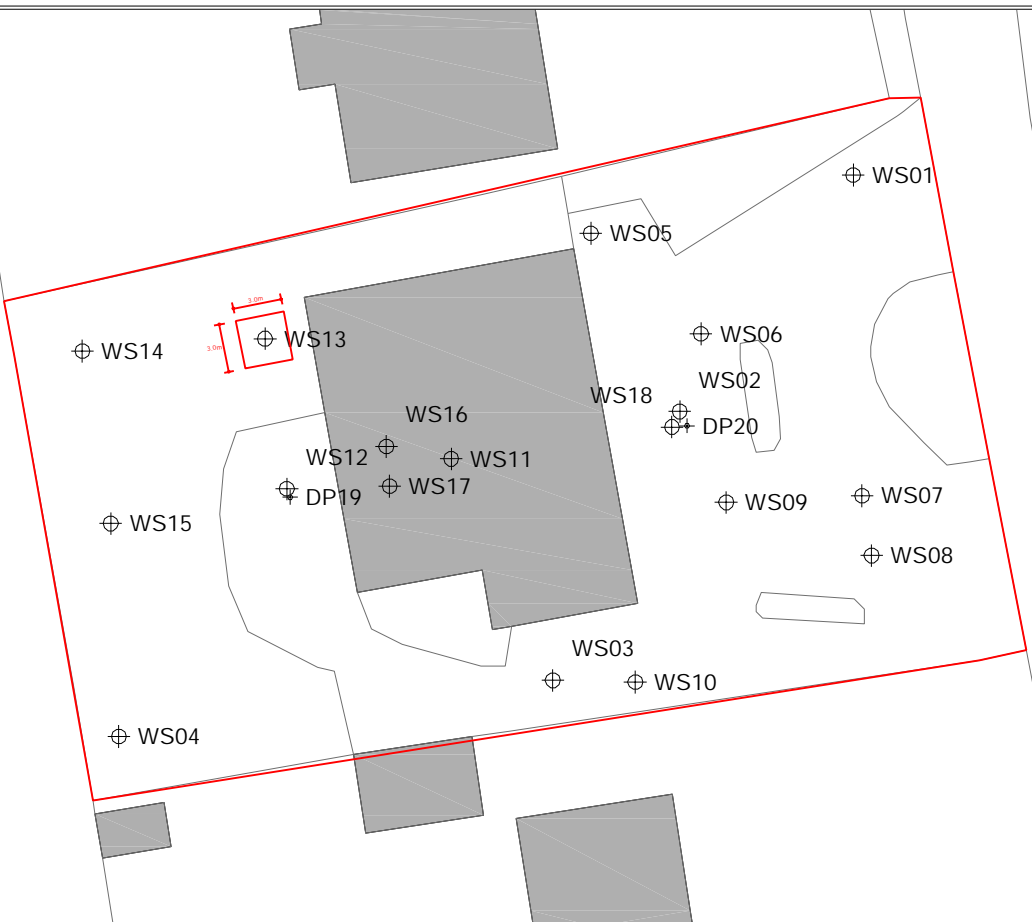
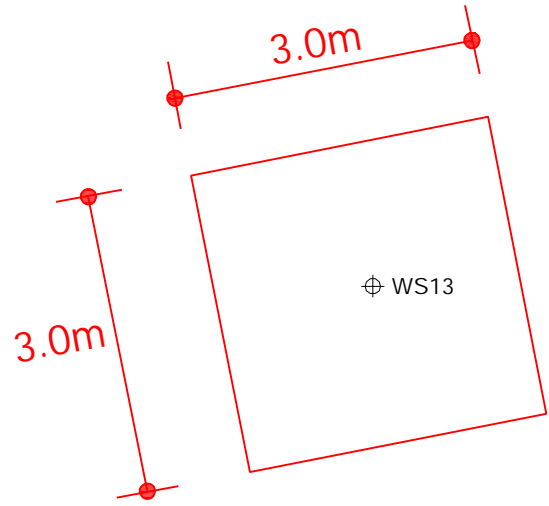
Appendix F

The testing has revealed an elevated Lead in TP13 at 0.30 metre within the Made Ground. It is therefore recommended that an area 3.0 x 3.0 metres is removed to a depth of 0.50 metre. (OSGR 595137/267832). Samples should be taken from the sidewalls and base and analysed for Lead to confirm that all the contaminated material has been removed. The excavated material should be disposed of to a suitably licensed facility. Conveyance notes shall be provided.
