3.0 Results of Inspection

3.1 General Site Description

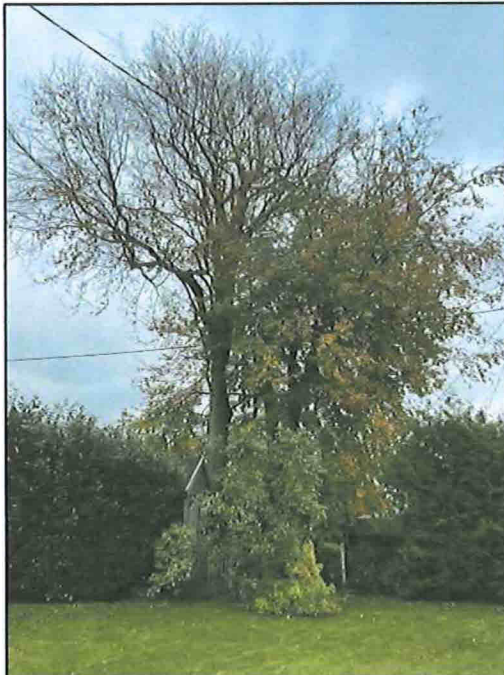
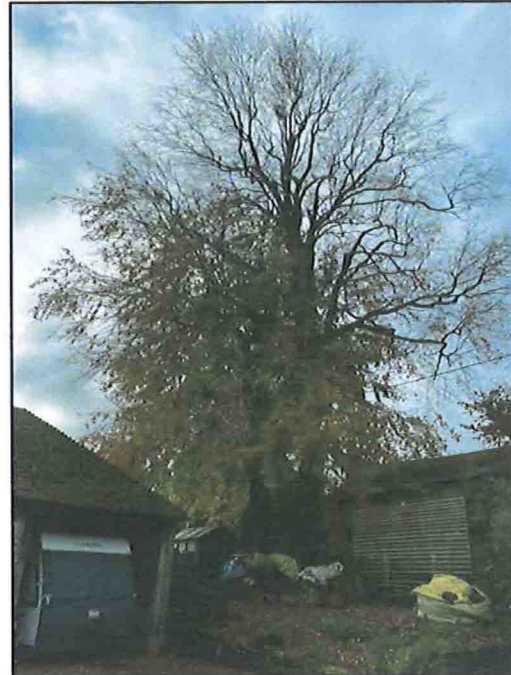
- Building materials and machinery, including piled earth, are located beneath the eastern crown spread of both trees in the grounds of Hollybank
- The ground levels within Hollybank, have been lowered to allow for the building of the property, the construction of the garage and the access path to the storage area c.20 years ago; exposed roots were noted jutting out of the exposed bank

Fig.1 - looking from Old Orchard and Hollybank drive respectively
Note the timber outbuilding, shed and garage beneath the crown of both trees

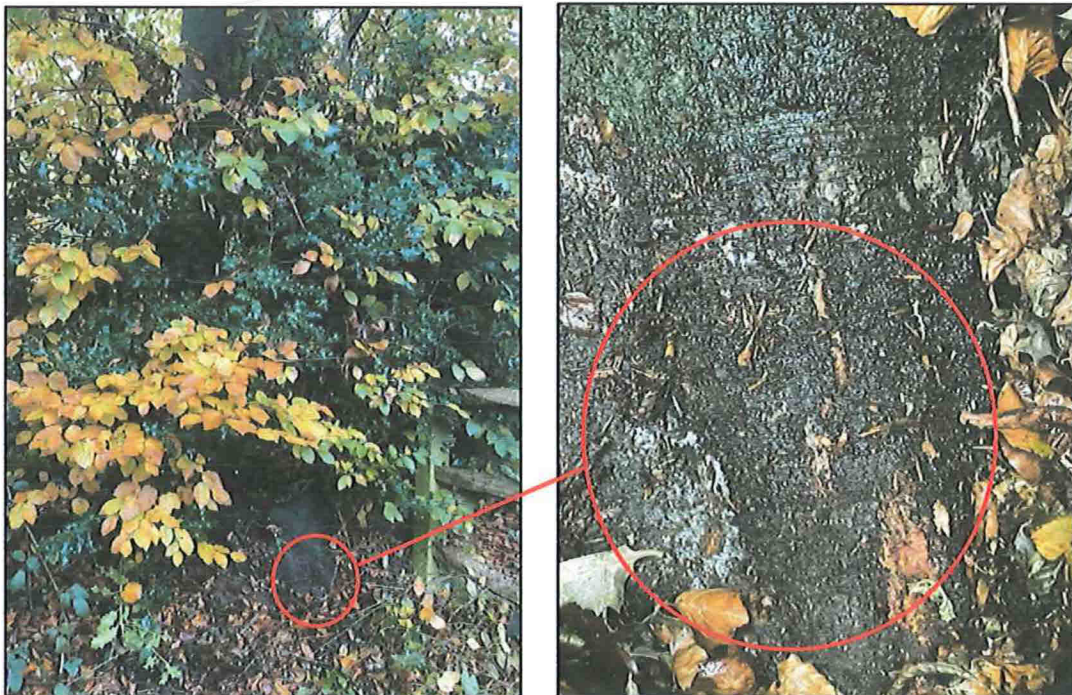
- Sections of the lower stem were obscured by thick holly and beech growth. The lower growth was pruned away to expose the western basal area
- A small split was noted on the western buttress roots along with a grey patch on the bark; when this area was assessed with the nylon headed mallet no change in tone was heard

Fig.2 - western buttress root with 'split' and grey patch on the bark circled red
Note the dense holly and beech obscuring the lower stem area

- The split in the western buttress root is not deep and is limited to the bark layer only suggesting it has been caused by rapid growth which has caused a separation in the bark

- This is typical of the tree species and can readily occur on the older sections of the tree. However, in the event cracks or splits occur which extend into the wood structure, further analysis should be made as these could be due to a separation of the wood fibres

- Upon further investigation, the grey patch on the lower stem rubbed away suggesting it was more than likely a leaf mould that was forming on the bark rather than a fruiting body of *Kretzschmaria deusta*

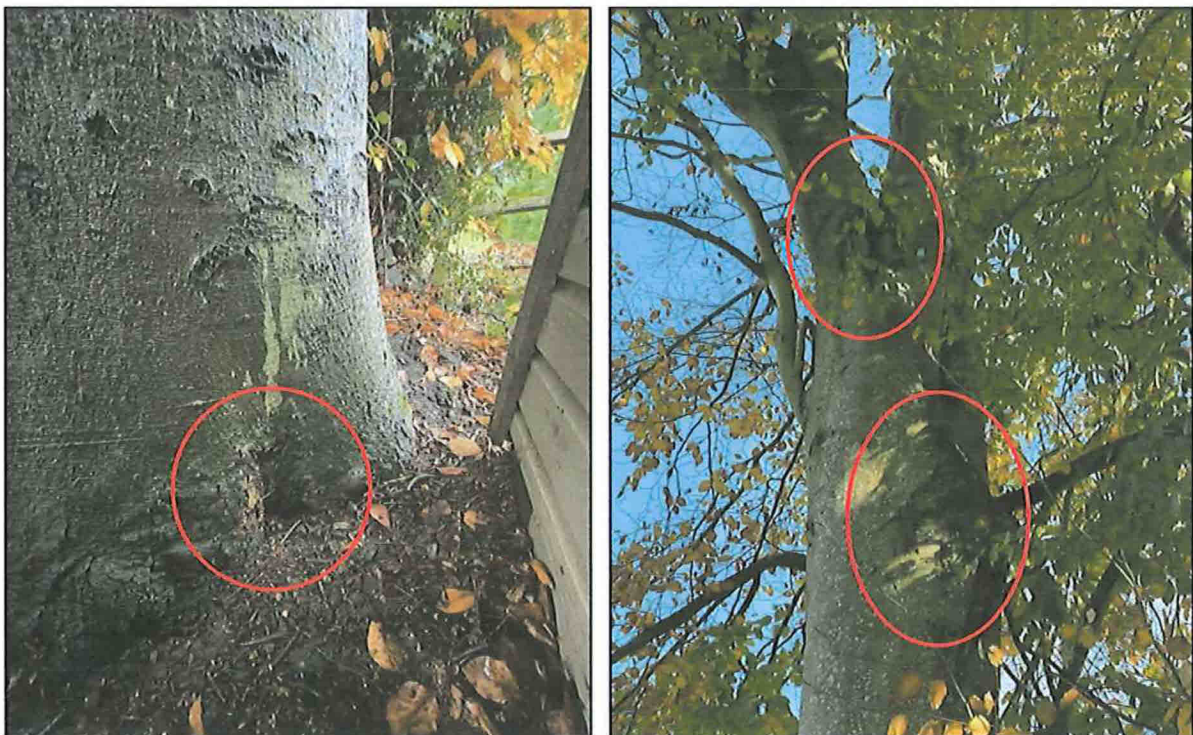
- The concrete raft base and fabric of the timber outbuilding are within 18cm of the western side of the tree where a patch of moribund bark was noted forming between the west and northwest buttress roots. No change in tone was heard when this area was assessed with the nylon headed mallet

- The stem forks at c.5.5m to form two primary stem sections in an east-to-west arrangement. The union formed is included on the north side of the stem with a large rib forming on the southern side

- The western primary stem section forks once again at c.7.5m to create two secondary stem sections in a southeast-to-northwest arrangement, the union of which is included on the northeast side with a rib forming on the southwest side

Fig.2 - western buttress root and fabric of outbuilding 18cm apart, the moribund bark area is circled red

The two unions with ribs forming on the southern and southwestern side circled red

- The patch of moribund bark between the buttress roots on the northwestern side of the stem may be a precursor to a cavity forming; at the time of the assessment no decay fungi fruiting bodies were noted

- However, due to the process involved in laying the concrete raft for the outbuilding, damage to the rooting system may have occurred which may become an entry point of decay fungi and other pathogens²

- Common beech trees are known for their predilection to produce included unions which can fail given the right situation. Such a situation would be when wind gusts cause an oscillation in the crown structure resulting in the unions separating

- To help reduce this risk, the tree should be reduced to its previous pruning points to establish a smaller tree with a smaller crown mass. The arborist undertaking the work should fully assess the unions for defects, reporting their findings back to me for comment if necessary

- Whilst performing the reduction, any deadwood greater than 25mm in diameter should be removed
- This is by no means necessary at this time but should be considered for the continued management of the tree and as such I would suggest a timeframe of no later than two years from the reports date
