HISTORIC BUILDING RECORDING

ST MARY'S COTTAGE, THE GREEN,
HARDWICK

JANUARY 2024

Level 2/3 Historic Building Survey

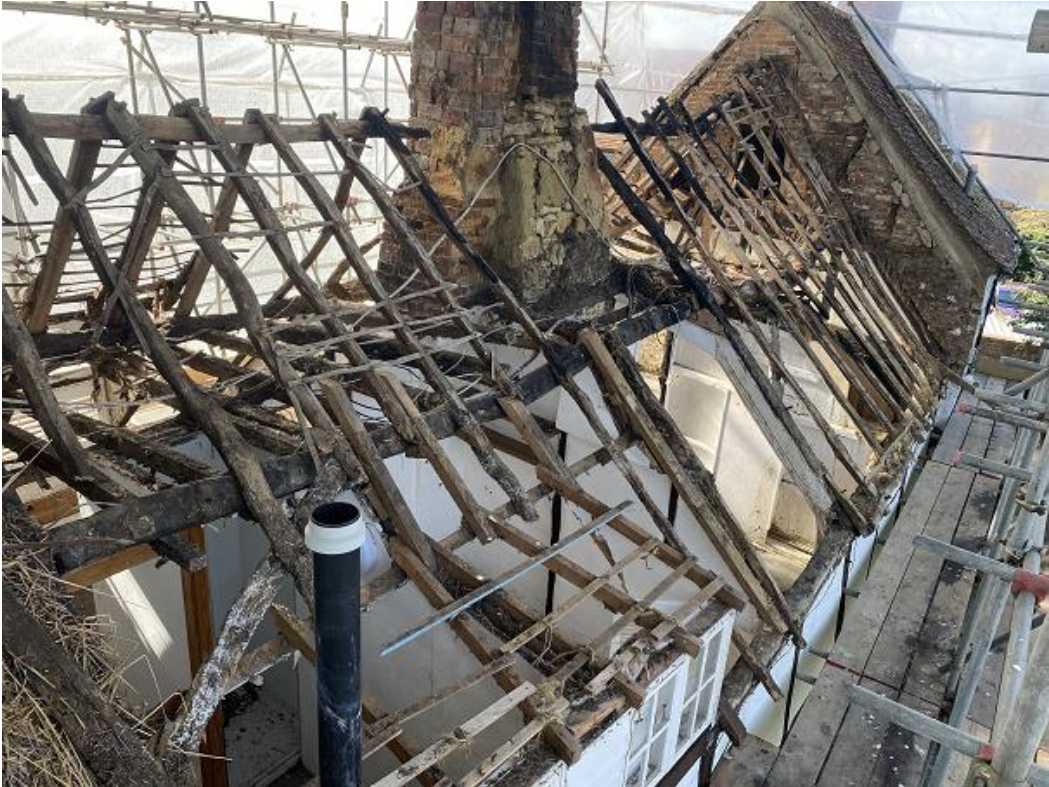
Plate 1: North-facing roof slope looking west

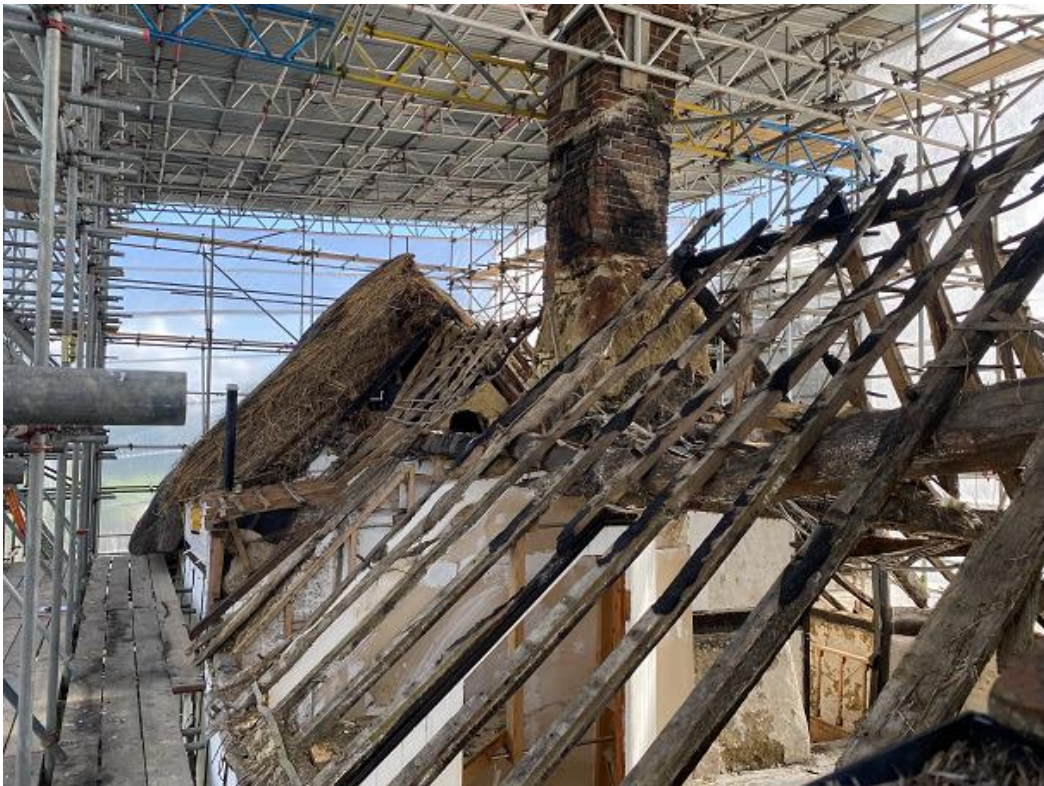
Plate 2: North-facing roof slope looking east

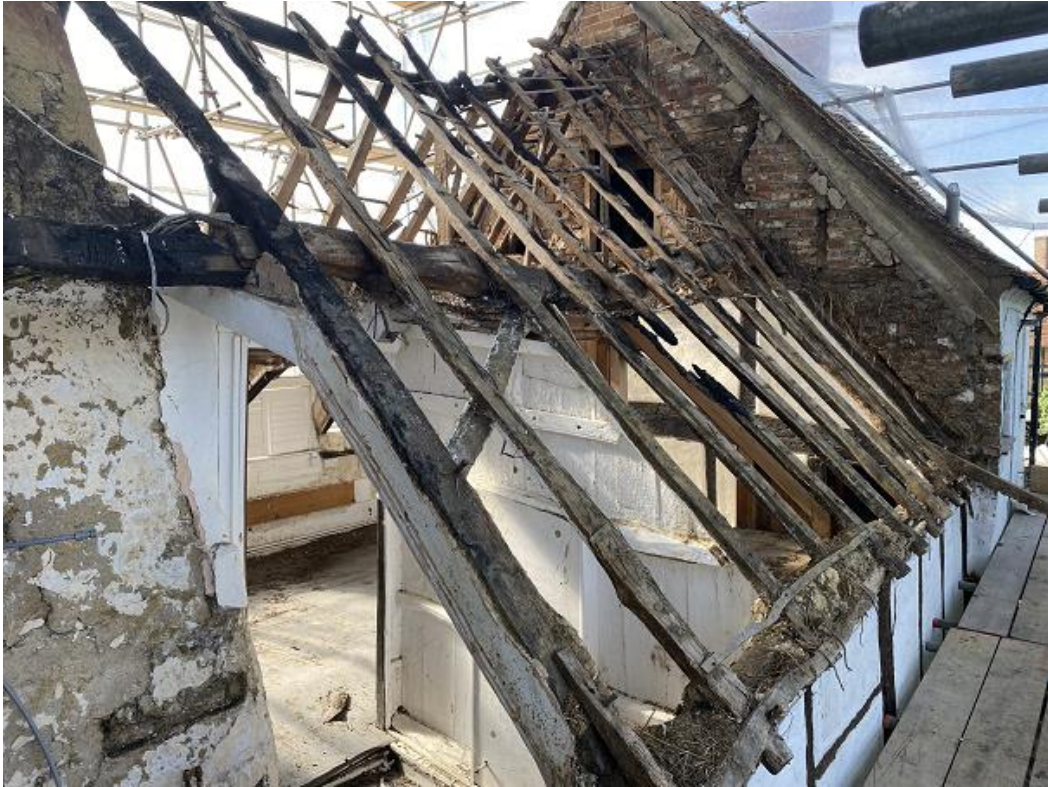
Plate 3: North-facing roof slope looking west, showing bracing timber beneath purlin and small section of riven lath to lower area

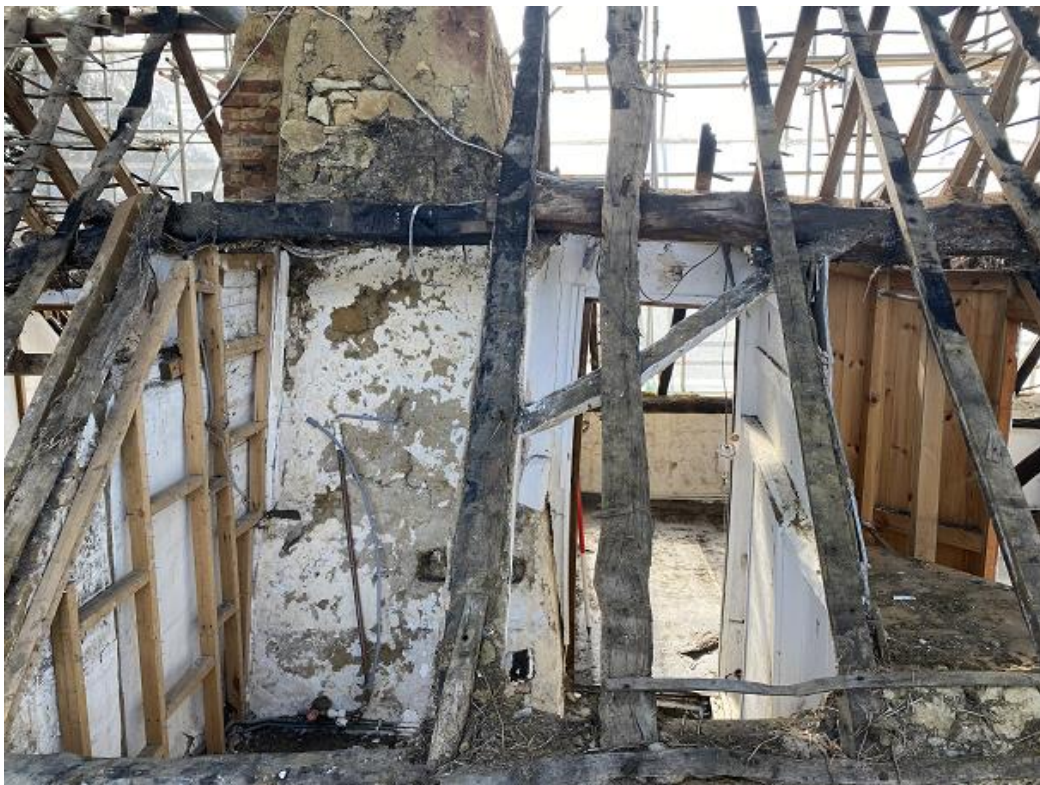
Plate 4: North-facing roof slope looking south, showing connection of brace into rafter and purlin

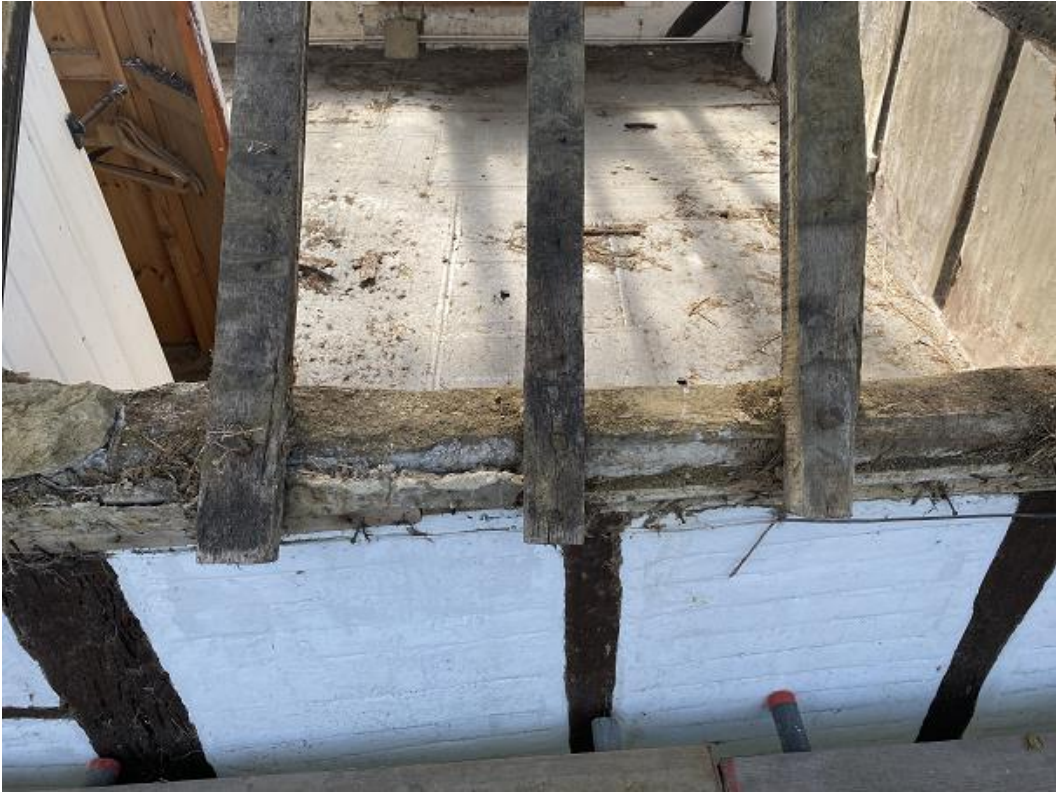
Plate 5: North-facing roof slope looking south, showing pegged connection of rafters into wall plate

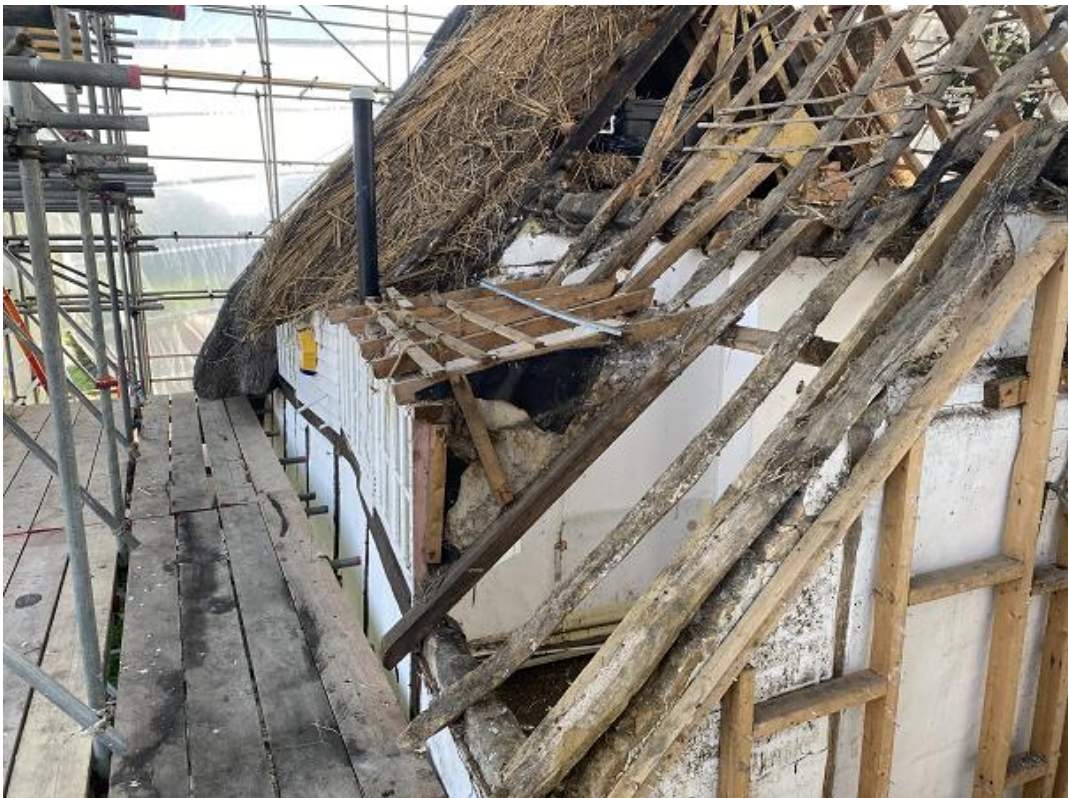
Plate 6: North-facing roof slope looking east, showing modern dormer construction

- 5.2 Notwithstanding the above, the roof structure shows evidence of being altered over the years, with the addition of dormer windows; the dormer on the north-facing slope being of modern, 20th century construction. There is also evidence on the southern slope of historic failure in the structure, with the addition of a large-section purlin over an historic member, which remains in situ.

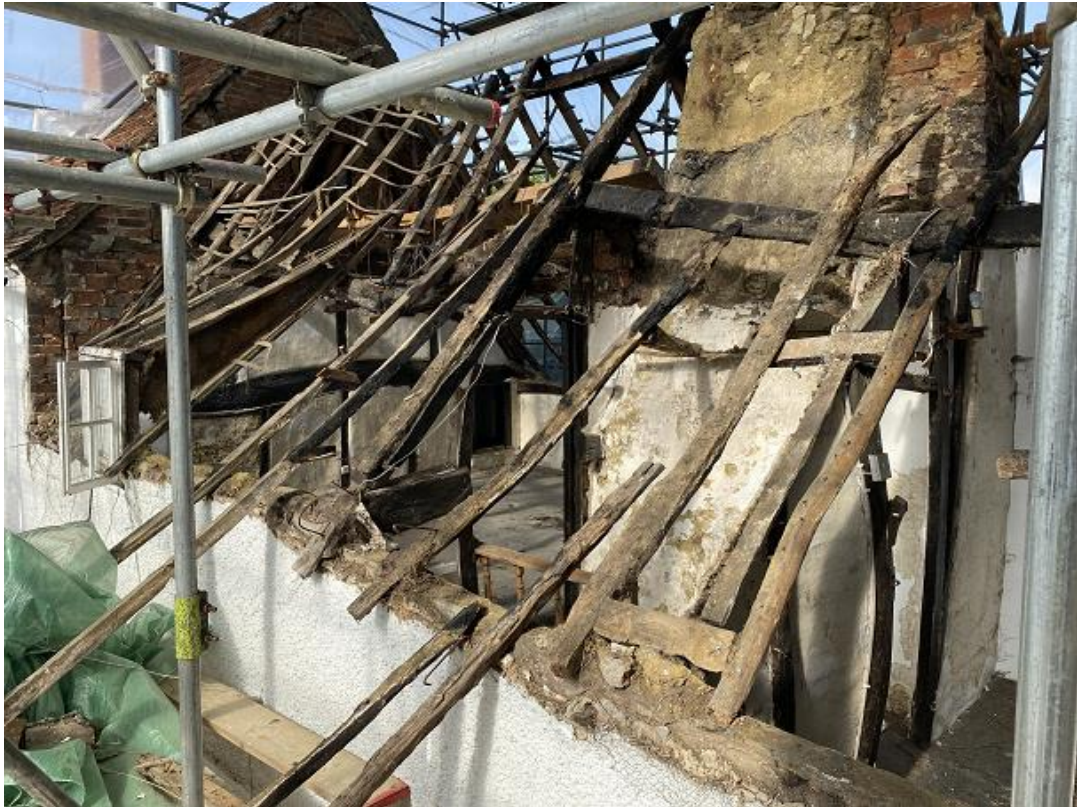
Plate 7: South-facing roof slope looking west

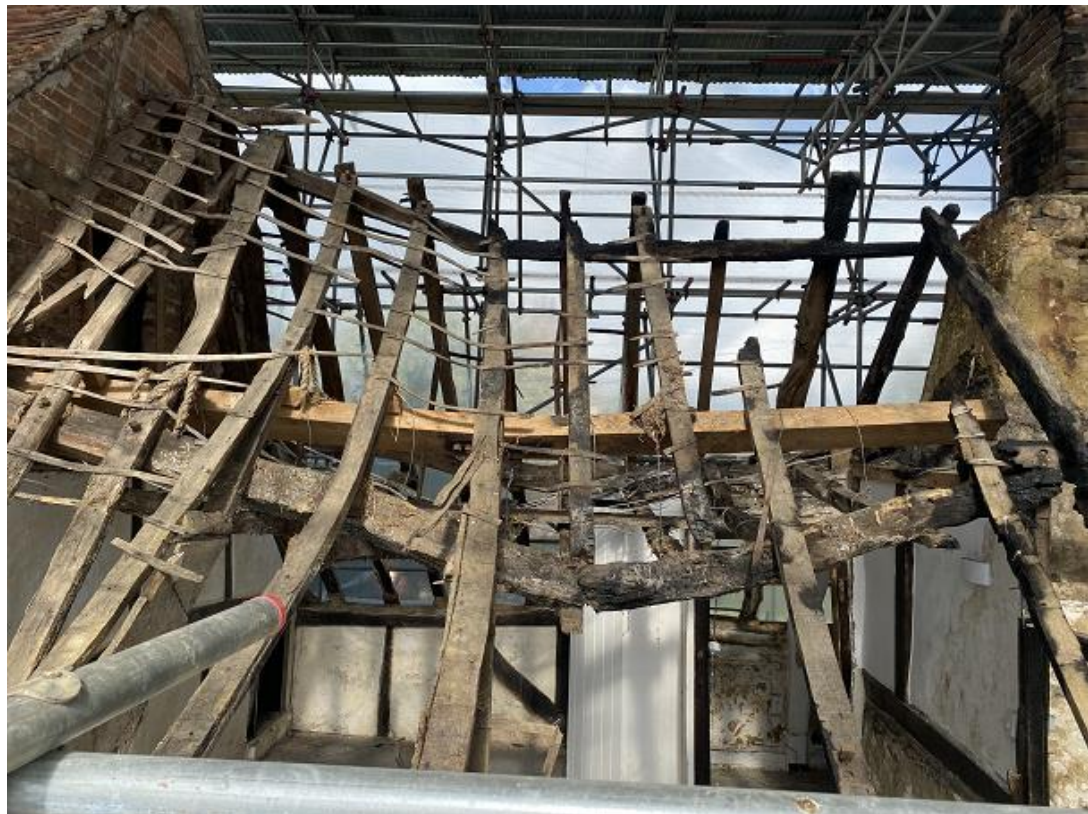
- 4.5 A large section purlin appears to have been inserted above an historic purlin within the southern slope of the western bay during the 20th century. It is assumed that this would have been done in response to structural issues with the existing structure.

Plate 8: South-facing roof slope looking north, showing failed purlin with modern purlin over

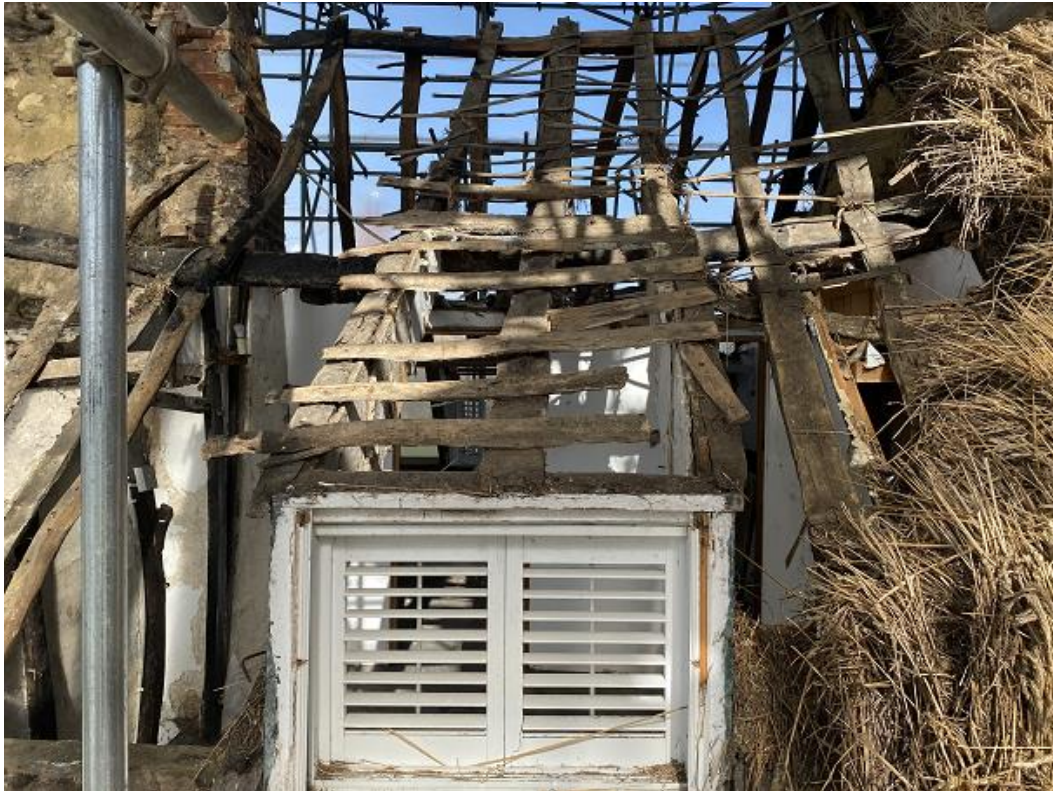
Plate 9: South-facing roof slope looking north, showing construction of easterly dormer

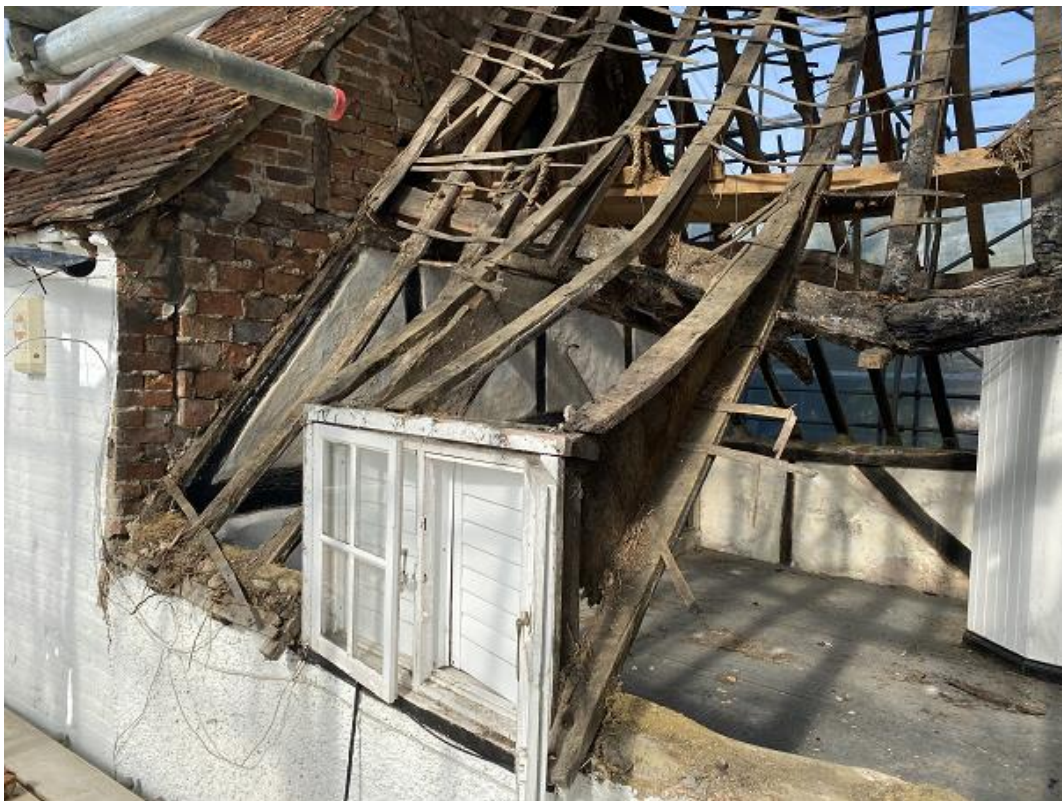
Plate 10: South-facing roof slope looking north, showing construction of westerly dormer

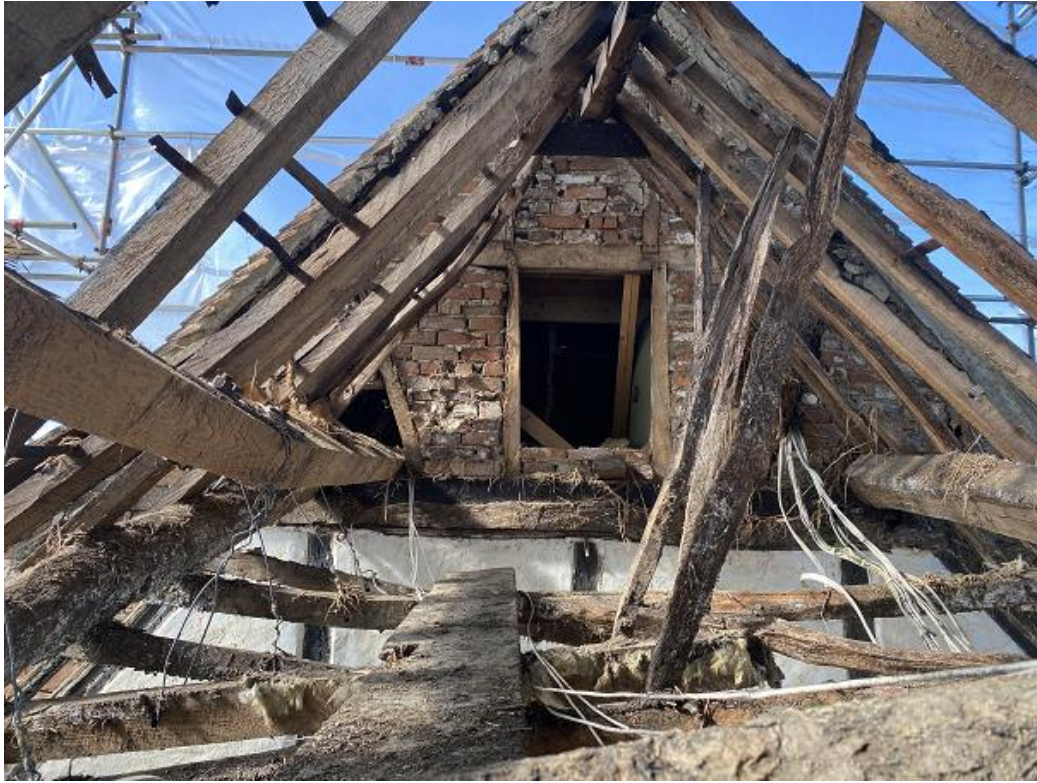
Plate 11: View looking west of underside of roof structure in western bay

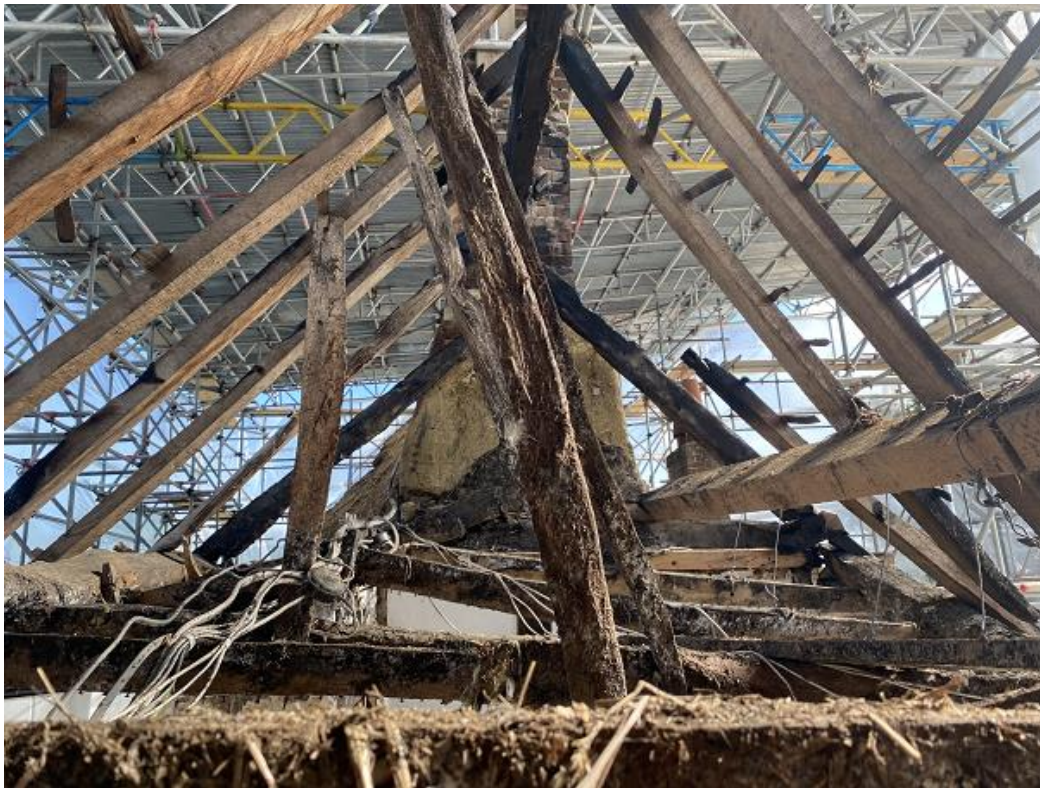
Plate 12: View looking east of underside of roof structure in western bay

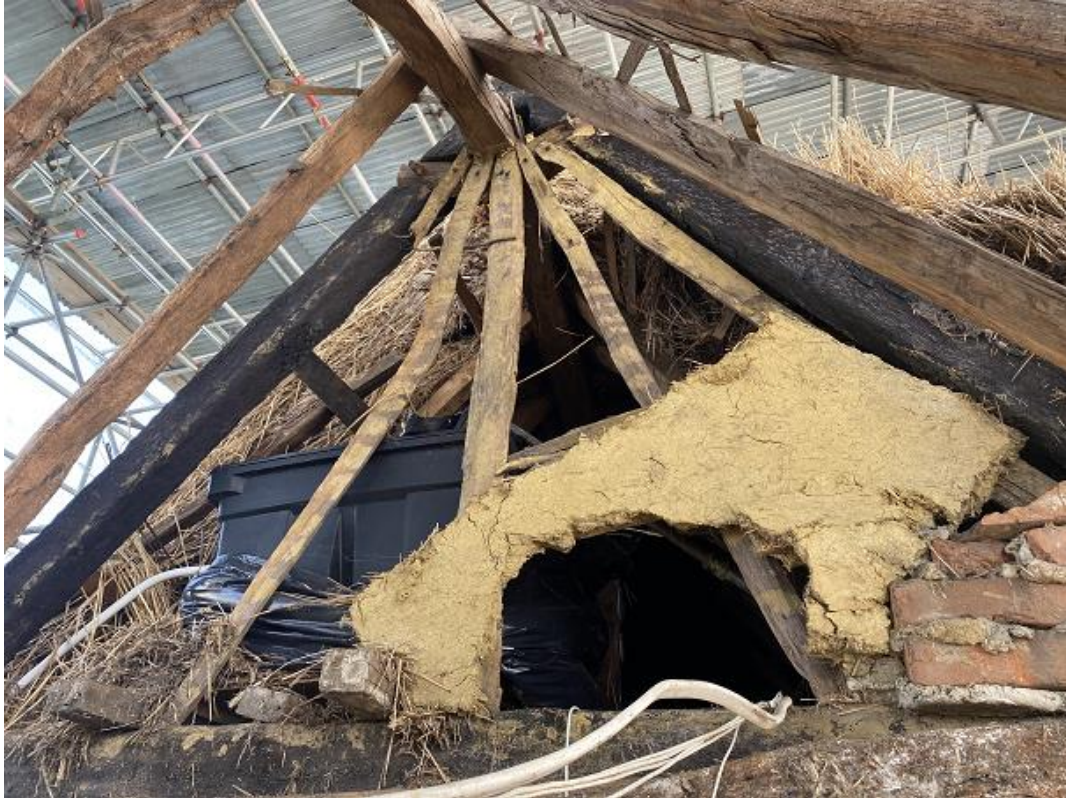
Plate 13: View looking east of plastered partition at east end

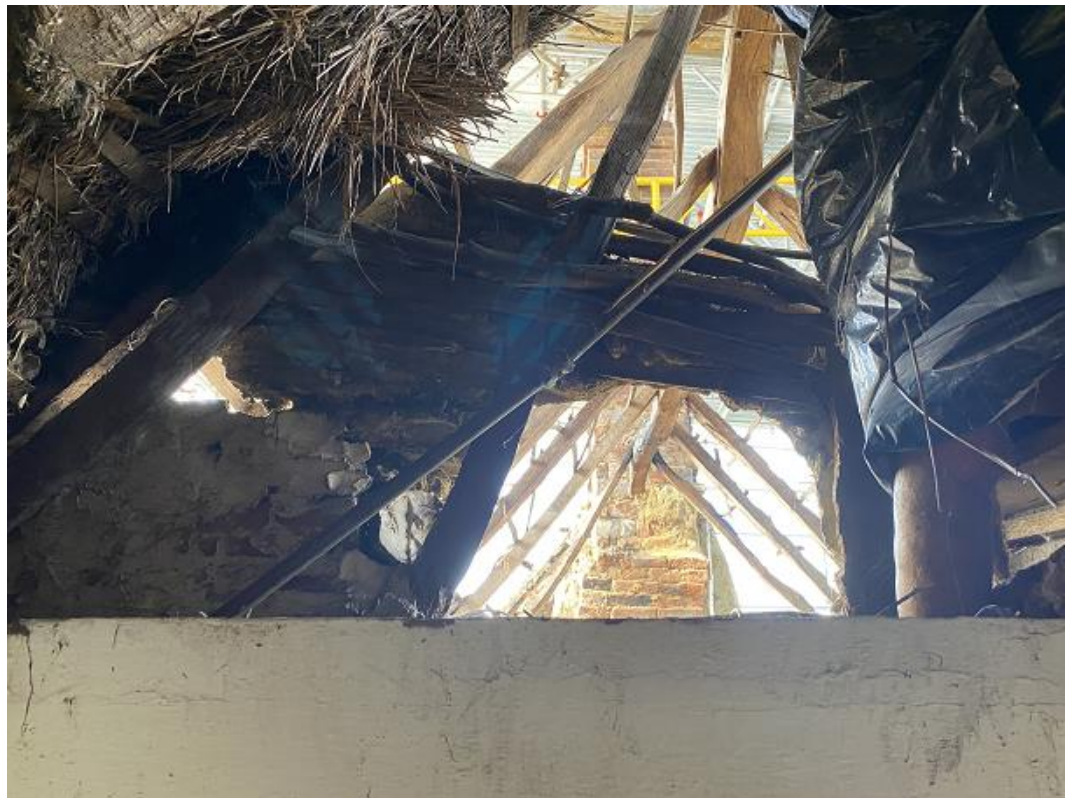
Plate 14: View looking west of rear of plastered partition
