BS5837:2012 Tree Survey  
 Land at 51 Main Street  
 Wilsford  
 Lincolnshire  
 NGR TF00217 43129

Report prepared by: C Barker	Date Issued: 04 November 2021
	Reviewed by: KLB	Report Version: V1
	Report ref: <b>P2343 /1121 /01</b>	C B E Consulting Highbank, 5 Grantham Road, Navenby Lincoln. LN5 0JJ. Telephone (01522) 810086. www.cbeconsulting.co.uk

# BS5837 Tree Survey, Land at Main Street, Wilsford

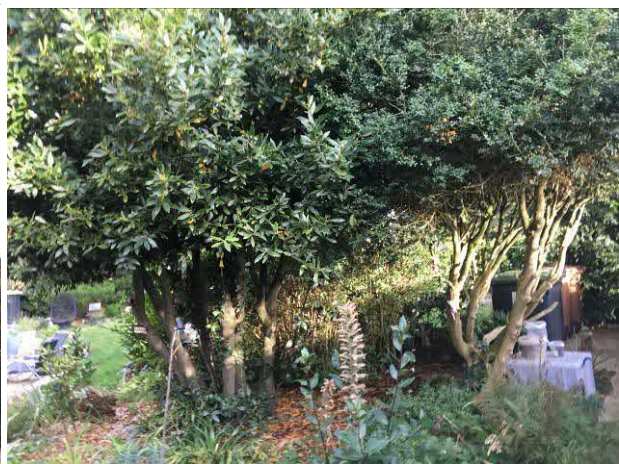
Trunks of T1 (left) and T2 (right)
