BS5837:2012 Tree Survey  
 Land at 51 Main Street  
 Wilsford  
 Lincolnshire  
 NGR TF00217 43129

Report prepared by: C Barker	Date Issued: 04 November 2021
	Reviewed by: KLB	Report Version: V1
	Report ref: <b>P2343 /1121 /01</b>	C B E Consulting Highbank, 5 Grantham Road, Navenby Lincoln. LN5 0JJ. Telephone (01522) 810086. <a href="http://www.cbeconsulting.co.uk">www.cbeconsulting.co.uk</a>

# BS5837 Tree Survey, Land at Main Street, Wilsford

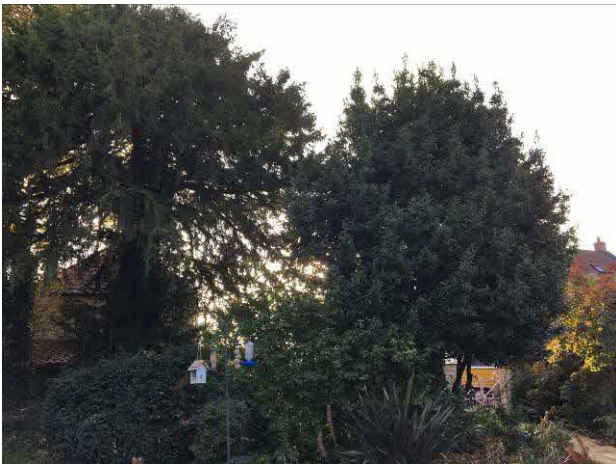
Holly T1 and Box T2

**Tress T1 and T2** comprises a small Holly and a large Box situated within the walled garden. These are not specimens of high landscape value in this position and the Box has not been trimmed. Holly T1 is placed into Category C and Box T2 is placed into Category U.

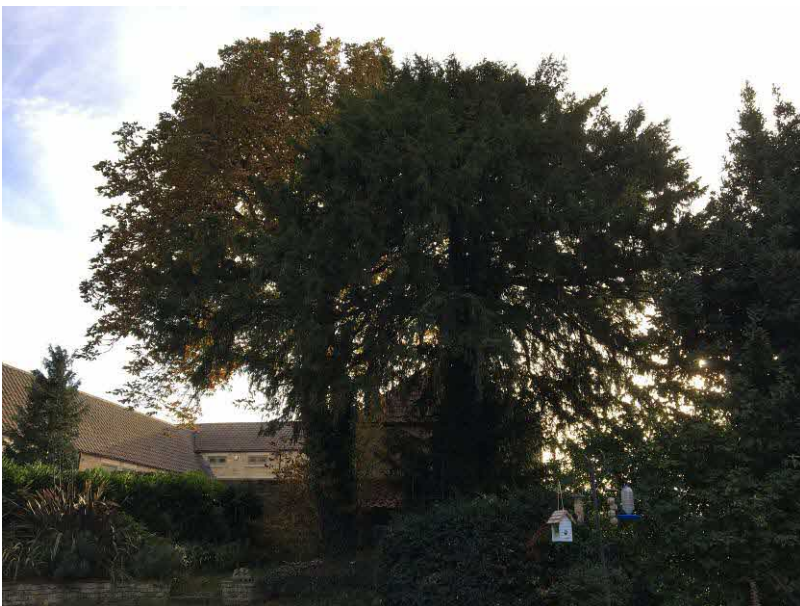
Yew T3 (right) and Horse Chestnut T4 (left)

**Yew T3 and Horse Chestnut T4** are large mature trees in the garden and the merging crowns of these tree dominate the position and can be seen from Main Street. The Yew is in good condition, crowded by the nearby Horse Chestnut but of sufficient quality to be placed into Category B. The Horse Chestnut is confined by the Yew and the property to the south, the crown extending across the edge of the roof of this property. There is no evidence of canker and the tree is placed within Category B.

Theoretically there may be some loss of rooting area for trees T3 and T4 from the garage. However, there are factors to take into consideration which may have restricted rooting in this specific location:

It is still possible that there will be tree roots from T3 and T4 in the area where the garage is proposed and therefore it is recommended that a foundation solution is used which incorporates mini-piles and a raft to avoid the need for significant excavation in this area. It is more likely that the majority of the roots for Yew T3 will extend to the north rather than the south due to the position of Horse Chestnut T4. The roots of this latter tree are likely to extend west and north east where there will be plenty of space but the house to the south and the wall will be barriers that the majority of the roots are likely to follow.

If the garage is constructed in a sympathetic manner which avoid any excavation of foundations then the potential loss of rooting to T3 and T4 is likely to be very small and significant impact on the vitality of these trees should be avoided. There is no conflict with the crowns or any low branches.

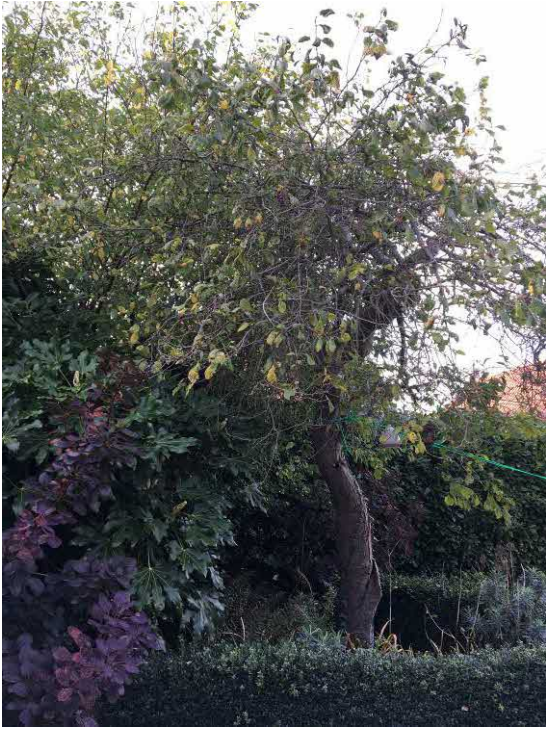
Damson T6

**Damson T5 and T6** are in the rear driveway area of the property outside of the walled garden. Both are small tree, hidden from view except from the south. Damson T5 is placed into category C and this tree will need to be removed to facilitate the proposed garage development. Damson T5 can be retained but there is a significant wound and decay in the main trunk of this small tree so this should be monitored. This tree is placed into Category U.

Tree No	Species	Ht (m)	Stem Diam mm@ 1.5m	Canopy Spread (m)	Height of Crown Clearance	Age Class	Est yrs	Overall Condition	Structural condition	Recommendations	BS 5837 Category	RPA Radius (m)
T6	Damson <i>Prunus domestica</i>	4	205	N-2 S-2 E-1 W-2	3	SM	<10	P	Single trunk with large deep split at 1magl showing evidence of decay in the trunk interior. Flat topped, lifted crown. No structural faults visible from ground level	None	U	2.4

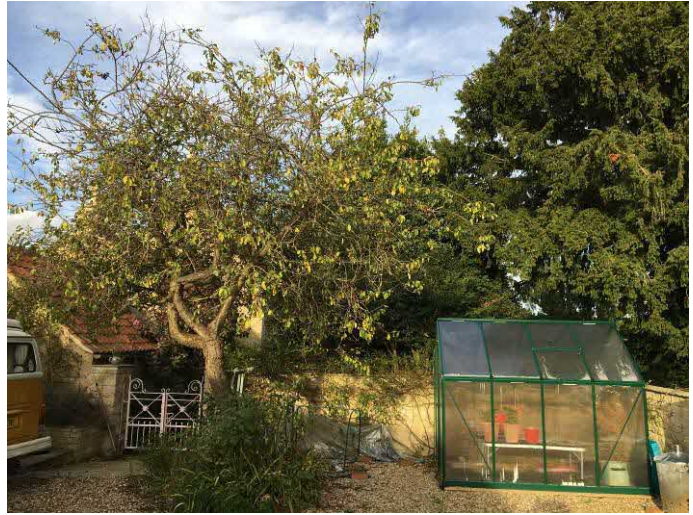
Damson T5

T5	Damson <i>Prunus domestica</i>	5	210	N-3 S-3 E-2 W-2	2	SM	10+	G	Single trunk leans to the north supporting a round irregular crown with a nest present. No structural faults visible from ground level	None	C2	2.5

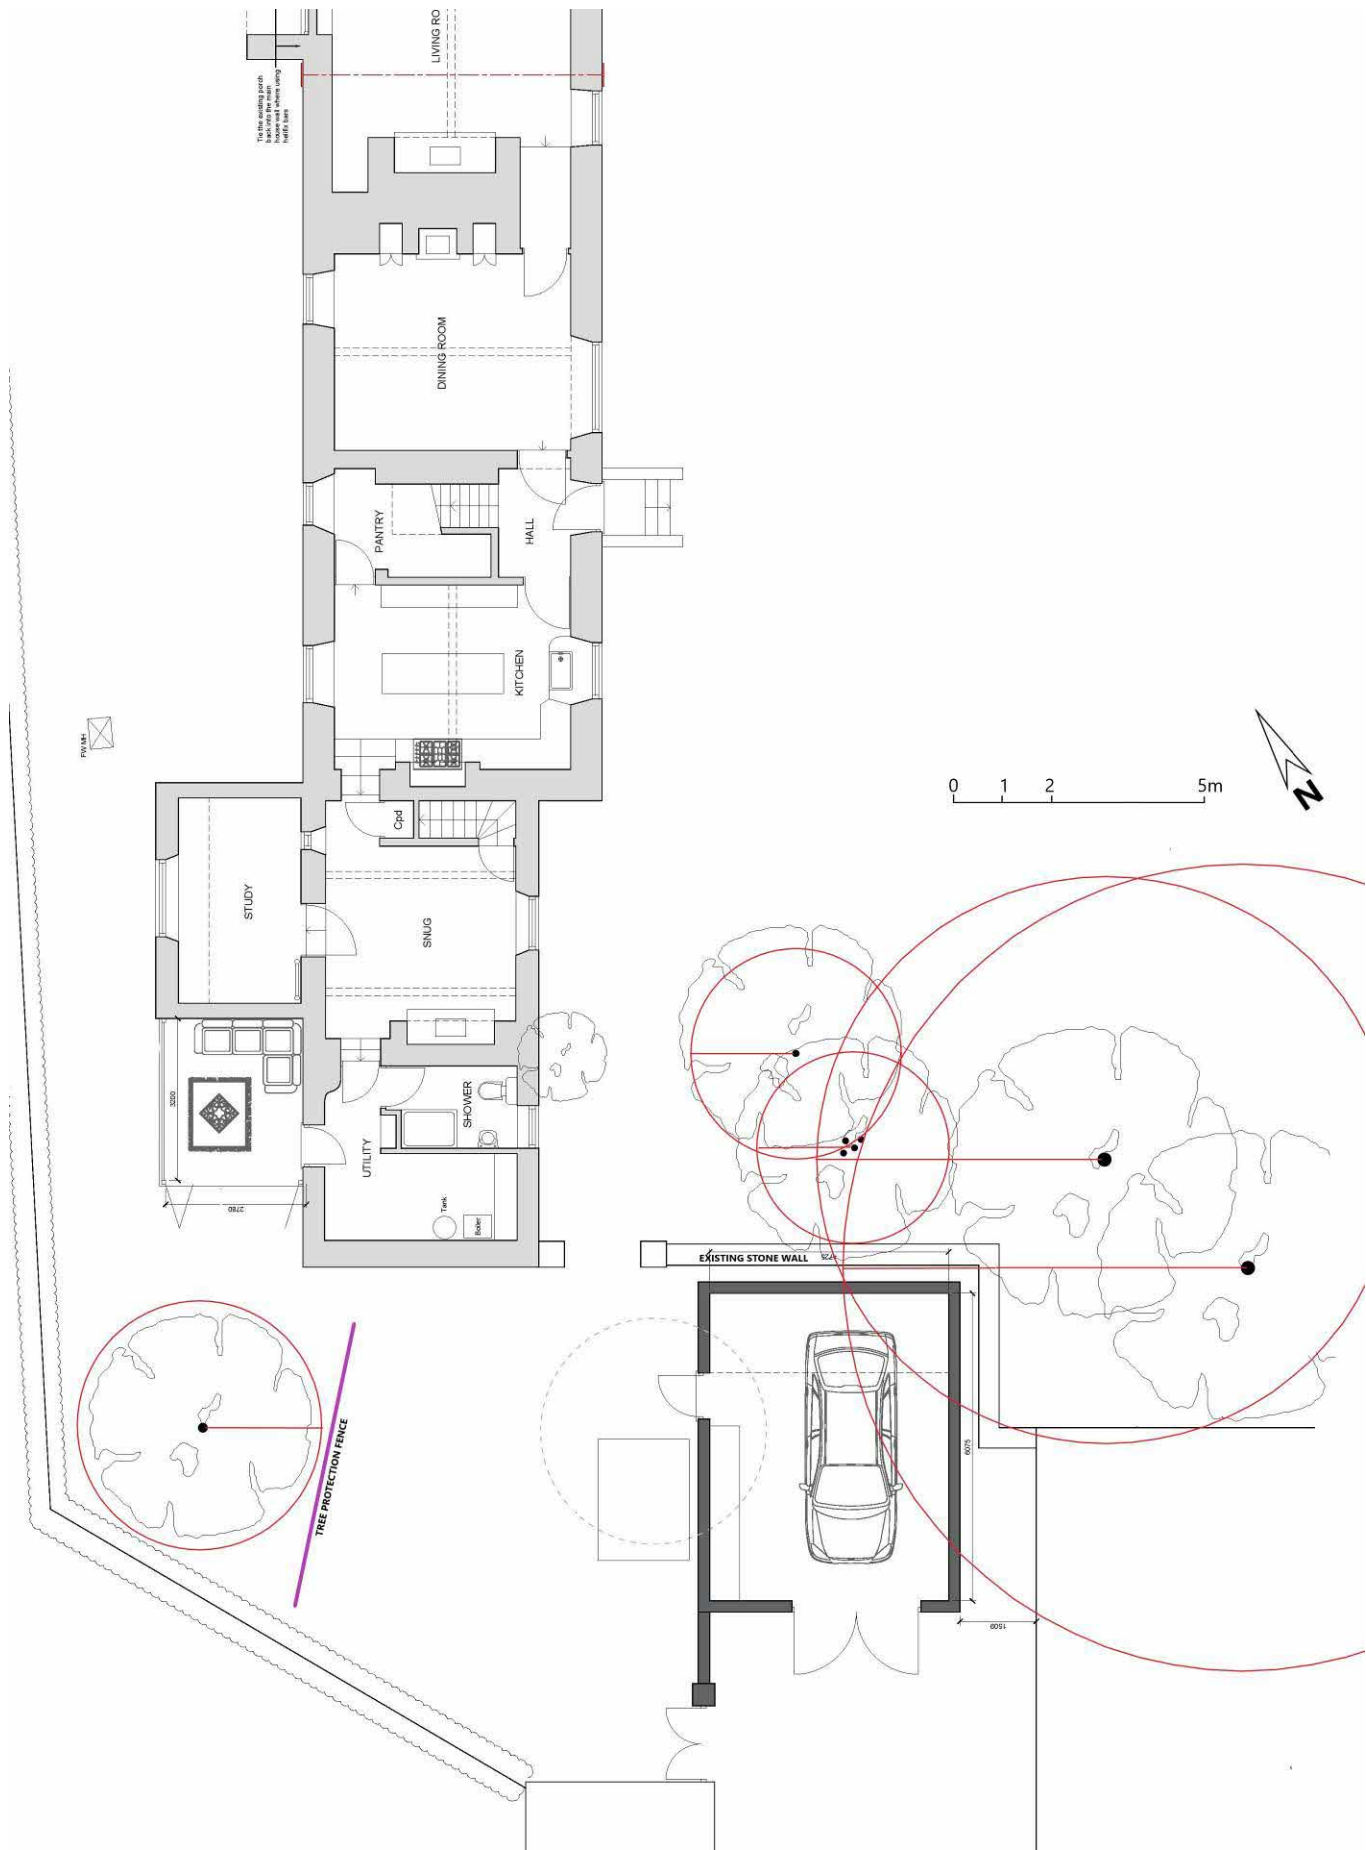
Figure 4 – Root Protection Area Plan

In the context of this site the proposed development will comprise a garage to be constructed outside of the walled garden area as shown within **Figure 4**. The table below summarises the potential impact of the proposed development on the trees present within the area surveyed.

Tree	Category	Impact of development
T1 Holly	C2	None. RPA and crown are outside of the construction area behind a stone wall
T2 Box	U	None. RPA and crown are outside of the construction area behind a stone wall
T3 Yew	B2	Minor loss of calculated RPA under the foundation of the garage. The rooting to the south is likely to be restricted by the stone wall and the nearby house so significant impact is very unlikely.
T4 Horse Chestnut	B2	Minor loss of calculated RPA under the foundation of the garage. The rooting to the south is likely to be restricted by the stone wall and the nearby house so significant impact is very unlikely.
T5 Damson	C2	This tree will have to be removed to facilitate the construction of the garage.
T6 Damson	U	None. RPA and crown are outside of the construction area and can be entirely protected by fencing.

Only one tree will need to be removed to facilitate the construction of the garage, three others not being impacted at all.
