PROJECT	DRG No	ALTERATIONS		BY	ALTERATIONS		BY
	0209-04	REV DATE	DESCRIPTION		REV DATE	DESCRIPTION	
Barn Conversion & Parking	SCALE	As Noted	@ A1				
DRG TITLE	DATE	15-10-2020					
	SURVEY Elevations / Sections		DWN BY

CLIENT: Mr & Mrs Cocker  
 18 Victoria St, Bassinghay, Lincs. LN4 4HQ (NKDC)

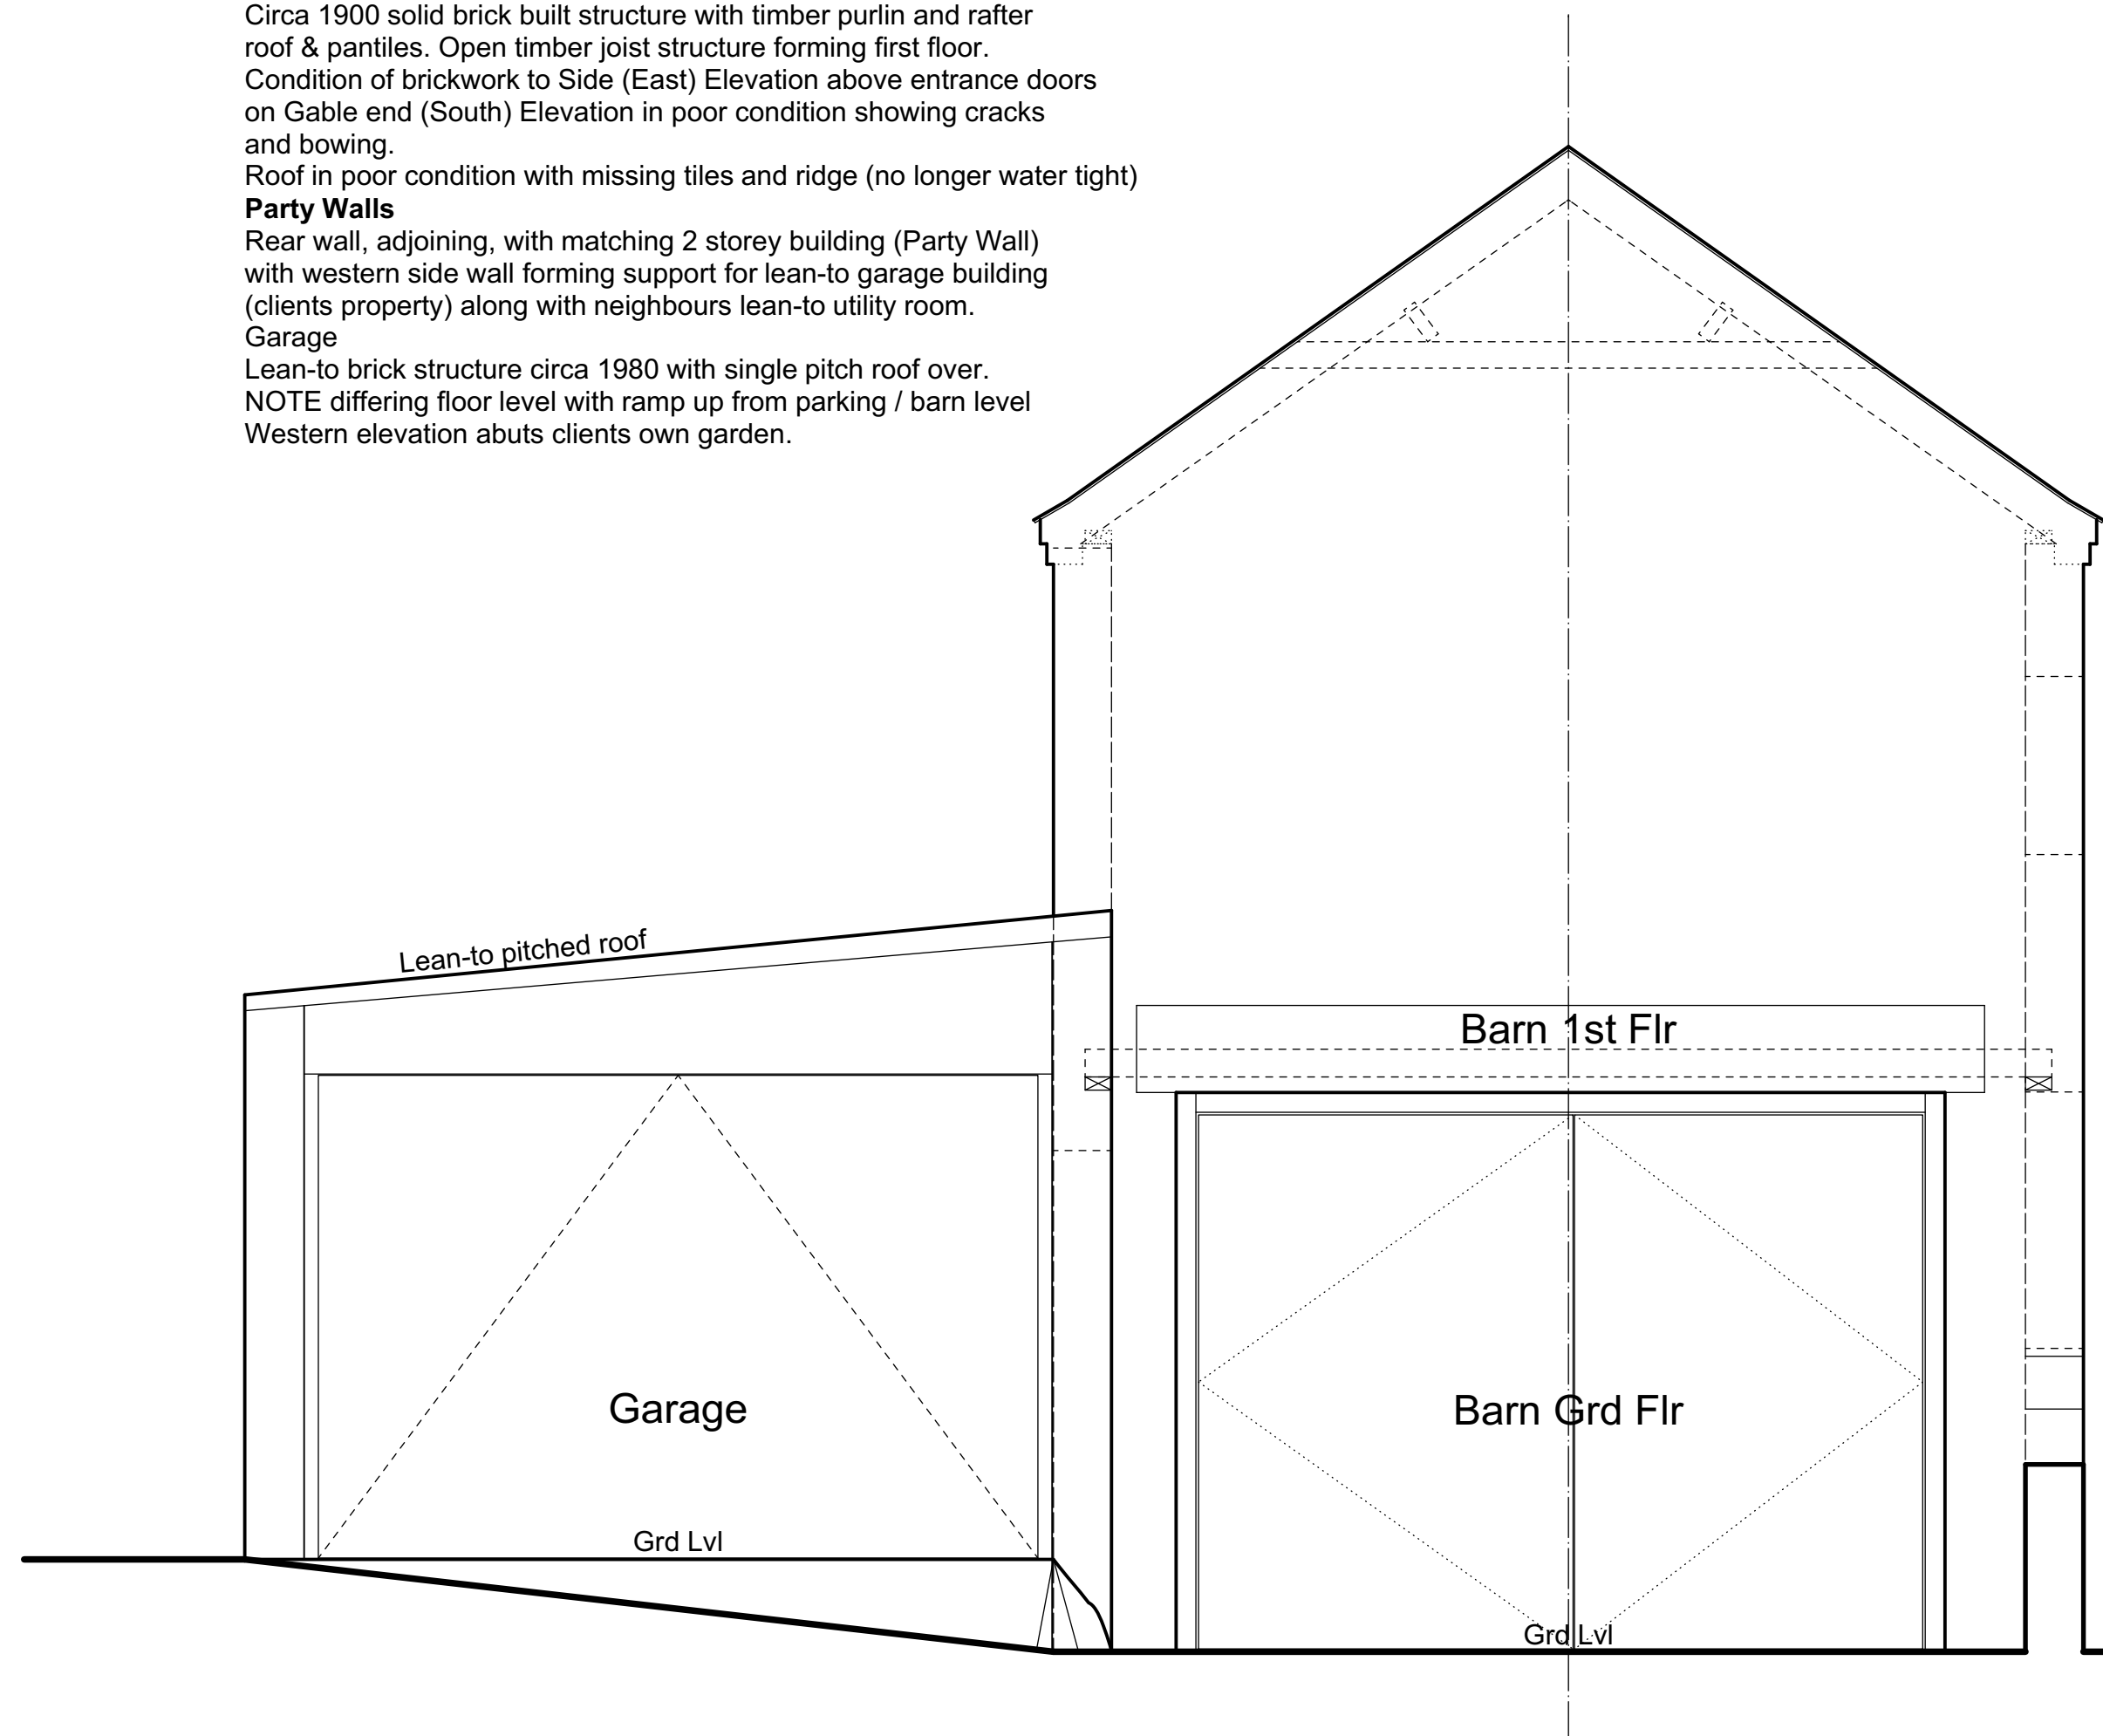
2 South Elevation (Front)  
 Scale: 1:25

**2 Storey Barn**  
 Circa 1900 solid brick built structure with timber purlin and rafter roof & pantiles. Open timber joist structure forming first floor.  
 Condition of brickwork to Side (East) Elevation above entrance doors on Gable end (South) Elevation in poor condition showing cracks and bowing.  
 Roof in poor condition with missing tiles and ridge (no longer water tight)  
**Party Walls**  
 Rear wall, adjoining, with matching 2 storey building (Party Wall) with western side wall forming support for lean-to garage building (clients property) along with neighbours lean-to utility room.  
**Garage**  
 Lean-to brick structure circa 1980 with single pitch roof over.  
 NOTE differing floor level with ramp up from parking / barn level  
 Western elevation abuts clients own garden.
