Tudeley Brook Stables, Crittenden Road, Matfield, Kent.

Structural Inspection Report

Reference: 23-0532

Date: 30th November 2023

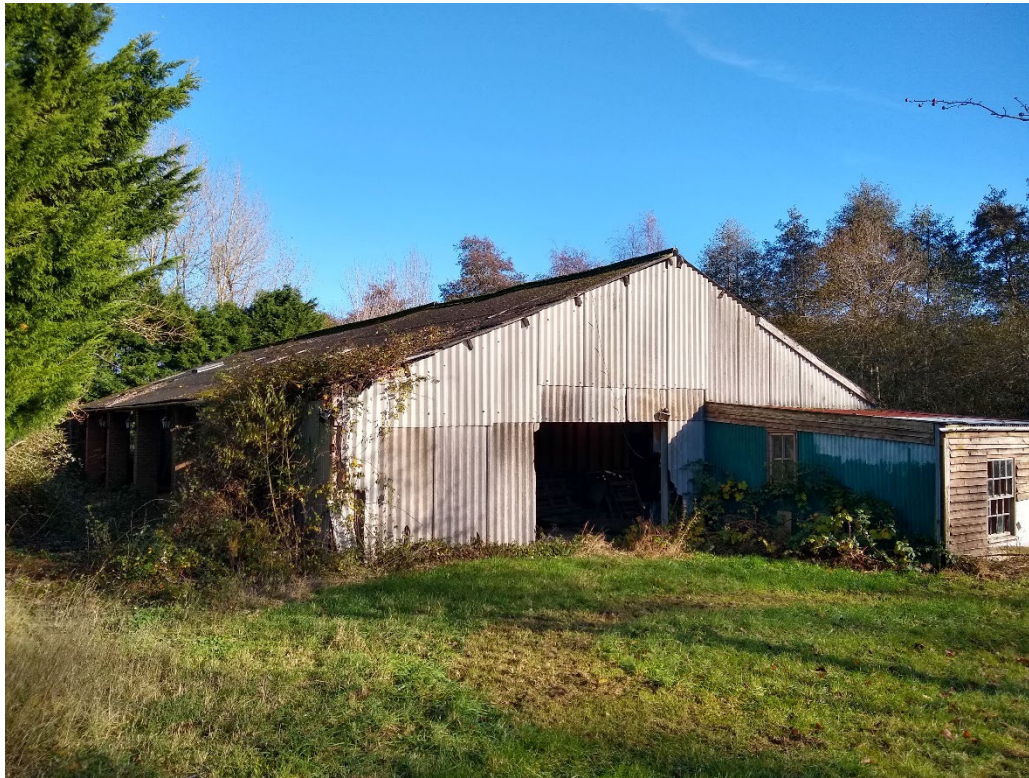
Photo 1 – South Elevation.

The walls to the south elevation consists of timber posts, either side of the main opening. From the posts to the external walls, run timber cladding rails supporting fibre cement sheeting.

Areas of fibre cement cladding will need to be replaced with new cladding.

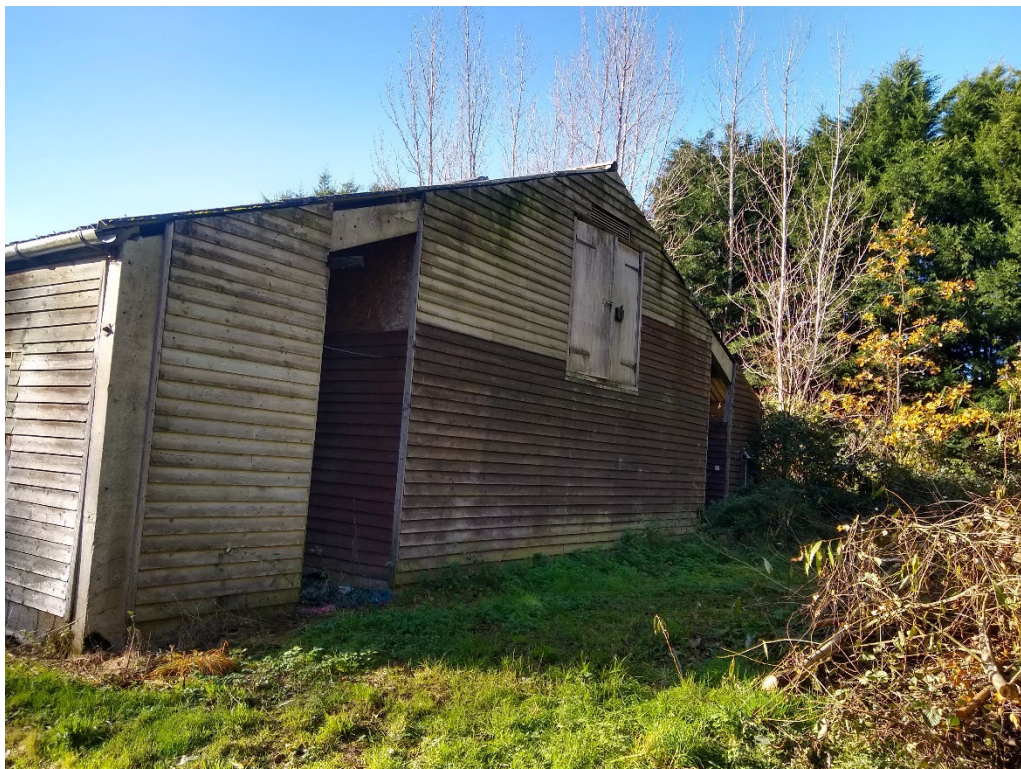
Photo 2 – North Elevation.

To the north elevation, the wall is timber frame, with timber weatherboarding

The areas of brickwork are suitable for reuse, timber cladding and rails may need to be strengthened where rot, though the proposed scheme is for new cladding to the building.

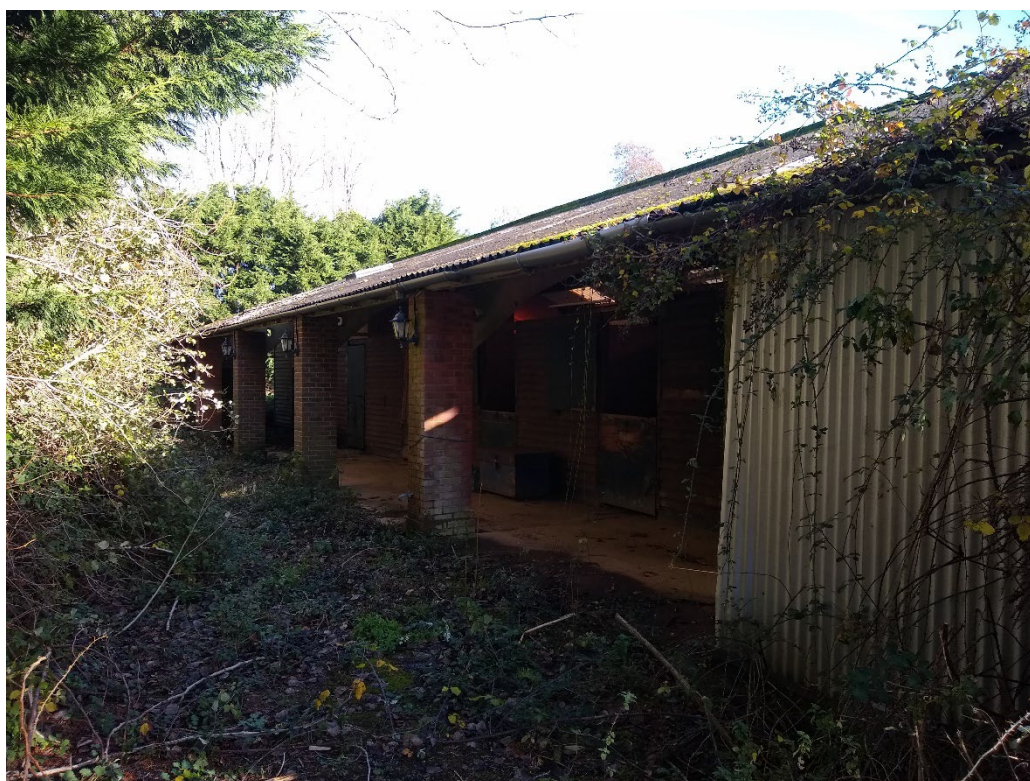
Photo 3 – West Elevation.

To the west elevation, the concrete columns are clad in brickwork, presumably as this was the main entrance to the stable block. The southern end bay is clad in fibre sheets on timber cladding rails.

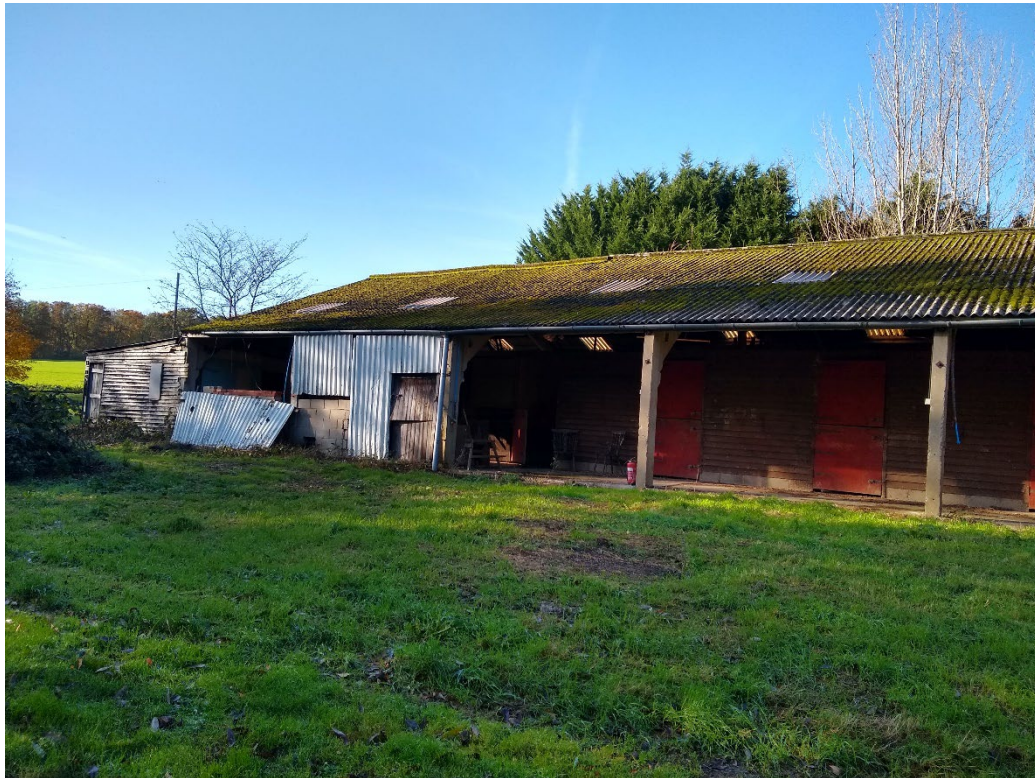
Photo 5 – East Elevation – southern end.

The east elevation to the two southern end bays has a low level block wall, with timber cladding rails above supporting fibre cement sheeting. Some of the sheeting has become dislodged.

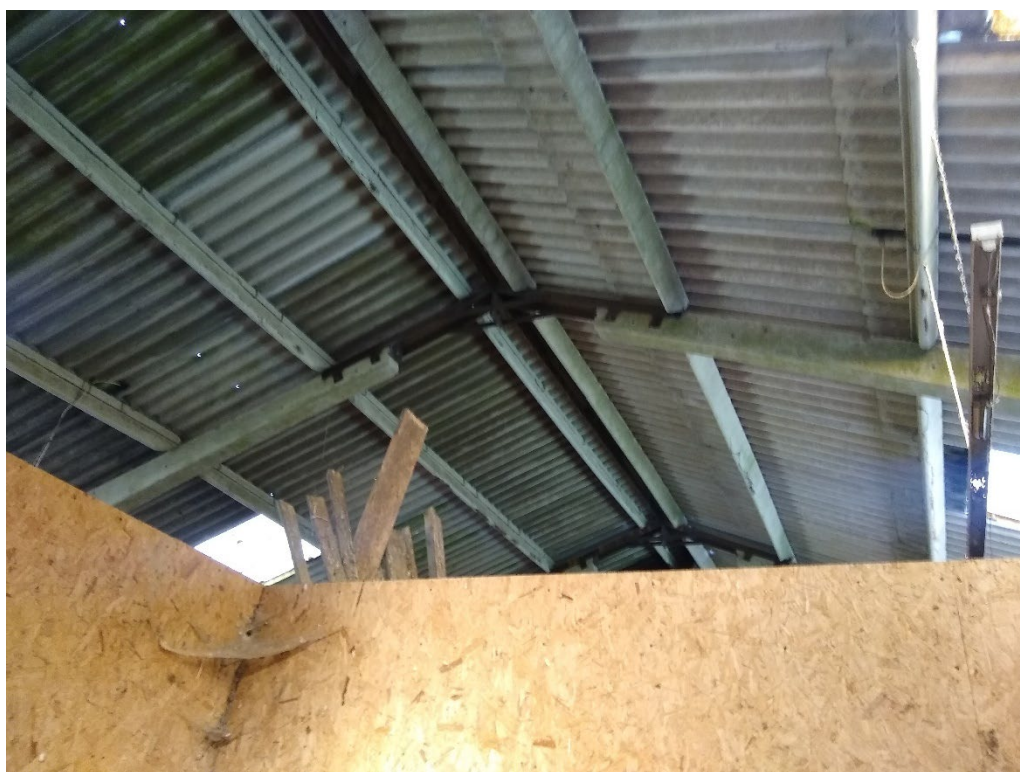
Photo 9 – Roof - internal.

The roof covering of the building is fibre cement sheets (probably containing asbestos) on concrete or timber purlins. There are translucent plastic panels forming rooflights to the building. The majority of the sheeting is intact, though there are localized areas (the north east corner) where the sheets are broken and openings have formed, though this bay is to be removed. Elsewhere, there are signs of pin holes and slightly larger holes within the roof covering. Fibre cement roof sheets have a finite life span and the building would benefit with a replacement roof covering such as an insulated metal sheeting.

The roof sheets were originally supported on precast concrete purlins, which are typical of concrete framed farm buildings. A number of these have been replaced in the two bays at the southern end, probably due to corrosion issues, as some of the concrete purlins within the centre bay have signs of corrosion and will need localized treatment to prevent it getting worse.
