MITCHELL ELEY GOULD

2208 Sanders Farm
Heritage, Design and Access Statement

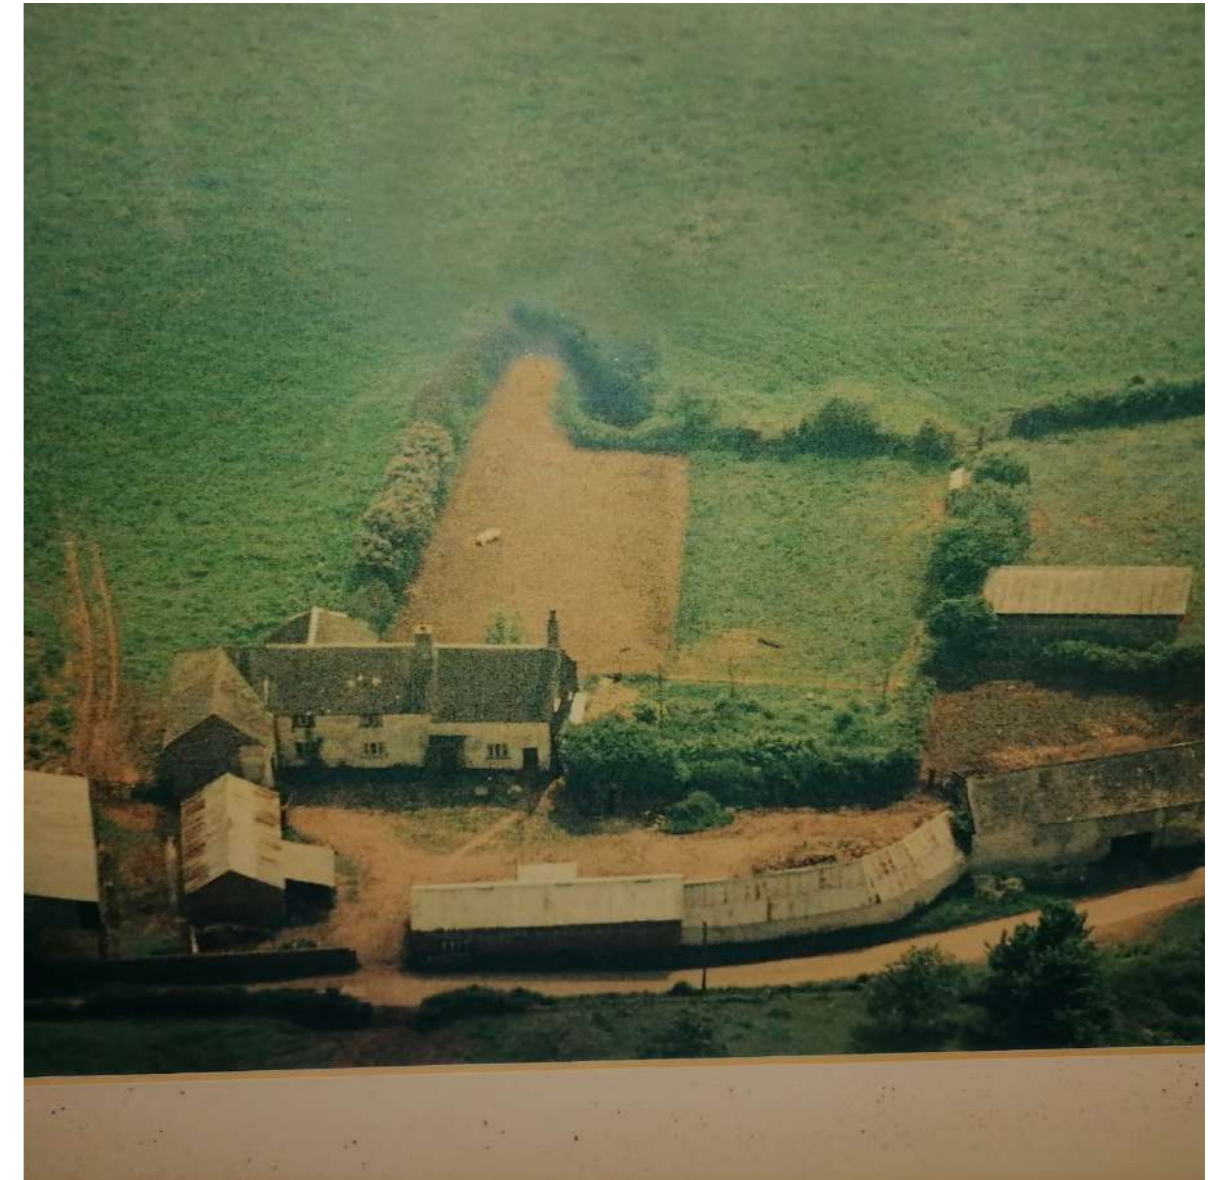
02 Heritage Statement

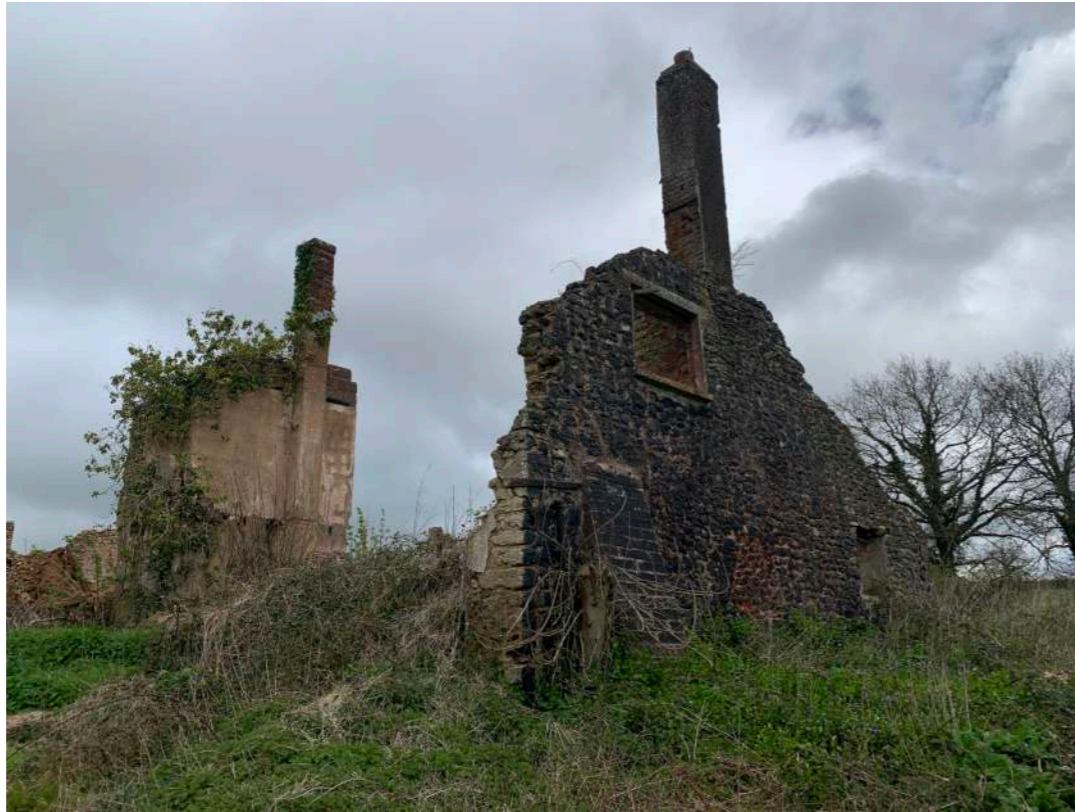
View from the southwest corner of the site (04/22)

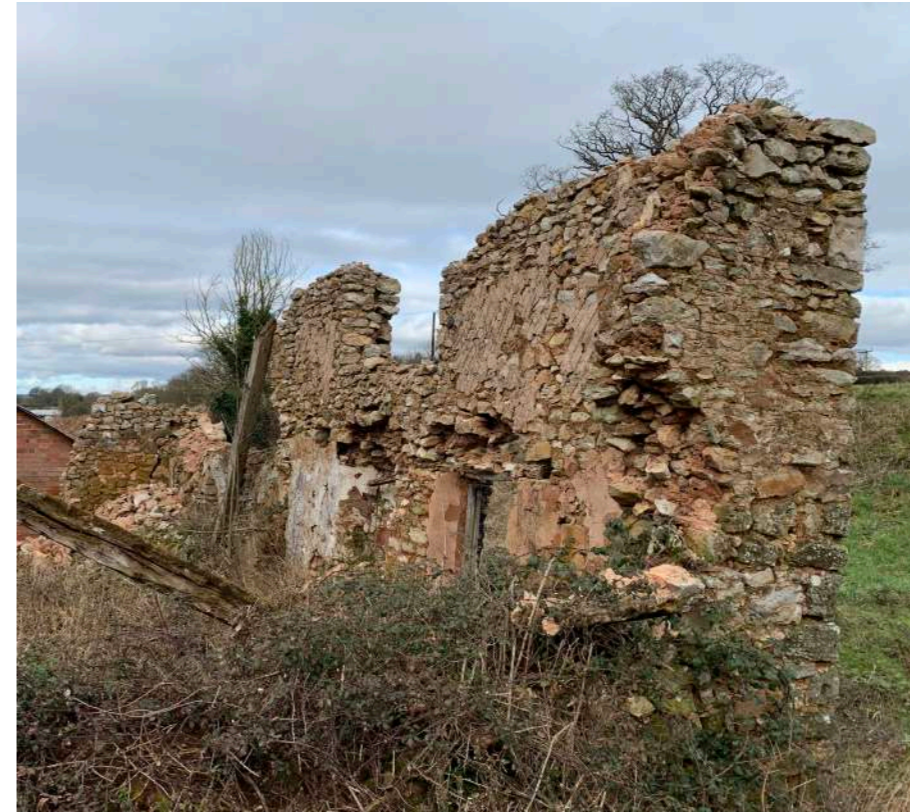
View of the north wall, showing the significant leaning and loose stones. (02/23)

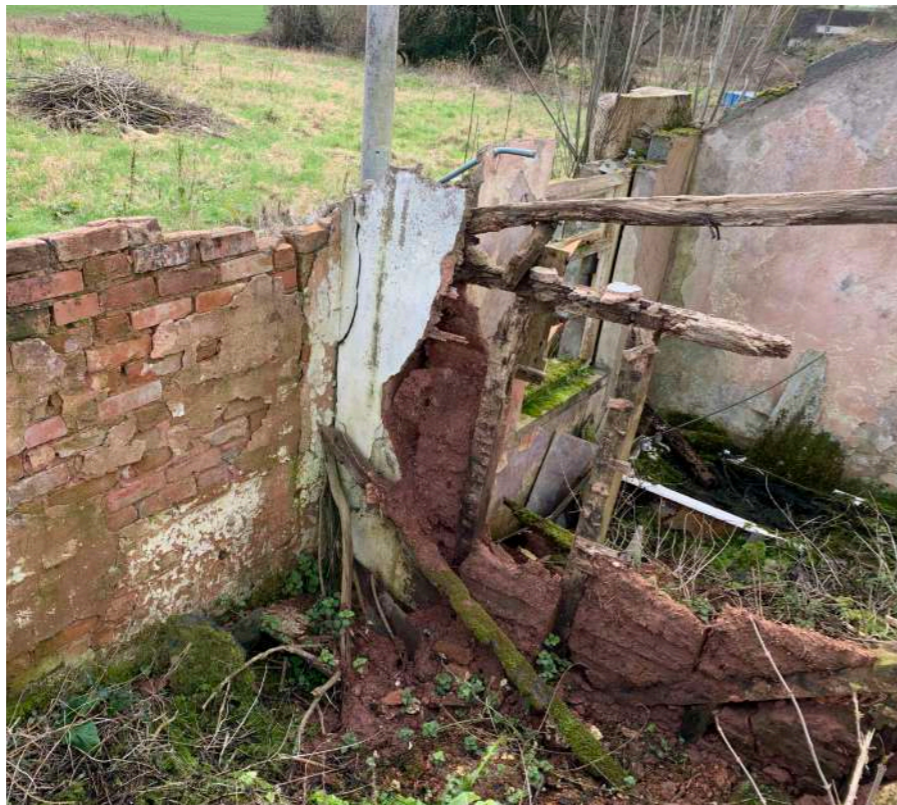
View of a section of the east wall and window from the inside, looking at the assumed former bathroom. (02/23)

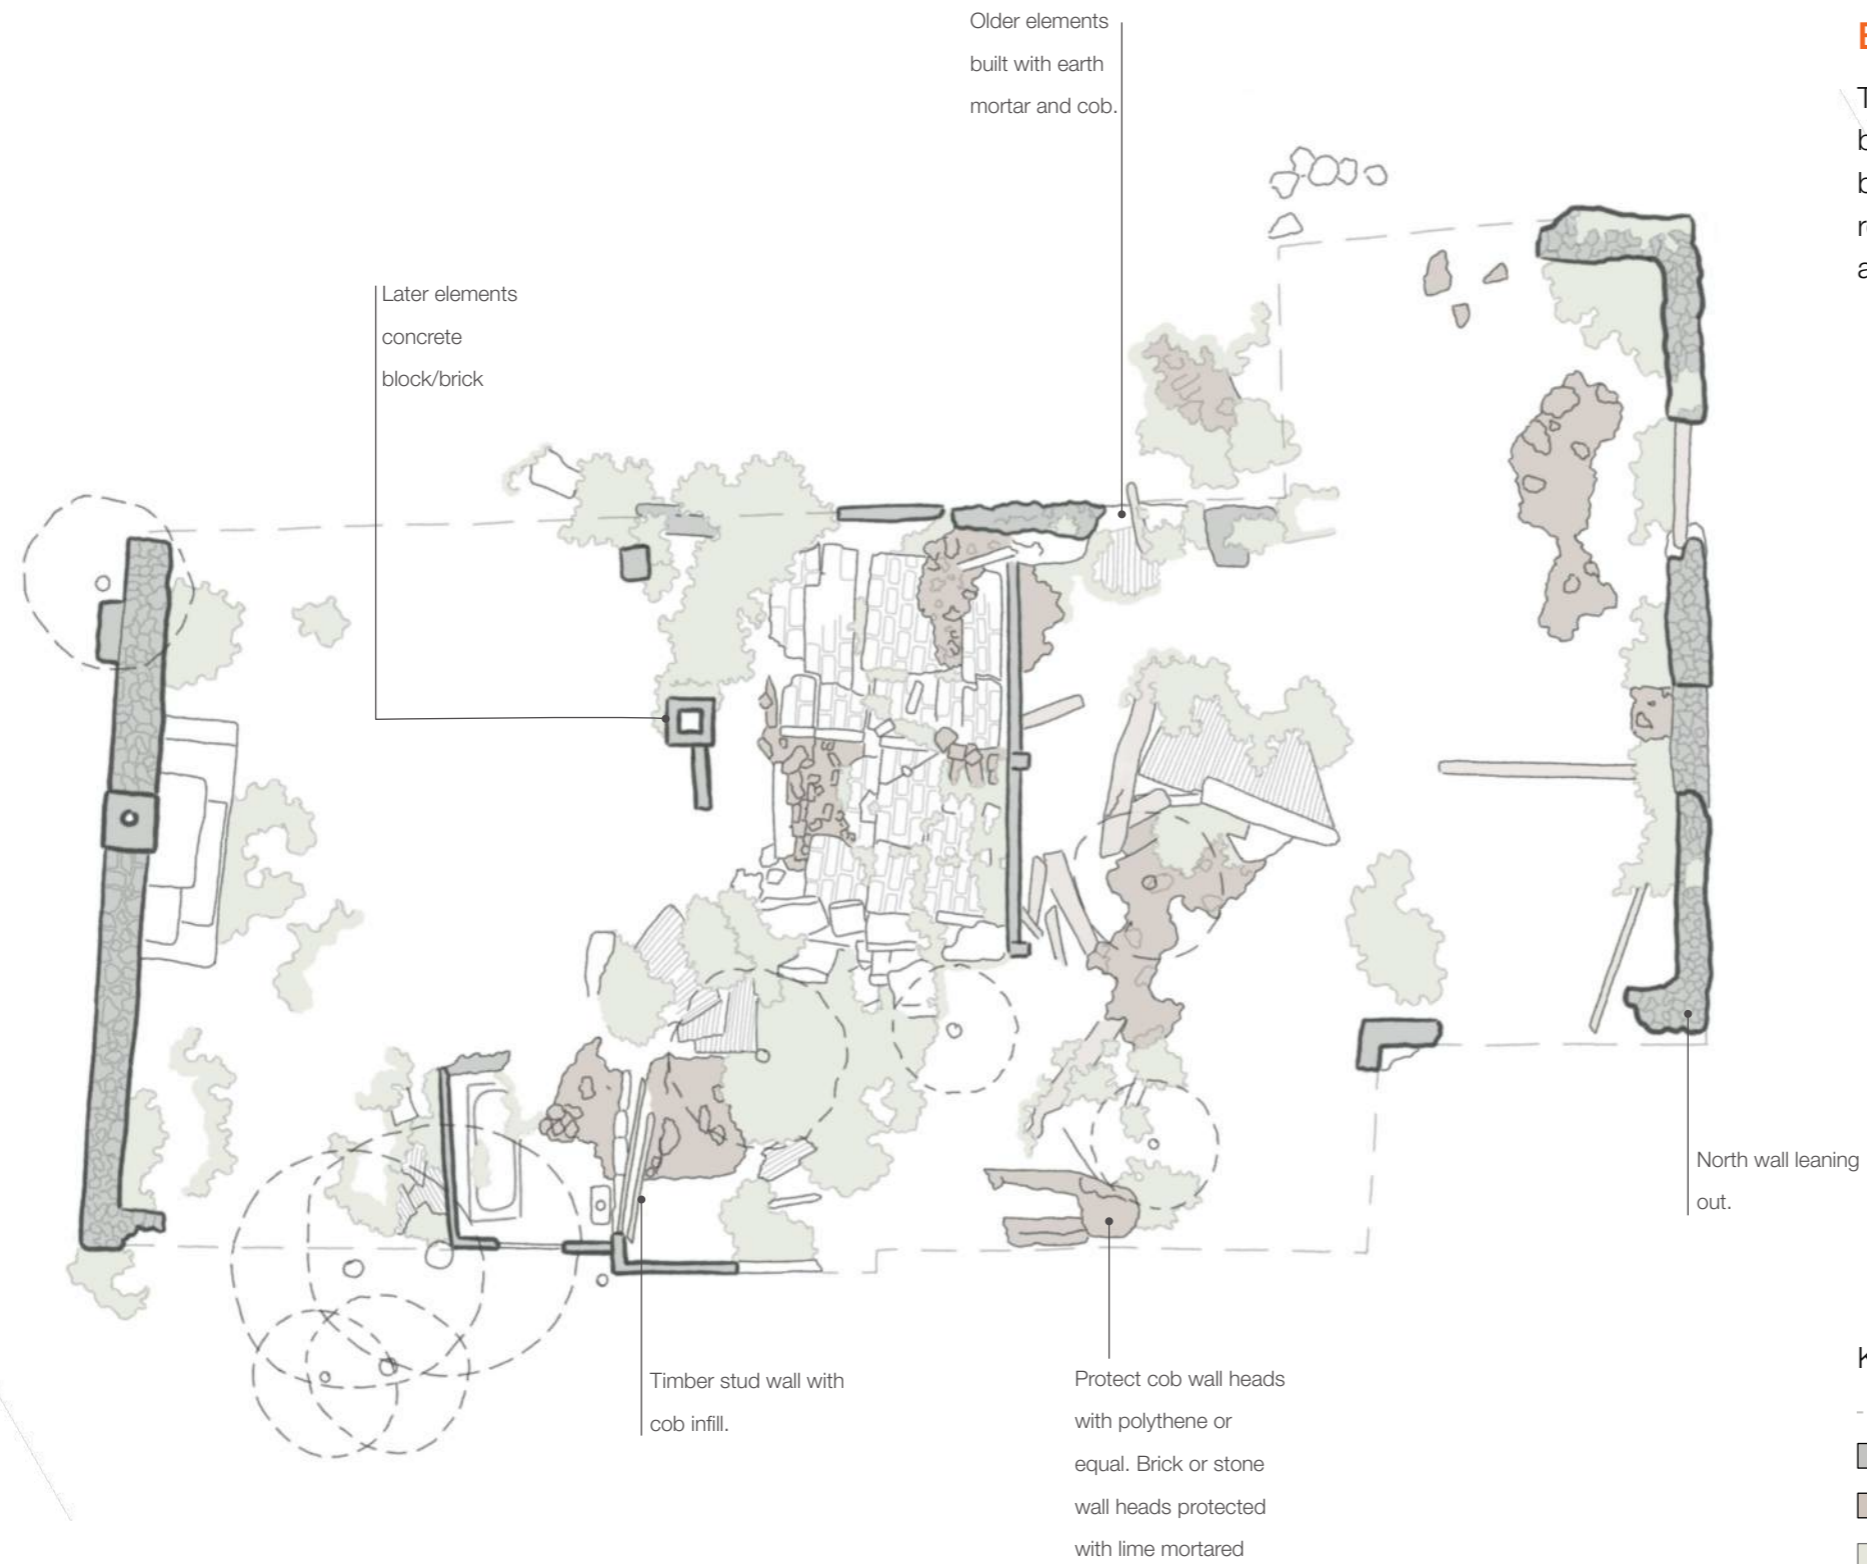
05 Existing Building Drawings

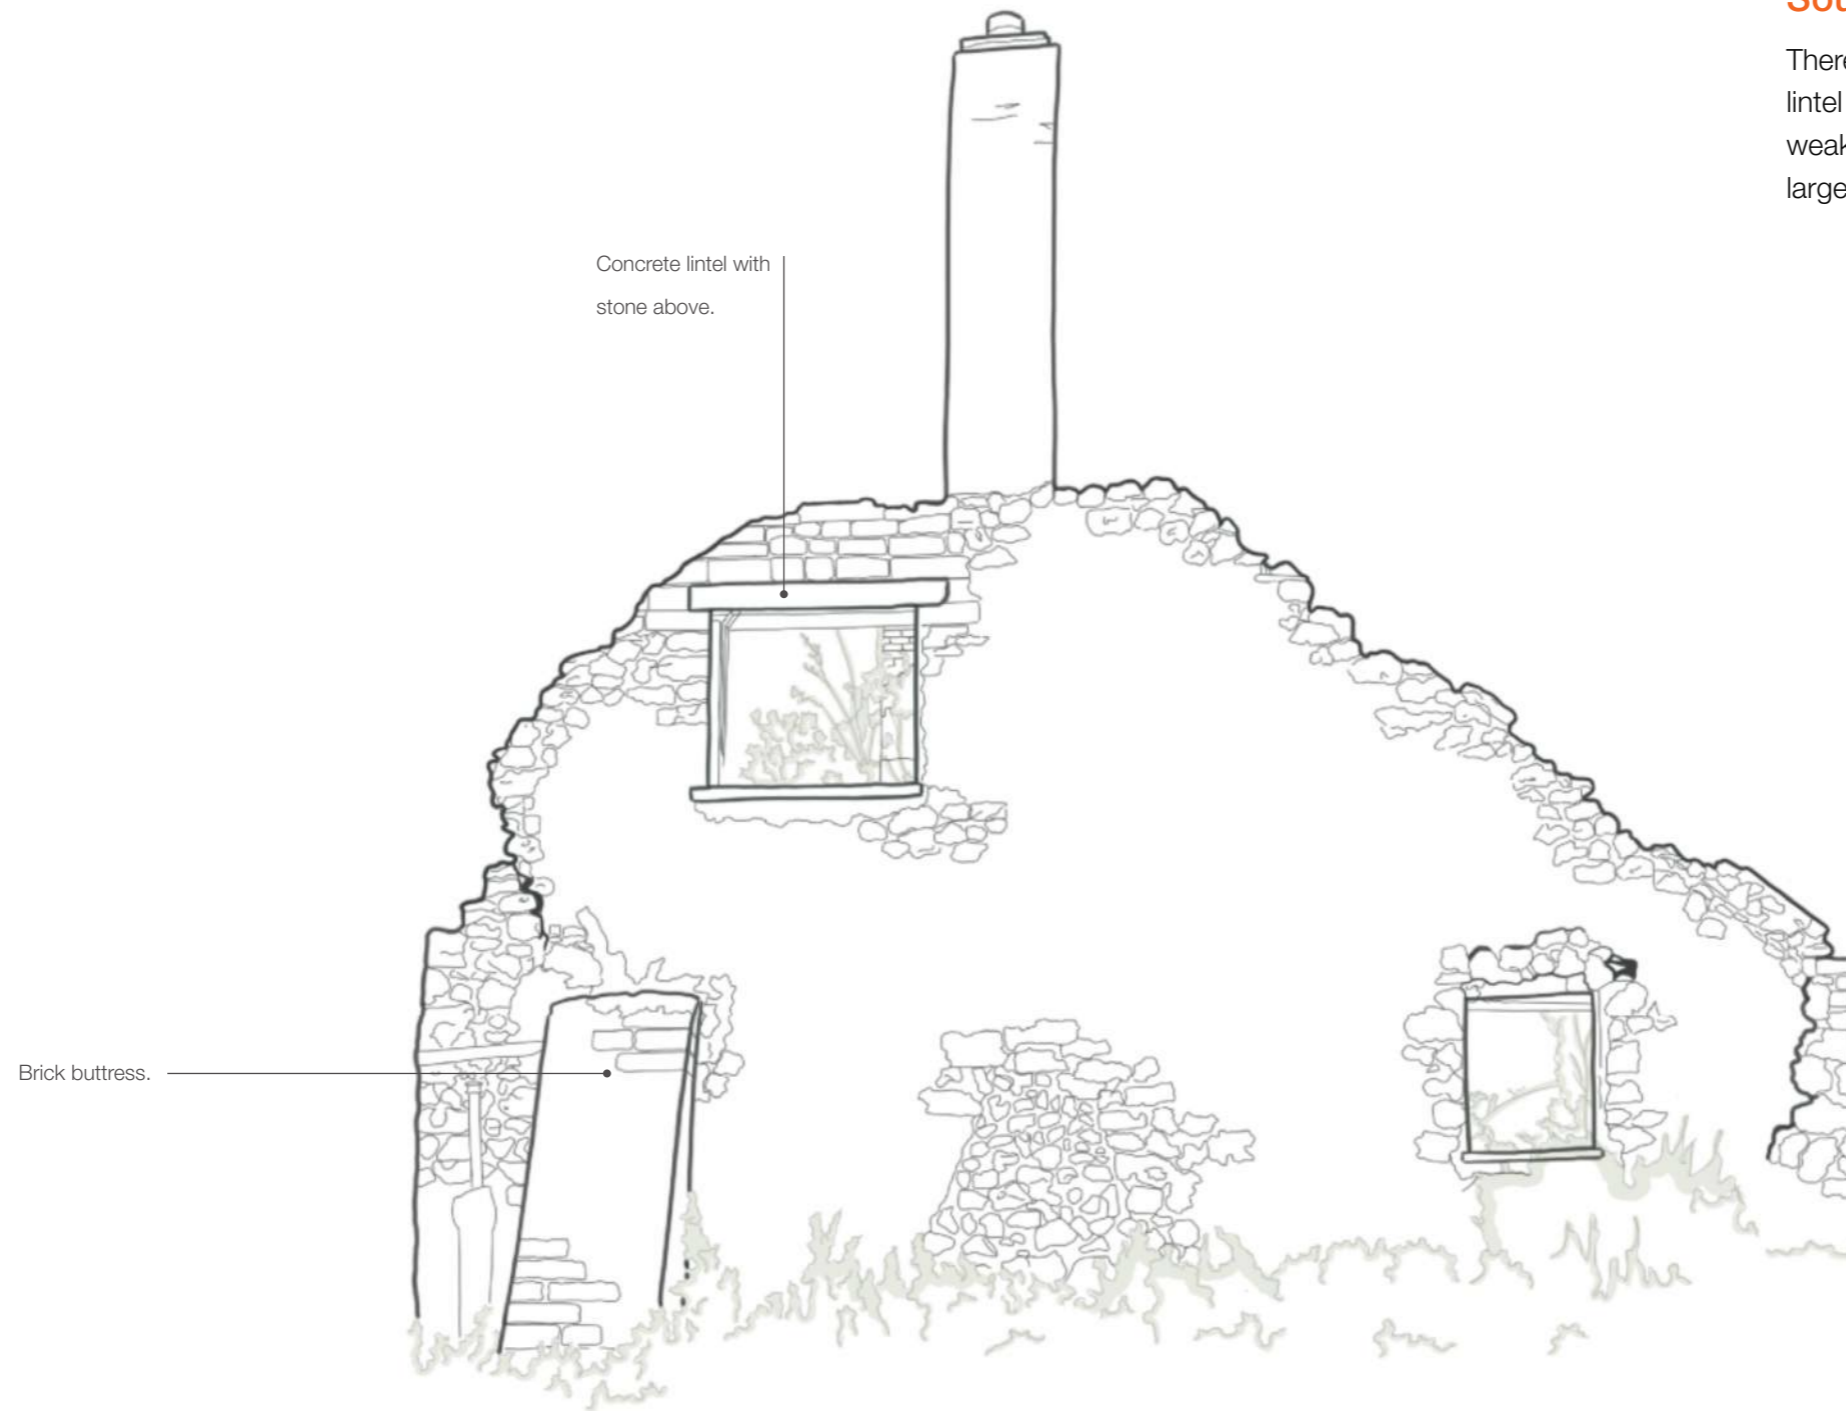
EXISTING SOUTH ELEVATION SKETCH
1:100 @ A3

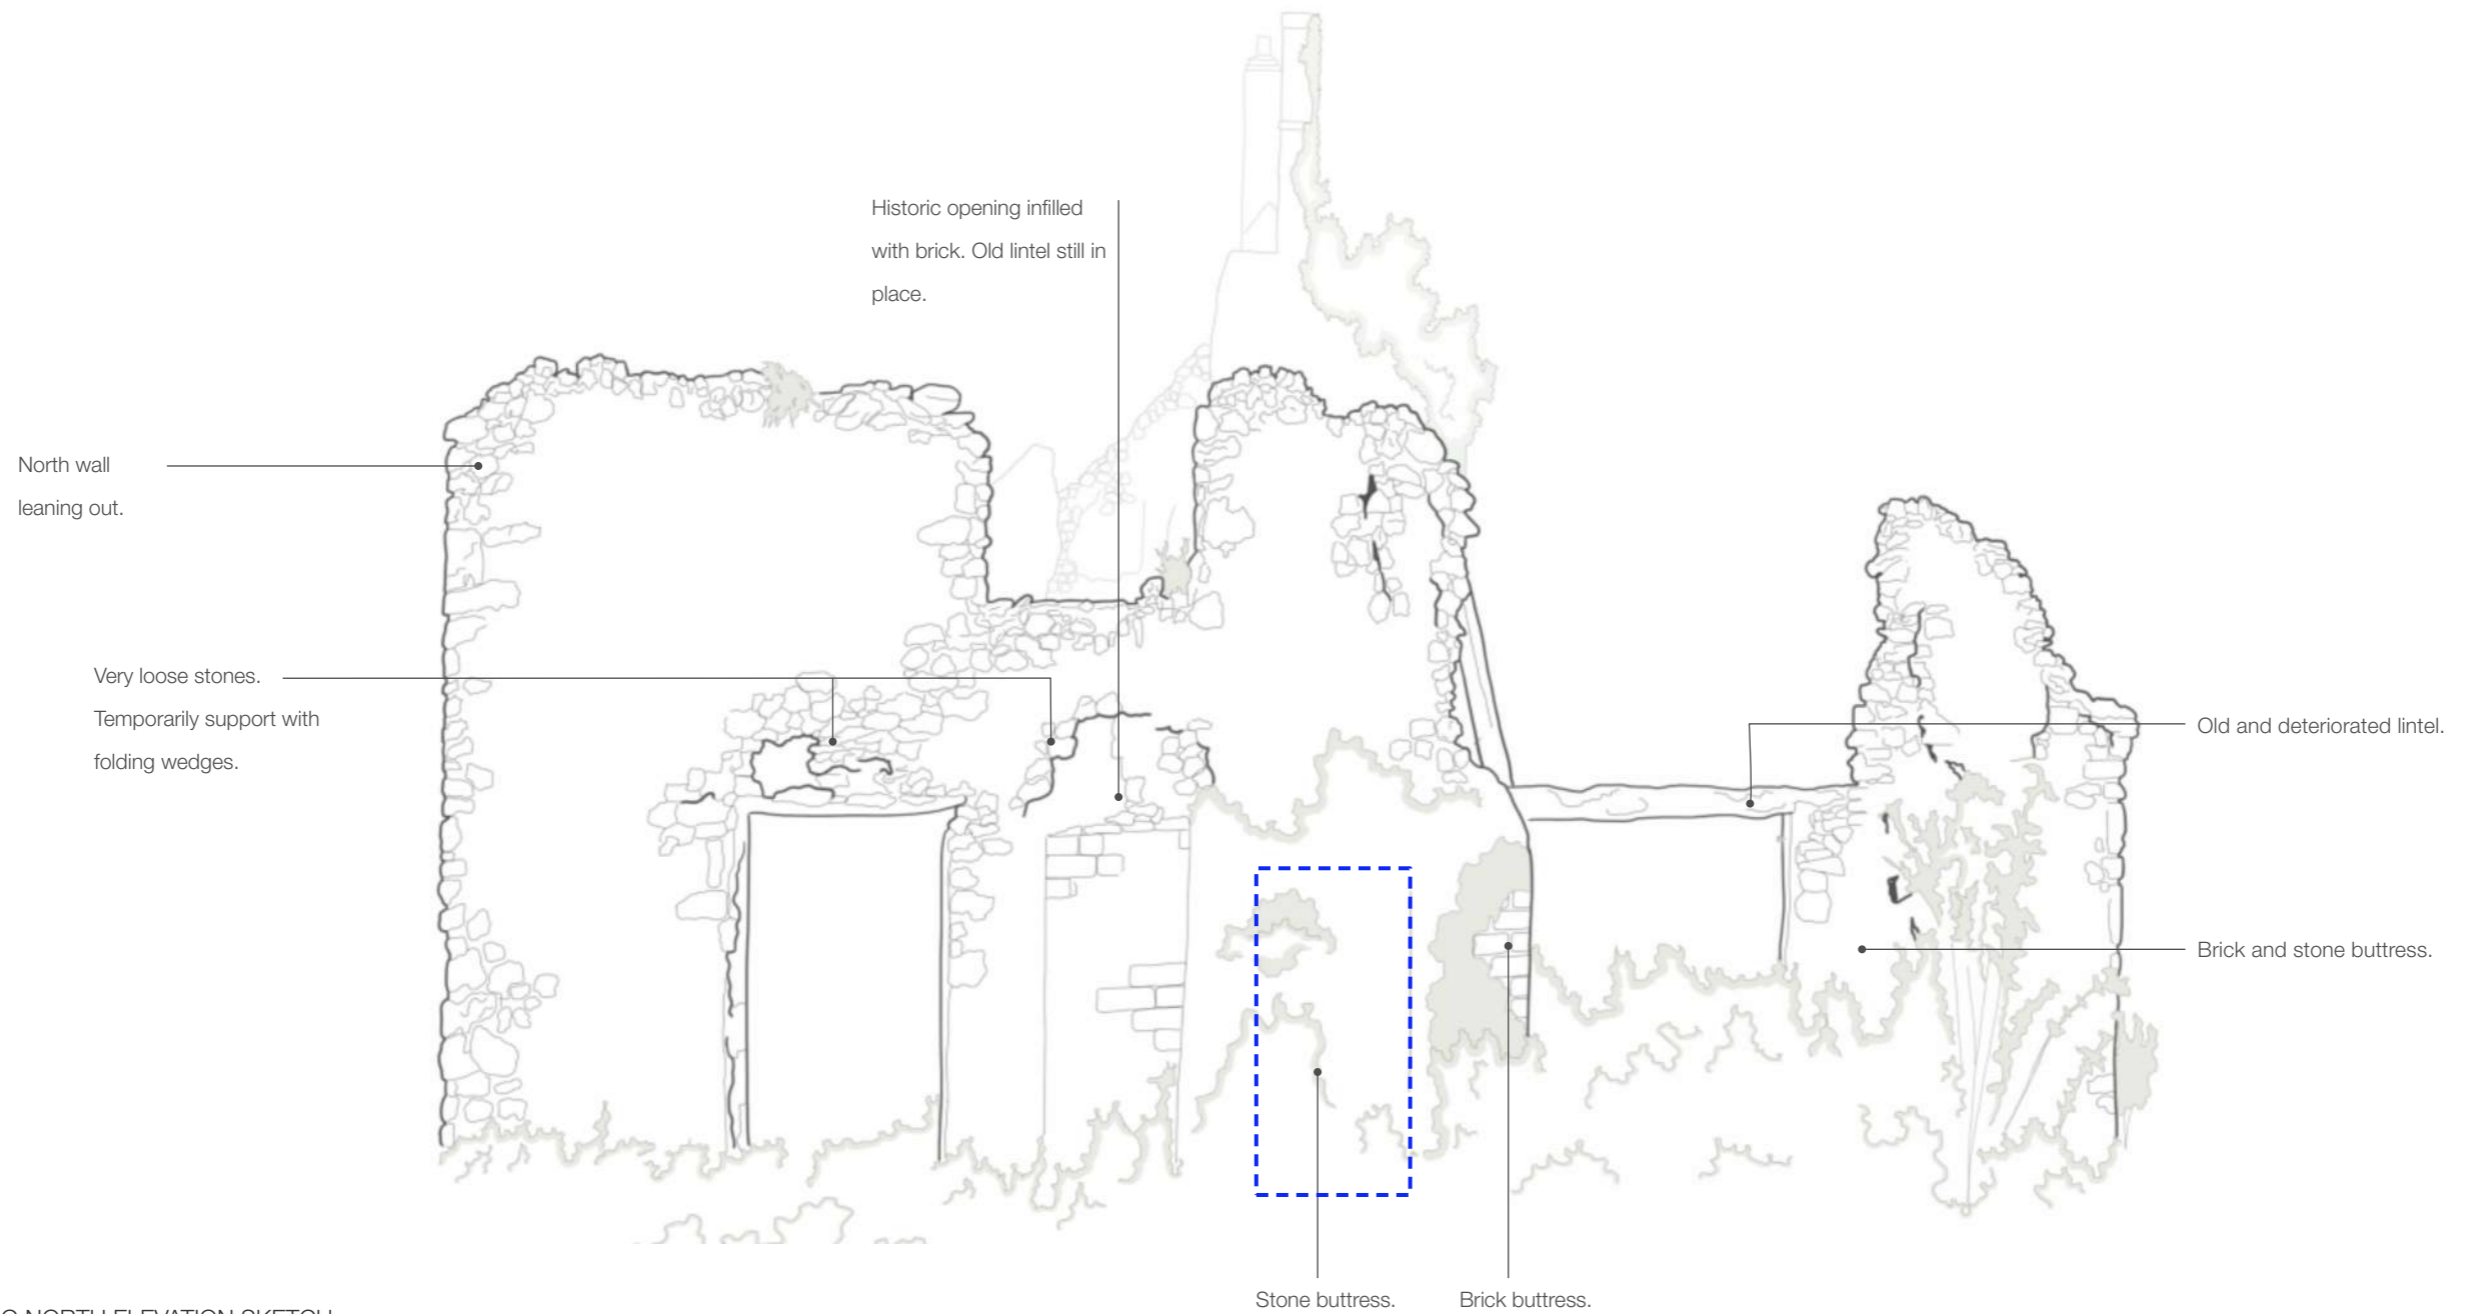
EXISTING NORTH ELEVATION SKETCH
1:100 @ A3

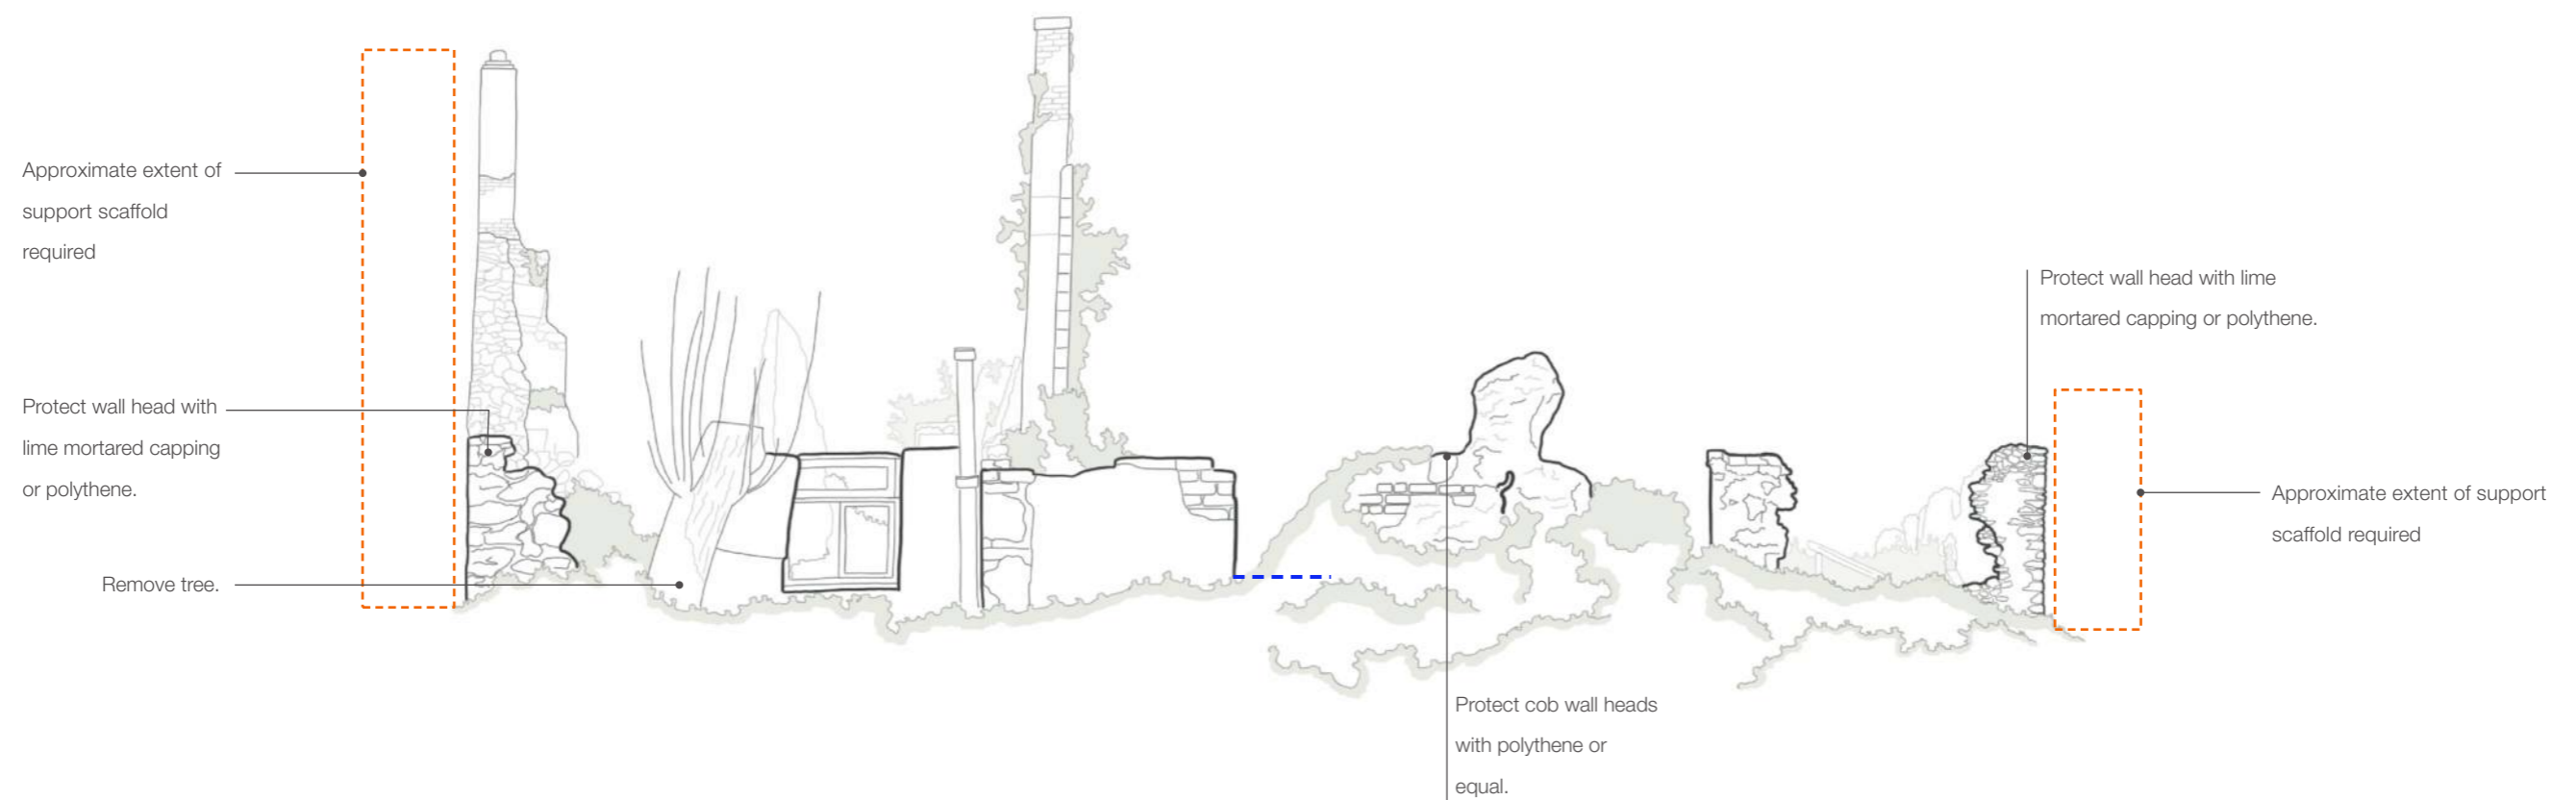
PROPOSED EAST ELEVATION SKETCH
1:200 @ A3

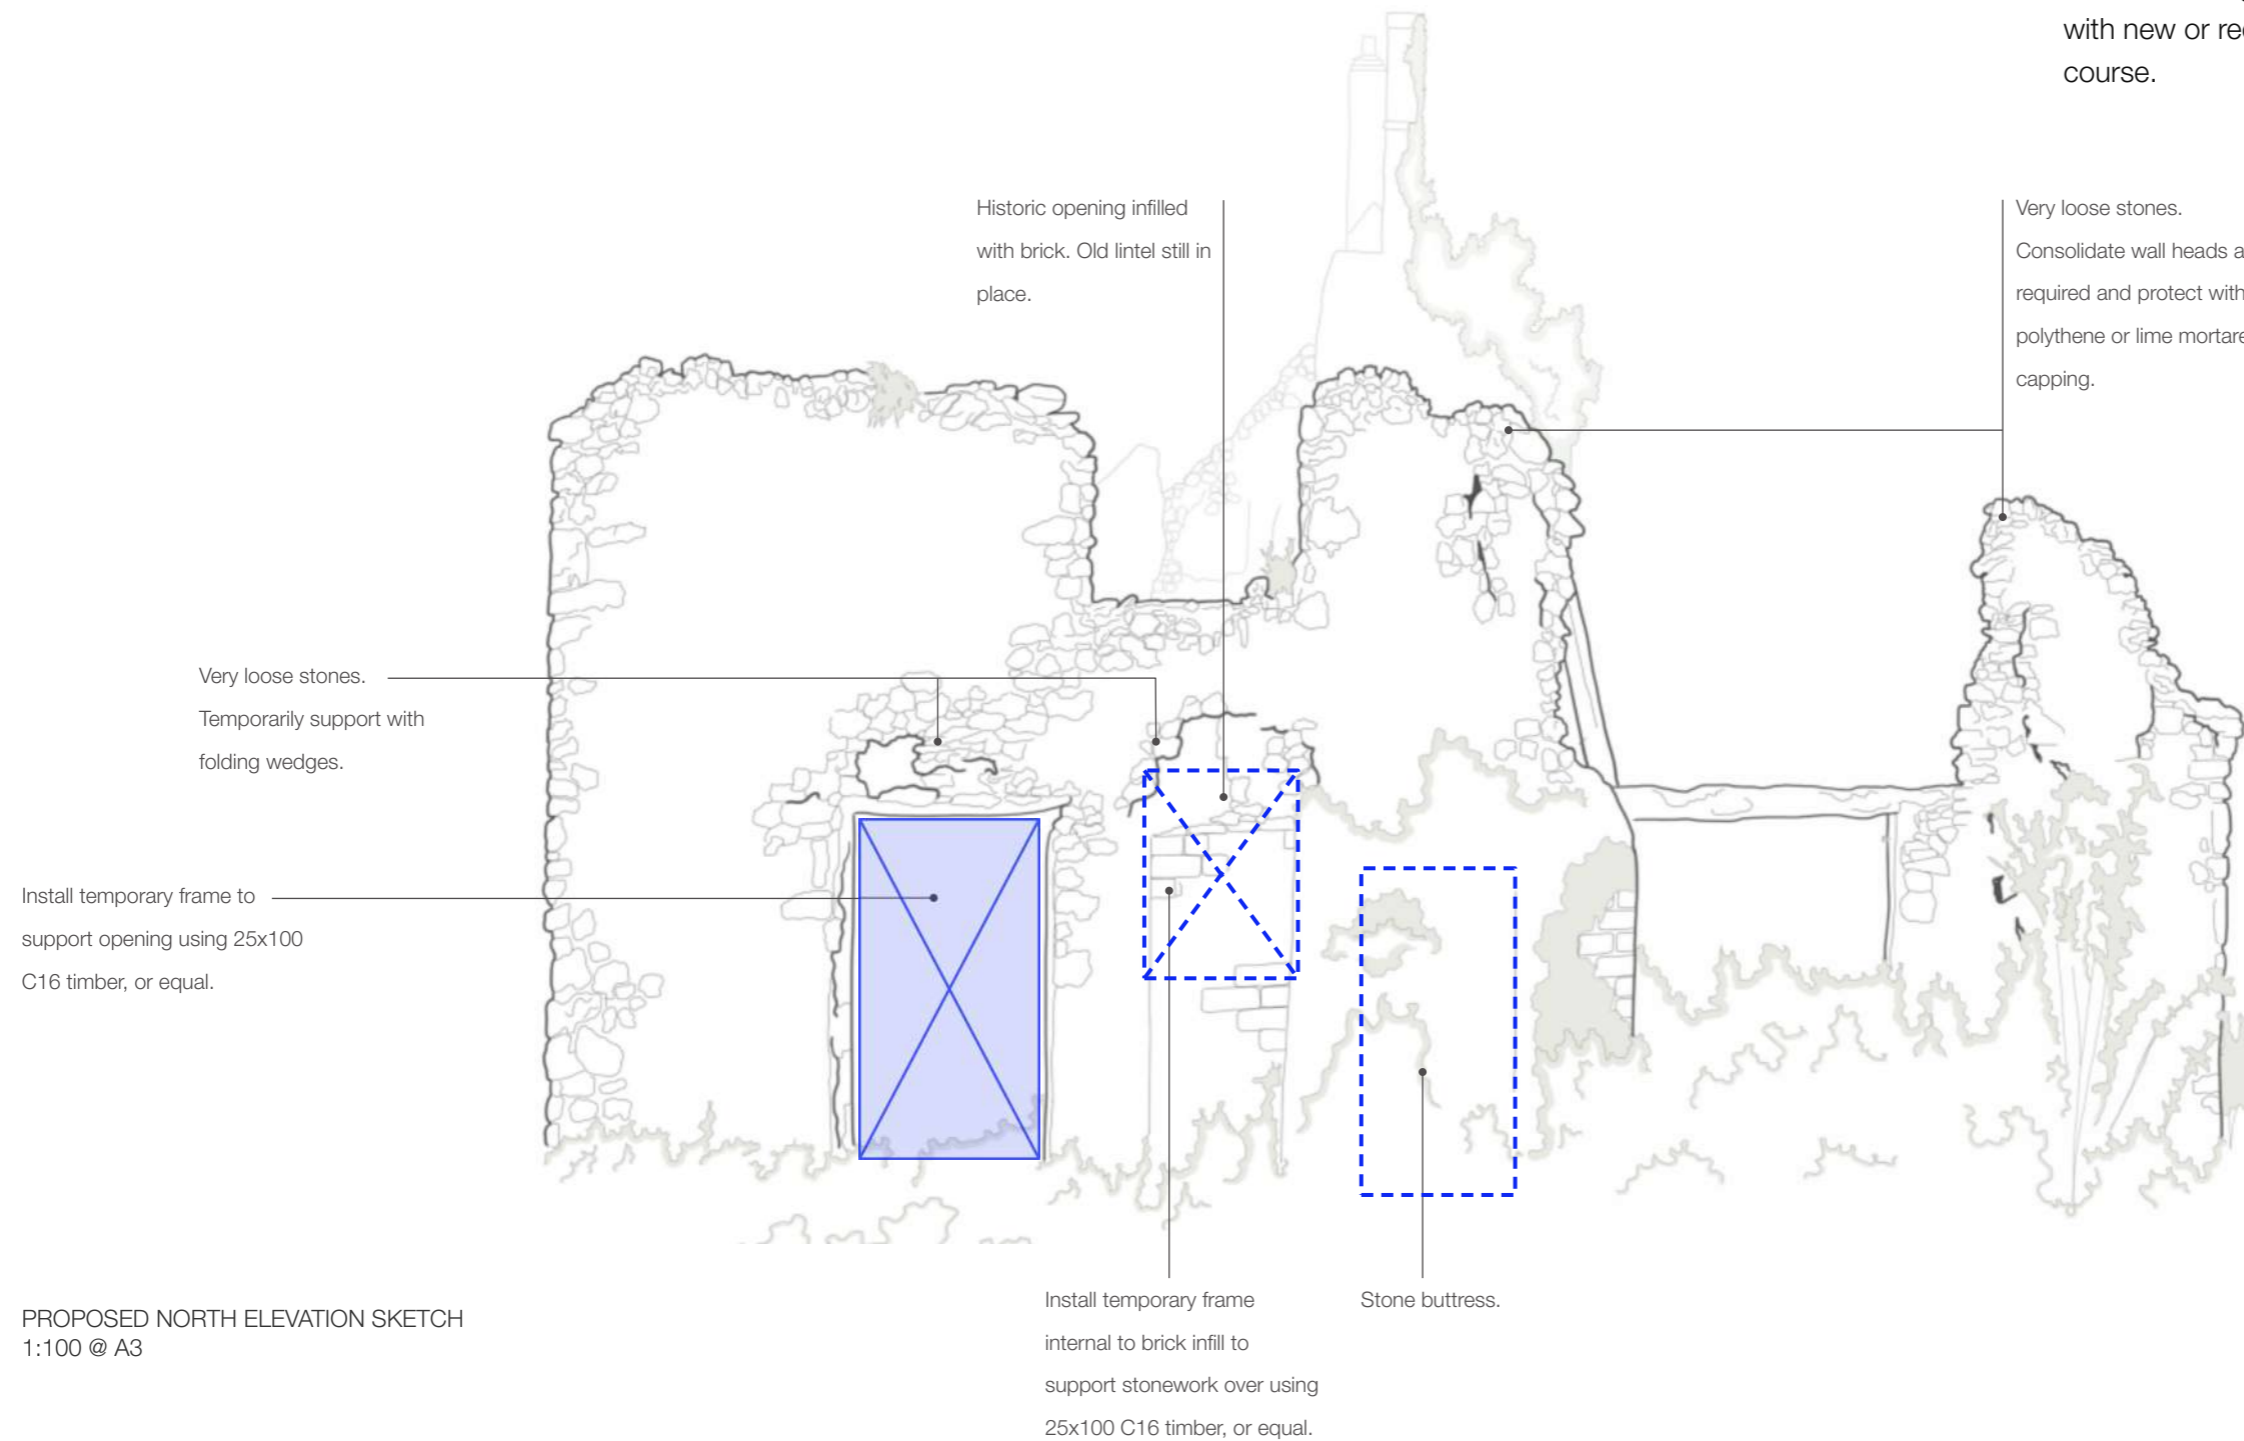
PROPOSED NORTH ELEVATION SKETCH
1:100 @ A3

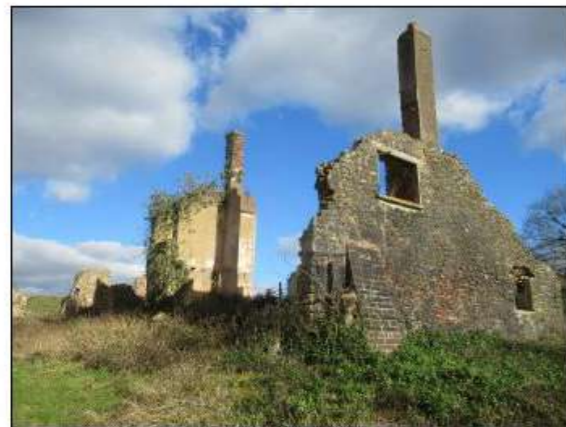
Further to our visit to the property on Thursday 9th February 2023, we comment as follows on the general structural condition of the ruinous farmhouse, in the context of the proposed Planning and Listed Building Consent application to consolidate and repair the ruins, so that the longevity of this historically important building can be protected.

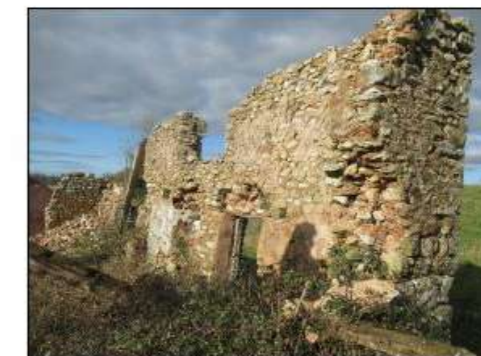
The most vulnerable areas are the north and south walls. It is recommended that an exterior support and restraint scaffold is constructed adjacent to both the north and south walls. The south wall is reasonably true to line, but the north wall is leaning out to a considerable degree local to the north-eastern corner.

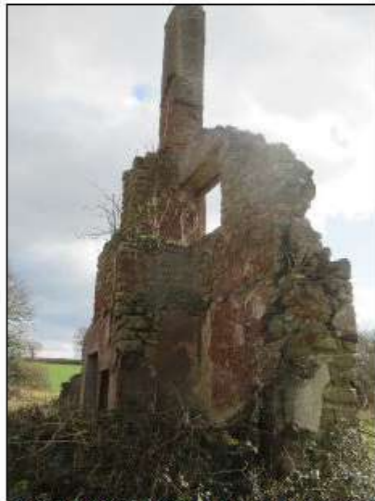
South wall, with vegetated shelves in chimney stack.
