CONDITION SURVEY AND SCHEDULE OF WORKS

SANDERS FARM CROYLE

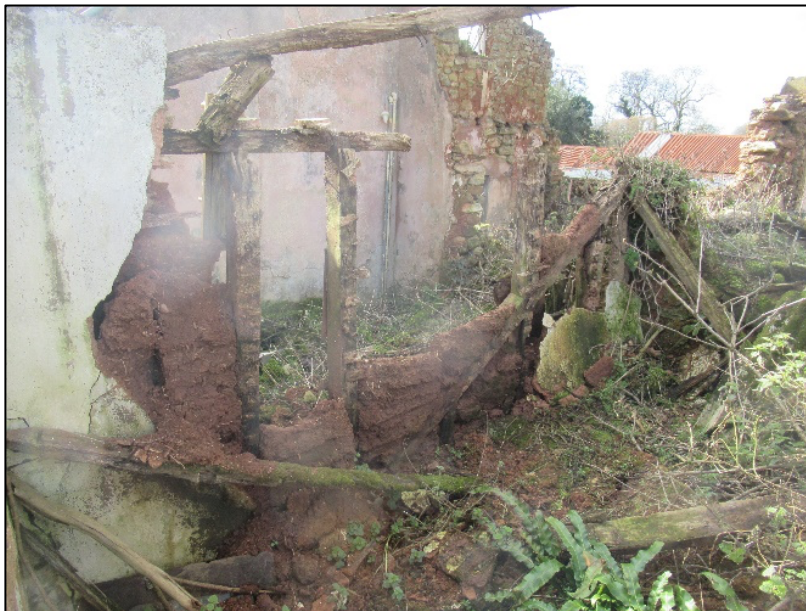
Internal timber frame wall with cob infill.

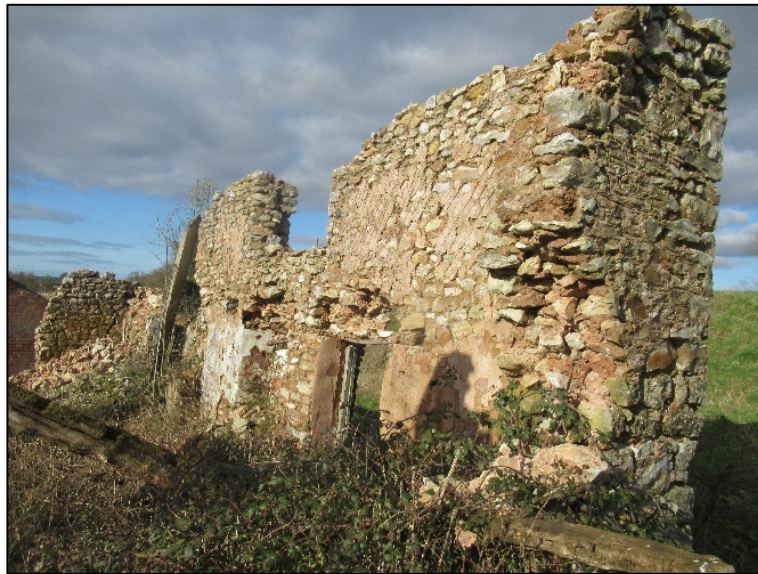
The most vulnerable areas are the north and south walls. It is recommended that an exterior support and restraint scaffold is constructed adjacent to both the north and south walls. The south wall is reasonably true to line, but the north wall is leaning out to a considerable degree local to the north-eastern corner.

Leaning north wall.

Exposed heads to the random rubble stone walls should be sporadically consolidated, and the wall head weather protected to allow for water runoff and to protect the core. This could be achieved with a lime mortar capping or alternatively a polythene sheet or equal. Similarly, the wall heads to remaining parts of cob walls should be protected as soon as practical as these are vulnerable, with evidence of recent collapse on the east side. These elements could be protected with a soft turf capping, or possibly polythene.

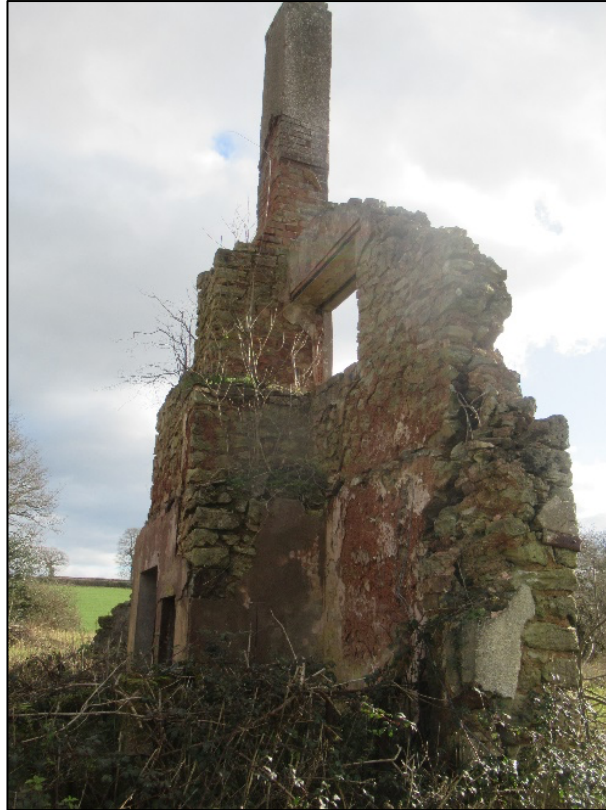
With respect to the south wall, the shelves in the western side of the chimney stack have shrubs and other vegetation growing from them. This should be carefully cleared, and the shelves weather protected with lime mortar or equal.

South wall, with vegetated shelves in chimney stack.
