Appendix D
CCTV Drainage Survey

CCTV Outcome Report

Site: Haskins and Birdworld

Date: 06/12/2023

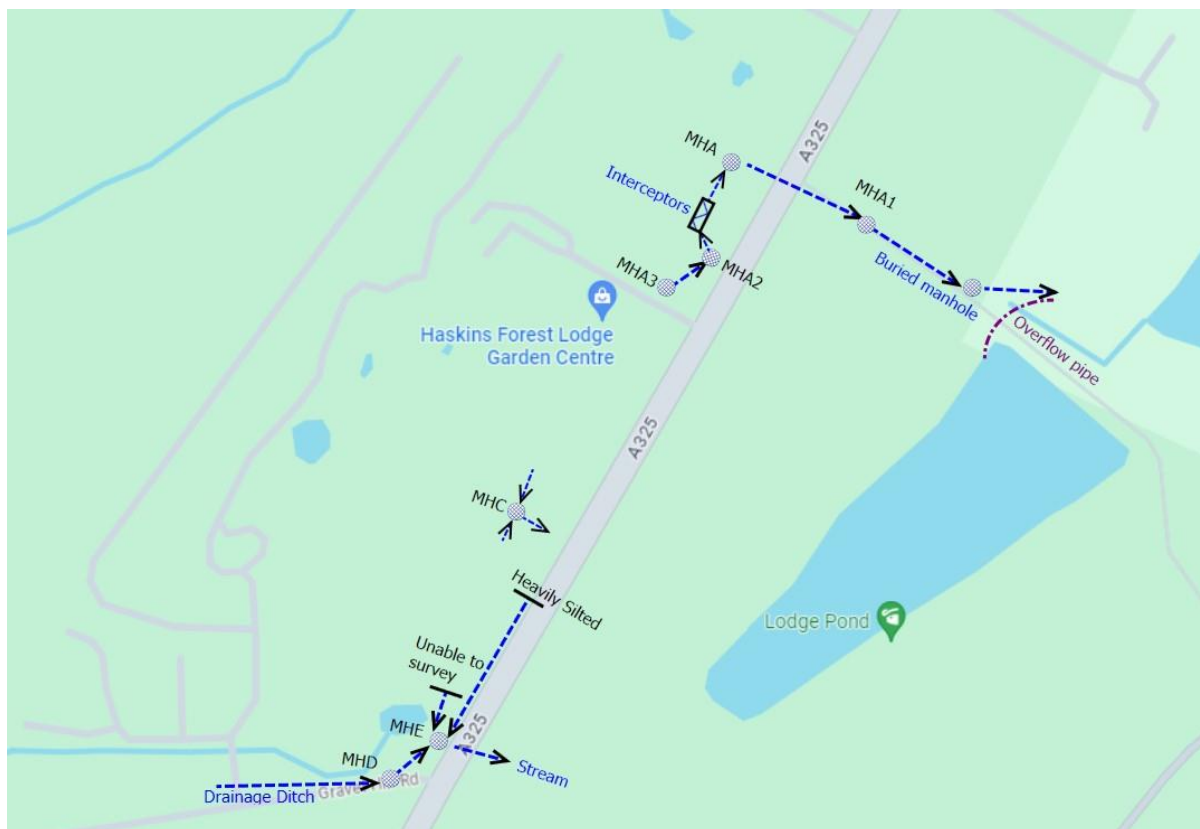
Drainage drawing

At the far end of the site Manhole E takes in storm water from Manhole D and possibly Manhole C although we cannot confirm this due to the conditions of Manhole C before it flows underneath the road via a brick culvert and continues as an open stream towards the lodge pond.

As can be seen from the drawing we have located two pipes running along the embankment of the A325, unfortunately both pipes are in a poor condition and were unable to be surveyed completely.

Location	Defect	Recommendation
MH1A-MHA	Roots	Root milling and re survey
MH1A-Buried Manhole	Cracks and fractures	Relining or excavation and replacement
MH1A-Buried Manhole	Roots	Root milling and re survey
MHA2-MHA3	Roots	Root milling and re survey
MHA3	Blocked	Jetting/silt removal and re survey
E1 Upstream	Heavily silted	Jetting/ silt removal and re survey
E2 Upstream	Coarse deposit blockage	Jetting/ silt removal and re survey
MHC		Re survey once water level is lower

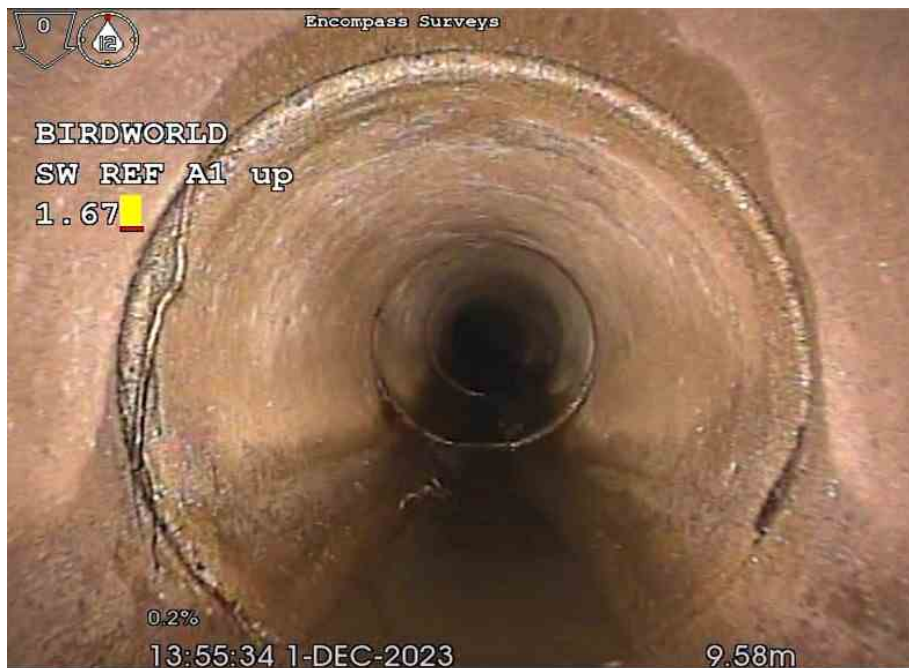
1-1-3A, 00:00:40, 9.58 m
Roots, tap at joint

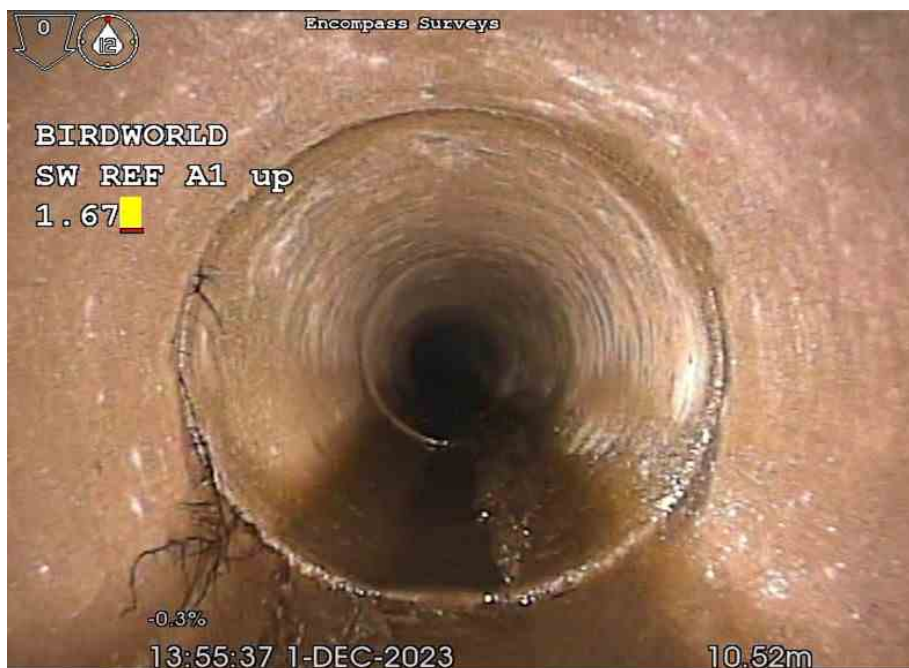
1-1-4A, 00:00:43, 10.52 m
Roots, fine at joint

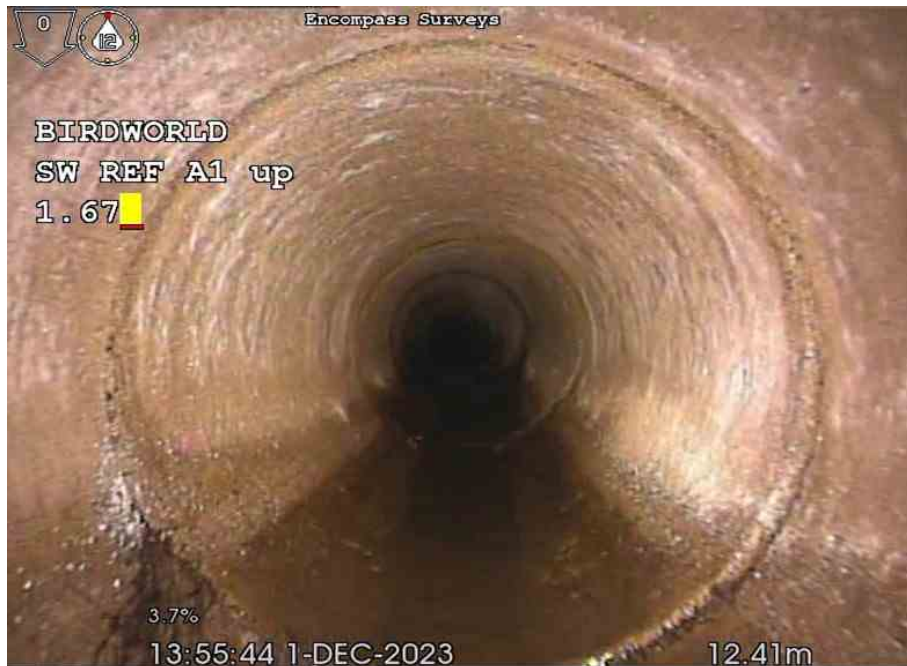
1-1-5A, 00:00:51, 12.41 m
Roots, fine at joint

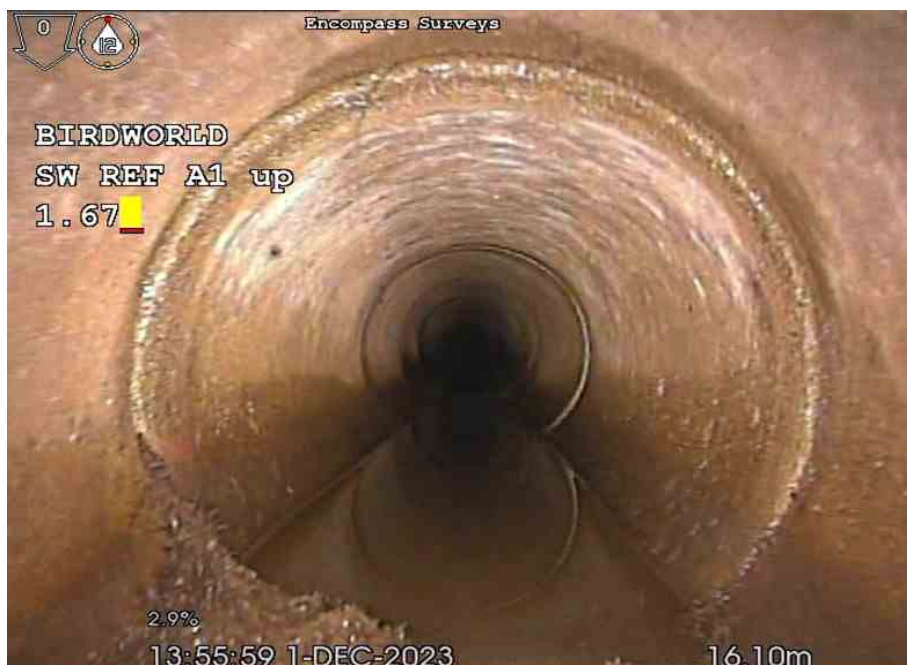
1-1-8A, 00:01:05, 16.10 m
Roots, mass at joint, 5% cross-sectional area loss

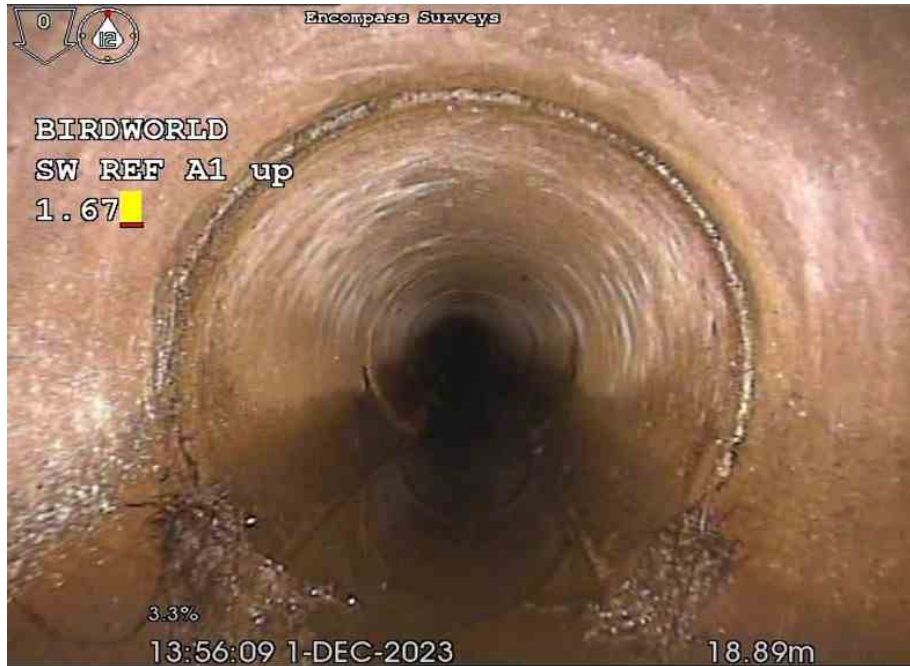
1-1-9A, 00:01:15, 18.89 m
Roots, fine at joint

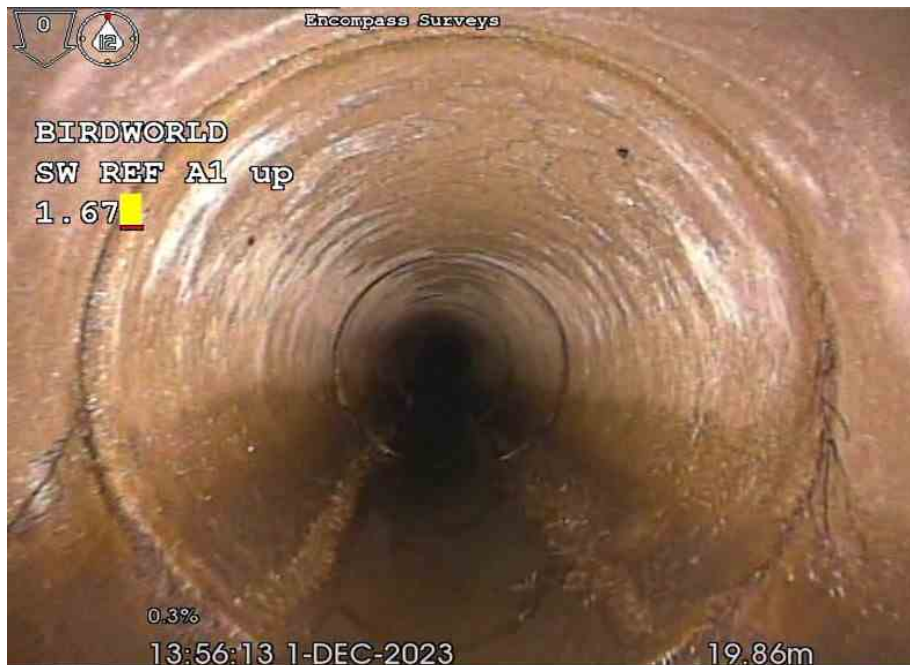
1-1-10A, 00:01:19, 19.86 m
Roots, fine at joint

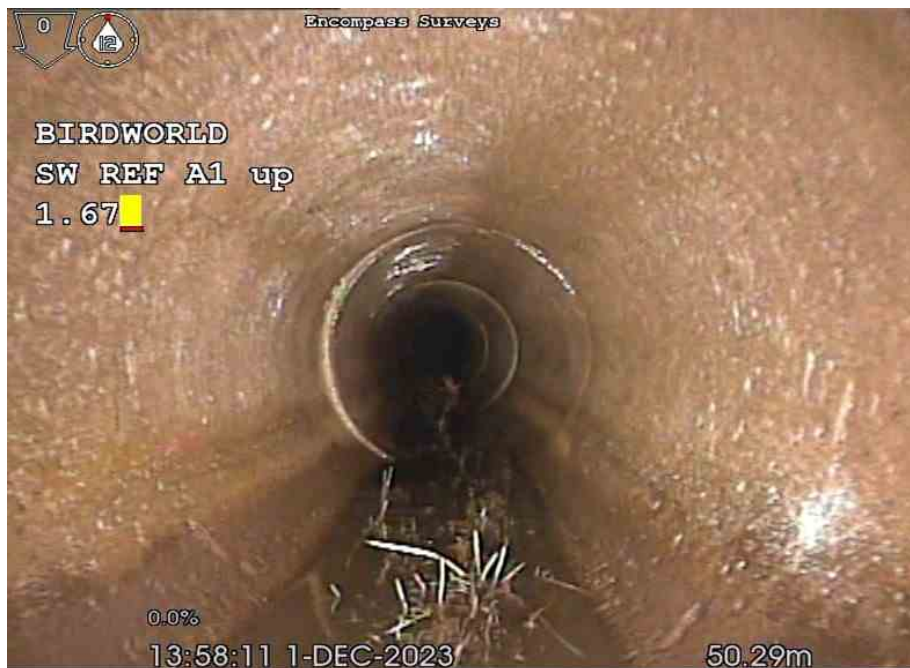
1-1-11A, 00:03:17, 50.29 m
Roots, fine, start

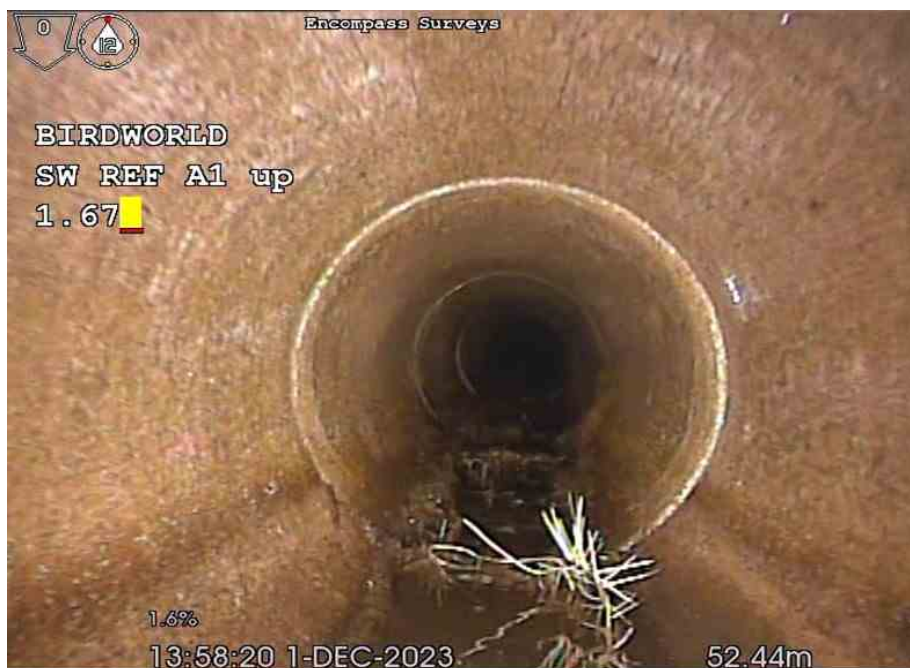
1-1-11B, 00:03:17, 50.29 m
Roots, fine, start

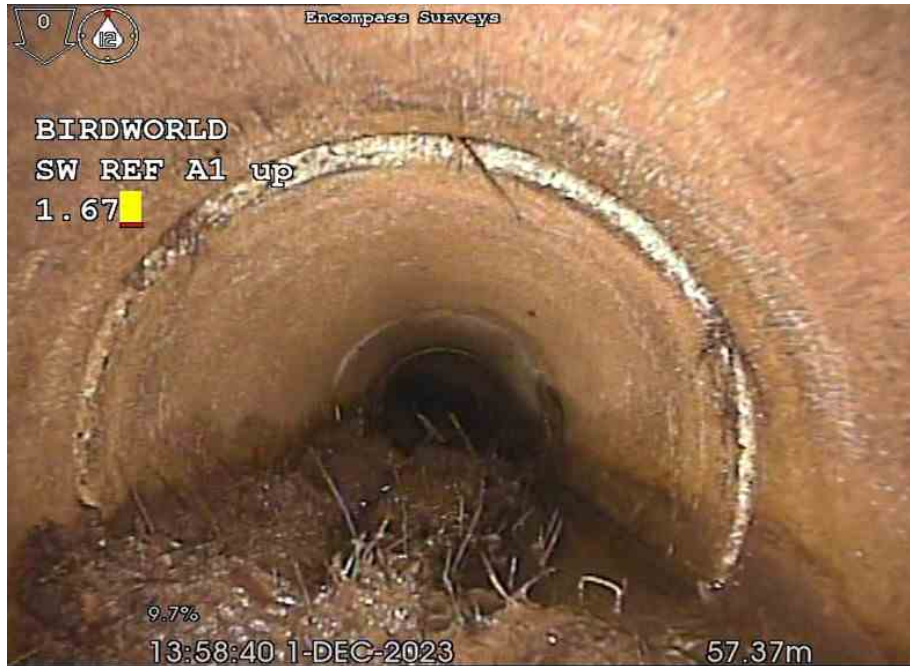
1-1-13A, 00:03:41, 56.28 m
 Roots, mass, 25% cross-sectional area loss

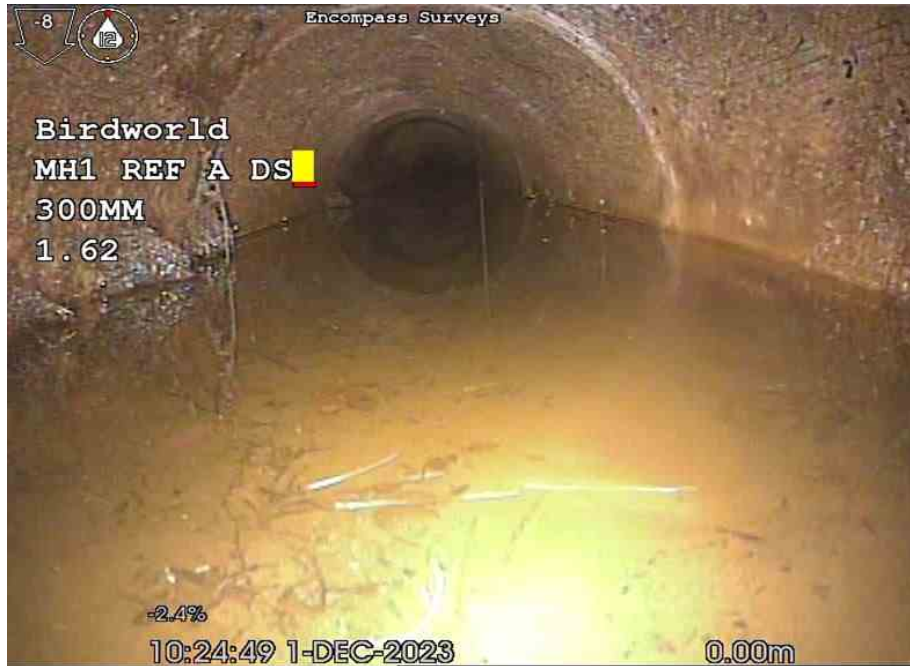
1-2-2A, 00:00:00, 0.00 m
Water level, 35% of the vertical dimension

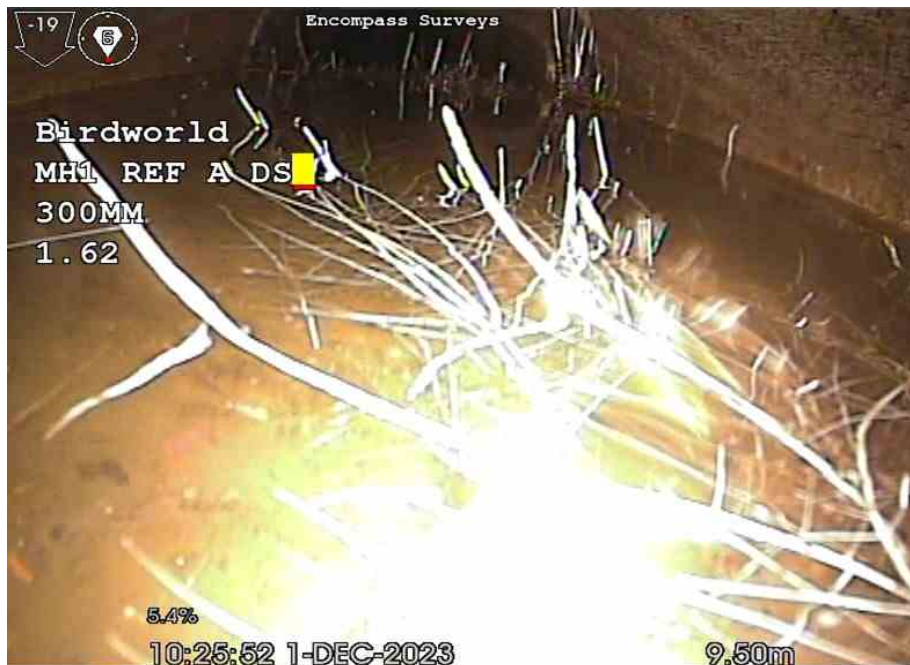
1-2-3A, 00:00:47, 9.08 m
Roots, fine, start

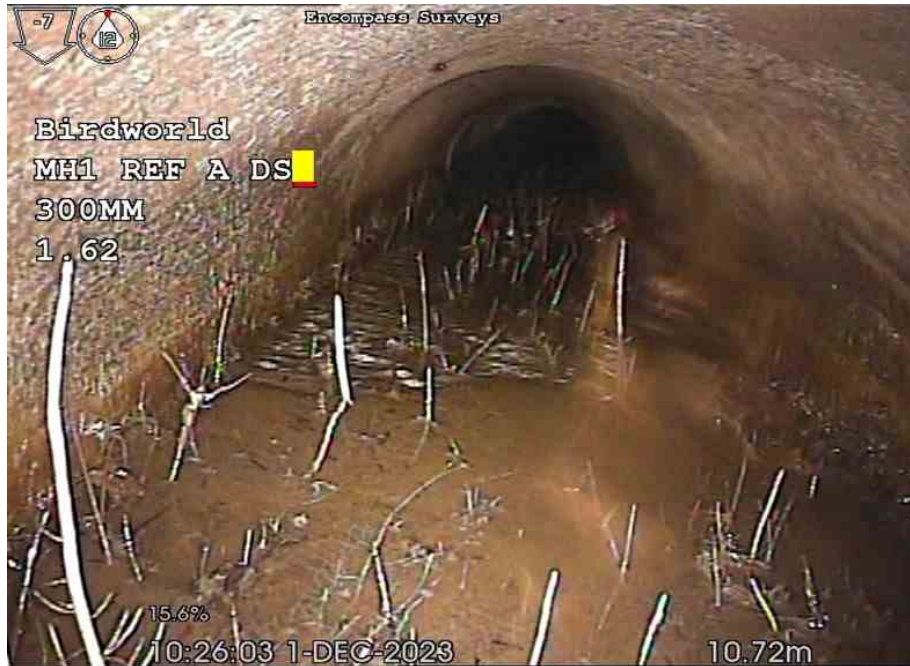
1-2-3B, 00:00:47, 9.08 m
Roots, fine, start

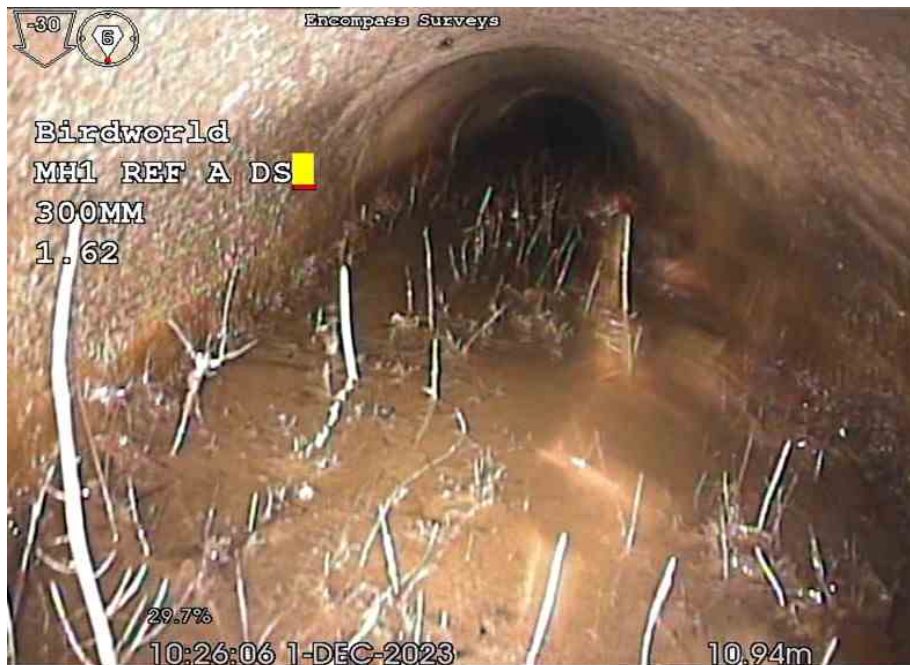
1-2-4A, 00:01:17, 10.94 m
Roots, fine, finish

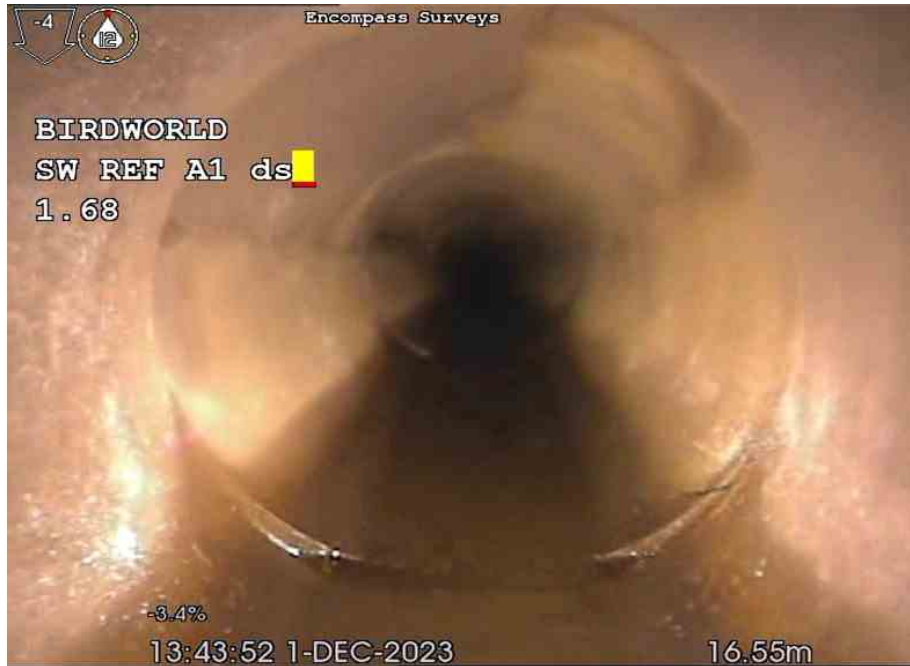
2-1-3A, 00:01:06, 16.55 m
Crack, longitudinal at 12 o'clock, start

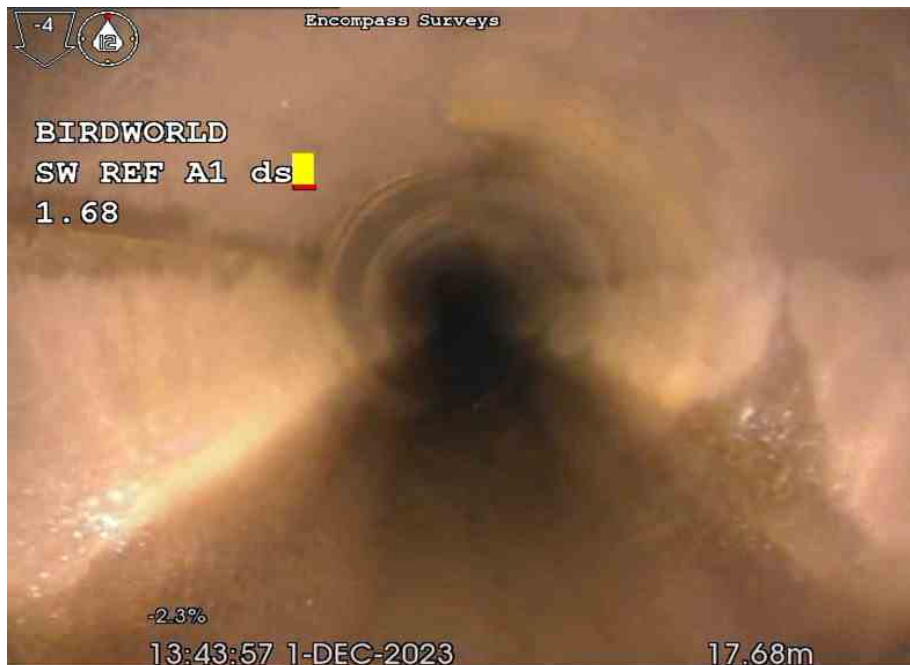
2-1-4A, 00:01:08, 16.59 m
Crack, longitudinal at 2 o'clock, start

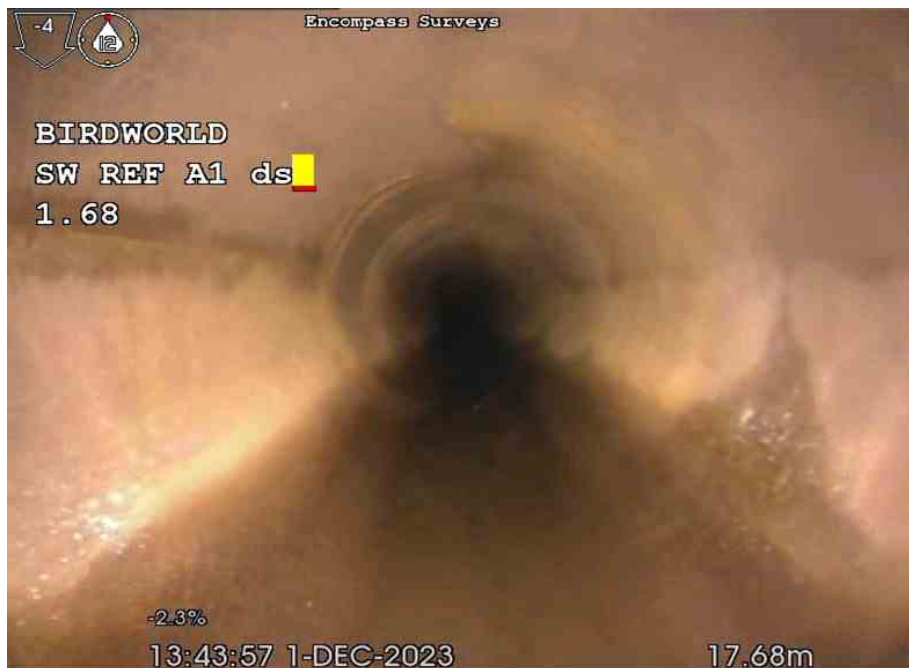
2-1-5A, 00:01:11, 17.68 m
 Crack, longitudinal at 9 o'clock, start

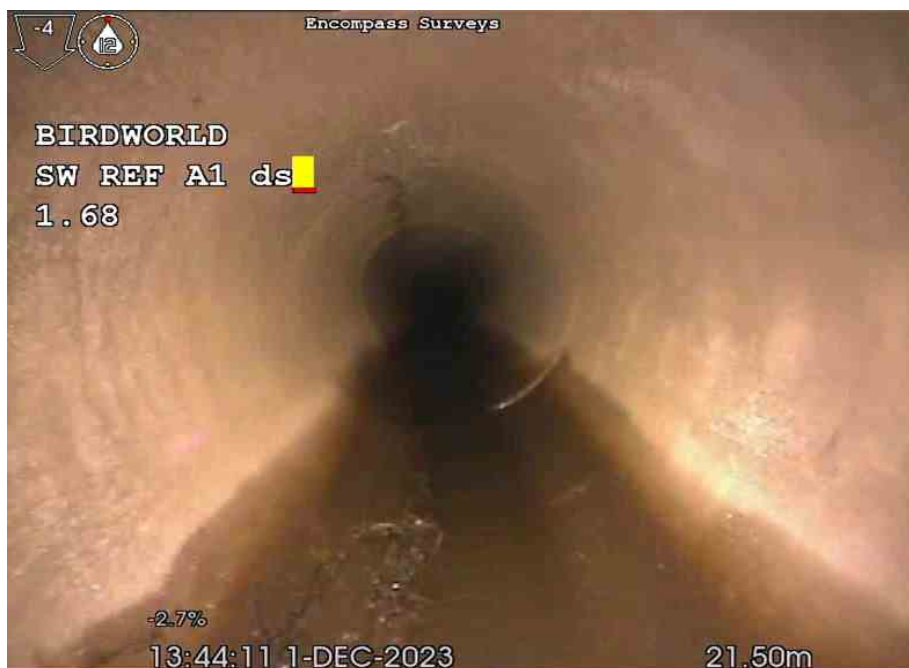
2-1-6A, 00:01:24, 21.50 m
 Crack, longitudinal at 12 o'clock, finish

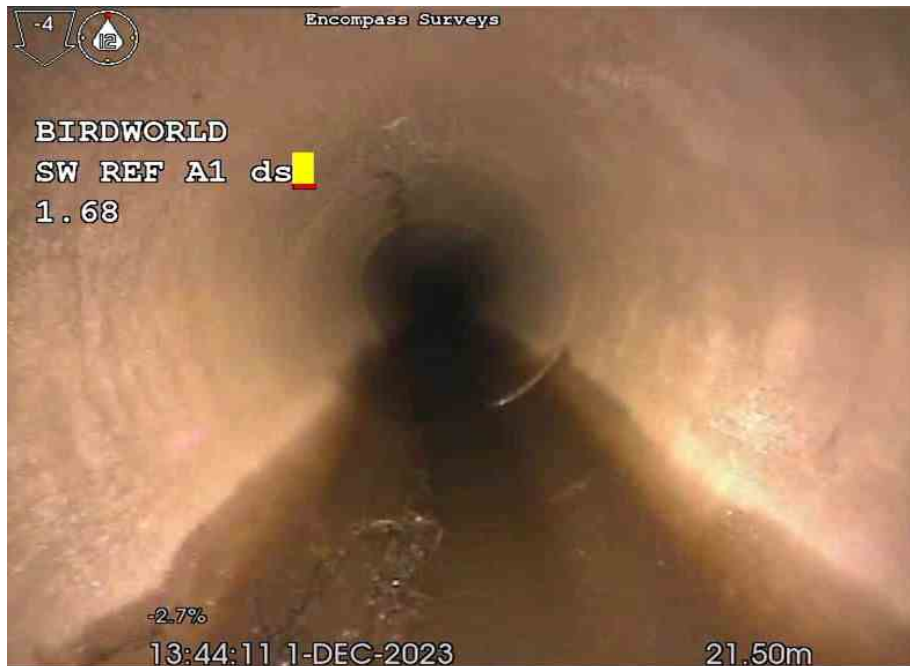
2-1-9A, 00:01:24, 21.50 m
Roots, fine

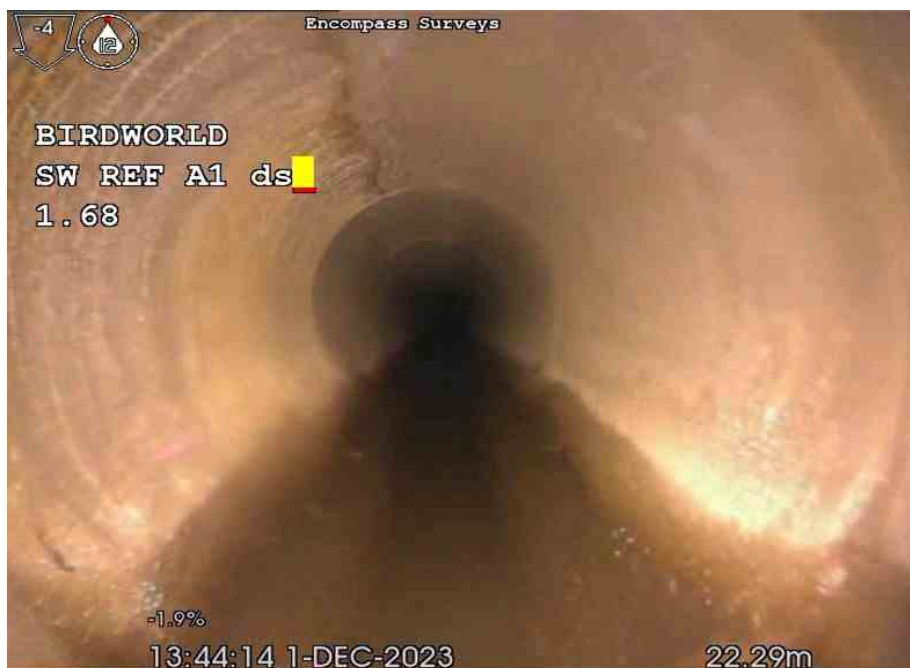
2-1-10A, 00:01:28, 22.29 m
Crack, longitudinal at 11 o'clock

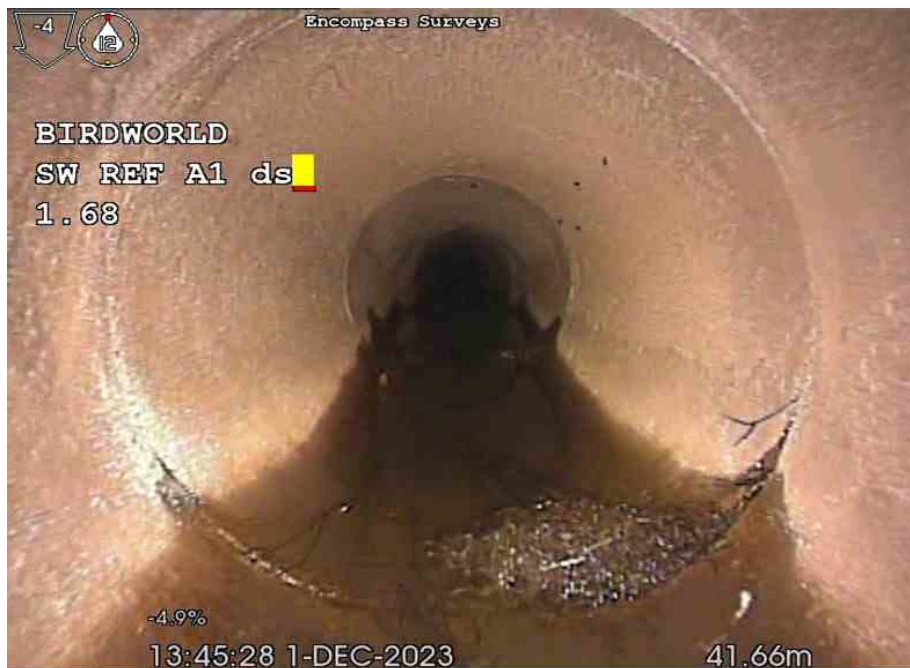
2-1-13A, 00:02:42, 41.66 m
Roots, mass at joint, 10% cross-sectional area loss

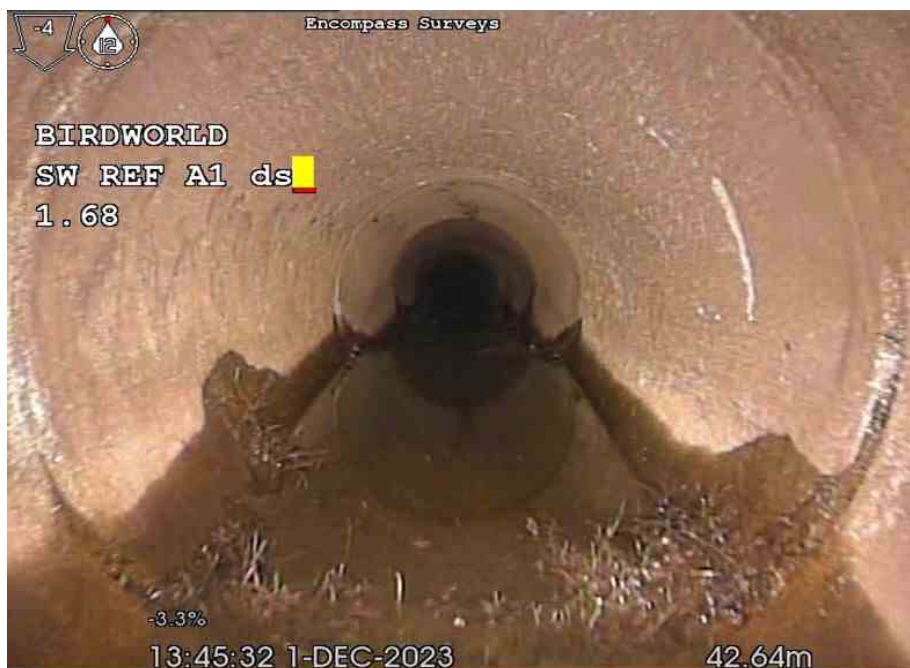
2-1-14A, 00:02:46, 42.64 m
Roots, mass at joint, 10% cross-sectional area loss, start

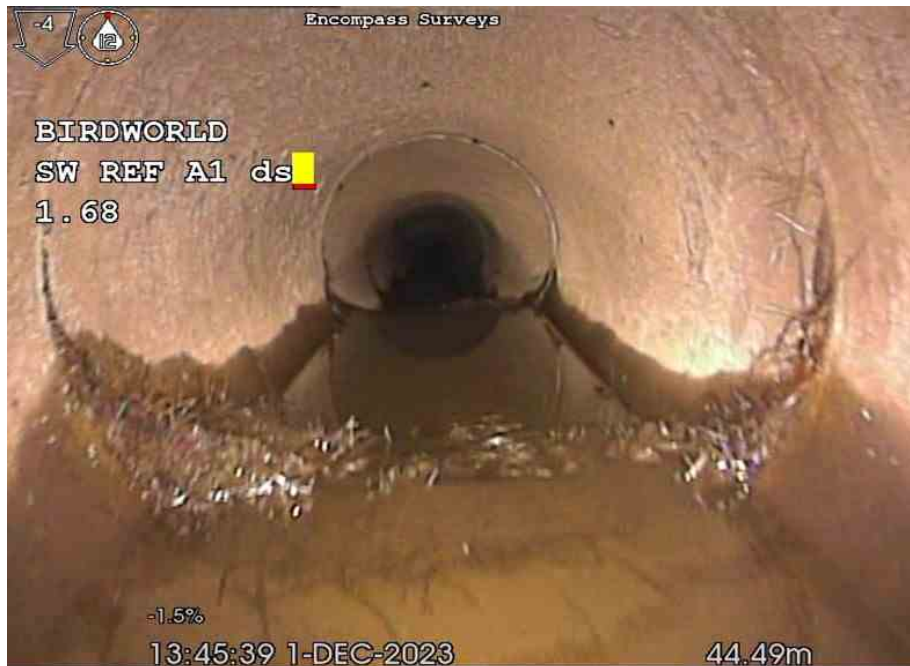
2-1-14B, 00:02:46, 42.64 m
 Roots, mass at joint, 10% cross-sectional area loss, start

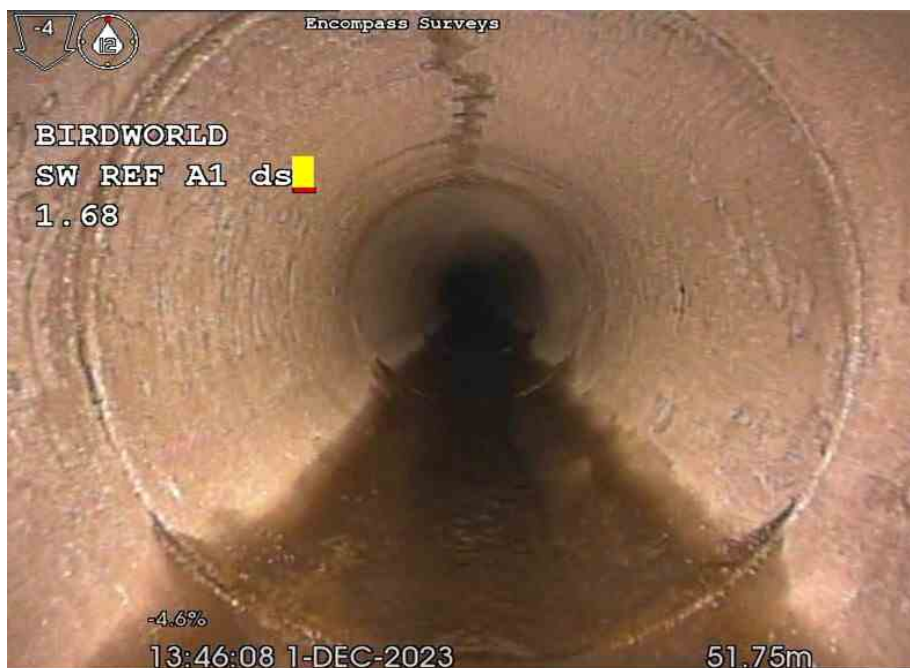
2-1-16A, 00:03:22, 51.75 m
 Crack, longitudinal at joint at 12 o'clock

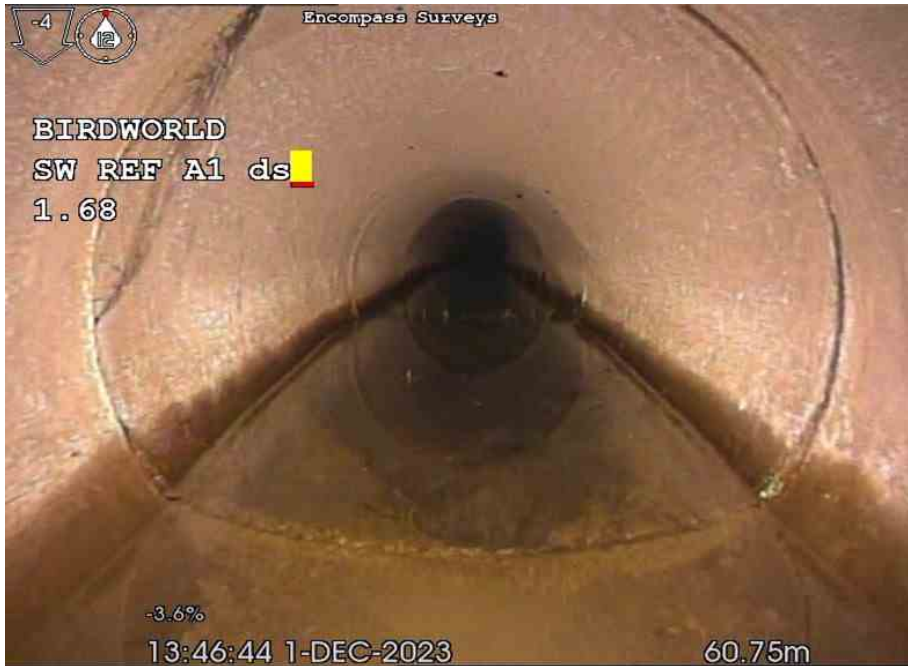
2-1-18A, 00:03:58, 60.78 m
Roots, fine at joint

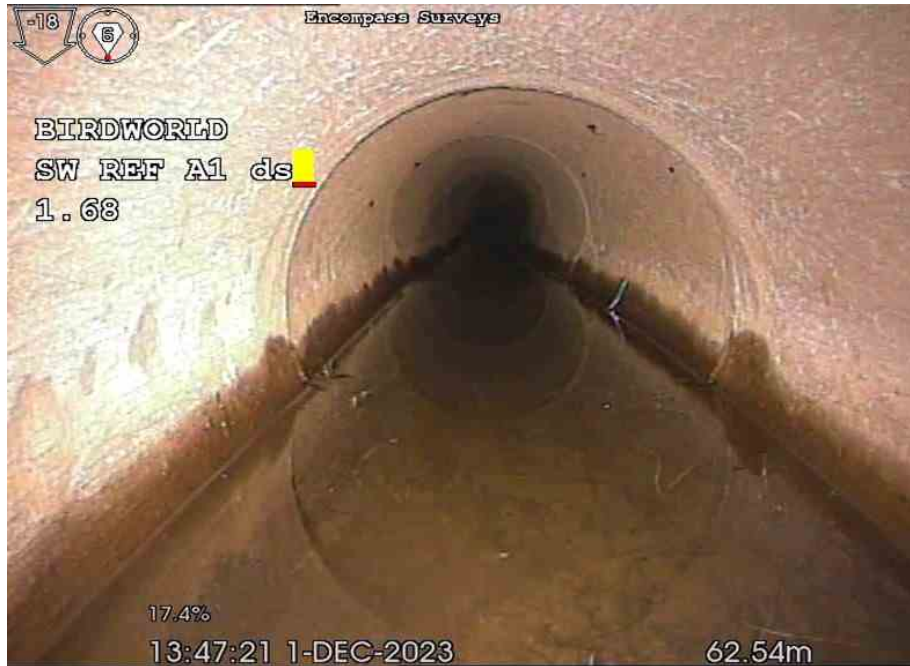
2-1-21A, 00:04:35, 62.54 m
Survey abandoned

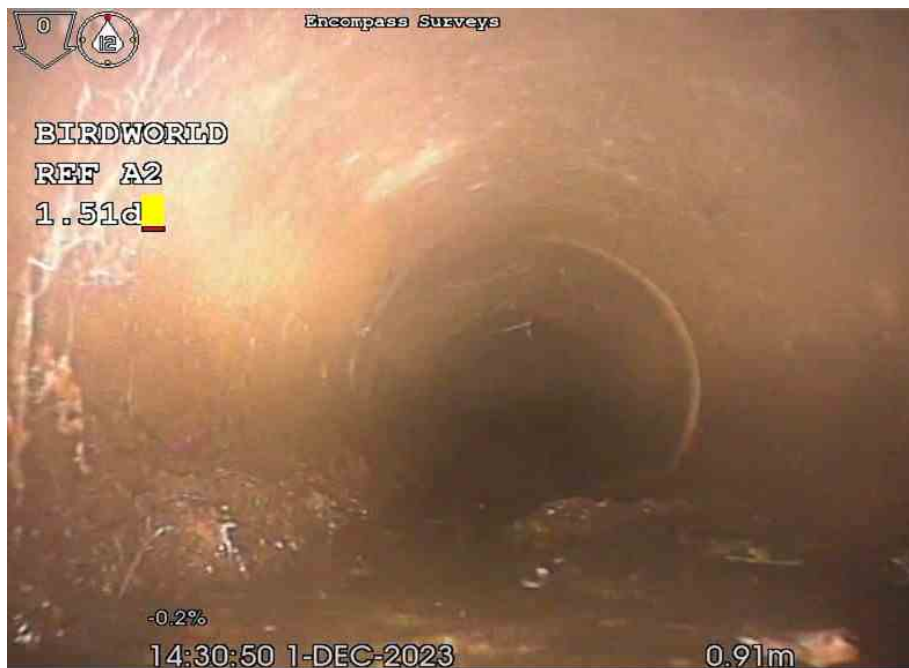
3-1-3A, 00:00:01, 0.00 m
Water level, 20% of the vertical dimension

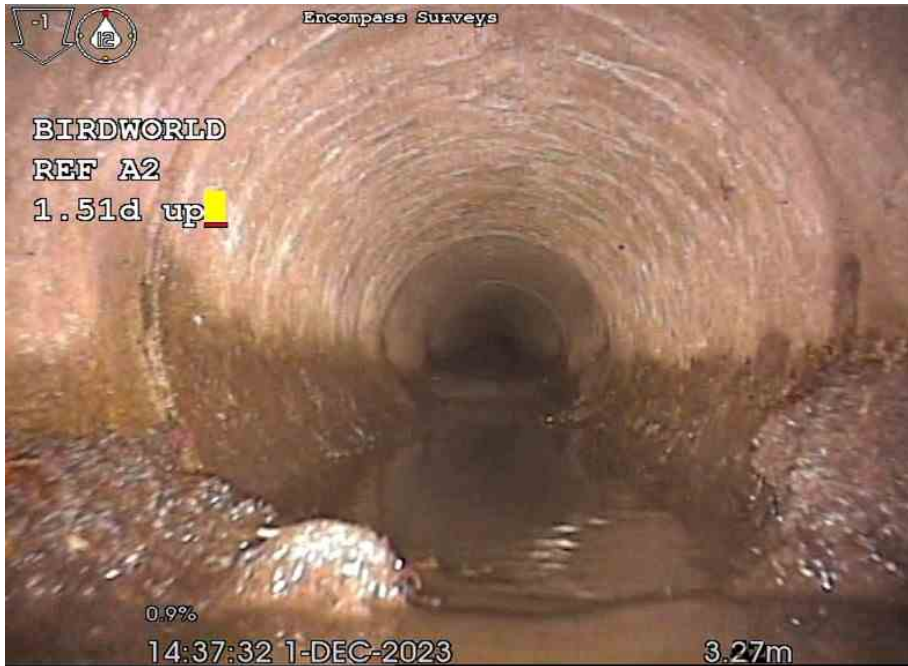
4-1-3A, 00:00:15, 3.27 m
Roots, mass at joint, 10% cross-sectional area loss, start

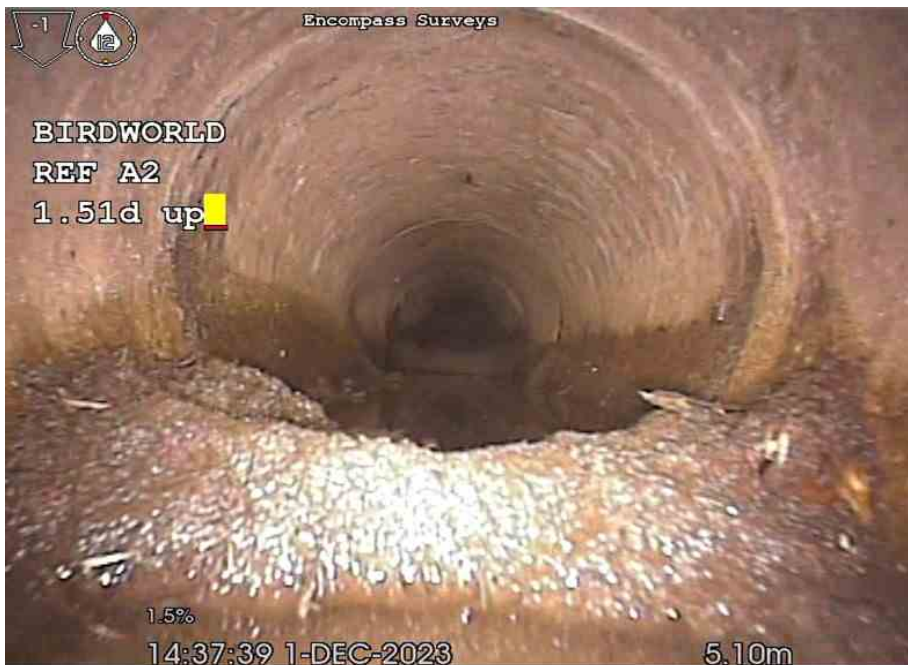
4-1-3B, 00:00:15, 3.27 m
Roots, mass at joint, 10% cross-sectional area loss, start

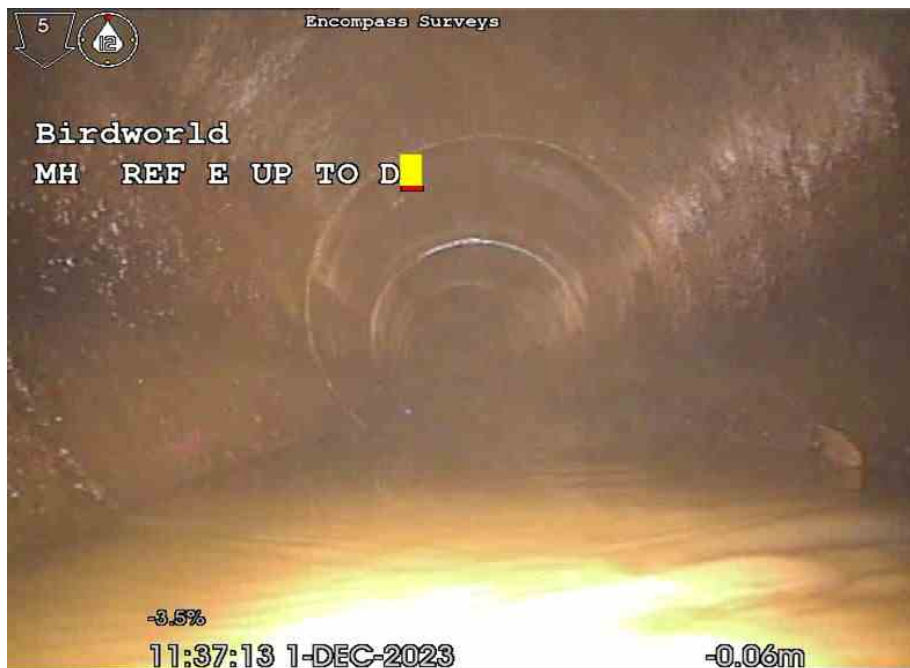
7-1-2A, 00:00:00, 0.00 m
Water level, 20% of the vertical dimension

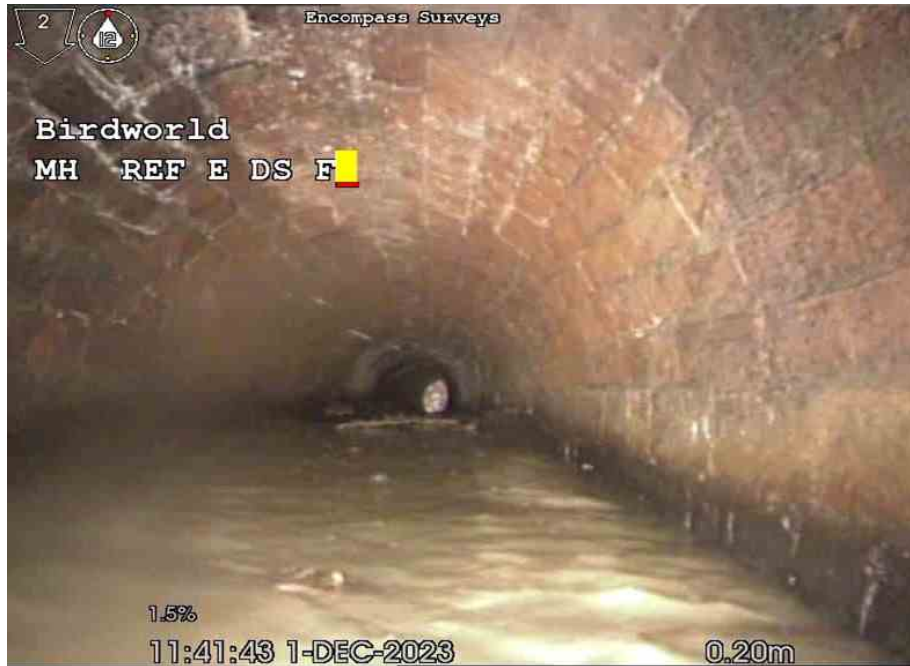
8-1-3A, 00:00:00, 0.00 m

Settled deposits, fine, 20% cross-sectional area loss, start

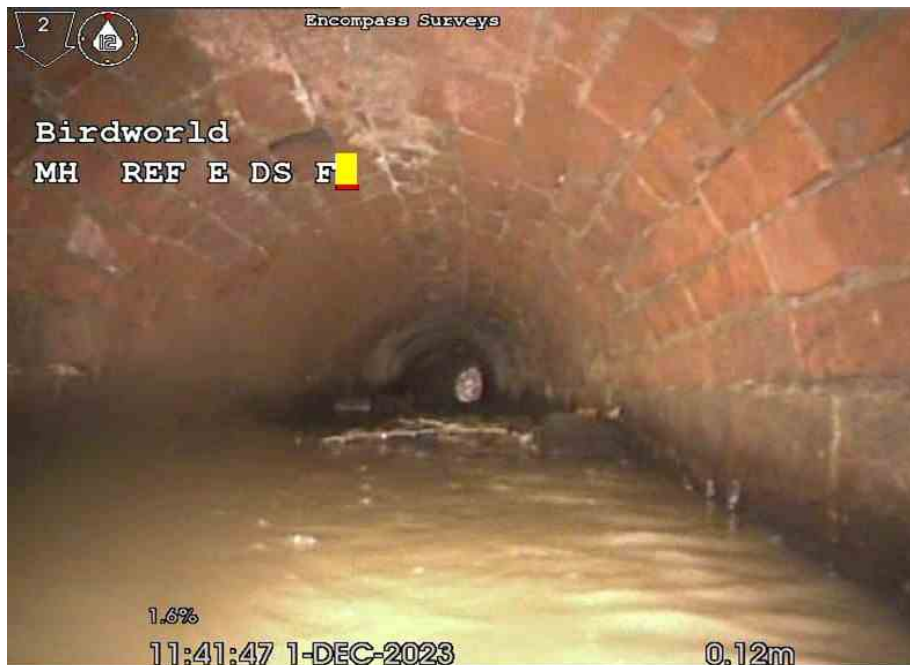
8-1-4A, 00:00:03, 0.12 m

Missing mortar, between 5mm and 15mm from 1 o'clock to 2 o'clock

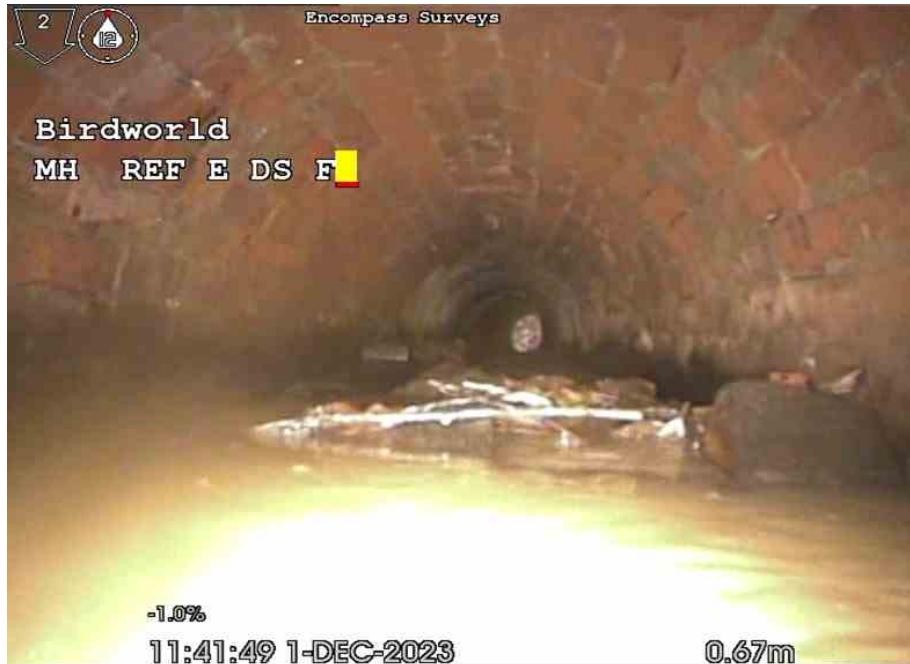
8-1-5A, 00:00:06, 0.67 m
Settled deposits, coarse, 25% cross-sectional area loss

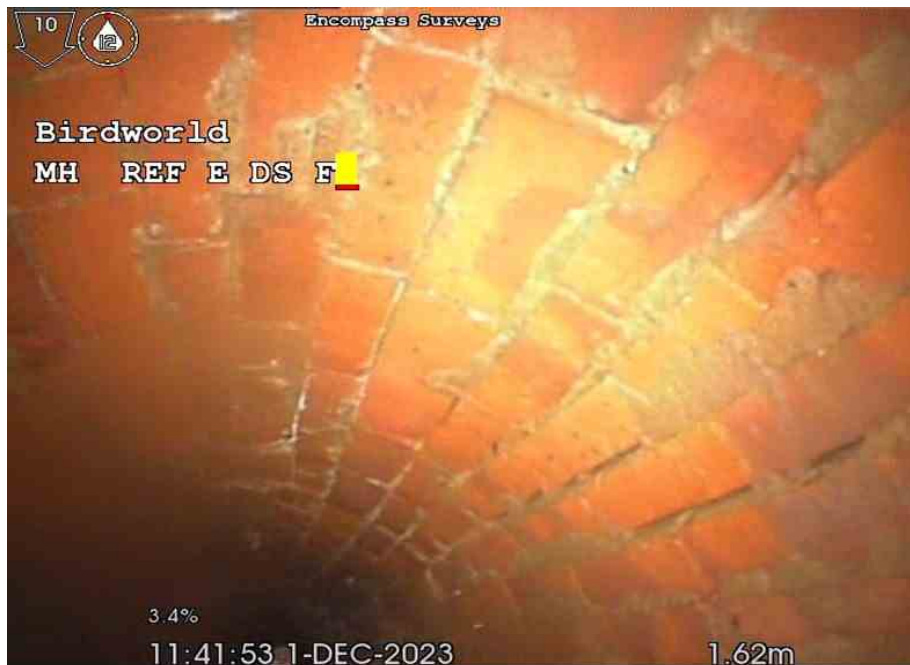
8-1-6A, 00:00:10, 1.62 m
Missing mortar, between 5mm and 15mm from 1 o'clock to 3 o'clock

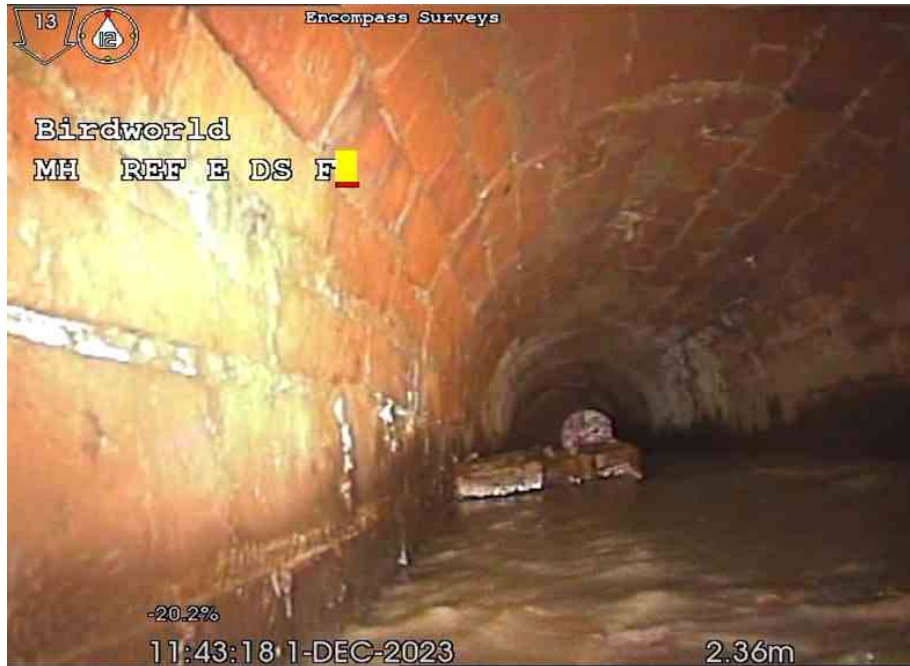
8-1-7A, 00:01:35, 2.36 m
Settled deposits, fine, 20% cross-sectional area loss, finish

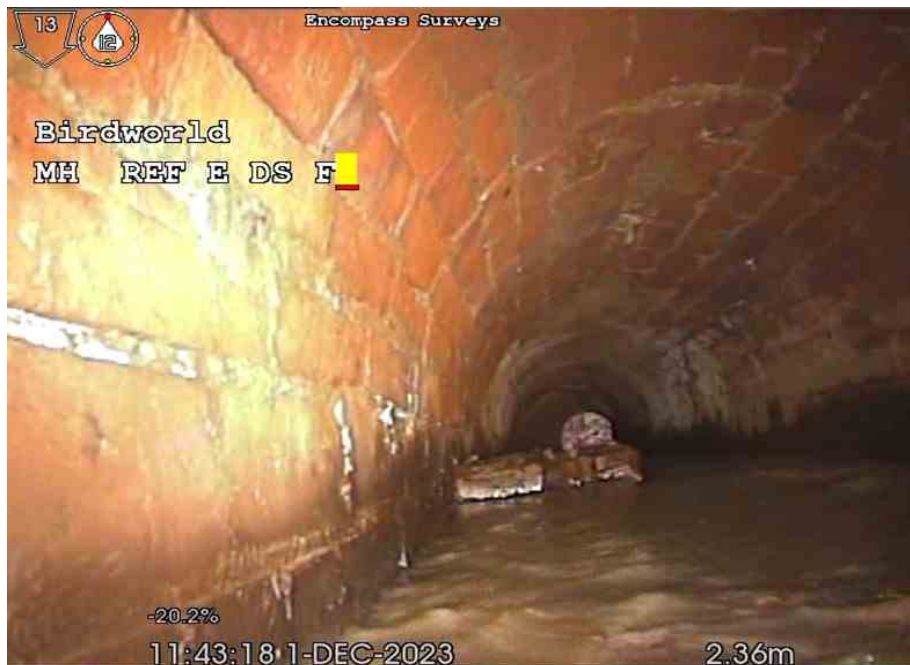
8-1-8A, 00:01:35, 2.36 m
Survey abandoned
