Appendix D
CCTV Drainage Survey

CCTV Outcome Report

Site: Haskins and Birdworld

Date: 06/12/2023

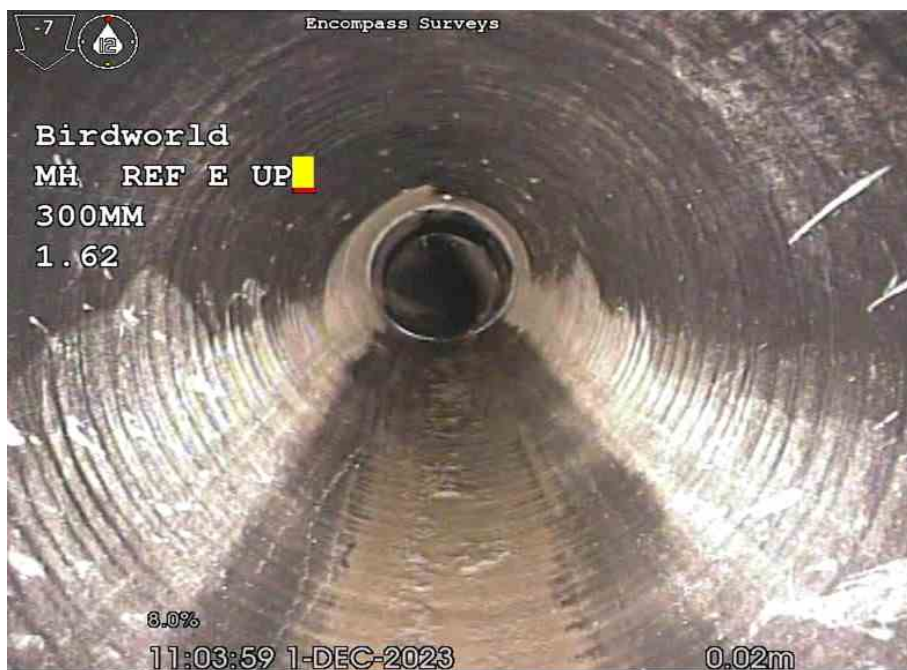
9-1-3A, 00:00:00, 0.00 m
Settled deposits, fine, 5% cross-sectional area loss, start

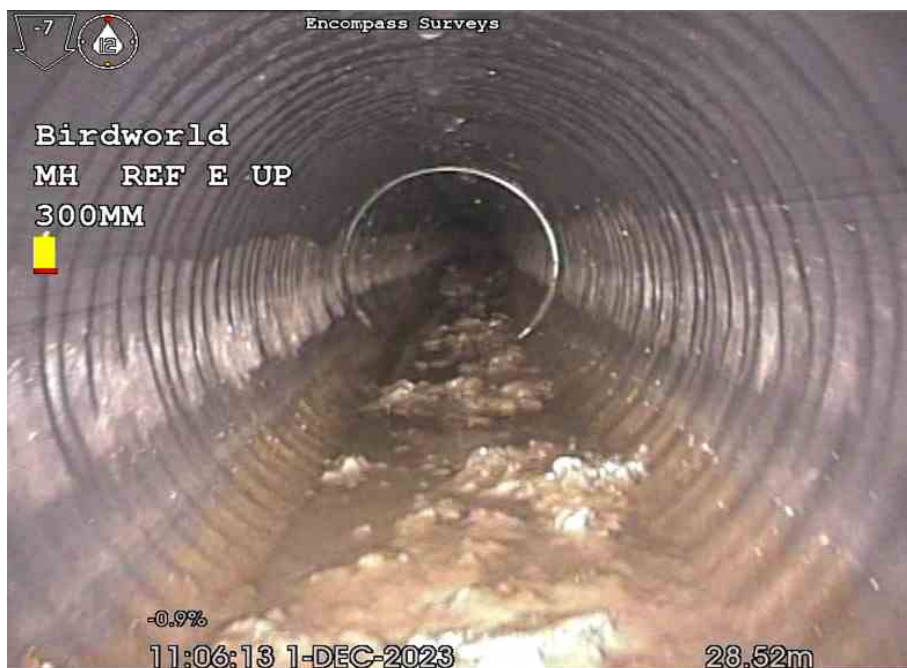
9-1-5A, 00:02:13, 28.52 m
Settled deposits, fine, 10% cross-sectional area loss

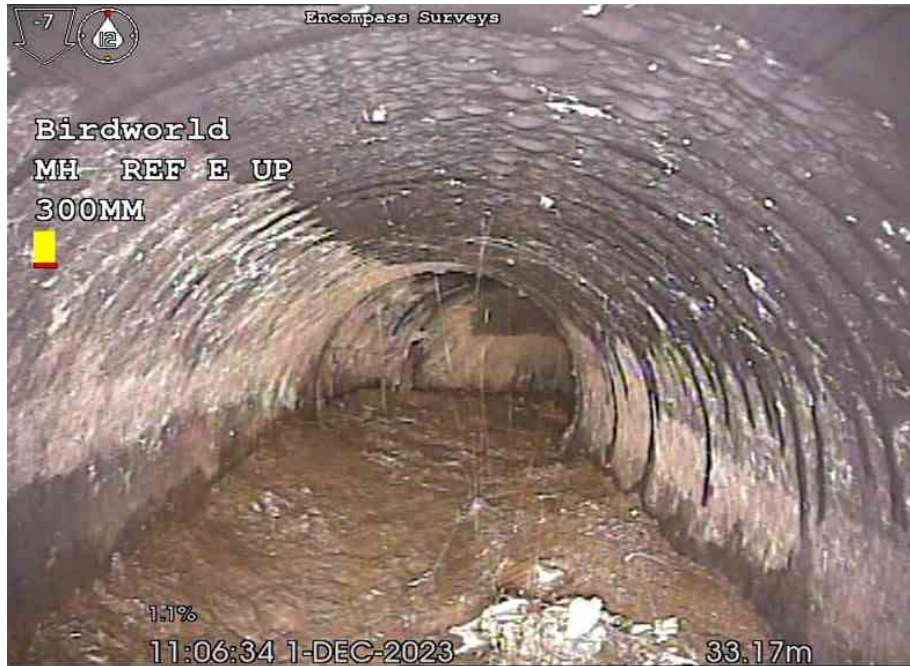
9-1-8A, 00:02:34, 33.17 m
Settled deposits, fine, 5% cross-sectional area loss, finish

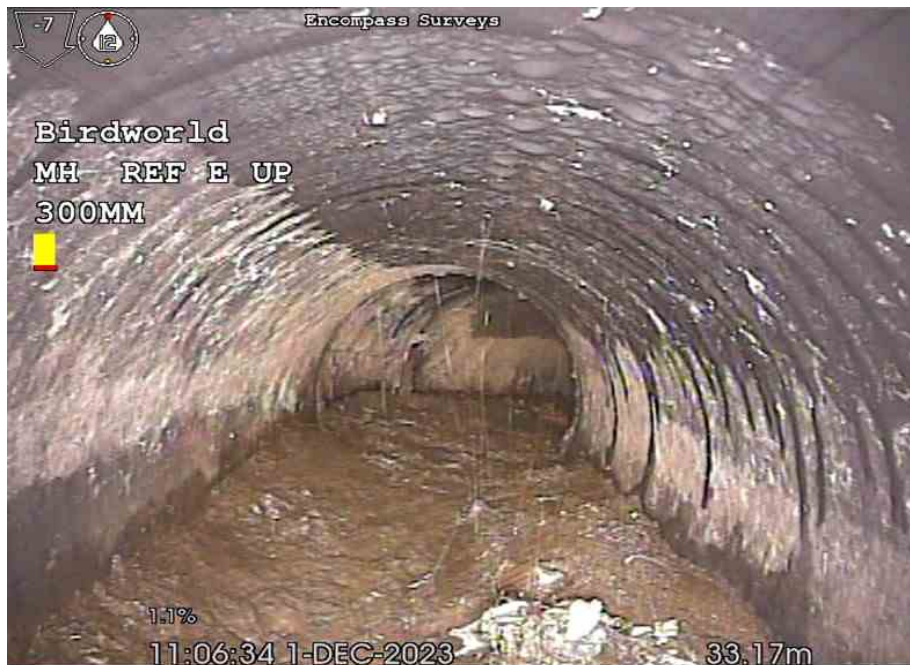
9-1-9A, 00:02:34, 33.17 m
Survey abandoned

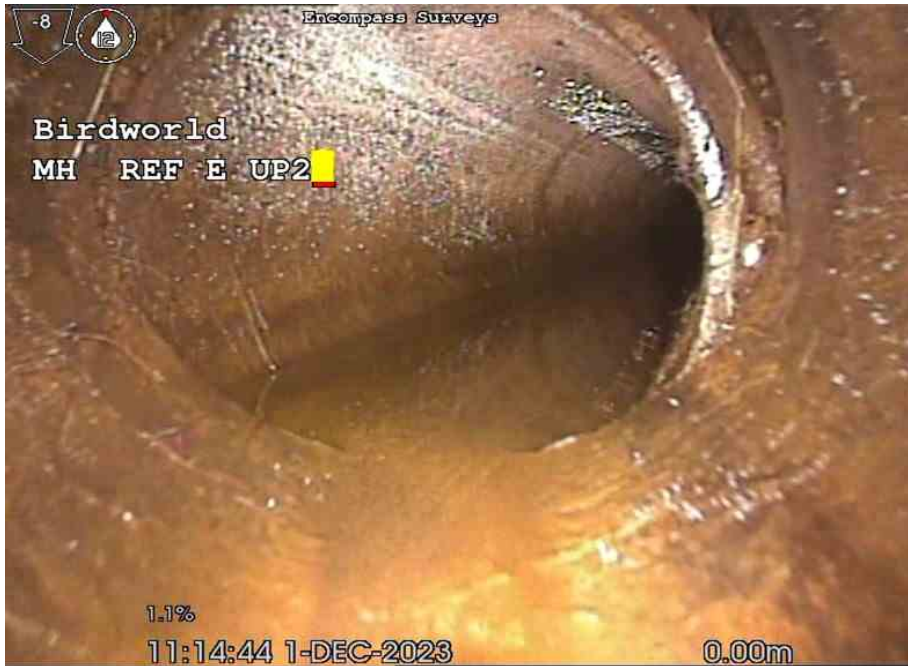
10-1-2A, 00:00:01, 0.00 m
Joint displaced, large
