Construction Damage Assessment
7 The Crest
Swillington
Leeds, LS26 8EA

Report Reference: 1671-1
September 2023

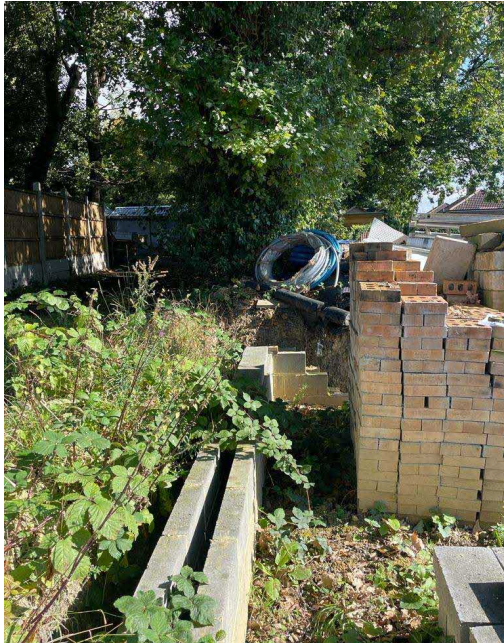
- 2.2.4. The soil level has been excavated to a depth of approximately 1m, some 1.3m to the west of T1. Desiccated roots are evident along the face of the excavation. The roots have a maximum diameter of 70mm. The condition of desiccated roots suggests they have been exposed for some time. Although no details regarding the site's original topography have been provided, it is assumed the garden was either previously terraced or sloped in the direction of the house in order to marry in with the neighbouring ground levels.
- 2.2.5. Footings and three courses of breeze blocks have been constructed 1.4m from the stem of T1. The depth and type of foundation is unknown.

Figure 1. Displays the extent of the excavation work and new footings in the vicinity of T1.

2.	Prune desiccated roots	Prune exposed roots to live material (where possible).	Yes	Qualified Arborist or Arboriculturist
3.	Carryout tree pruning works	Reduce T1 by 2.5-3m in height and 2m in lateral spread. Work to be completed in accordance with BS3998 Tree Work Recommendations.	Yes	Qualified Arborist

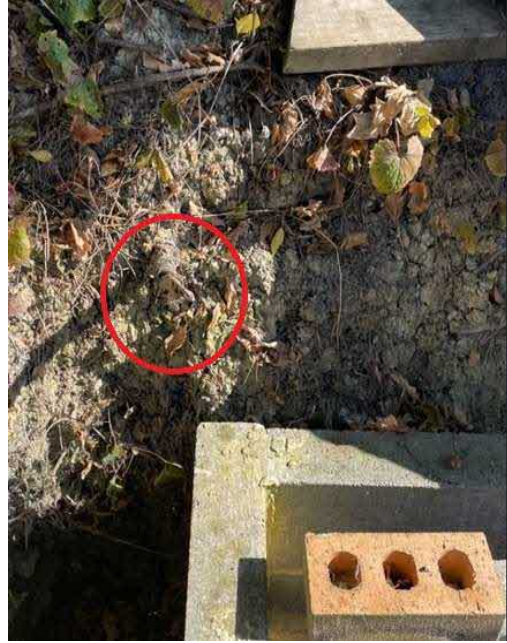
Figure 2. Identifies a desiccated severed tree root.

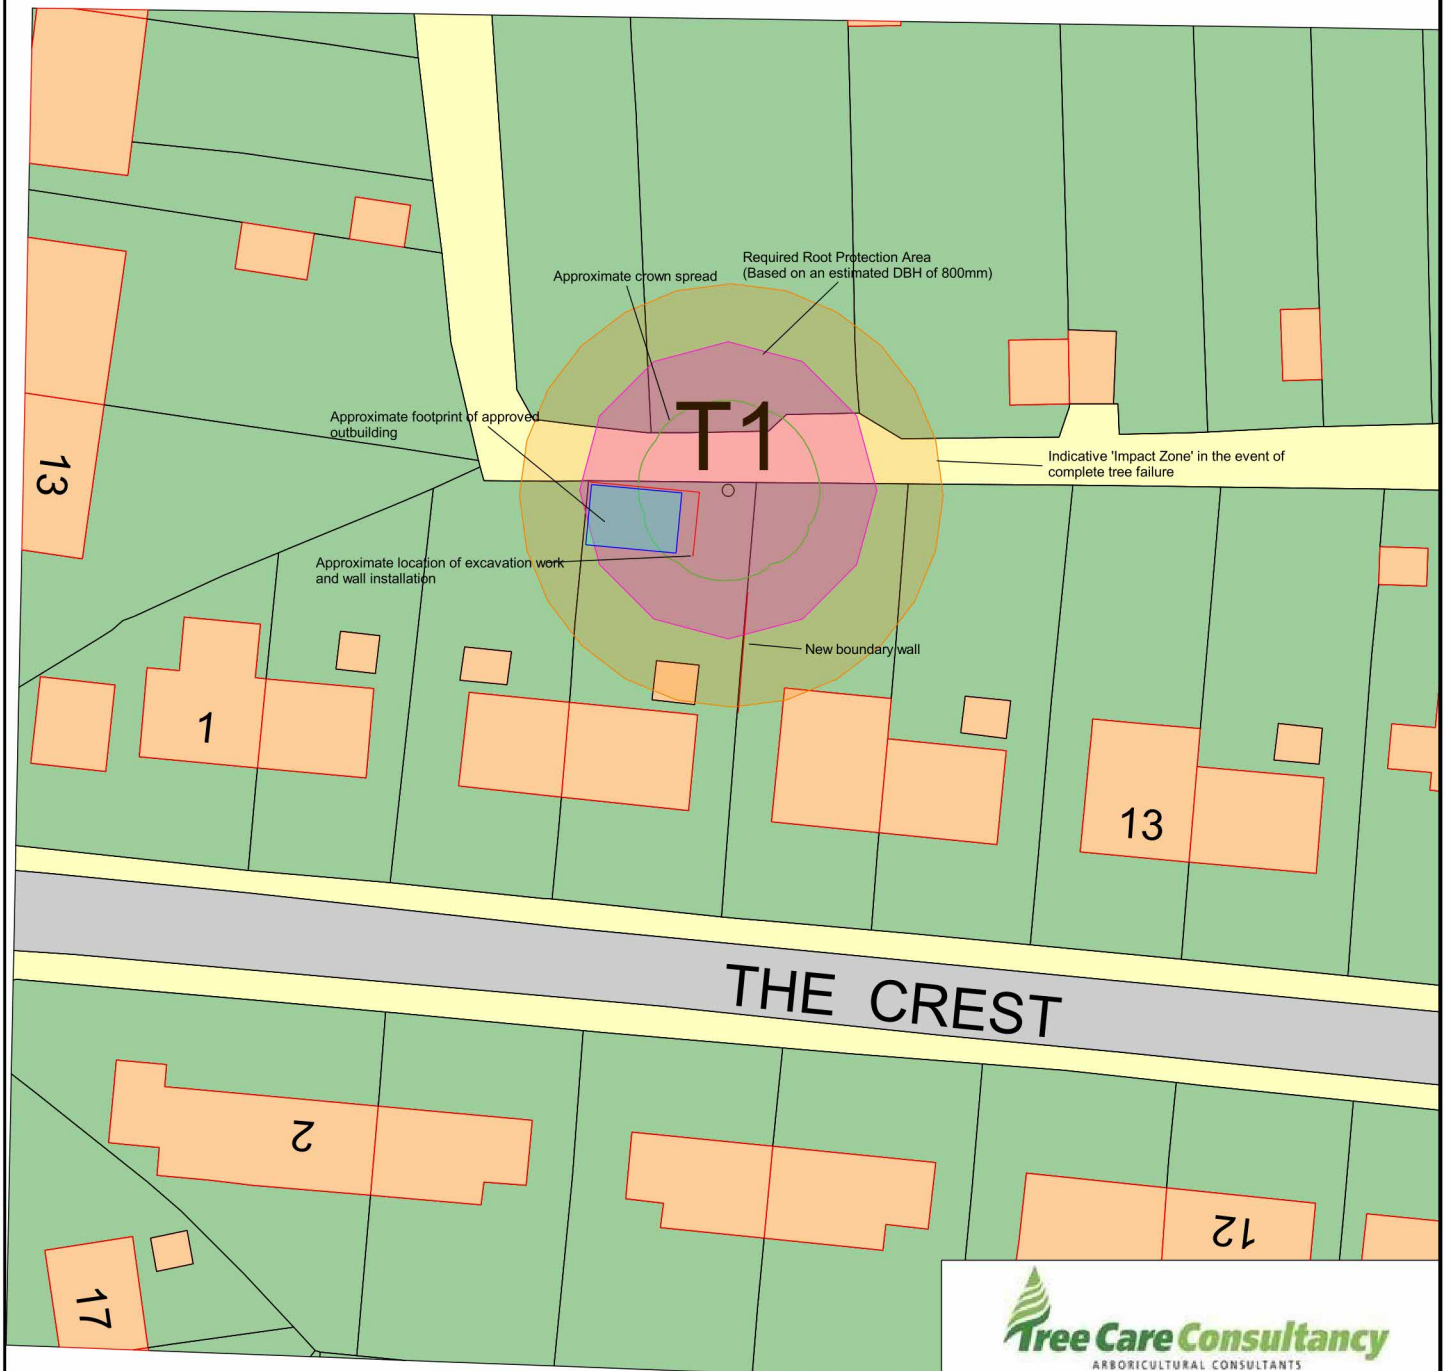
- 2.3.2. As recommended in BS5837 'Trees in relation to design, demolition and construction –Recommendations', the required Root Protection Area has been calculated and plotted on the accompanying Tree Location & Damage Identification Plan (appendix 1). Assuming T1's root growth has developed symmetrically; it is estimated that approximately 25% of its rooting volume has been destroyed including roots that potentially provided stability. The extent of root loss may have jeopardised T1's ability to withstand wind loads. It is also likely to have had an adverse effect on tree vitality which may take years to become symptomatic and evident within the crown of T1.
