## REPAIR OF WOOD WINDOWS AND EXTERNAL DOOR

The Mill Cottages, Mill Lane, Empingham

Client : Mrs M. Griffin

February 2024 V1

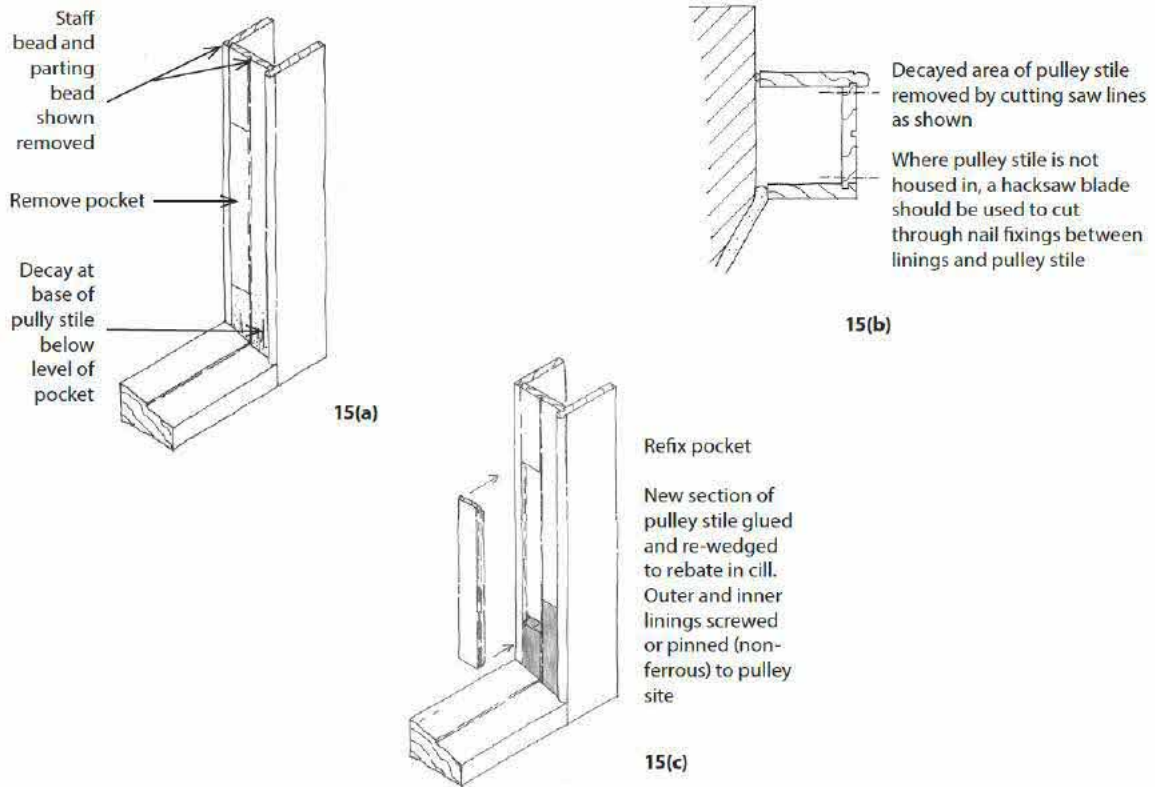
**Figure 15:** Base of pulley stile: (a) Dismantling. (b) Cutting back shown on plan of sash box. (c) Repair.

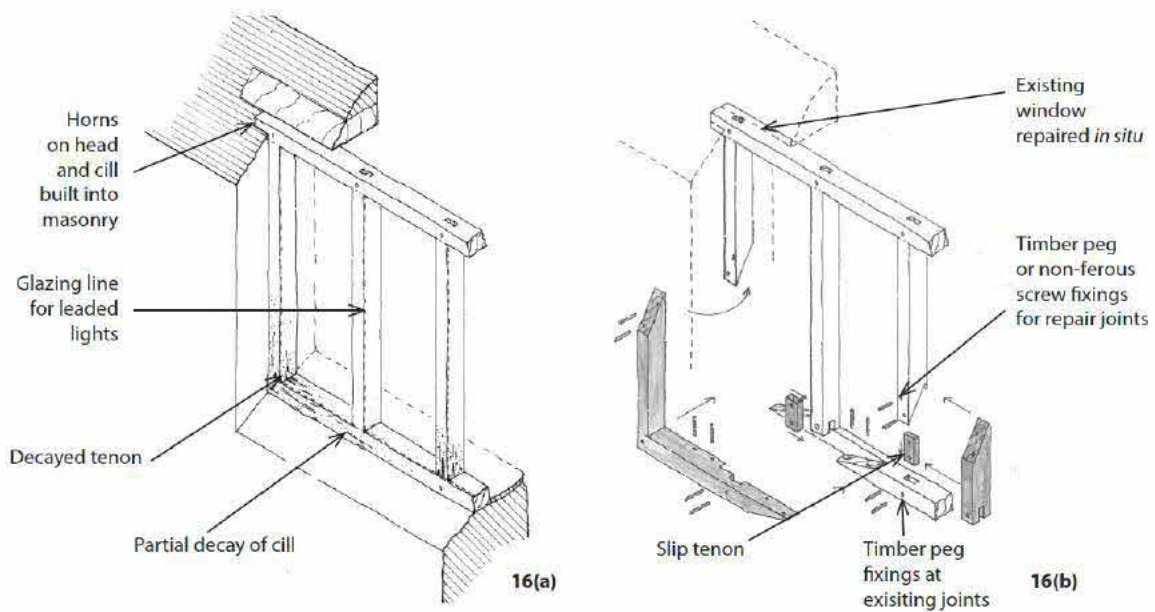
**Figure 16:** Mullion window: (a) Decay. (b) General repairs.

Mullion/ Casement window – general repairs

See figure 16.

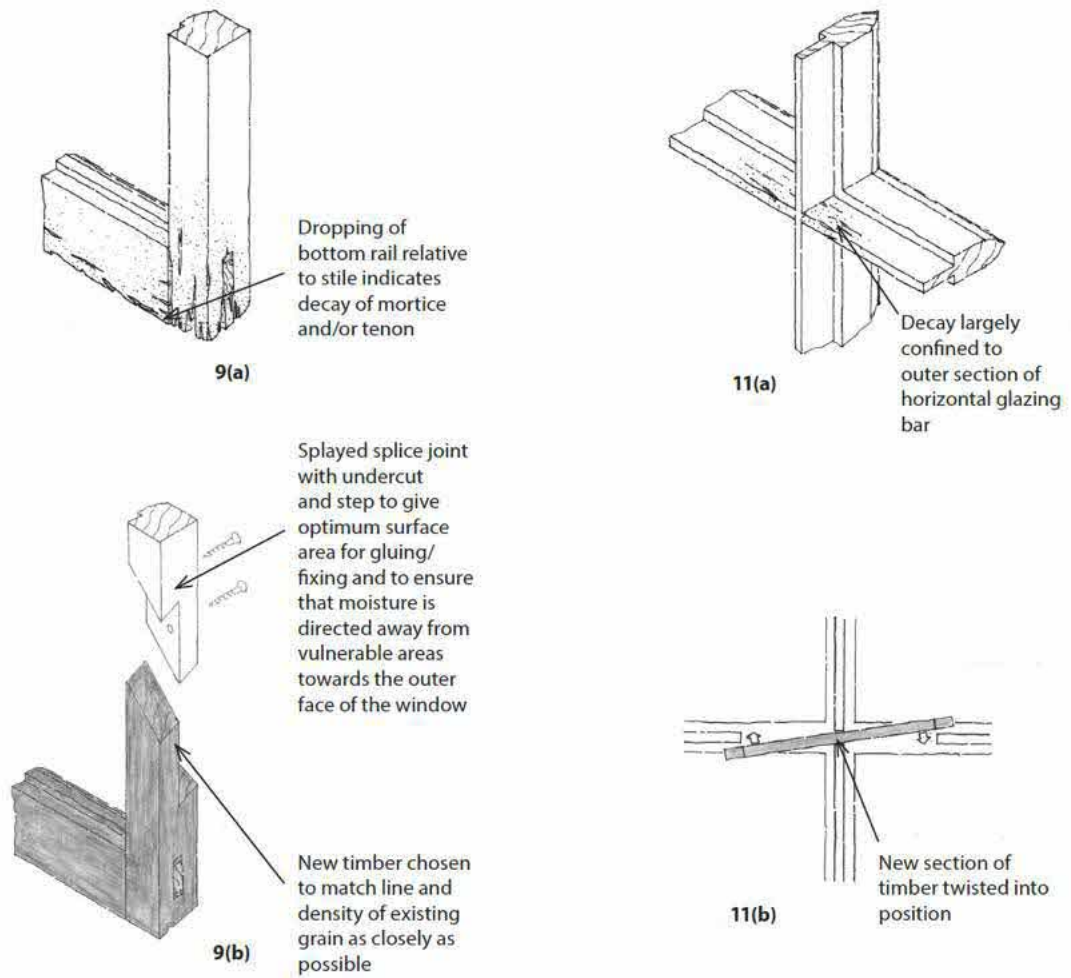
**Figure 9:** Bottom rail/base of sash stile: (a) Decay. (b) Repair. Illustrations: SPAB

#### Bottom rails

The method of repair illustrated in SPAB Guidance allows for the work to be carried out without dismantling the windows. The same procedure for removal and replacement may be used where total renewal of the bottom rail is necessary, although removing the existing decayed rail is easier if a series of vertical cuts are made through the rail before removal.

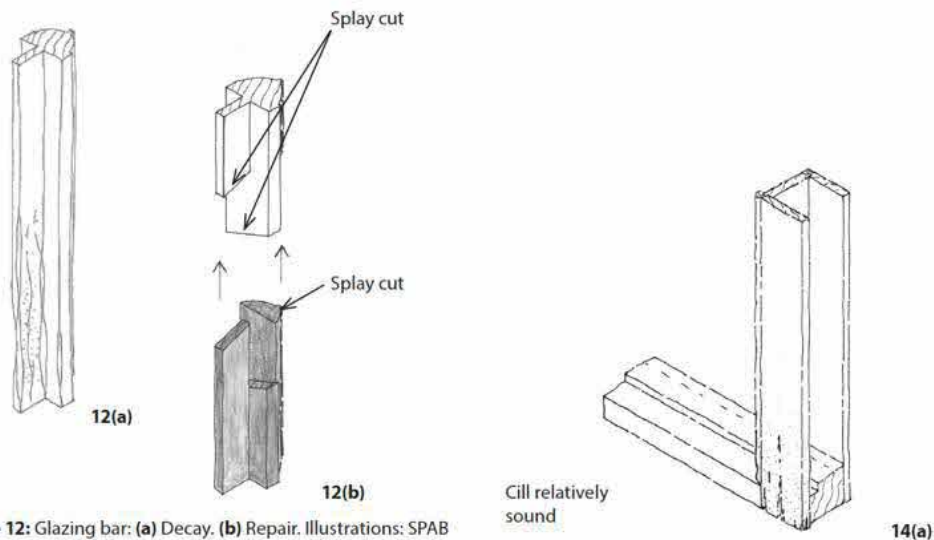
Figure 12: Glazing bar: (a) Decay. (b) Repair. Illustrations: SPAB

Glazing bar

See figure 12.

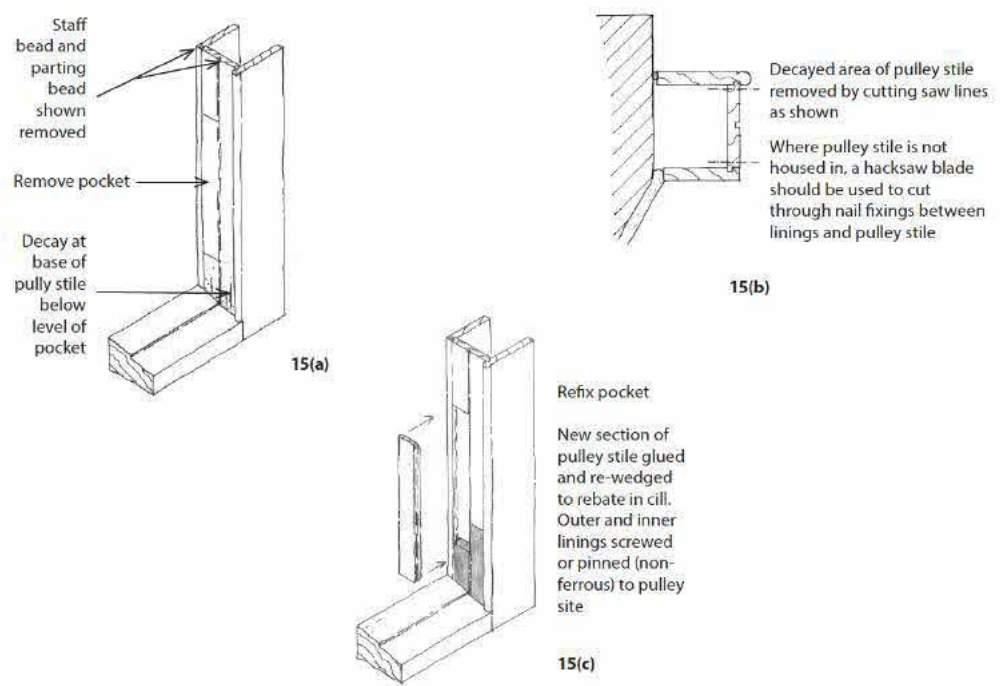
**Figure 15:** Base of pulley stile: (a) Dismantling. (b) Cutting back shown on plan of sash box. (c) Repair.

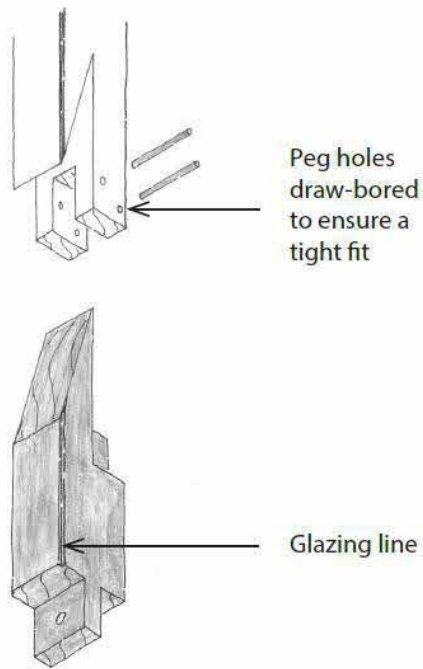
**Figure 17:** Mullion window – alternative repair to base of jamb or mullion  
Illustrations: SPAB

Mullion/ Casement Window – alternative repair to base of jamb or mullion

The type of repair shown in figure 17 is appropriate where the window is performing a load-bearing role and a simple splice repair may not be strong enough. It also ensures that more of

the internal face (including mouldings) of the existing mullion is retained than would be the case if the splice illustrated in figure 16 were to be employed.

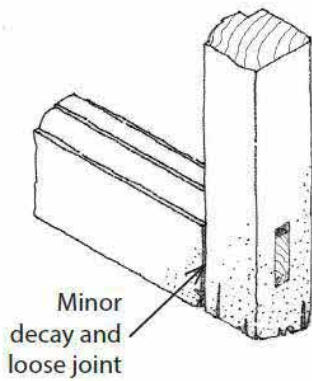
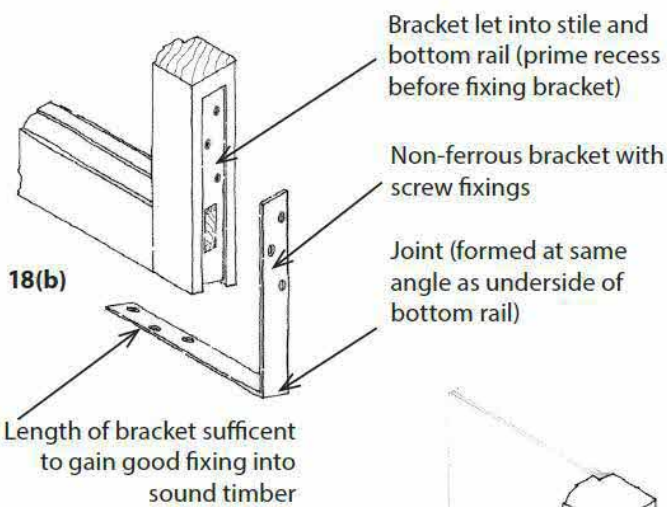
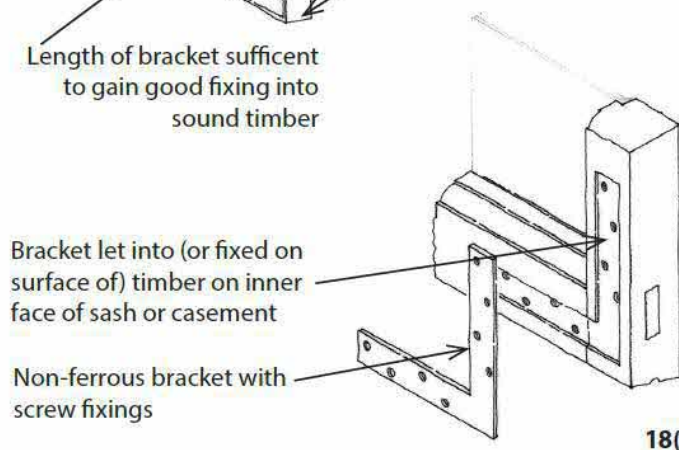
Where opening of joints is combined with minor decay such that regluing alone will be inadequate, reinforcement of the timber at the joint can be achieved with a non-ferrous bracket (see figure 18).
