SCHEDULE OF WORKS – GREEN FARM HOUSE

January 29th 2024

This document sets out the repairs in progress to the west elevation undertaken during January 2024.

A. West elevation - front door to right hand corner

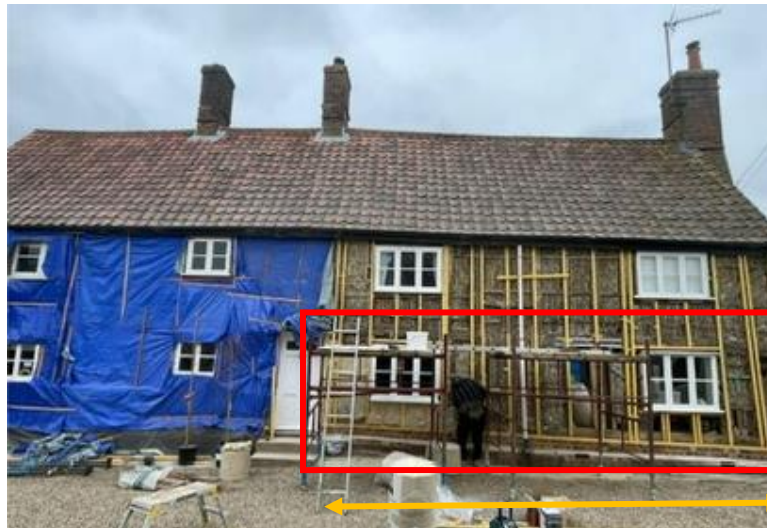
Image 2, West elevation, front door to right hand corner (marked by yellow arrow)

Sole plate was found to be completely rotten and beyond repair.

We have completely replaced this run with an 8" oak beam cut into existing struts.

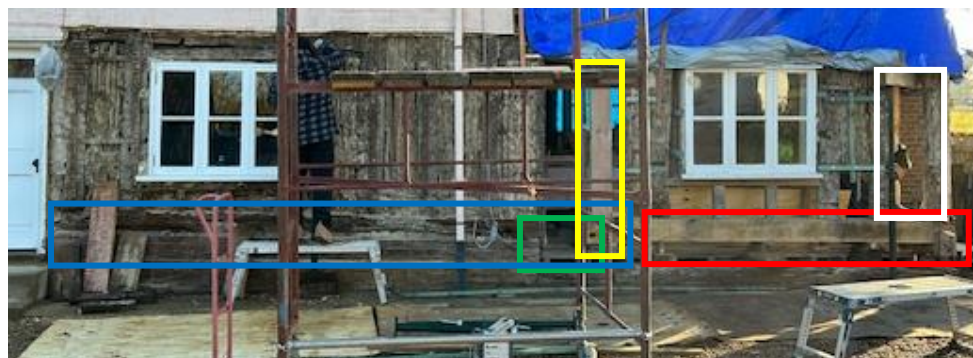
Image 3 showing works to RHS of west elevation. (close up of red box in Image 2)

Red box shows first section of new sole plate introduced.

Green box: we found evidence of an old doorway cut into the elevation post-original construction (there was a gap in the sole plate). This gap has been filled by the replacement sole plate.

In good condition except for one missing upright (**yellow** box in Image 3), where a doorway had been created at a previous point unknown. An oak beam has been introduced (marrying up with the existing frame at first floor where the location of the removed beam was evident).

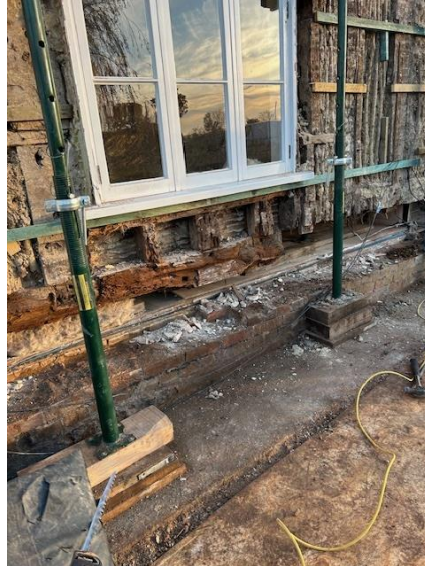
Image 4 - showing extent of rot to left of this section of sole plate (close up of area inside the **blue** box in Image 3)

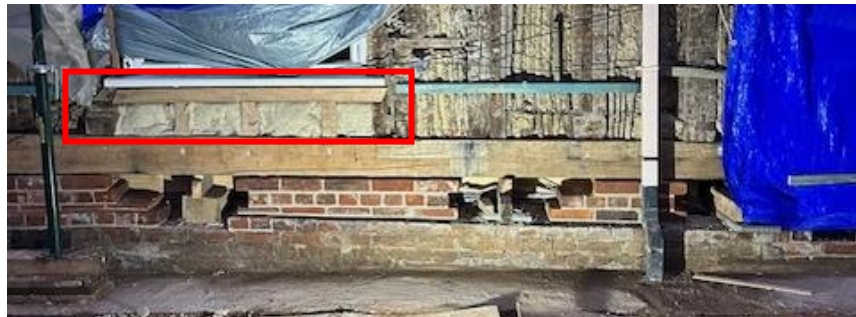
Image 5 - new sole plate to right of front door, extending full length across discovered gap (**blue** box in image 3, also showing plinth rebuild in progress)

<p>Existing infill status on removal of cement render & works undertaken.</p>	<p>Original wattle and daub infill largely intact notwithstanding voids found around windows which have been filled with sheepswool - Image 5, Red box is an example of such voids, now filled with sheepswool.</p> <p>Images 6, 7 wattle section to RH corner of west elevation</p> <div style="display: flex; justify-content: space-around;">

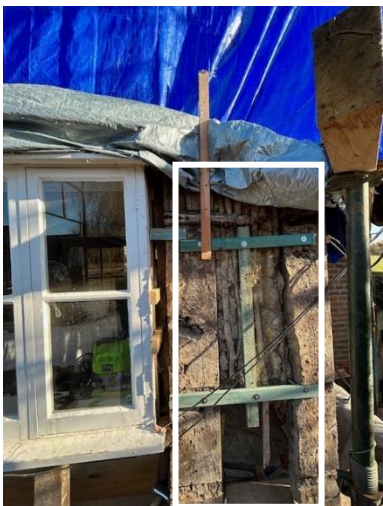
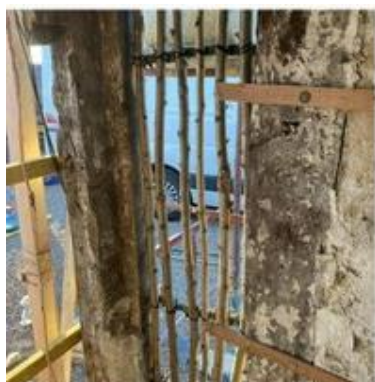
</div> <p>White box: wattle and daub panel fell out when render was removed (position marked in Image 3 with a white box) : this has been reinstated with wattle, daub will be added when weather permits.</p>
--	--

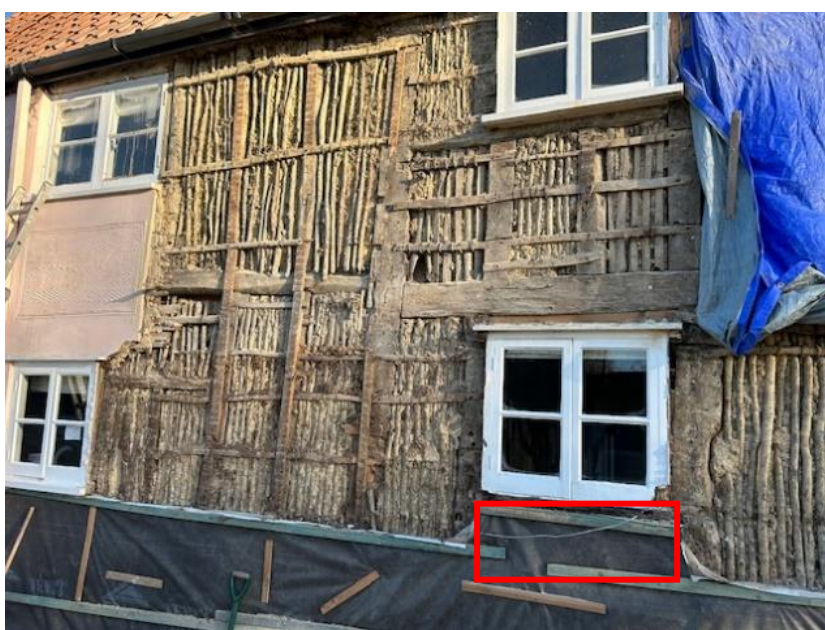
B. West elevation, left hand end to front door	
<p>Sole plate</p>	<p>As seen on site visit, sole plate is rotten, complete replacement with oak is in progress along this length.</p>
<p>Existing frame status on removal of cement render</p>	<p>Image 8, mid section of west elevation.</p> <div style="display: flex; align-items: center;">

Frame is in sound condition, no repairs necessary.

Infill in good condition, notwithstanding gaps found around windows/doors (red boxes in Image 8 & 9), which will be filled with sheepswool, and a section under the kitchen window (blue box) where non-original rubble infill has fallen out following cement removal.

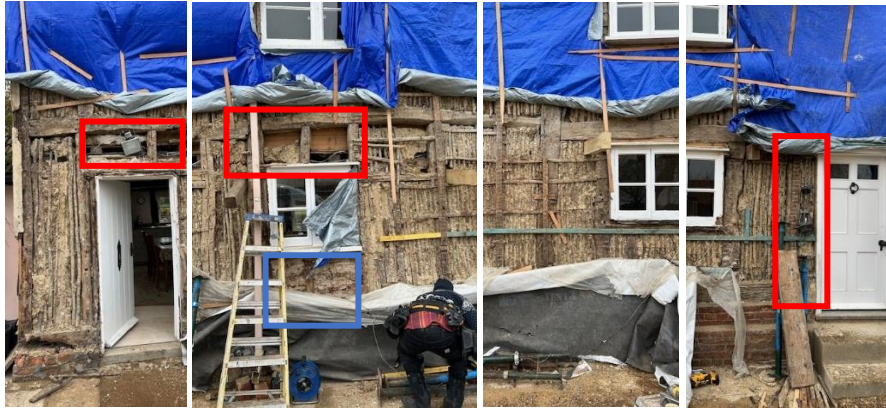
Image 9, composite photograph showing left hand end of west elevation stripped of cement (ground floor).
