Demolition / Refurbishment Asbestos Survey Report

Former Bingo Hall

The Palace Cinema

13th January 2016

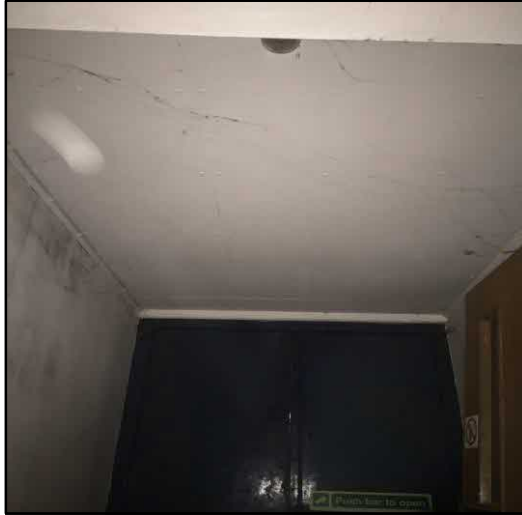
Sample Ref: B01 Location: Fire Escape RHS Ceiling

- B01 – Fire Escape RHS Ceiling – Cement – Chrysotile (White) Asbestos.

Material Sampled: Cement

Analysis Result: **Chrysotile (white) Asbestos**
Approximate Quantity: 4 m²
Product Type: **Asbestos Re-inforced Composites**
Condition: **Good Condition**
Surface Treatment: **Cement / Sealed AIB / Enclosed Lagging**

Material Assessment Score: **3**

Remarks / Recommendations: **REMOVE**
Removal prior to demolition works.

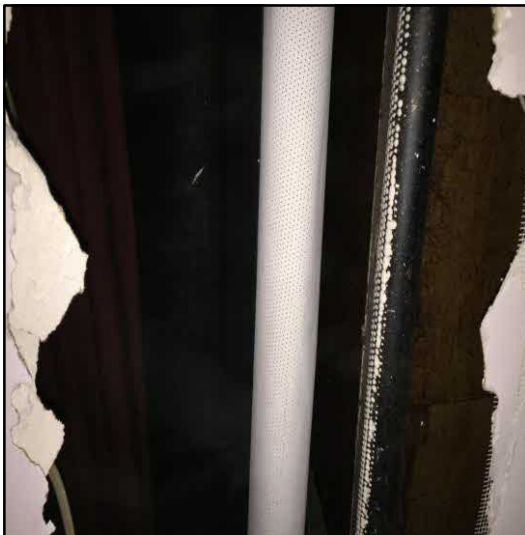
Sample Ref: B02 Location: Stage Area

Material Sampled: Stage Curtain

Analysis Result: **No Asbestos Detected**
Approximate Quantity:
Product Type:
Condition:
Surface Treatment:

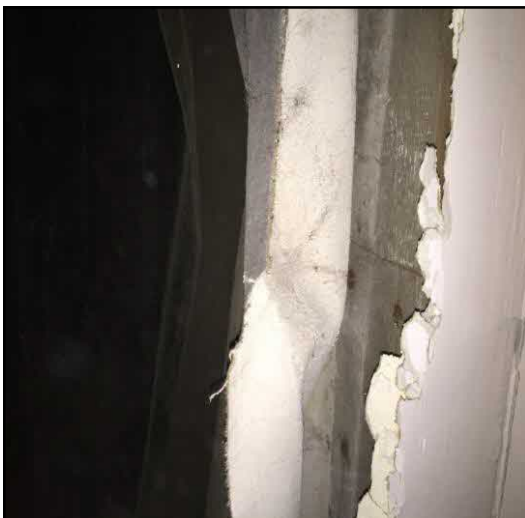
Sample Ref: B03 Location: Stage Area

Material Sampled: Stage Curtain

Analysis Result: **No Asbestos Detected**
Approximate Quantity:
Product Type:
Condition:
Surface Treatment:

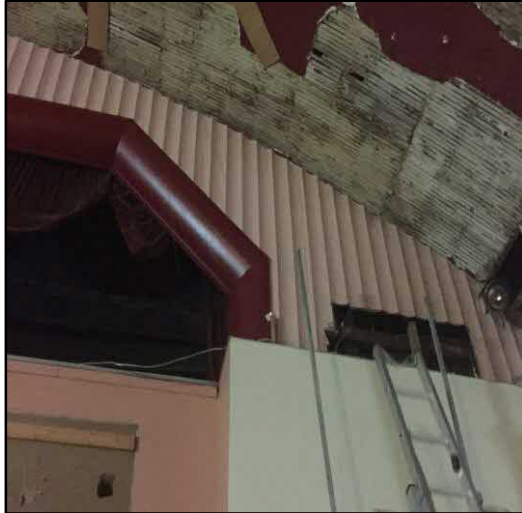
Sample Ref: B04

Material Sampled: Decorative Plaster

Analysis Result: **No Asbestos Detected**
