ARBORICULTURAL ASSESSMENT REPORT

Henham Village Hall, High Street, Bishop's Stortford CM22 6AR

PRI Ref: 264862

Survey Date: 30/06/2023

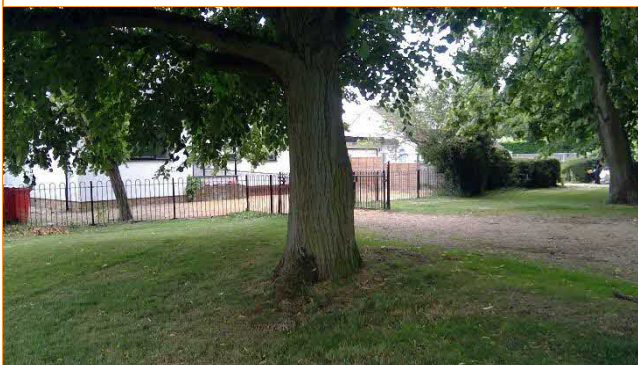
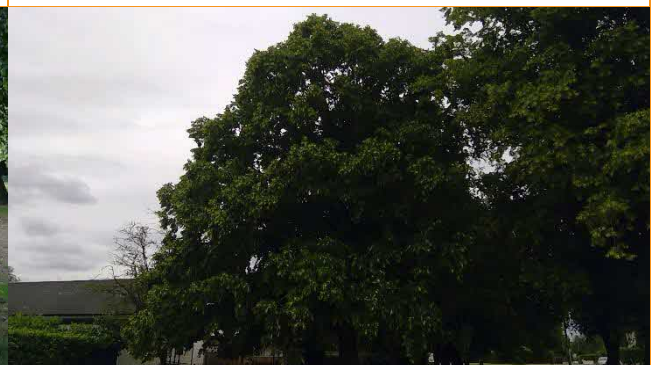
T3 - Lime

Chelmsford Council has confirmed that the implicated T3 Lime vegetation is subject to a Tree Preservation Order

Tree No:	Species	Works Required	CA	TPO	Ownership
T1	Hawthorn	Fell and treat stump with eco plugs (broadleaved).	Yes	No	PH
T3	Lime	Fell and treat stump with eco plugs (broadleaved).	Yes	Yes	PH
