Structural Report on Boundary Retaining Wall

25, Rochester Drive, Burnley

Job No: 23172

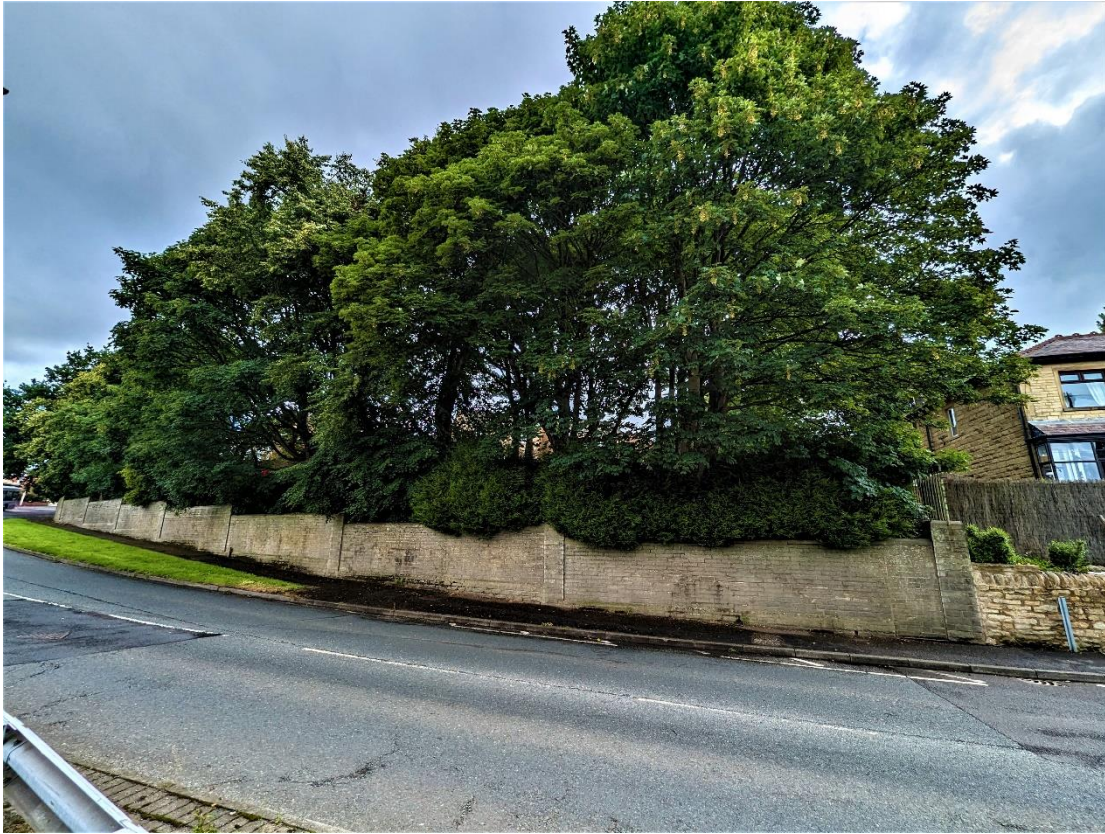
2.2 The wall fronts on to the back of the footpath on the southbound lane of Marsden Road. Photograph 01 gives a general view of the retaining wall and the trees growing immediately behind the top of the wall.

Photograph 01 – General view of the front face of the retaining wall.

4.1 We would recommend that the tall mature trees at the back of the wall are immediately removed. We understand that one or more of the trees may be subject to TPO's. However, under the circumstances the trees are putting the public at risk from the collapse of the retaining wall and this safety aspect will surely override the TPO if affected.

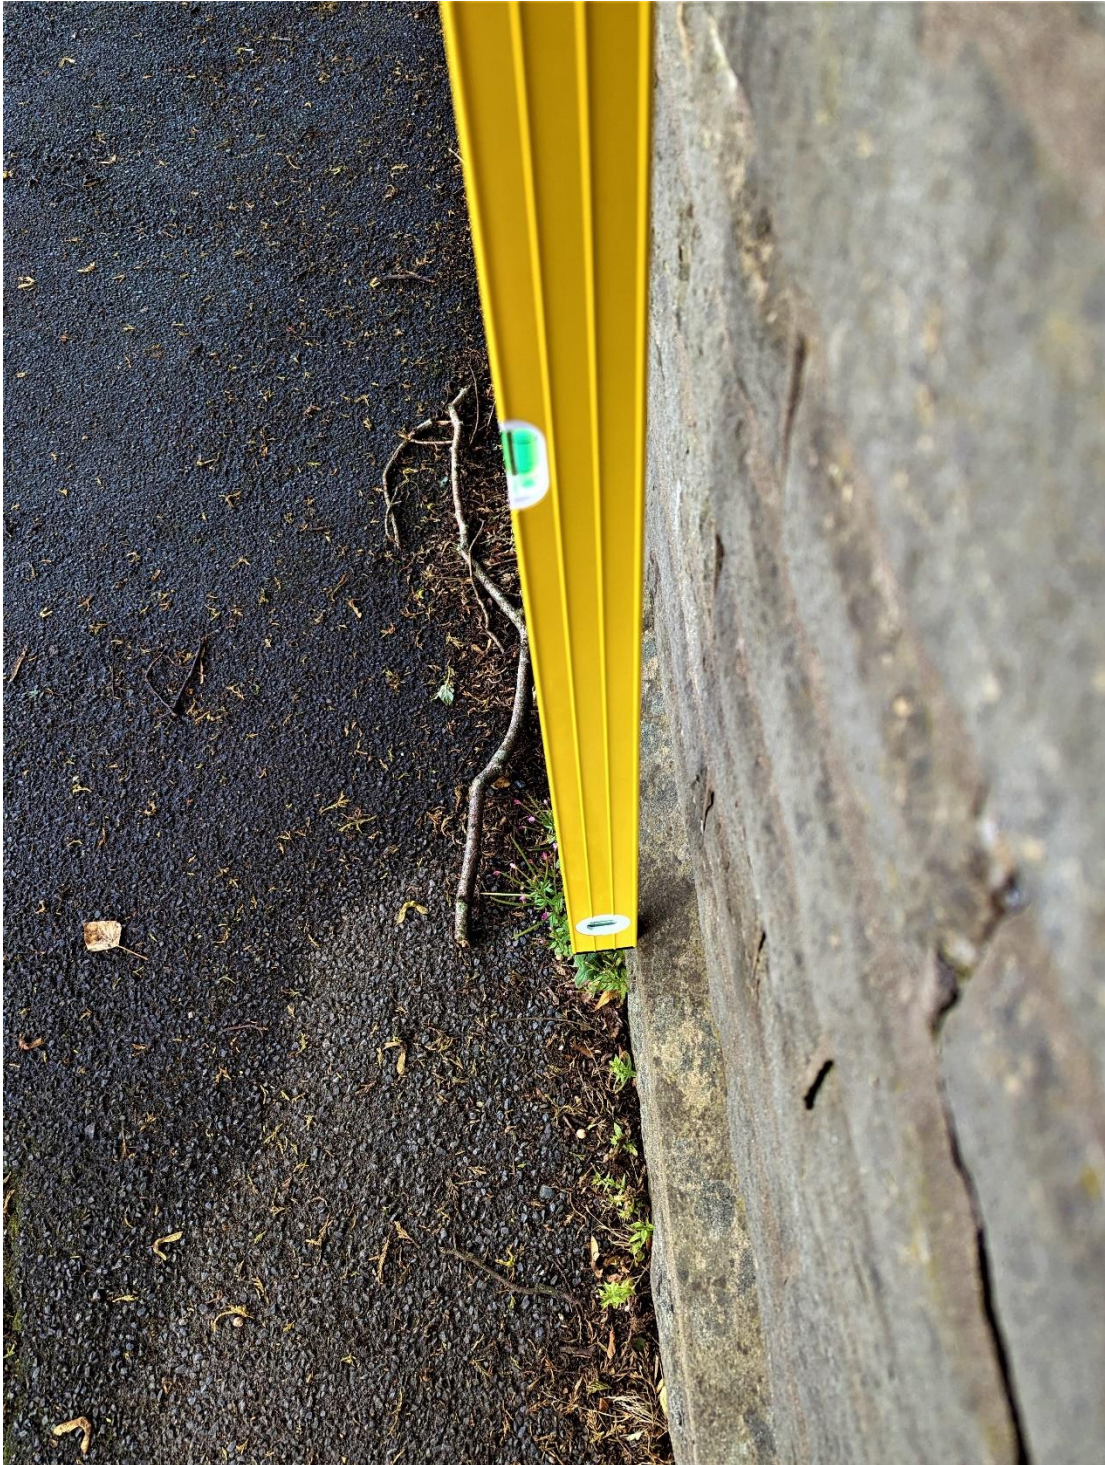
2.3 The retaining wall was checked for verticality using a 1.2m spirit level and found to be leaning outward at the top of the wall as indicated in photograph 02.

Photograph 02 – Showing the horizontal movement over the height of the retaining wall.

4.2 We would recommend that the garden levels adjacent to the back face of the retaining wall are reduced to allow the height of the front face of the retaining wall to be reduced by 50%. The garden may be tiered with new retaining structures being introduced remote from the back of the main retaining wall or gradually sloped to meet the top of the retaining wall at its new 50% reduced height.

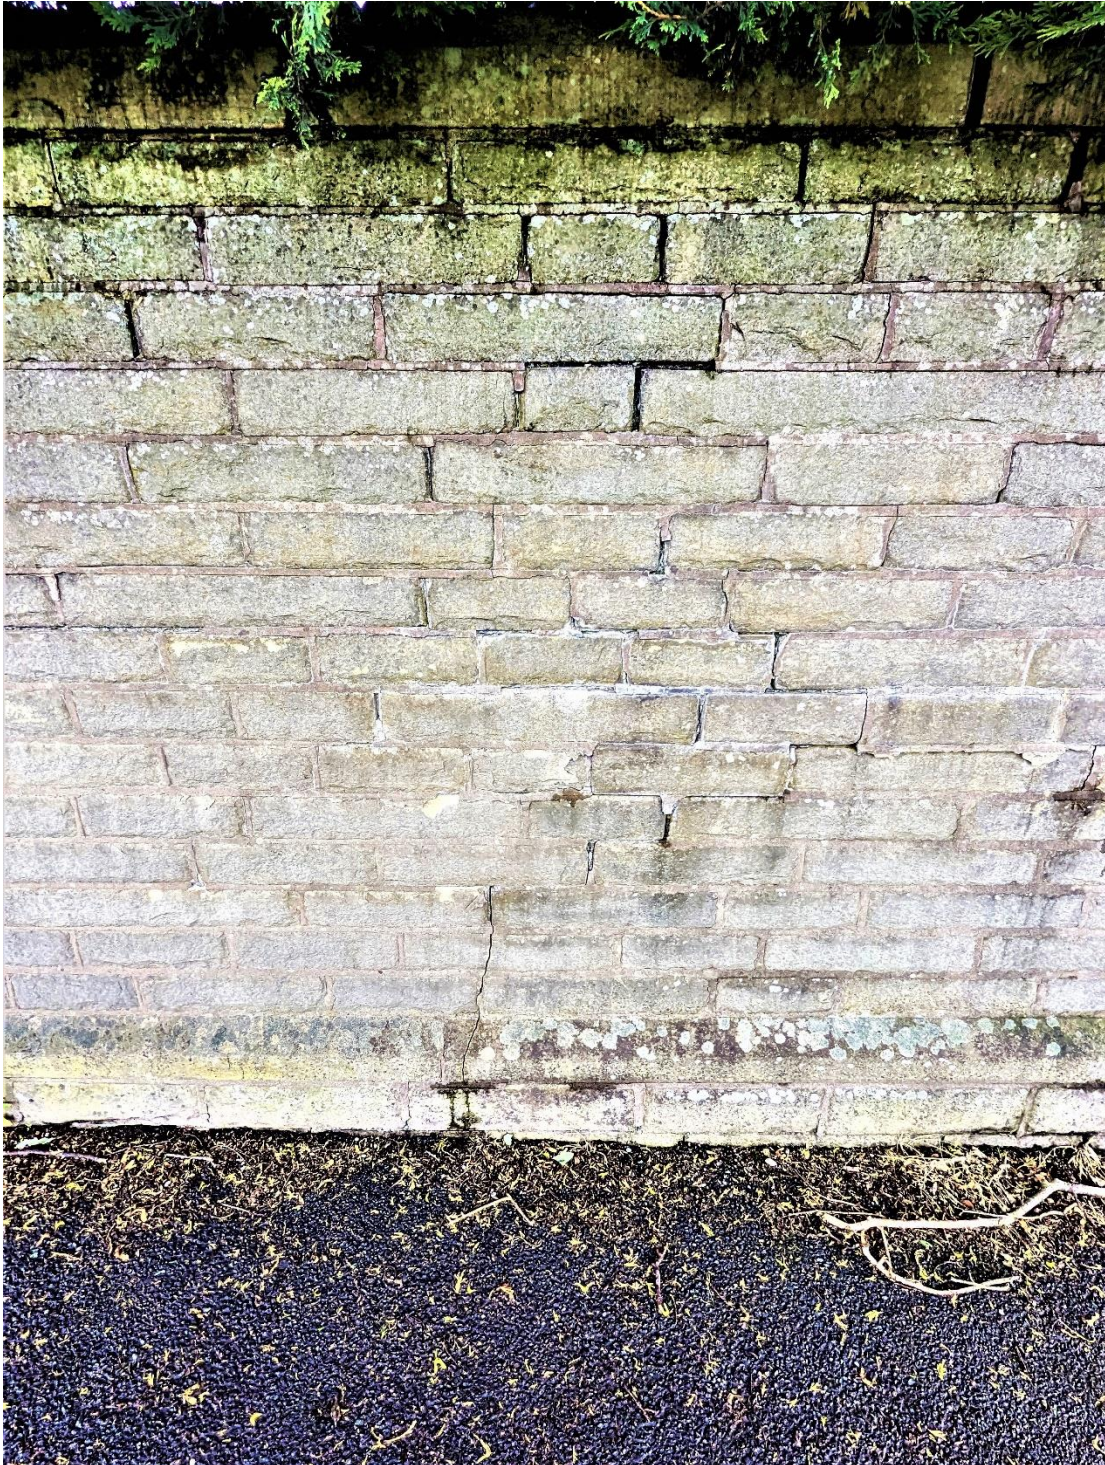
2.4 Photograph 03 shows a detailed elevation of that part of the wall most affected by the lateral movement. The vertical crack extends fully down from the coping stones to the surface of the footpath.

Photograph 03 – Showing a detail elevation of the area most affected by the lateral movement in the retaining wall.

4.3 Following the reduction in the height of the main retaining wall we would recommend that the cracks are repaired using crack stitching techniques in conjunction with the installation of 'Helibar' bed joint reinforcement along the full length of the wall panel between the masonry piers.

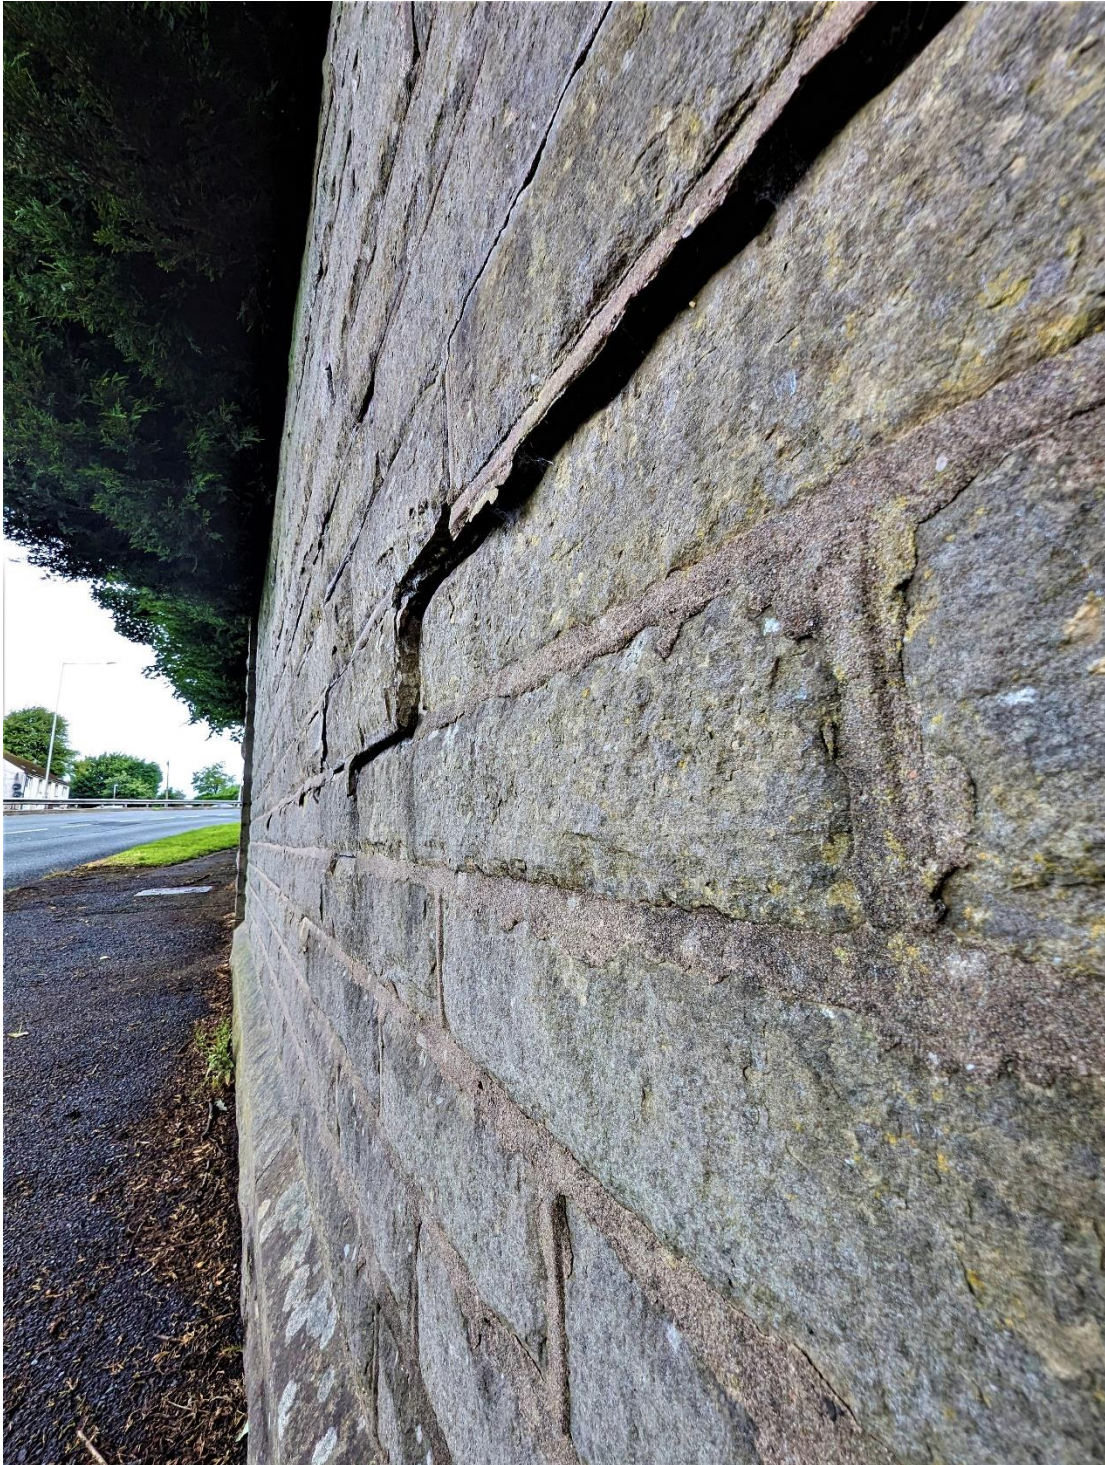
2.5 Photograph 04 shows a close-up view of the degree of the differential horizontal movement between the upper half of the wall and the lower half.

Photograph 04 – Showing the extent of the differential lateral movement of the upper half of the retaining wall.

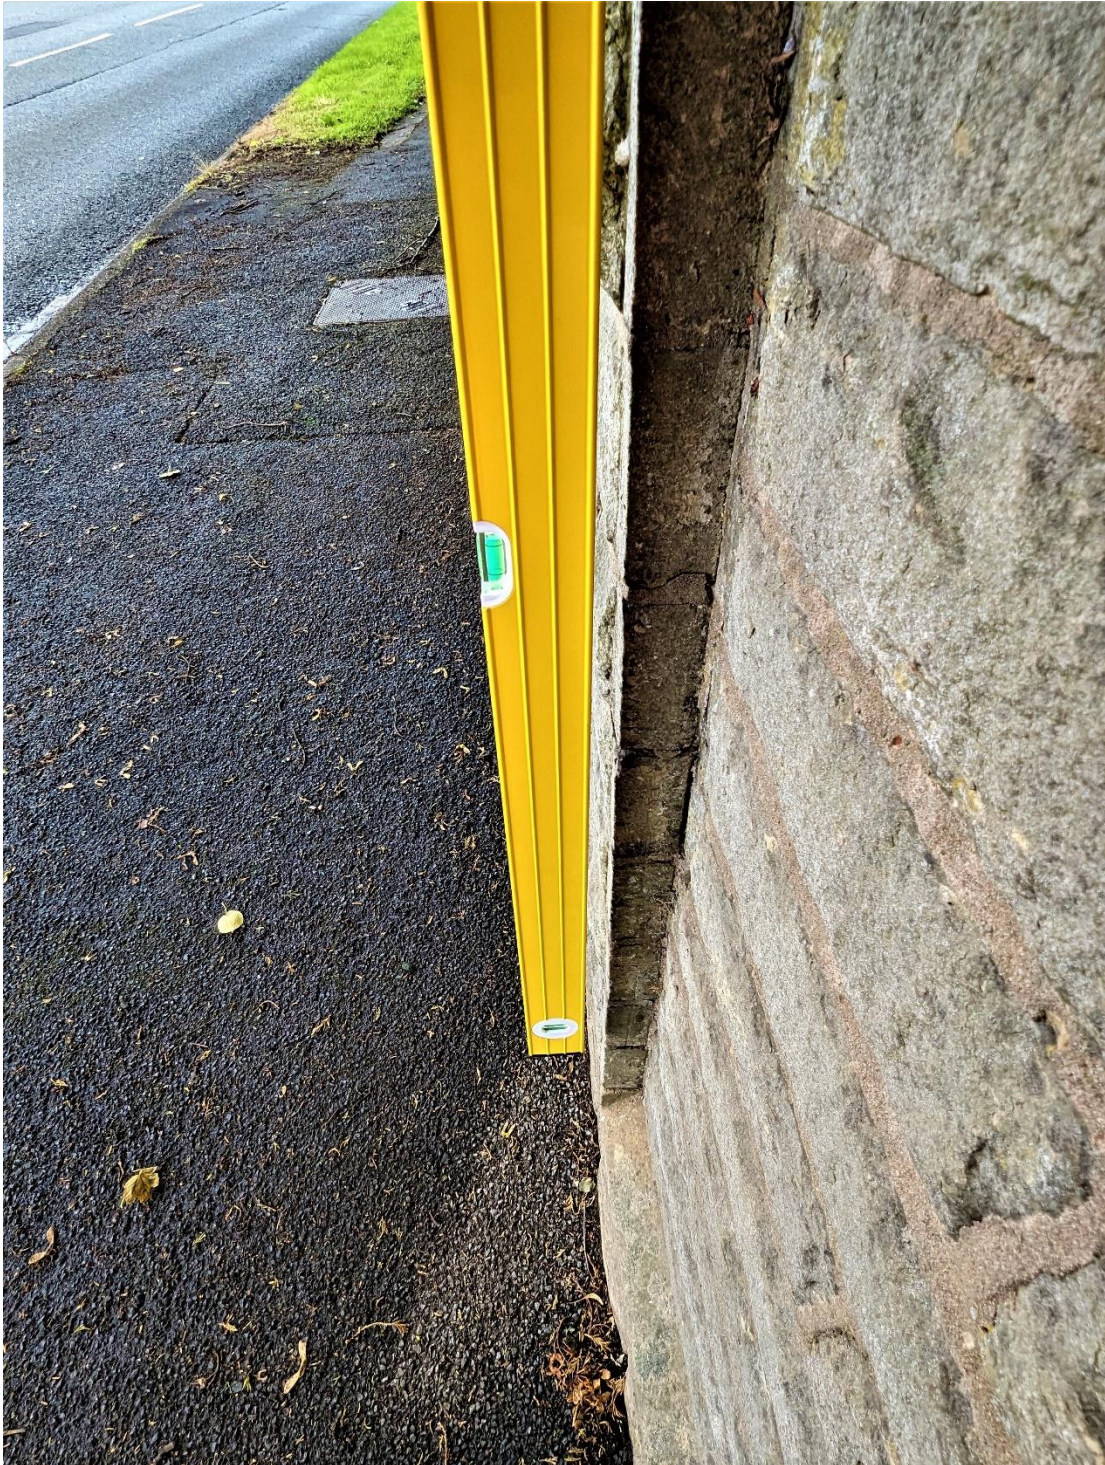
2.6 Photograph 05 shows a detail of one of the masonry piers which can be seen to be leaning outward almost as much as the wall panel between the piers.

Photograph 05 – Showing the lateral movement at the top of the masonry piers.
