Building Survey Report (Pre-Acquisition)

Hinton Hall

October 2016

Building Survey Report (Pre-Acquisition) Hinton Hall, Hinton, Whitchurch SY13 4HB

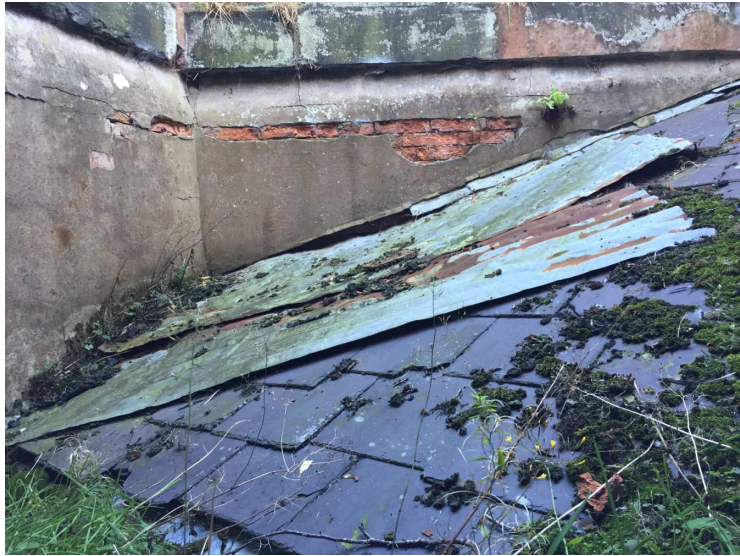
9.JPG

- Not surprisingly, traditional mortar fillets provide weatherproofing to the roof against abutments, chimney stacks and awkward detailing. These have failed over the years and significant water penetration has taken place in these vulnerable locations as illustrated on photo's 6, 7, 8 and 9.

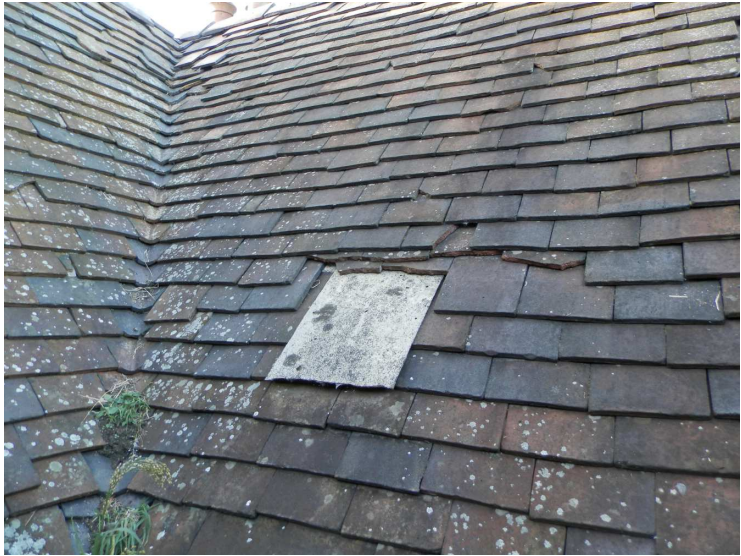
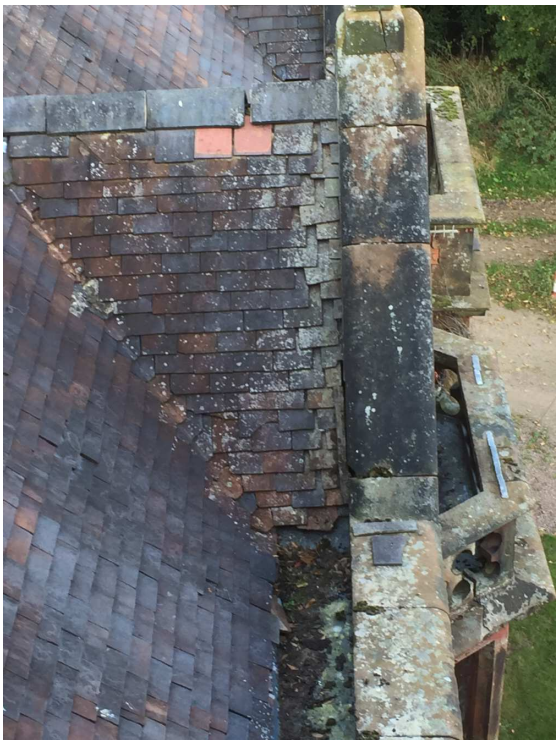
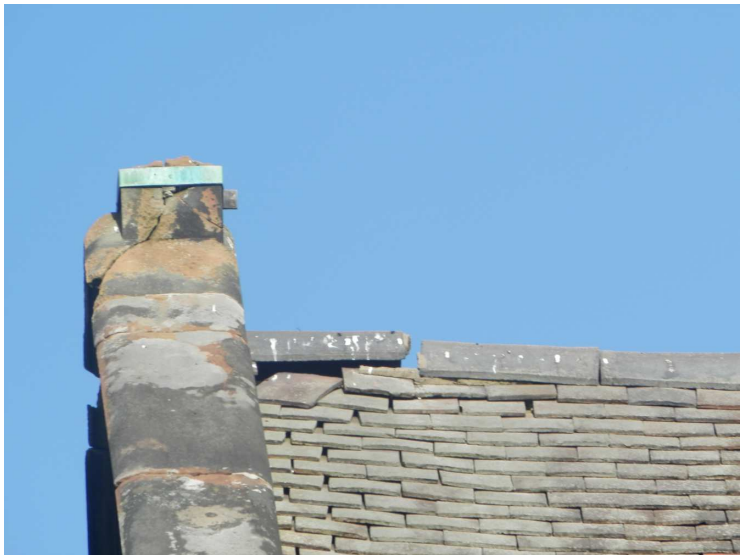
- The plain clay tiles are traditionally held in place with tile battens, nails and a torching material comprising mortar with horse hair for reinforcement. The torching is now either missing or very soft and thus not having the desired effect. Consequently the tiles have blown off, become damaged, slipped and crudely repaired over the years. Similarly, the ridge tiles, which are not all, deemed to be originally, have been subject to mortar erosion and all of this contributes significantly to moisture ingress. This is illustrated on photo's 10, 11 and 12.

Based on the above findings we would advocate that the roofs are carefully stripped and recovered, the roof structure repaired in sections, a breathable underfelt is introduced together with thermal insulation under, new treated tile battens introduced and the roof is recovered utilising the existing plain clay tiles as far as practicable (allowing for breakages).

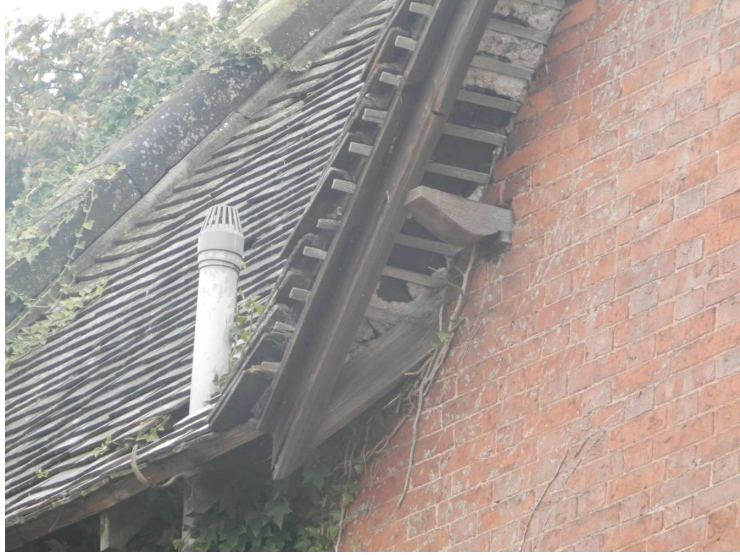
17.JPG

- On the North elevation of the East Wing, a parapet wall detail is not provided, which is not unusual as the front of period buildings tend to incorporate superior detailing compared to the rear. To this end the open eaves arrangement has deteriorated over

the years where the exposed timbers are suffering from the effects of wet rot as illustrated on photo's 16 and 17.

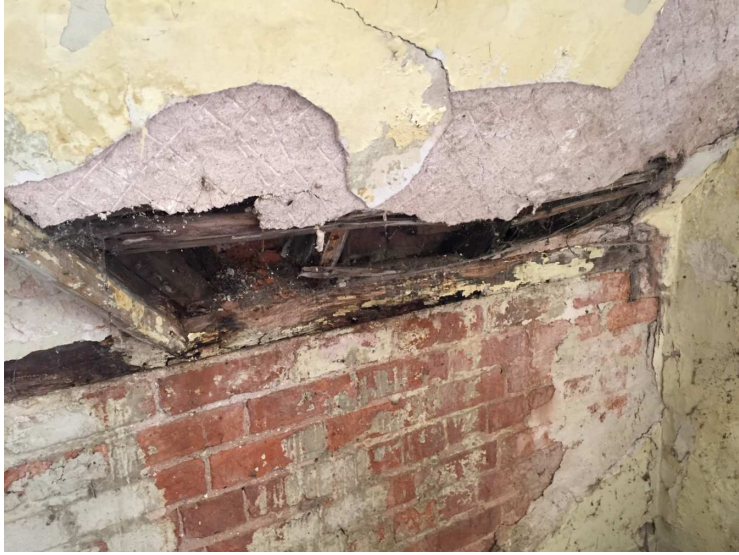
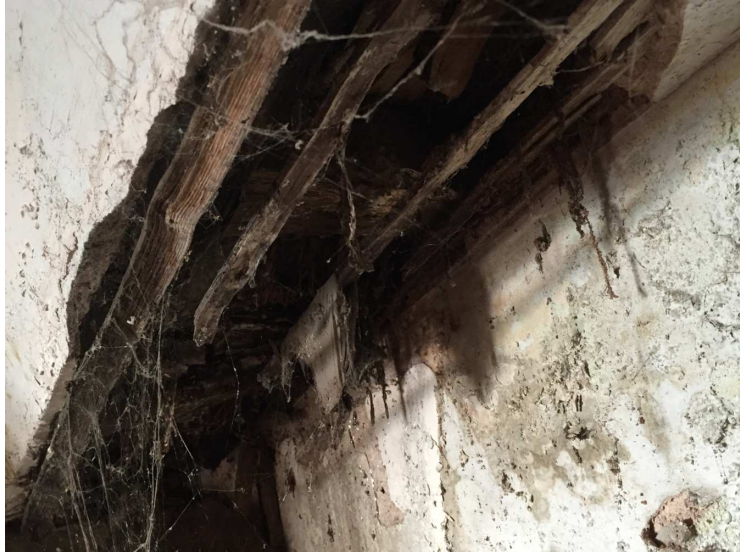
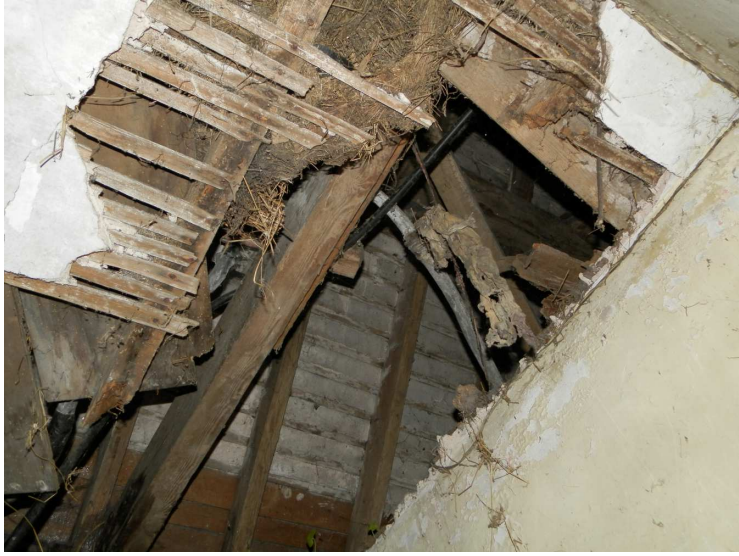
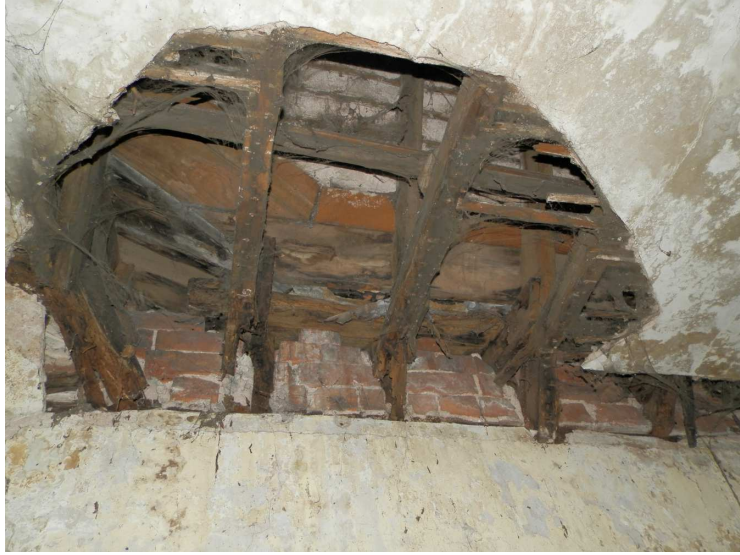
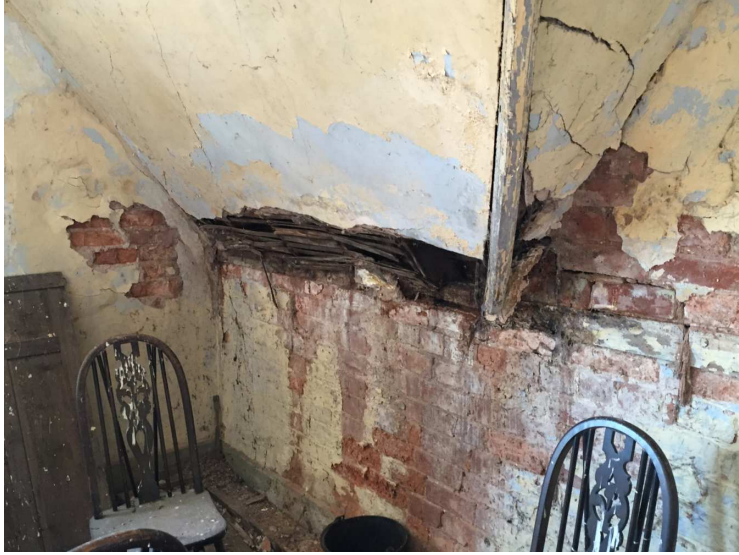
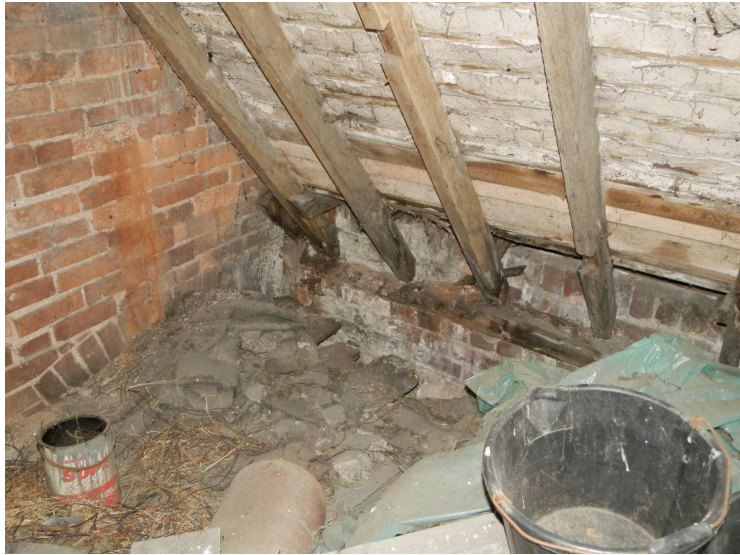
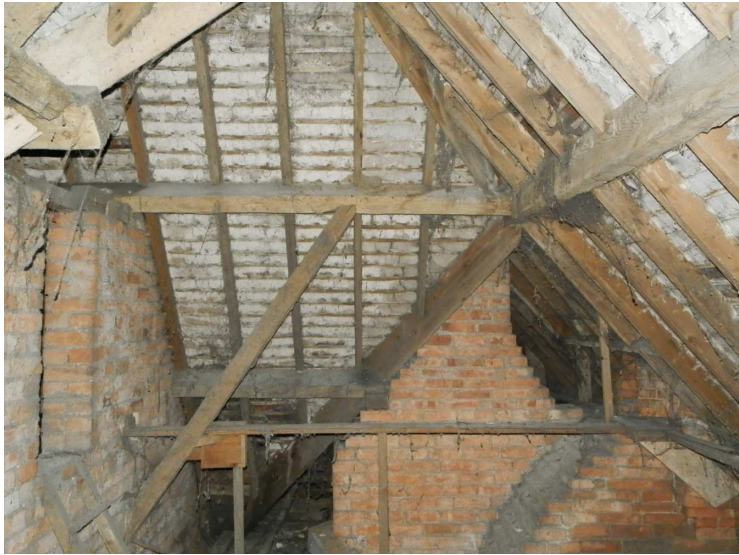
- All of the above factors have contributed to failure of the roof coverings and partial structure where we would estimate that about 30% of the roof timbers will require replacement. This is evidenced from our inspections of the upper floors not least where we could gain access into the roof space at the junction with the main building and East Wing. The timbers have deteriorated near eaves level where the rafter feet and ceiling joists have rotted away and do not actually take support from the walls any longer. Experienced tradesmen, conversant with large-scale conservation projects will need to be employed to remedy these defects satisfactorily under the guidance of a chartered building surveyor and or structural engineer. The following photographs are not exhaustive but clearly show where moisture ingress has had a profound effect to the roof structure and subsequent floors below. Photo's 18, 19, 20, 21, 22, 23, 24 and 25.

- Carefully cut out and replace the roof timbers suffering from dry and wet rot with new treated timbers together with architectural / structural bracing where exposed.

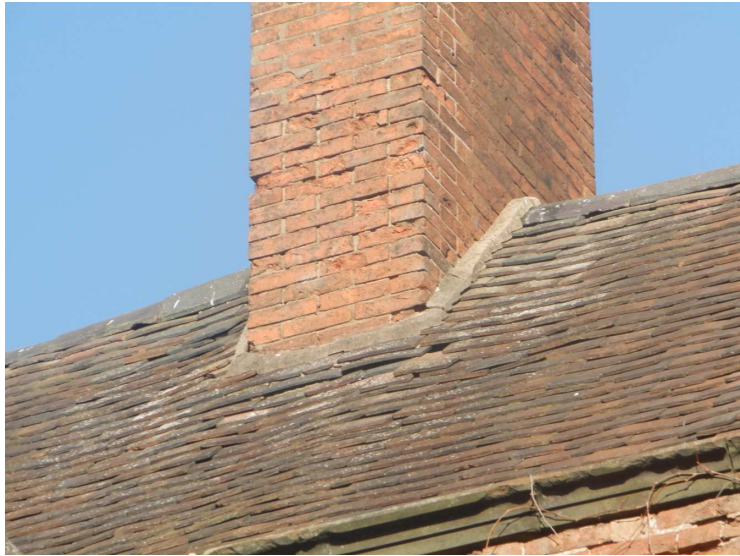
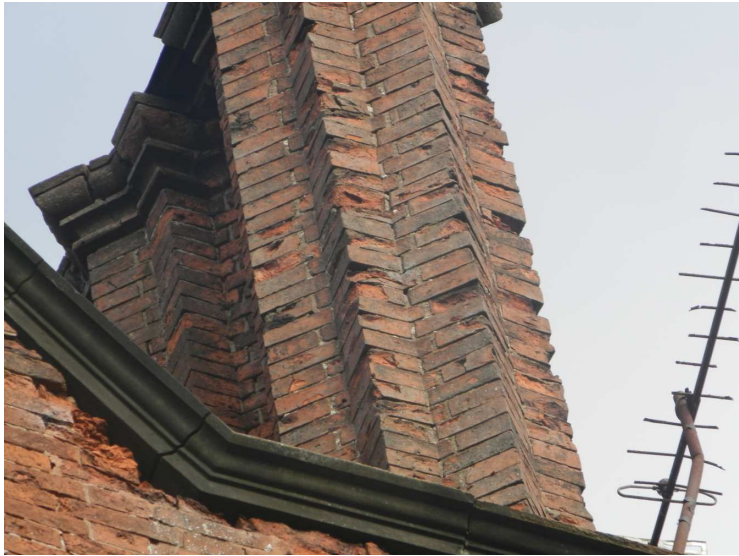
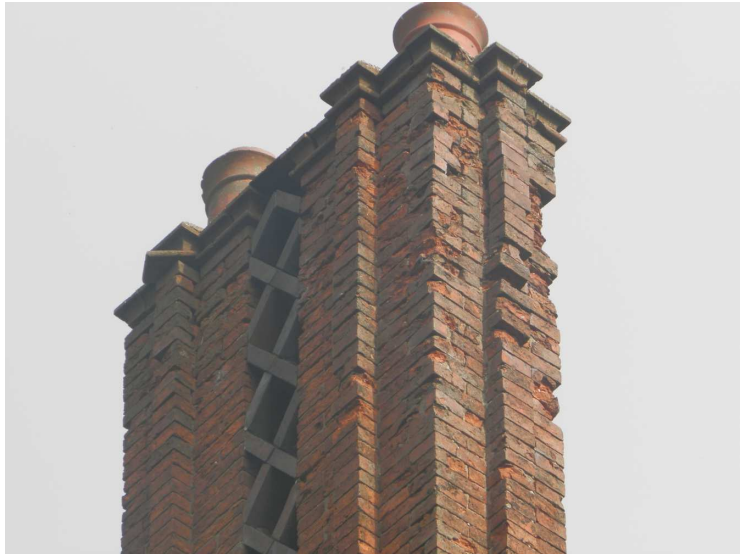
- At this juncture we would advise that Hinton Hall incorporates an abundance of substantial chimney stacks some of which are very ornamental which is a testament to the skills of the bricklayers at the time. Due to extreme exposure the chimney stacks are suffering from various degrees of decay and either need partly rebuilding or significant repair. The stack on the West elevation is of particular prominence due to the clay tiles incorporated in a herringbone pattern. A stack on the South elevation has in fact been taken down and rebuilt previously but does not replicate the ornamental stack of the other side of the bay window to the same elevation. A couple of stacks have been taken down to roof level and capped but the following photographs clearly show the severity of the essential repairs required. Photo's 26, 27, 28, 29, 30 and 31.

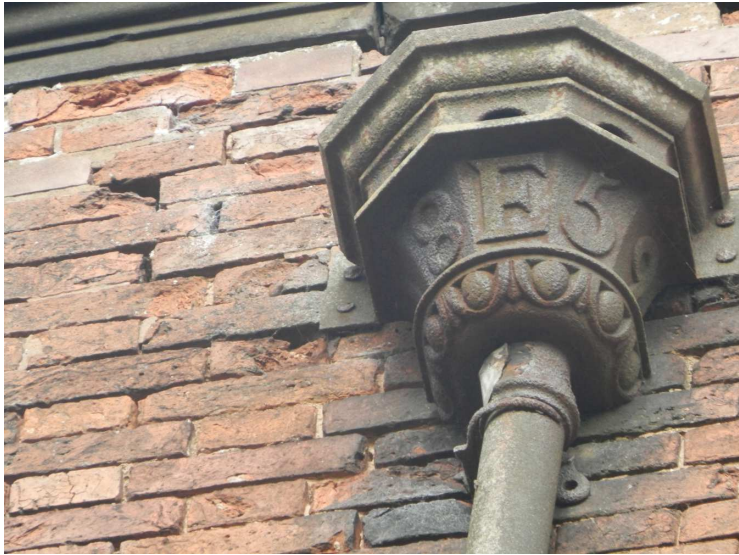
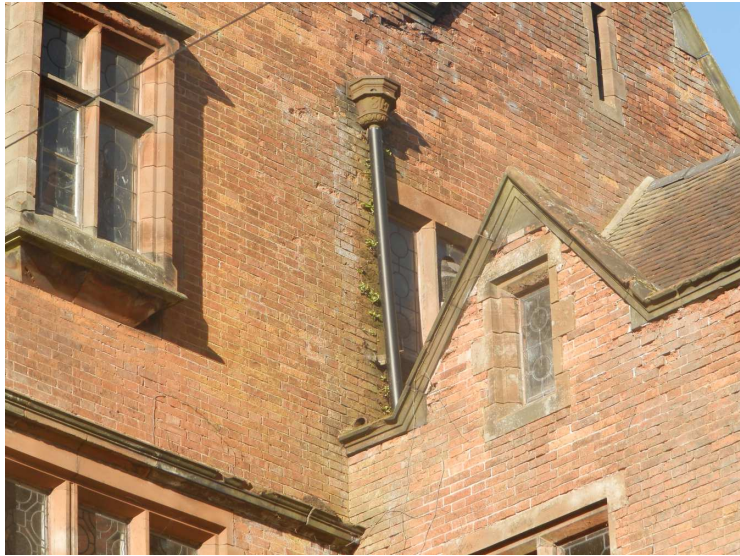
- Finally, the cast iron rain water goods associated with Hinton Hall are also in disrepair due to their age and these require totally replacing with new cast iron components where the existing hopper heads should be repaired and reused. Disappointingly, a number of plastic rainwater pipes, soil and vent pipes and waste pipes have been introduced over the years particularly on the North elevation, and these should be replaced for cast iron to maintain the character of the period. Refer to photo's 32, 33 and 34.

- Replace the flat roof structures to the bay windows with new decking, insulation and GRP coverings.
- Replace all of the rainwater goods with new cast iron components but repair and reinstate the hopper heads (date stamped 1856).

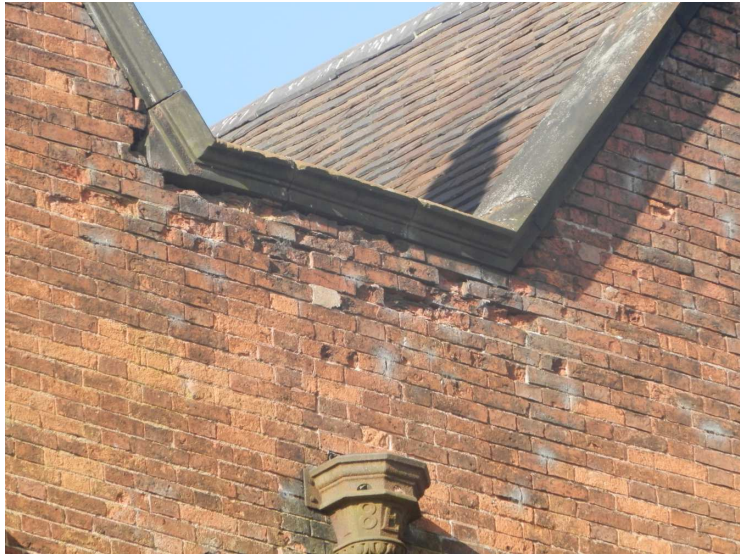
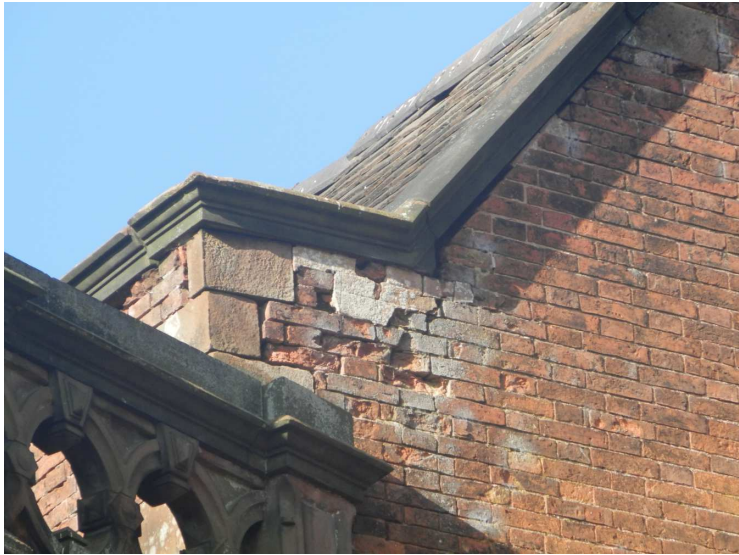
- Poor back gutters to the parapet walls and coping stones to the gables has caused the brickwork at eaves level to perish and thus generally the top 6 courses of brickwork requires taking down and replacing to the complete perimeter as shown of photo's 35, 36, 37, 38 and 39.

- Replace the spalled/perished brickwork to the parapet walls and other isolated locations including partially rebuilding the affected chimney stacks.
- Demolish the garage adjacent to the staircase of the East Wing and make good with materials to match existing.

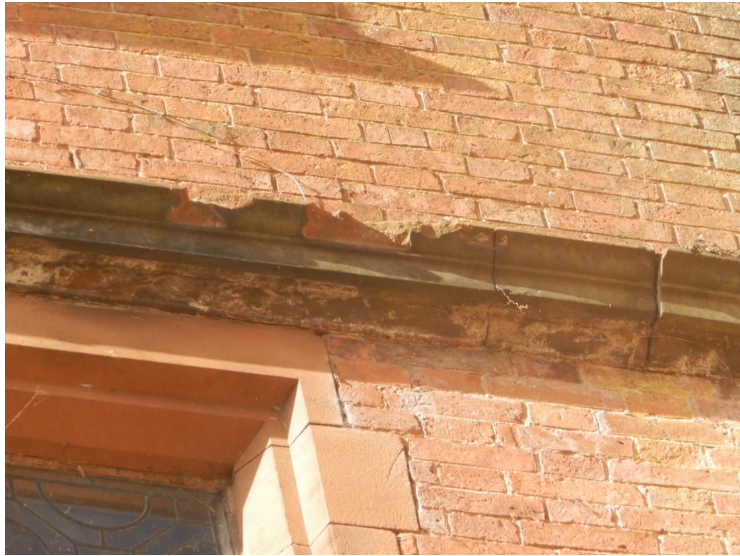
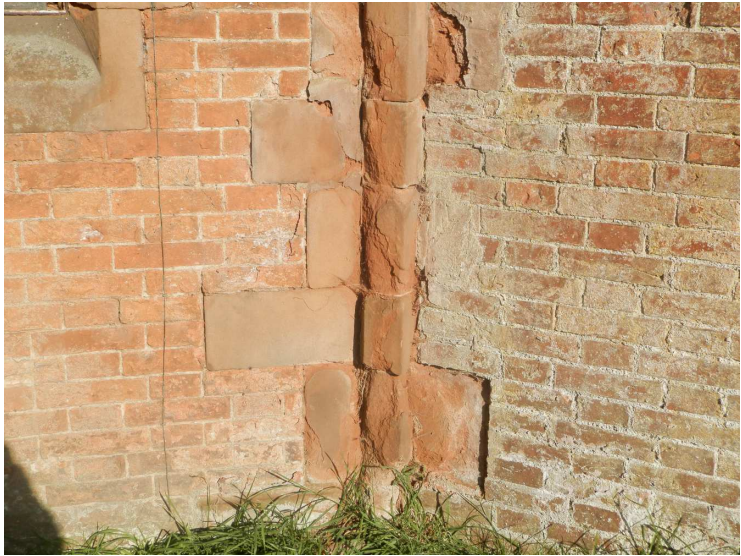
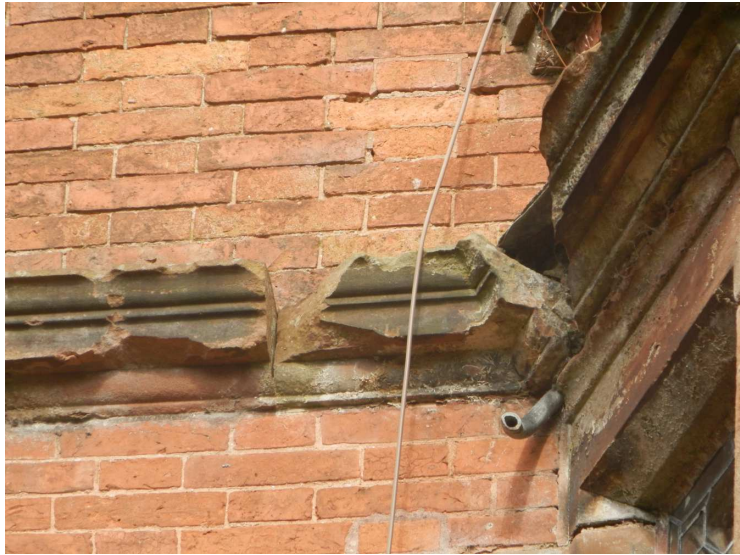
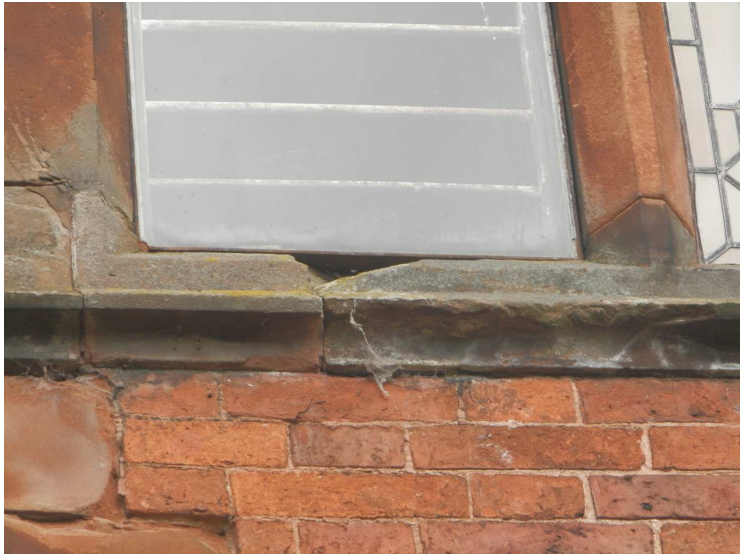
- Another concern of Hinton Hall is the vast amount of sandstone which has perished over the years partly by a natural process of delaminating where layers of sandstone simply breakdown and crumble away. This is particularly visible around the window frames and again to the corncing or banding between first and second floor levels. We are of the opinion that the Conservation Officer will allow reconstituted stone to be incorporated by way of repair but all of this will be very expensive to replicate. Refer to photo's 40, 41, 42, 43 and 44.

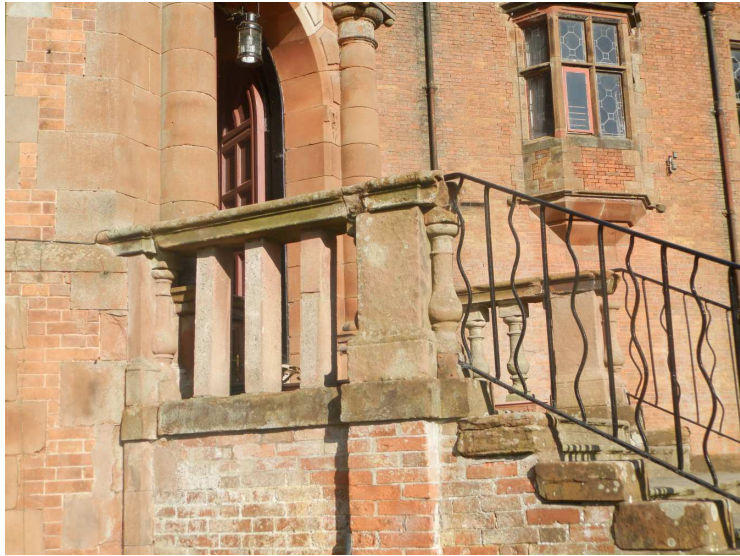
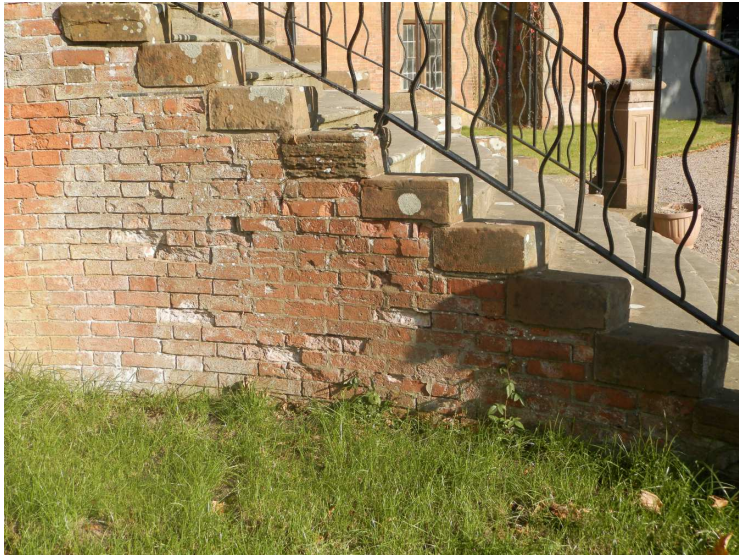
- At this juncture we would advise that the feature stonework to the main external staircase has previously been subject to a degree of vandalism where the spindles have now been replaced for wrought iron balustrading. Similarly, on the left hand side of the landing, replacement rather crude spindles now replace the original ornate spindles, but perhaps this offers some character. Photo's 45 and 46.

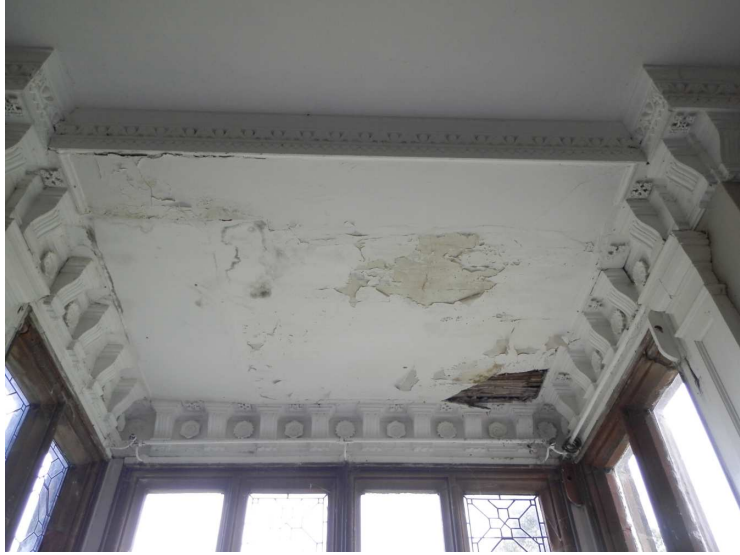
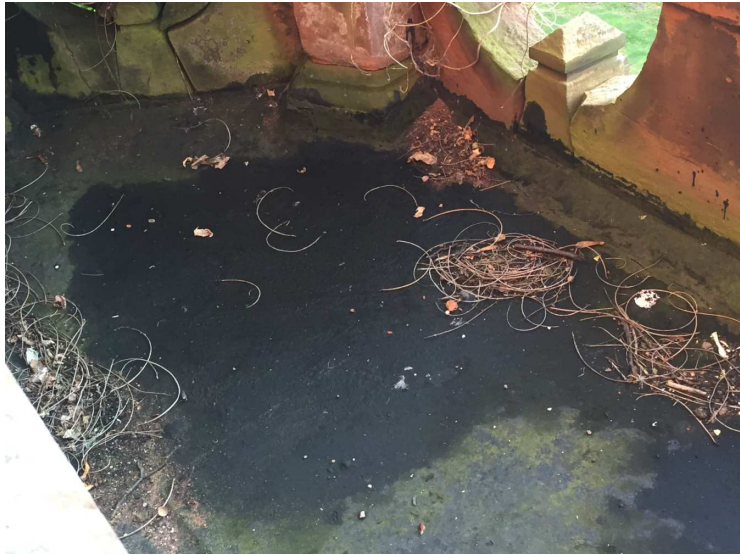
- Indeed the small flat roofs over the bay windows would have originally been finished with lead but over the years crude attempts of alternative weatherproofing have been adopted but without success. The joints to the leadwork, commonly known as rolls, have opened up allowing wind and rain to penetrate and this is very obvious particularly within the drawing room where the lath and plaster ceiling is about to collapse. The up-stand between the flat roofs and the stone balustrading is also totally inadequate. Photo's 53, 54 and 55.

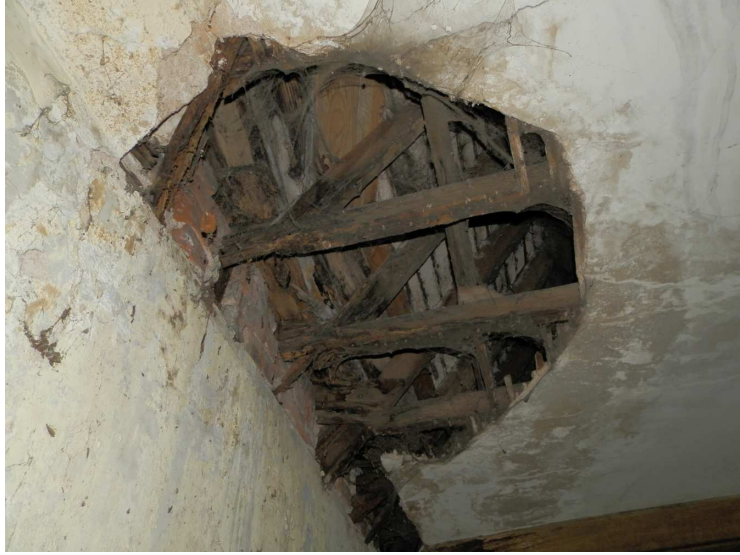
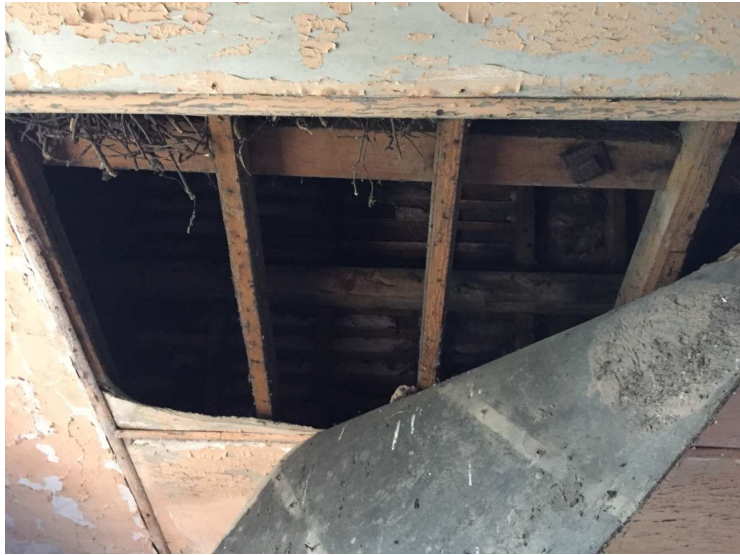
We have previously advised that severe damage has occurred at roof level and this emanates from the parapet walls which have caused the rafter feet to rot and thus they are no longer taking support from the masonry. However, as this has not been arrested, water damage has also caused the joists to the lower floors to rot and the lath and plaster ceilings in many rooms are at the point of collapse. This is illustrated in photos 56, 57, 58, 59, 60 and 61 where structural, yet sympathetic repairs are required.

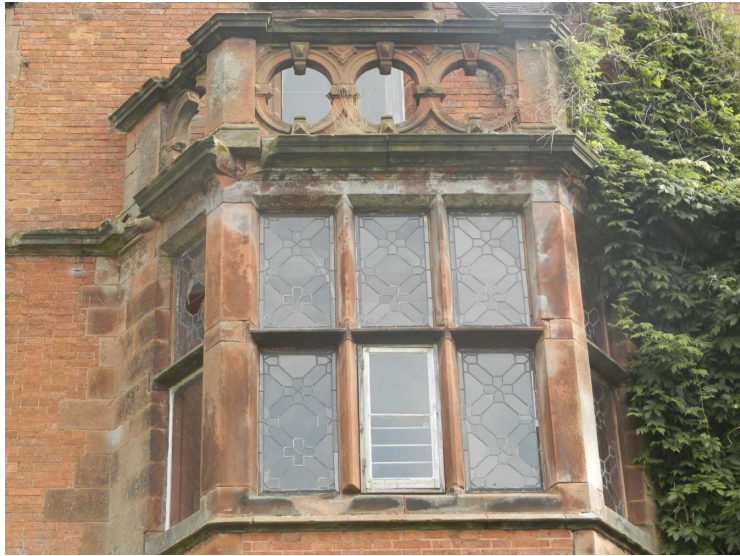
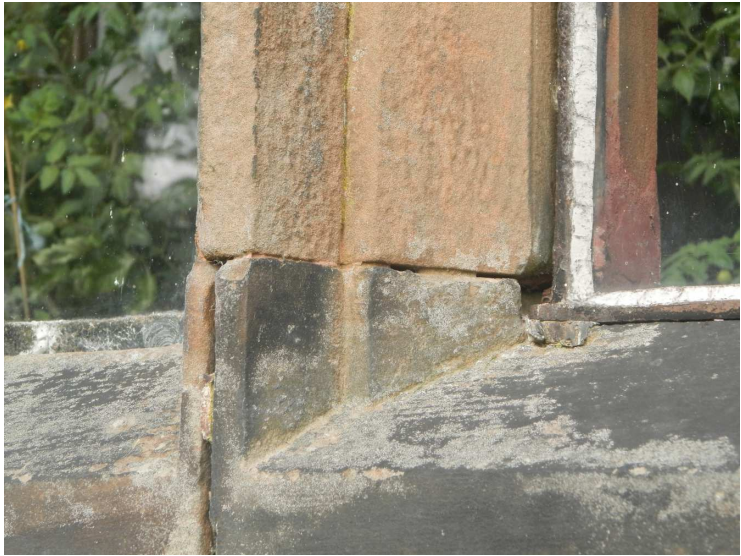
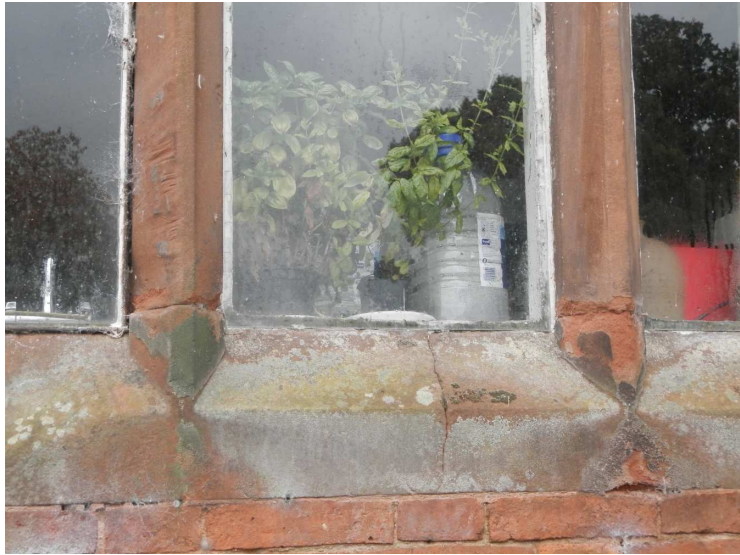
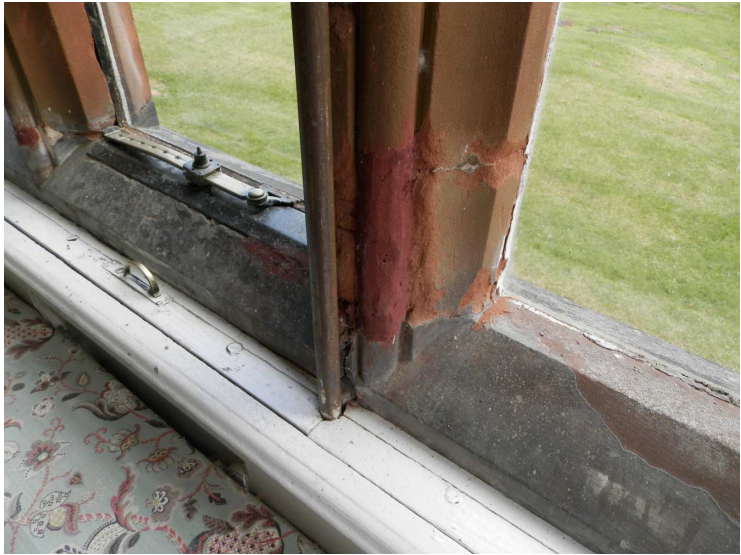
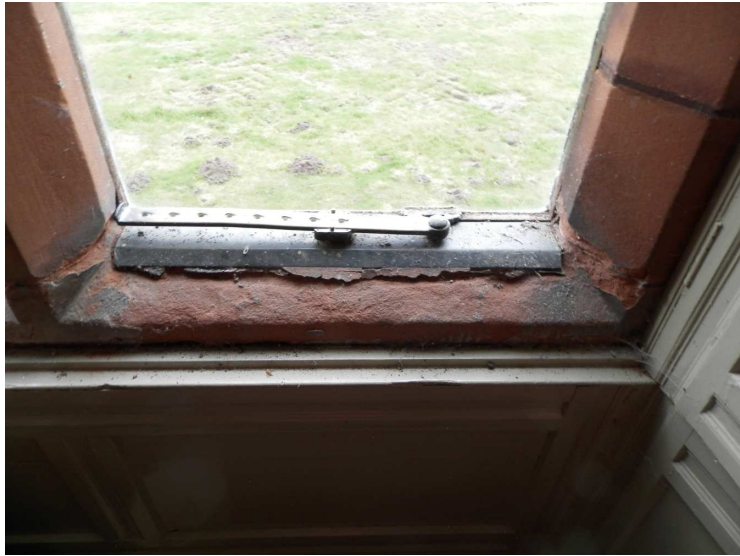
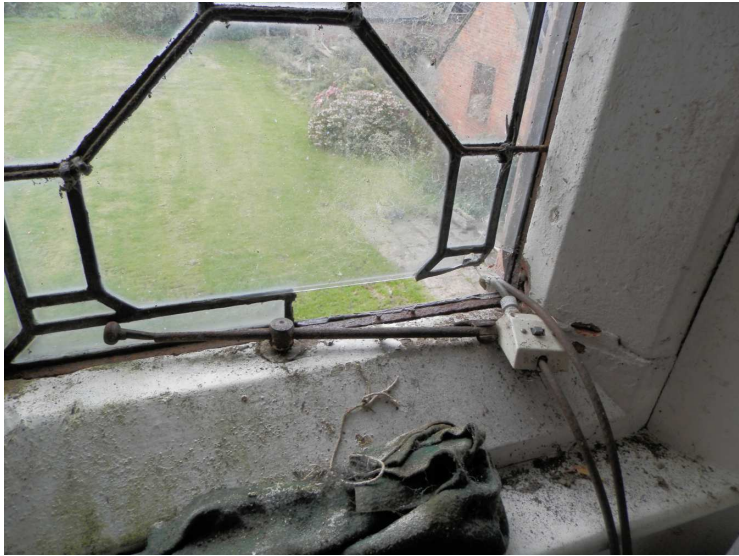
A feature of Hinton Hall is the large sandstone window frames to all elevations which are very large and distinctive but at the same time allow an enormous amount of natural daylight to penetrate within. The window frames are not only suffering externally but also internally they have been crudely repaired previously or show significant signs of wear and tear. The opening lights to the windows comprise very thin metal frames but these have largely rusted and are laminating.

In addition, over the years many of the leaded lights have been replaced for clear glass and overall the facades are spoilt to some extent due to inconsistencies with the glazing. The retained leaded lights are mostly associated with the top sections of the windows and in a few locations, crude timber framed opening lights have been introduced where it is anticipated that the original steel frames would have simply fallen out. The condition of the windows is shown in photos 62, 63, 64, 65, 66, 67, 68, 69 and 70.

The photos may seem exhaustive but the stone frames are in need of repair with a suitable epoxy mortar and internally the frames would benefit from decorating. The fixed panes are simply bedded into the rebates of the stone frames with a type of putty and are mostly loose or damaged to some extent where extensive re-glazing will be necessary to make the facades more uniform and to replicate the period.

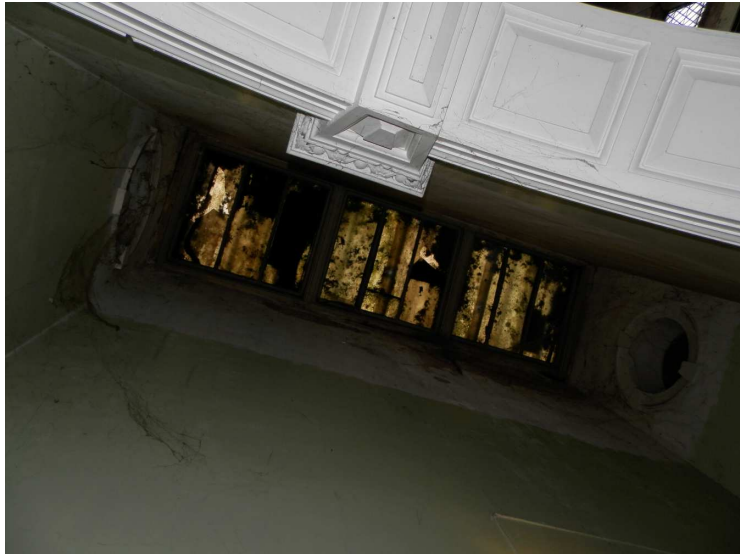
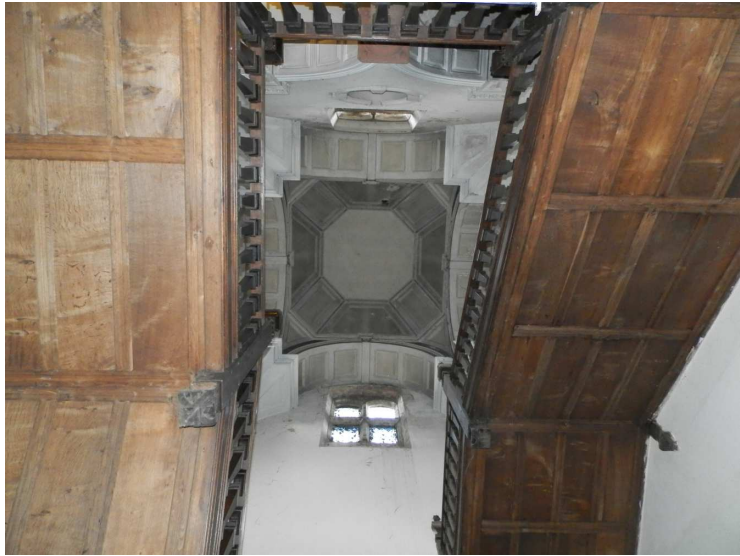
At this juncture we would reiterate that the turret at the top of the main staircase was believed to have incorporated glazing originally but this has now been replaced with solid materials. It would be magnificent to reintroduce suitable glazing to the turret with close liaison with the Conservation Officer and this is where an archaeological report comes into its own as part of the planning/conservation process.

On the half landing of the main staircase, a roof light is actually provided but this is covered with debris. Upon closer examination it is most likely that this component will require replacement. This together with the aforementioned turret is illustrated on photos 71, 72 and 73.

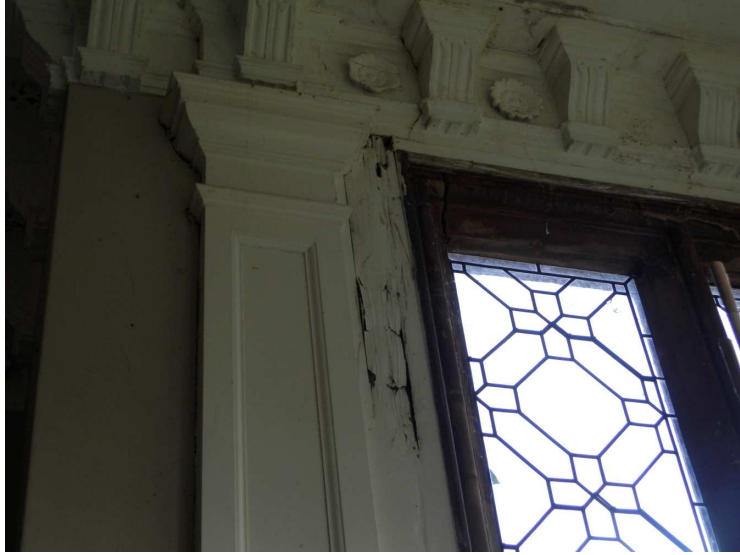
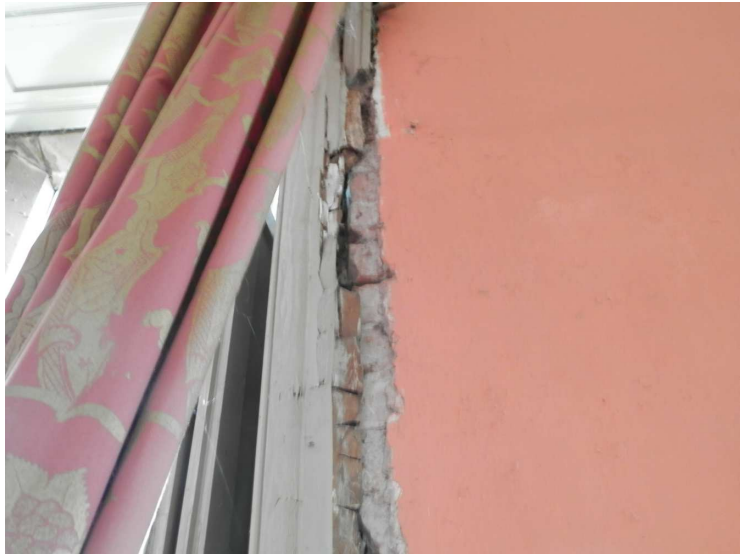
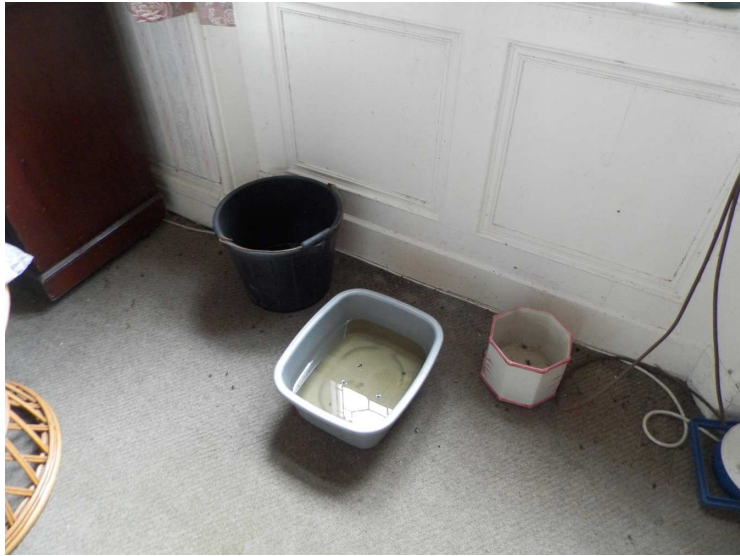
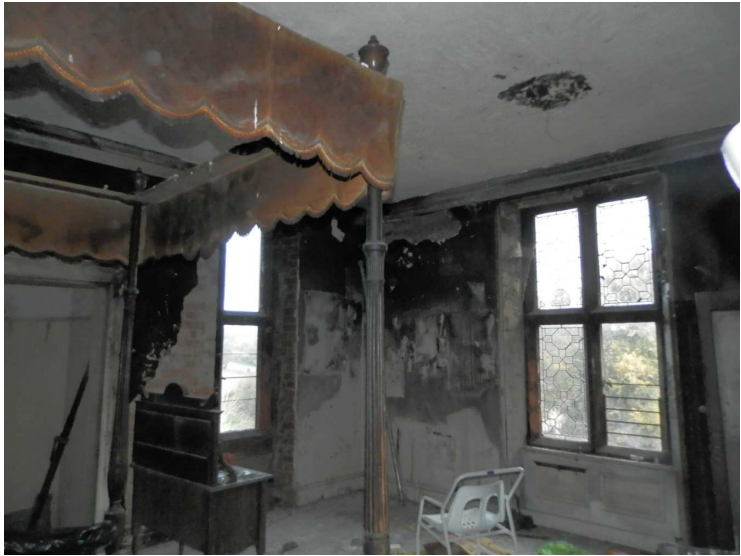
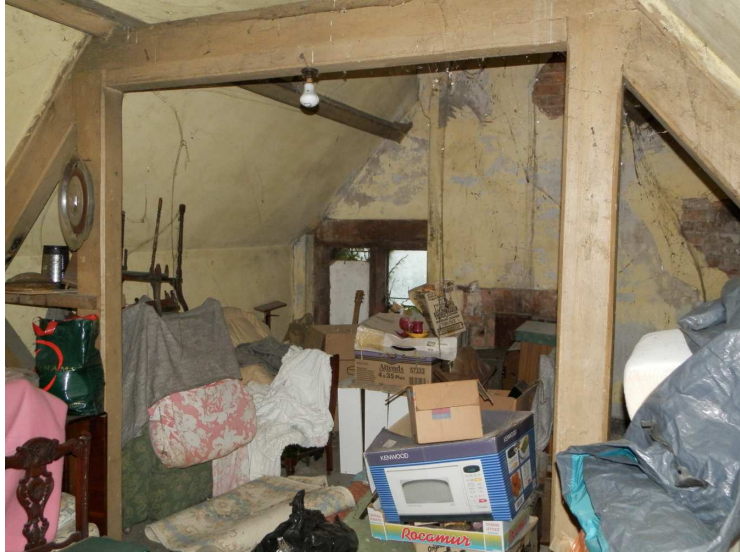
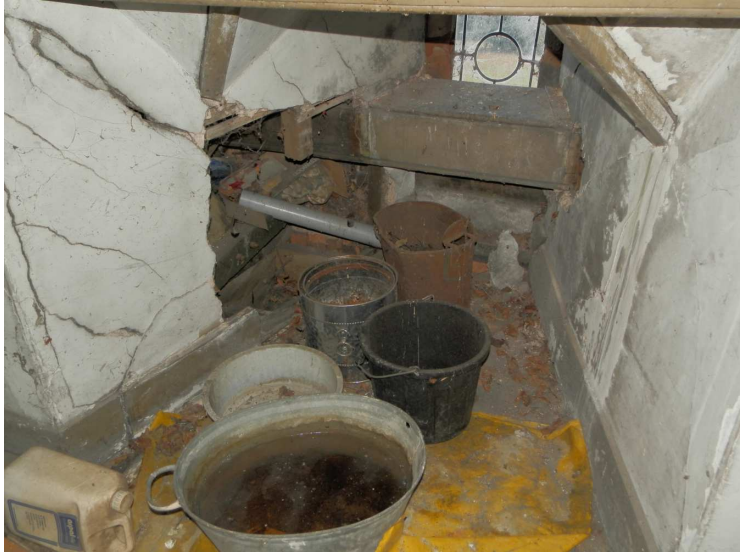
There are countless buckets and containers throughout Hinton Hall to collect rainwater where one might expect these to be at second floor level, directly under the roof, but this defect is summed up when buckets are observed at first and ground floor levels and even in the cellar to collect water from the main roof. Refer to the following range of photos to illustrate our findings, 81, 82, 83, 84, 85, 86, 87 and 88.

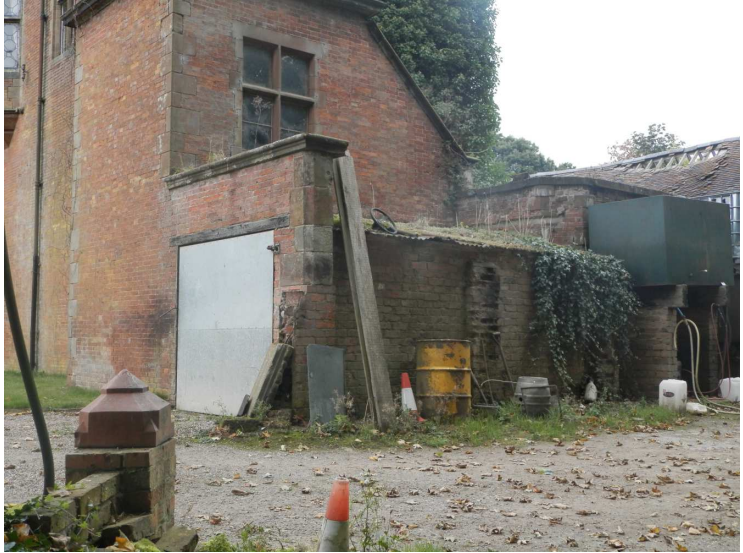
90.JPG

- The timber framed sheds attached to the North elevation of Hinton Hall are in a dilapidated condition and require complete removal. At the same time we would also advocate the complete removal of the attached single garage located on the north-east of the property which is not believed to be original. Similarly, a brick built shed is also provided behind the garage and this should be removed. This will then create space for a contemporary extension to connect the hall to the outbuildings. The existing arrangement is show on photos 89, 90 and 91.

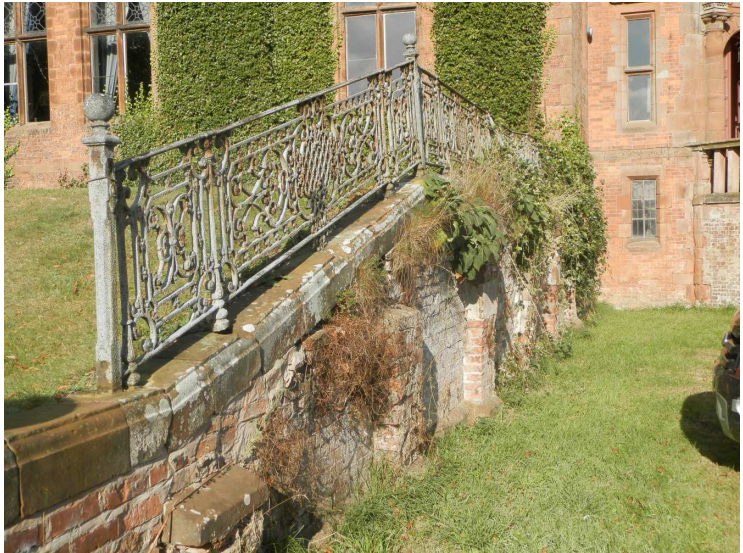
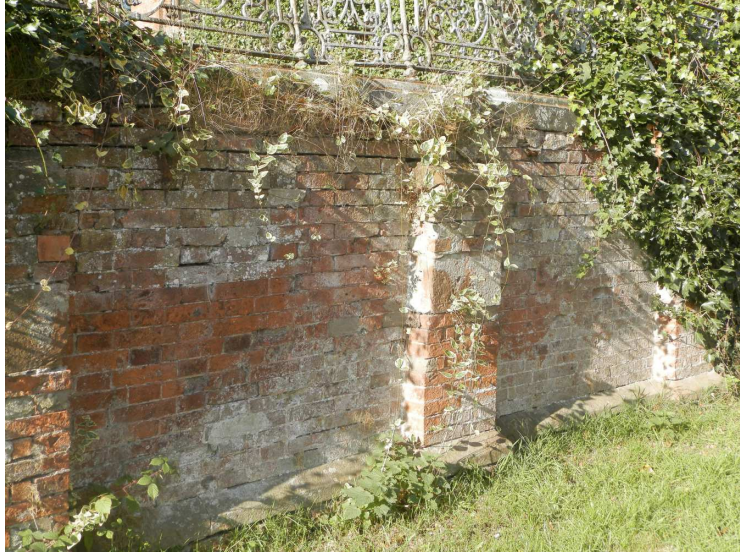
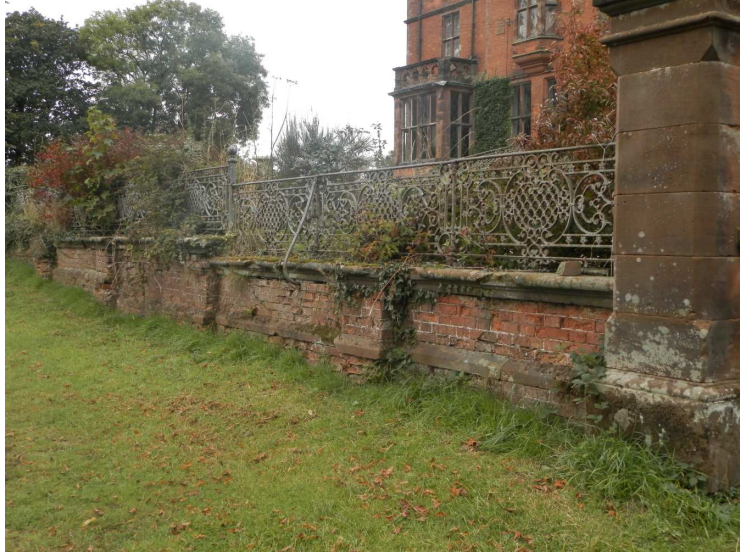
- A retaining wall is provided to the southern and western sides of the gravelled drive where the brickwork is showing signs of severe spalling and thus significant repairs are required including restoring the cast iron fencing over and ramped approach. Photos 92, 93, 94 and 95.

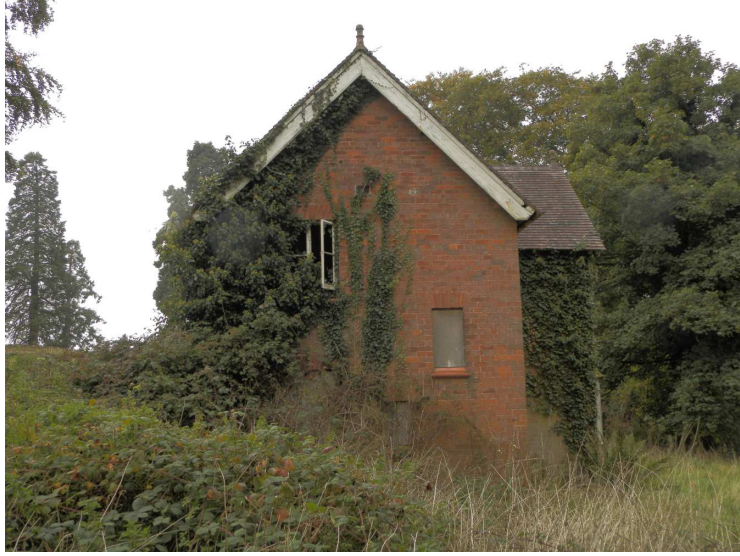
99.JPG

- The Lodge near the junction with the A41 has not been occupied for over 20 years and is believed to have been extensively damaged by an overflowing bath. This property has the potential for renovation and occupation by a member of staff. See photos 98 and 99.
