Structural Appraisal
Lawndowns Bungalow
Grampound Road
For

Ms T. Davey

Job no 21:8121

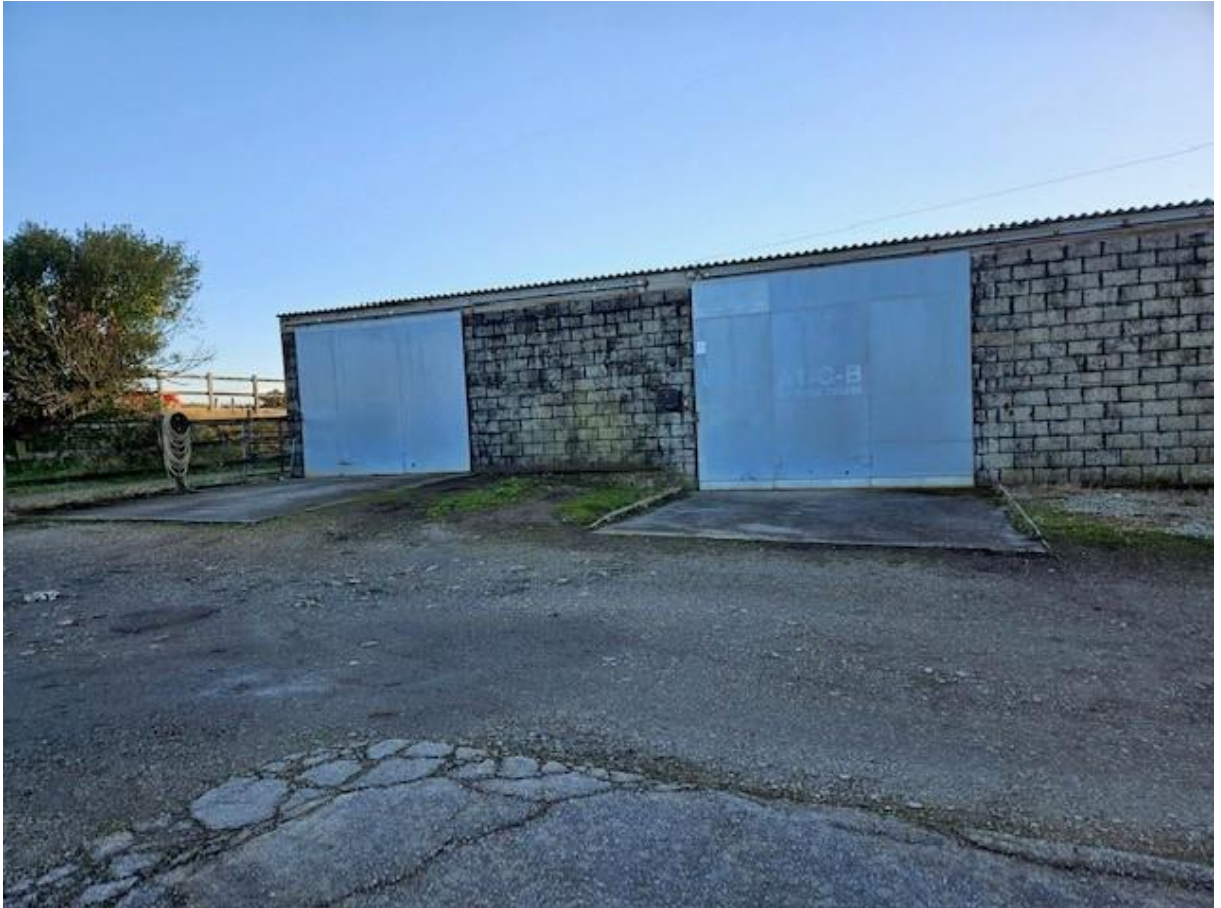
Northern end of western elevation

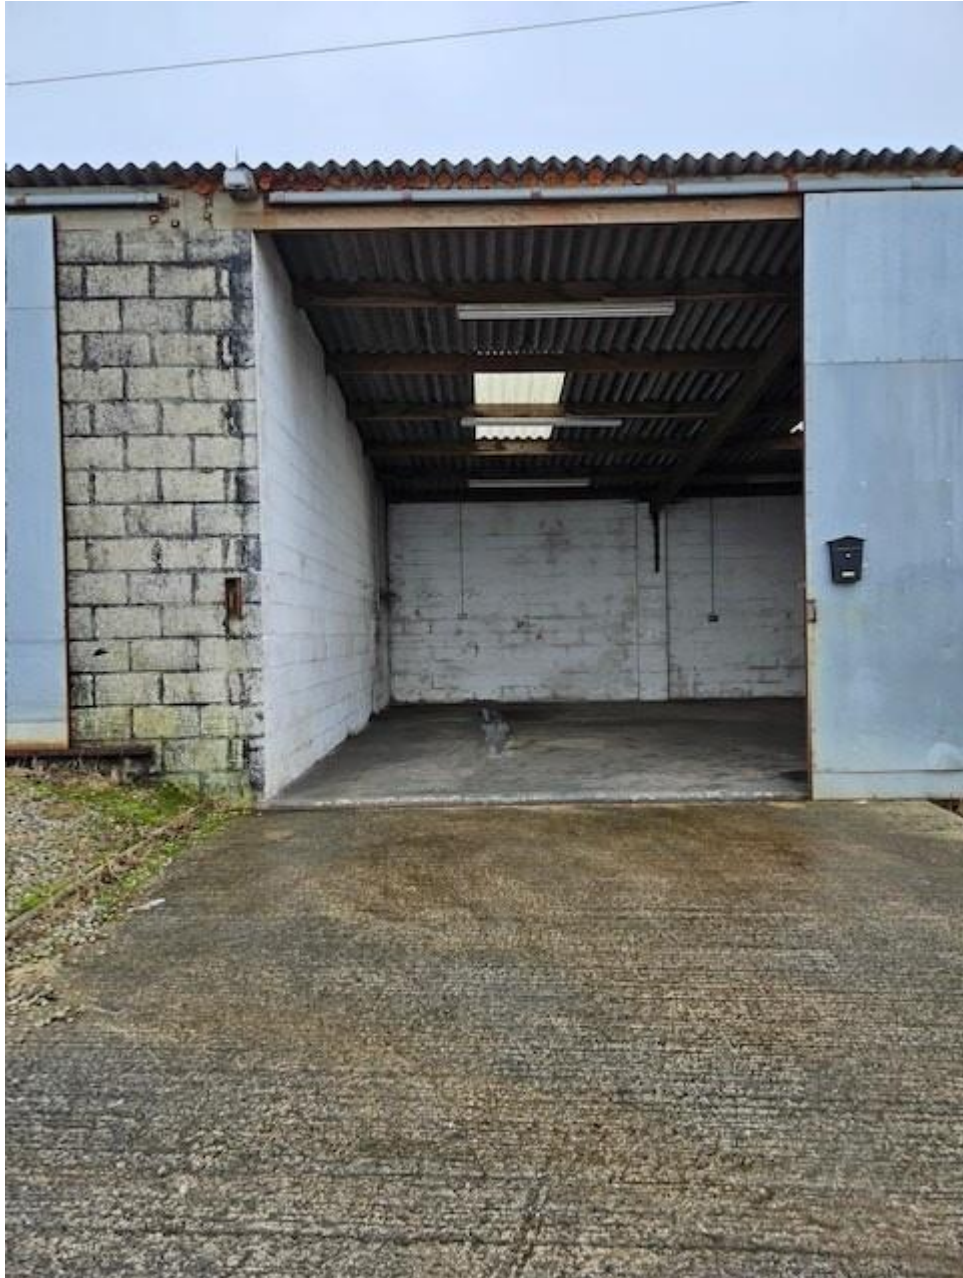
Entry doors in western elevation

The three main openings on the west elevation are no longer required. It is intended to block up these openings with new cavity walling constructed with a blockwork outer face and timber frame lining.

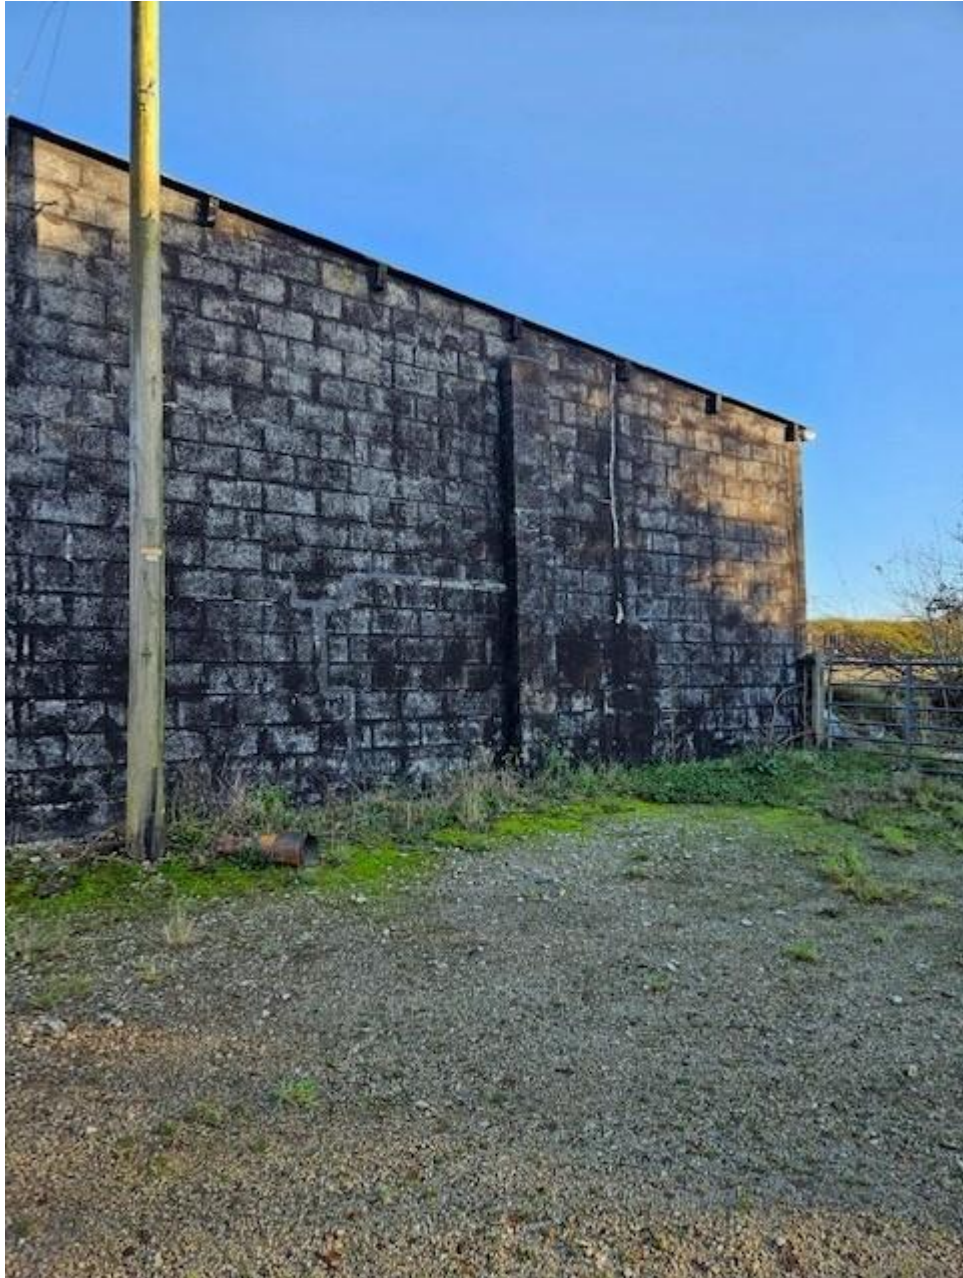
Northern end of eastern elevation

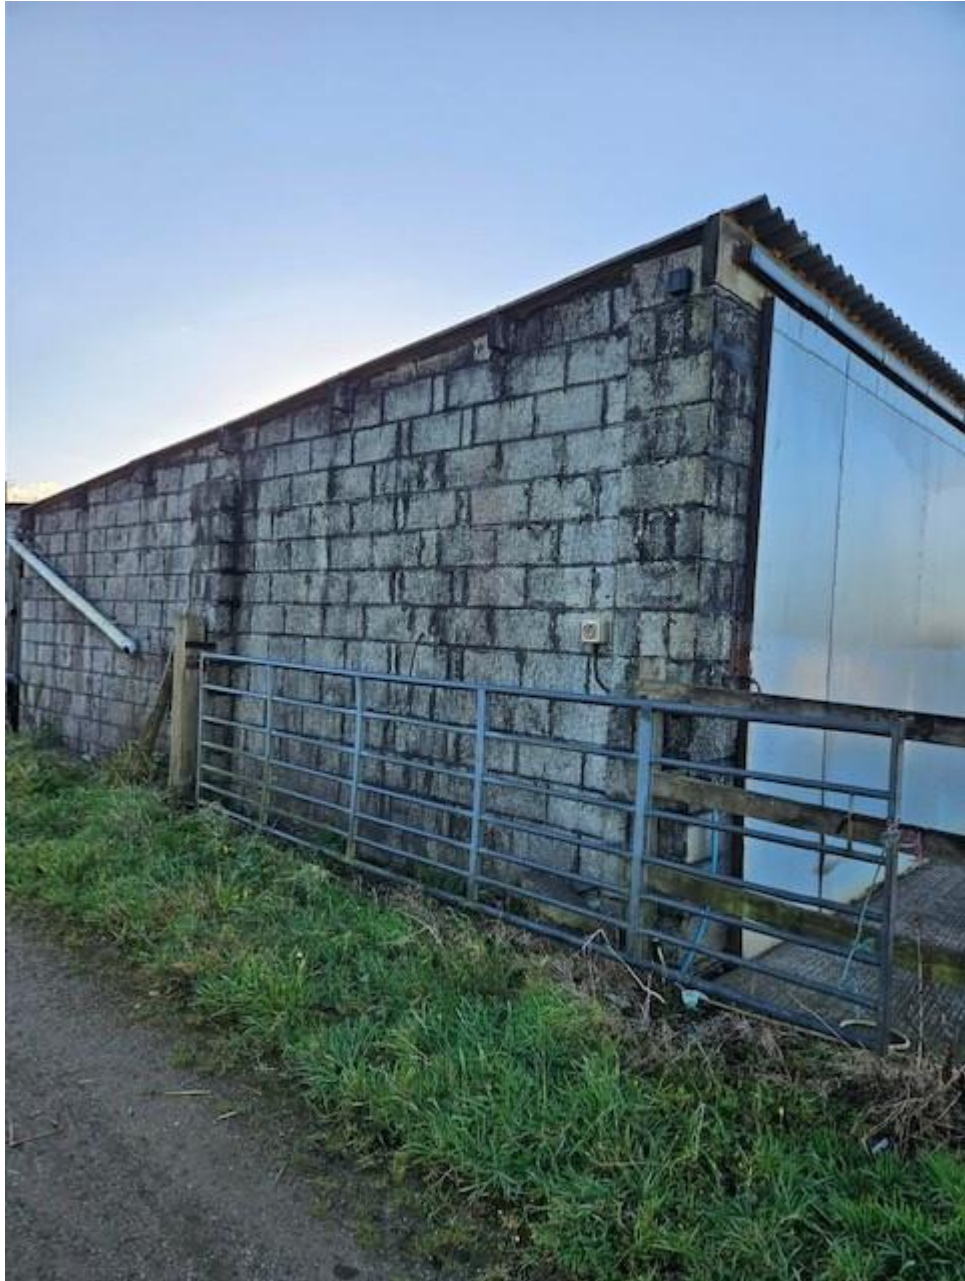
Northern elevation

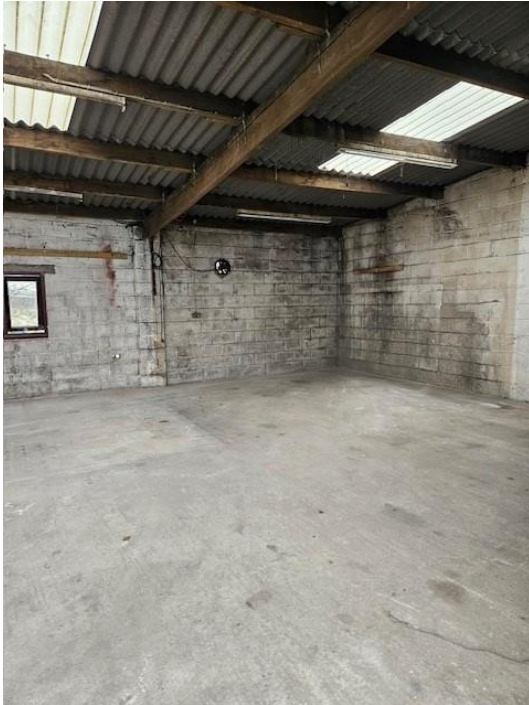
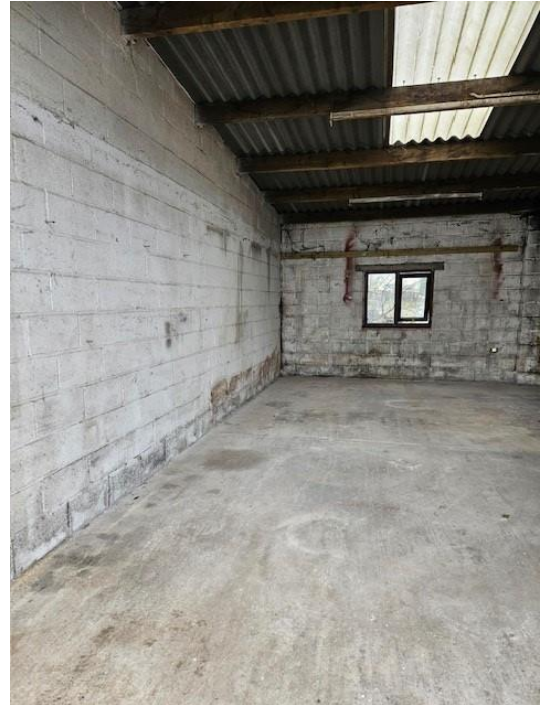
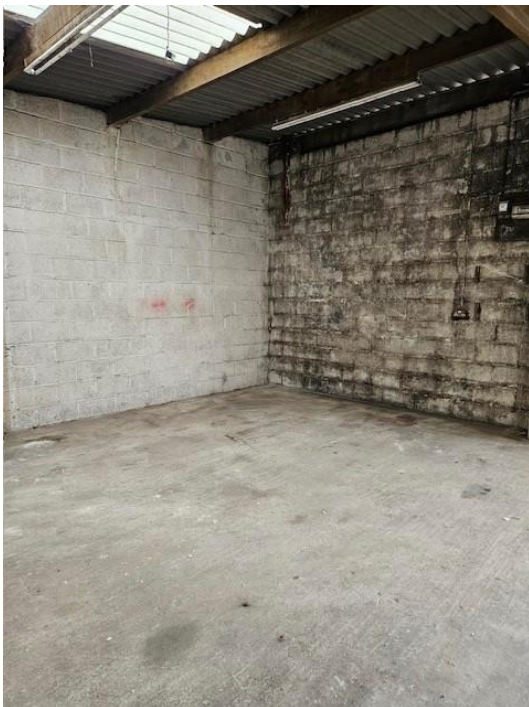
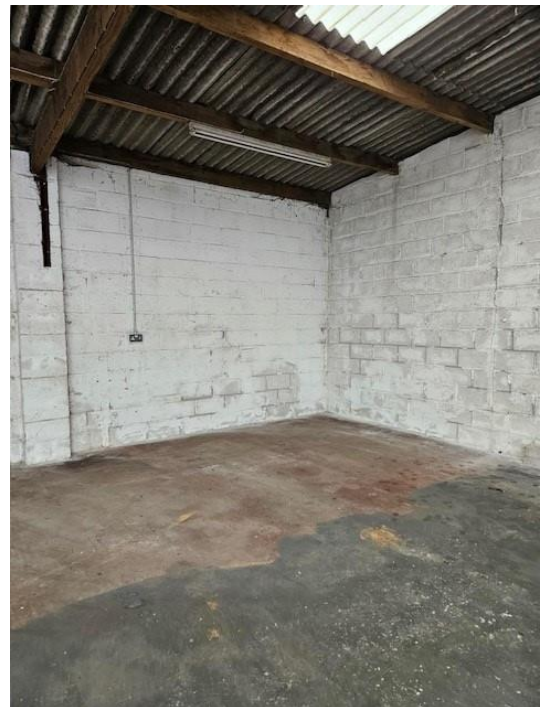
Various internal views of walls

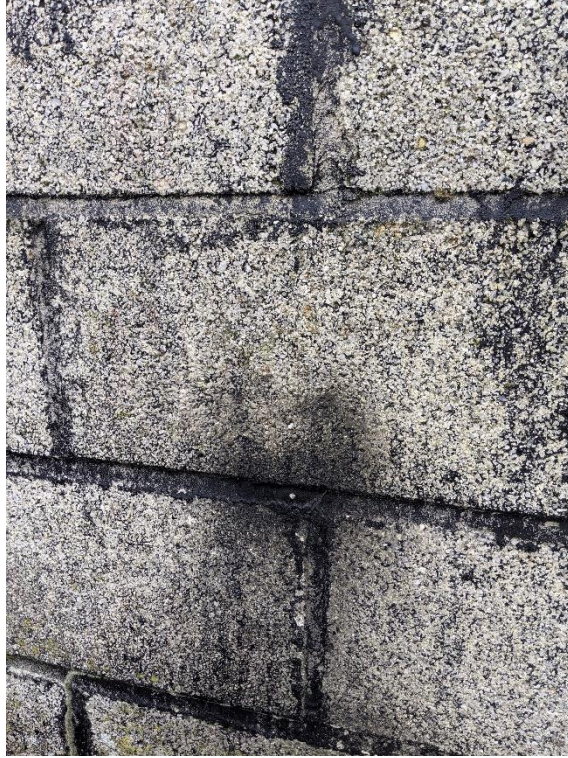
The walls are in good condition and were well constructed.

Blockwork
