ARBORICULTURAL REPORT

Ardleigh Oaks, Old Ipswich Road, Ardleigh, Essex, CO7 7QR

H T Industrial Ltd

OUR REF: SHA 1720 Rev A

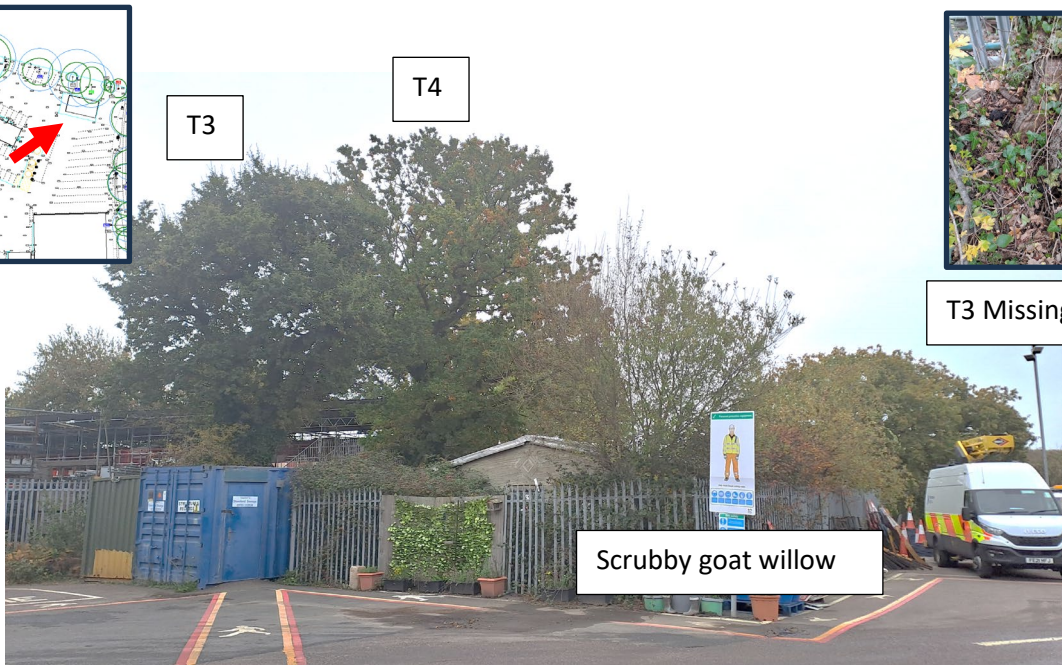
The mature oaks are part of an old field boundary. They have a strong landscape presence and are an important habitat. T3 has an area of missing bark and sounds hollow when tapped with a mallet. Further investigation is recommended using specialist equipment. T8 ash has a decay fungus (*Inonotus hispidus*) that could lead to tree failure. This has been assessed by climbing inspection by an ecologist at Tim Moya Associates and its removal will be carried under ecological supervision.

T3 Missing bark

Tree Number	Botanical Name (Common name)	Age	Dia (mm)	Stems	Height (crown height)	Ult ht (m)	N	E	S	W	Cond	Life Exp	BS Cat	RPR (m)	RPA (m ²)	Comments	Recommendations
T3	Quercus robur (Common Oak)	M	1070	1	13(5)	22	7	6	7	7	Fair	40+	B2	12.84	518.01	Reasonable form and condition. Collective, rather than individual, visual amenity. Part of linear group. Ivy on tree. Unable to inspect stem due to Ivy. Decay present on stem. Major bark wounding on stem. Epicormics on stem. Small amount of twig sized dead wood interspersed in the crown. On edge of loose hardstanding. One third of the lower trunk has a large area of bark missing from the trunk. Tree sounded with a mallet revealing that it is hollow behind the decay and decayed fungal fruiting body at base. Ivy to 5m. Has been heavily pruned in the past resulting dense growth with late autumn.	Carry out investigation with tomography and or resistograph.

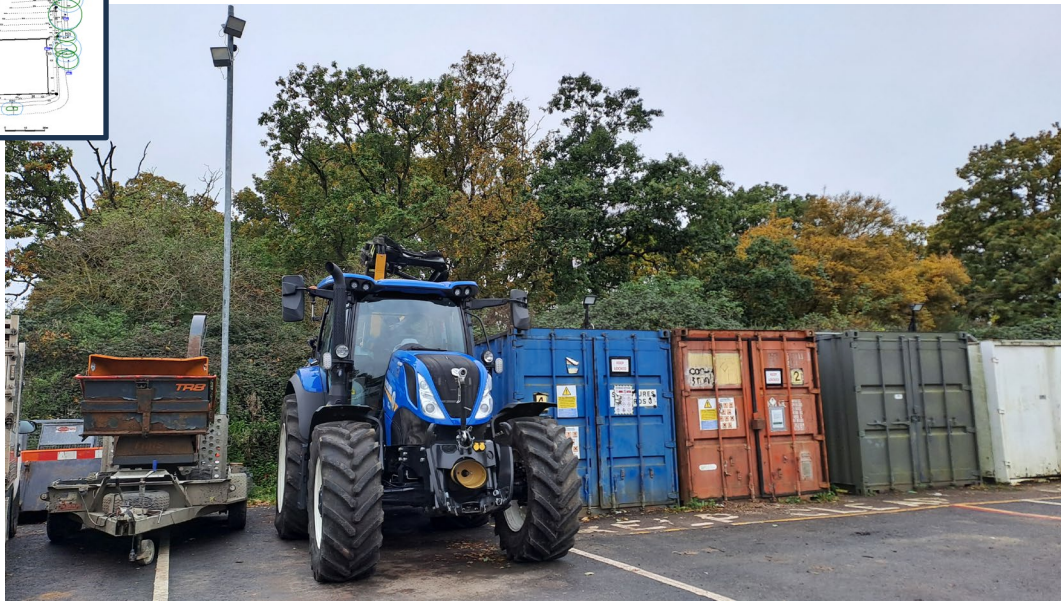
Photo 7 of G19 looking south

G19	Quercus robur (Common Oak), Acer campestre (Field Maple)	M	600	1	18(4)	22	7	7	7	7	Good	40+	B2	7.2	162.88	Offsite group to the south of bund. Observed from site and plotted approximately. Attractive backdrop to site.

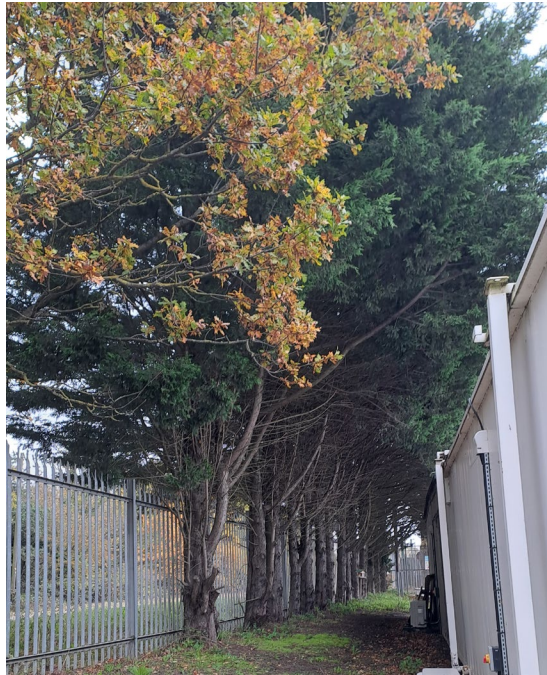
Photo 11 showing interior of the line of conifers G23. Looking north.

Tree Number	Botanical Name (Common name)	Age	Dia (mm)	Stems	Height (crown height)	Ult ht (m)	N	E	S	W	Cond	Life Exp	BS Cat	RPR (m)	RPA (m ²)	Comments	Recommendations
G23	X Cupressocyparis leylandii (Leyland Cypress)	SM	350	1	18(2)	28	4.5	4.5	4.5	4.5	Good	40+	C1	4.2	55.42	Provides a high level of visual amenity. Reasonable form and condition. Forms a dense screen. Collective, rather than individual, visual amenity. Part of linear group. Crown distorted due to group pressure. Dense unmanaged line of conifers functioning as a high hedge. Average dimensions given.
