STRUCTURAL APPRAISAL AND REPORT ON
DETACHED BARN 1 AT BROOKSIDE FARM, MAIN ROAD,
PONTESFORD, SHREWSBURY SY5 0UA

Job Number: 21/120
Date: 20th October 2021

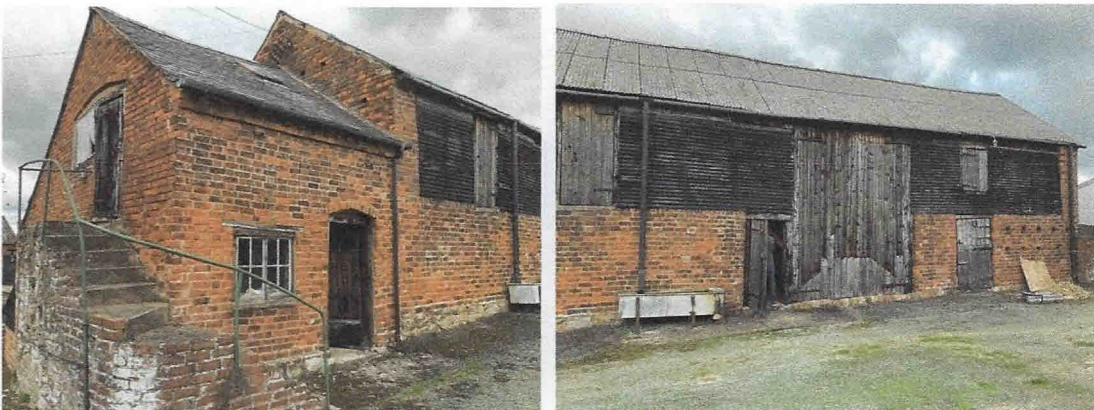
The main elevation to the Barn was clad with metal sheeting above first floor level, with brickwork below. Whilst the brickwork was seen to be in relatively good condition, it leaned outwards below the sheeting line, likely to be due to roof spread and associated movement of the upper framing. This will need to be considered further.

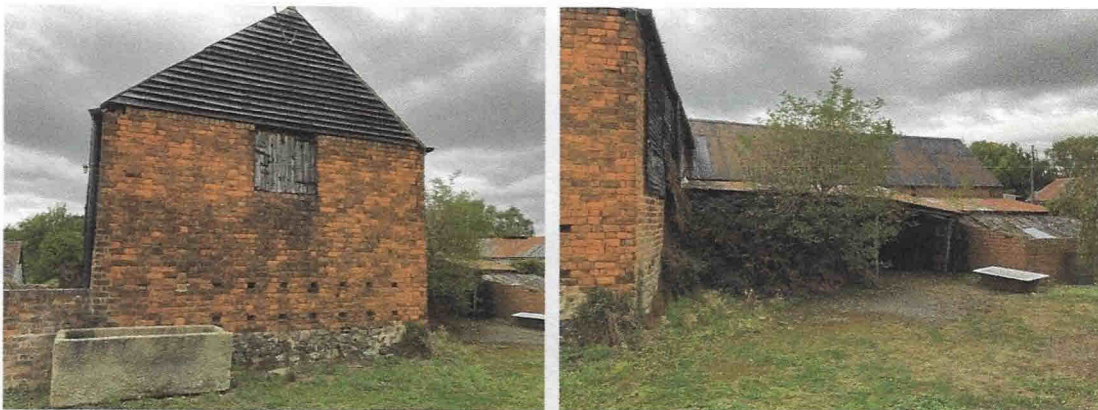
The elevation was predominantly brickwork, with embedded timber posts. The right hand post was showing signs of decay at the top and will require attention or replacement.

Low level stonework was random and will require attention.

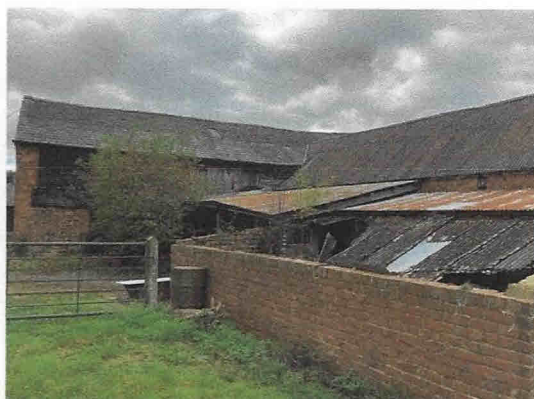
The lower section of wall to Cow Barn 3 bulged outwards significantly adjacent to the South Eastern gable and localised rebuilding will be required.
