# Gale Tree Consultancy

## Tree Condition Report

New Grove Petworth

Ref: TCR/292/21

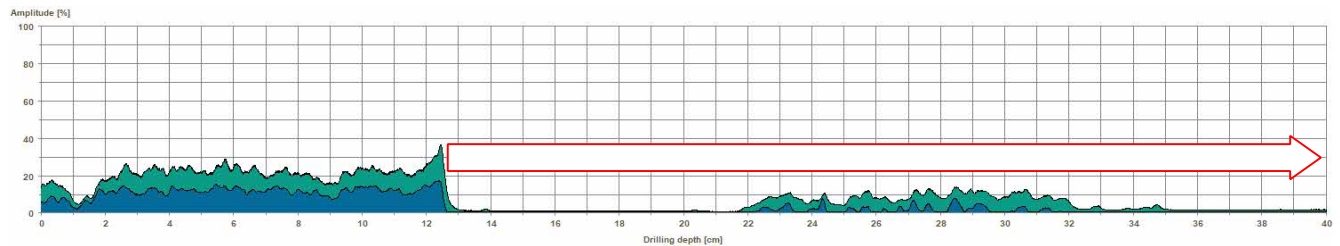
### Drill Trace 1 – North

The drill trace indicates sound wood to a depth of c.12.5cm after which the drill enters an area of extensive decay/hollowing through to the end of the 40cm assessment

Between c.22cm and c.32cm, the drill enters an area of variable resistance which appears incipient in nature

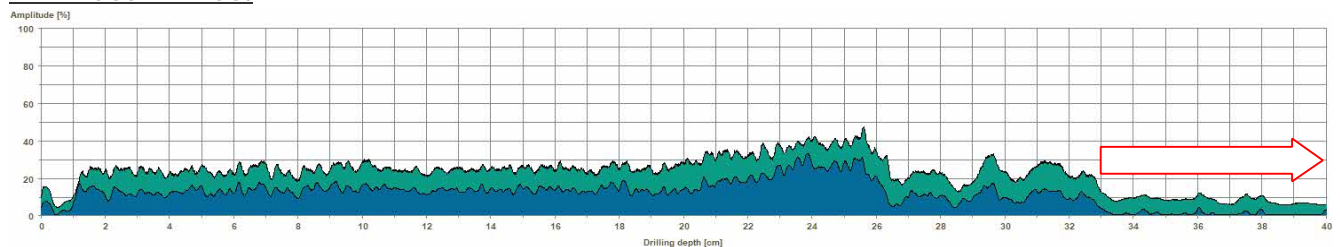
### Drill Trace 2 – East

After a steady increase in resistance, the drill enters an area of incipient decay at c.33cm through to the end of the assessment

The east drill trace was undertaken on a buttress root that separates the larger cavity with the smaller cavity on the north east side of the stem and indicates a thickness of c.33cm of sound wood before the drill enters the main void area

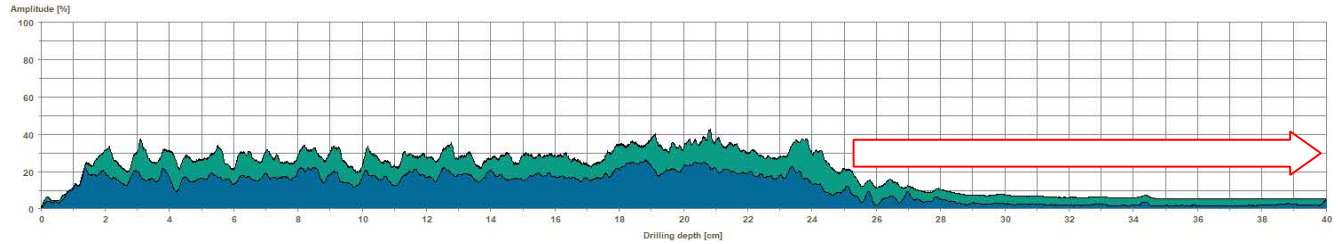
## Drill Trace 3 – South

After a steady increase in resistance, the drill enters an area of extensive decay/hollowing at c.24cm through to the end of the assessment

The southern assessment was also undertaken on a buttress root and suggests a thickness of sound wood c.24cm deep before it enters an area of extensive decay/hollowing

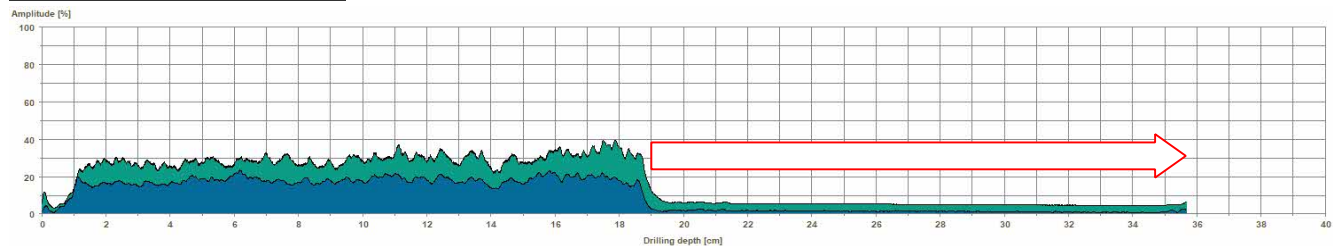
## Drill Trace 4 – South West

After a steady increase in resistance, the drill enters an area of extensive decay/hollowing at c.19cm

The Resi PD400's automatic needle retraction feature was triggered at c.35.5cm to remove the risk of damage/breakage of the drill bit

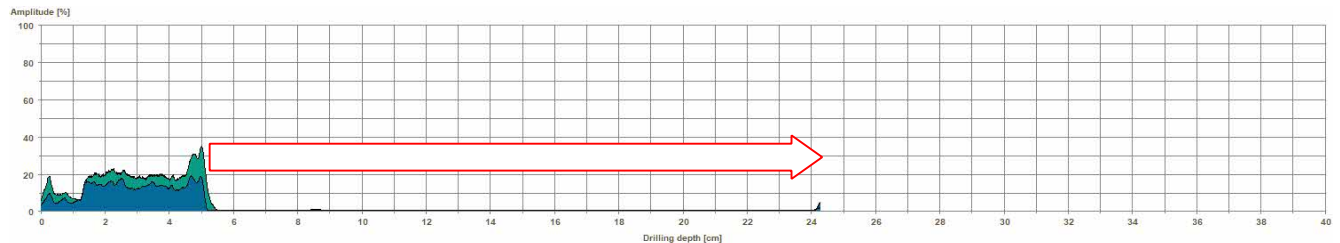
## Drill Trace 5 – West

The drill enters a hollow in the stem at c.5cm

The Resi PD400's automatic needle retraction feature was triggered at c.24.5cm to remove the risk of damage/breakage of the drill bit

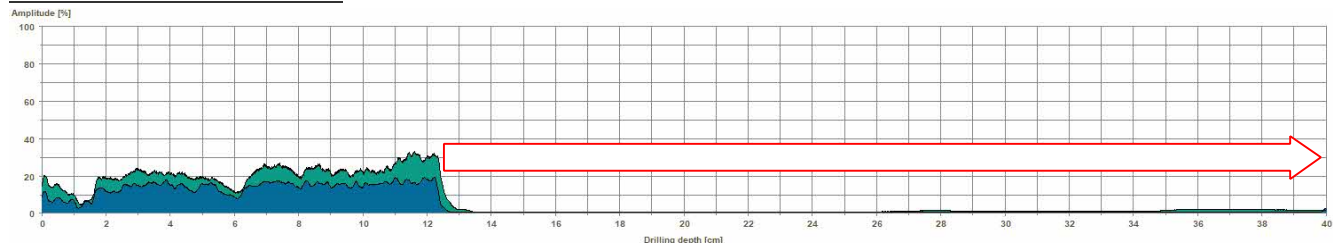
## Drill Trace 6 – North West

The drill trace indicates an increasing resistance to the drill up to c.12.5cm where it enters an area of hollowing in the stem

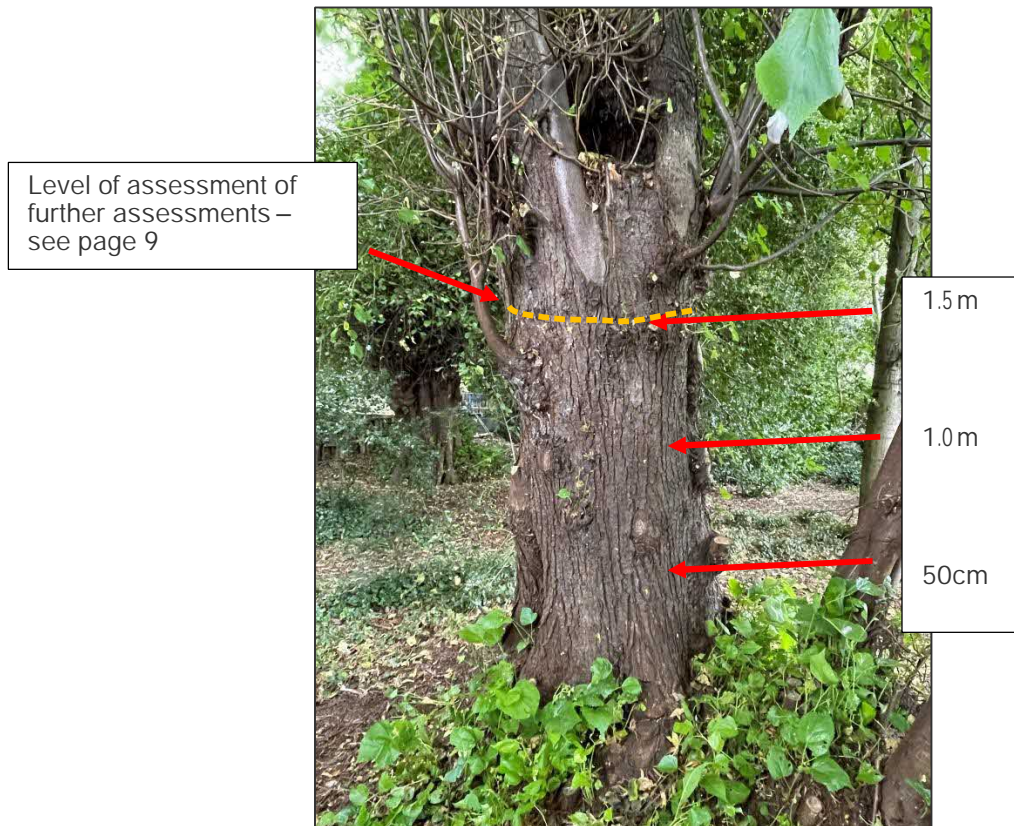
A further three assessments were undertaken on the north west side of the stem from Drill trace 6 up to the cavity at c.2.3m

In my opinion, the large basal cavity has coalesced with the cavity at c.2.3m resulting in a column of extensive decay and hollowing. The action of the decay fungi will continue to affect the wood structure with an increased risk of complete failure in the event the decay expands further into currently sound wood

To reduce the risk of failure, the tree should be reduced in height to leave a stem height shorter than the distance to the boundary wall to the west, c.5.0m and although I do not consider there to be a need for complete removal at this time, this option would be justifiable

I would recommend the work is undertaken within the next 6 months and before the start of the 2022 bird nesting season

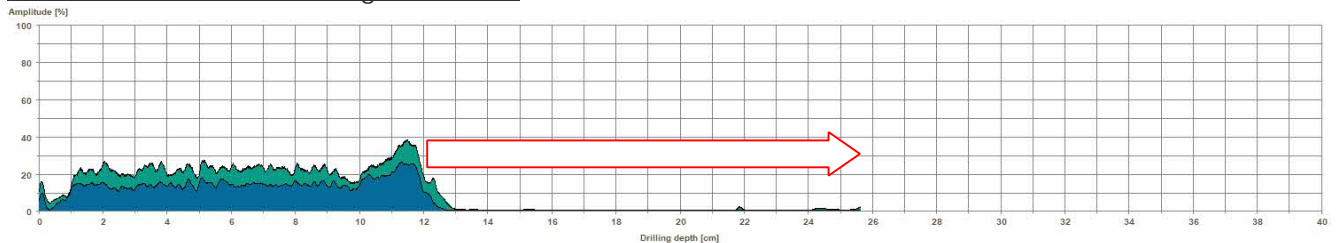
## Drill Trace 7 – 50cm above ground level

After an area of increasing resistance, the drill enters a hollow in the stem at c.12cm

The Resi PD400's automatic needle retraction feature was triggered at c.24.5cm to remove the risk of damage/breakage of the drill bit

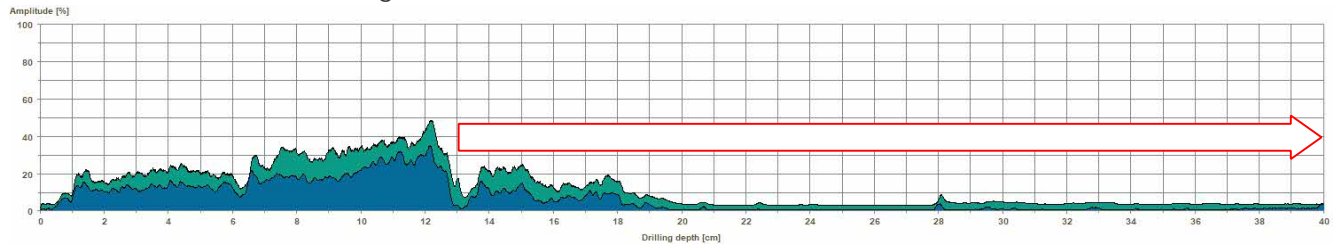
## Drill Trace 8 – 100cm above ground level

The drill trace indicates an increasing resistance to the drill to a depth of c.12cm where it drops suggesting incipient decay is forming

After a brief increase from c.14cm, the variable drill trace decreases further to an area of extensive decay/hollowing from c.20cm to the end of the assessment

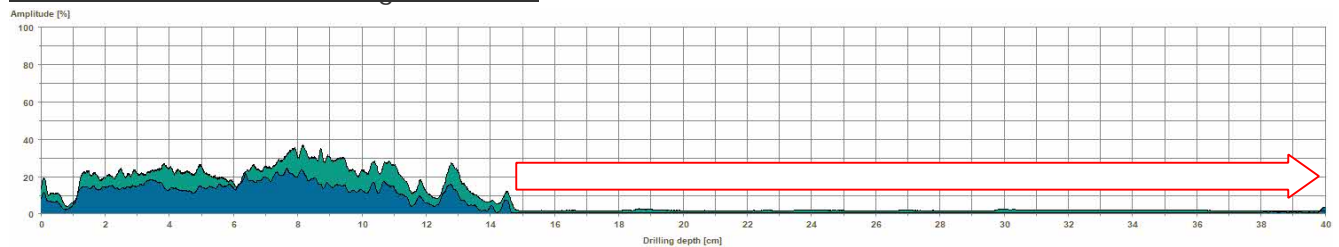
## Drill Trace 9 – 150cm above ground level

The drill trace indicates an increasing resistance to the drill up to c.8cm where it begins to decrease suggesting incipient decay is forming

From c.14cm the drill enters an area of hollowing in the stem through to the end of the assessment

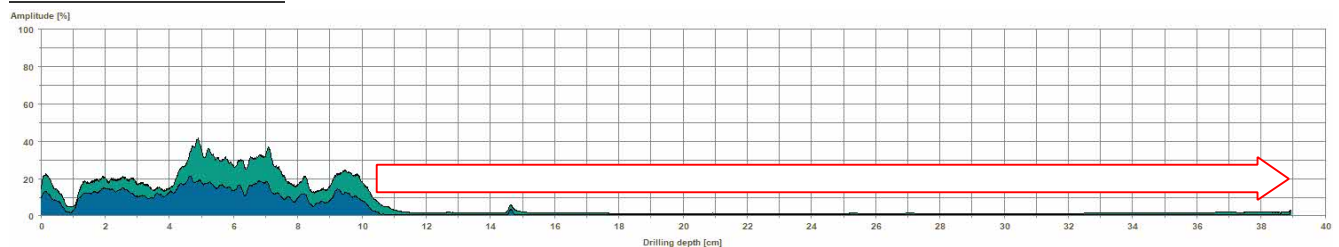
## Drill Trace 10 – North

After an area of increasing resistance, the drill enters a hollow in the stem at c.10.5cm

The Resi PD400's automatic needle retraction feature was triggered at c.39cm to remove the risk of damage/breakage of the drill bit

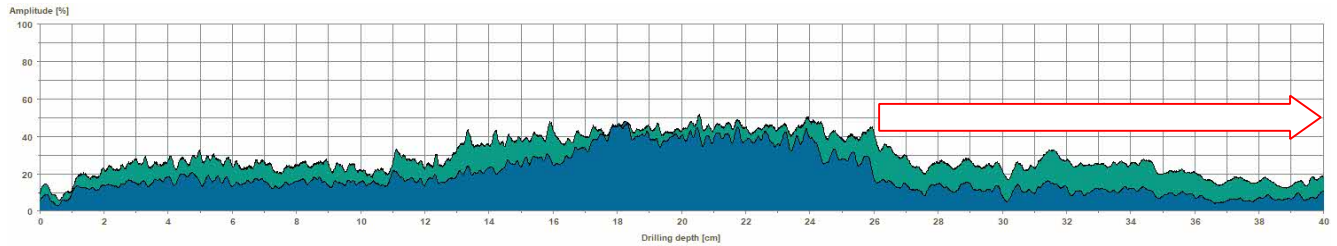
## Drill Trace 11 – East

The drill experiences an increase in resistance to a depth of c.26cm. From this point, the drill enters an area of forming incipient decay as indicated by the gradual reduction in resistance

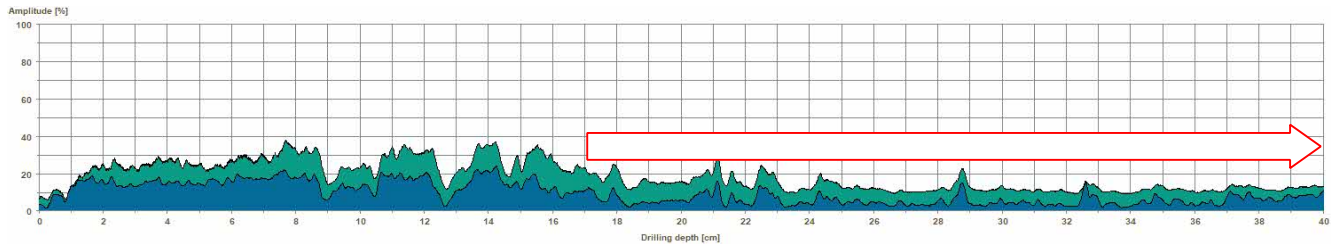
## Drill Trace 12 – South

The drill trace indicates an area of variable resistance from c.8cm to c.17cm

From c.17cm through to the end of the assessment, the drill trace suggests an area of more advanced decay is forming

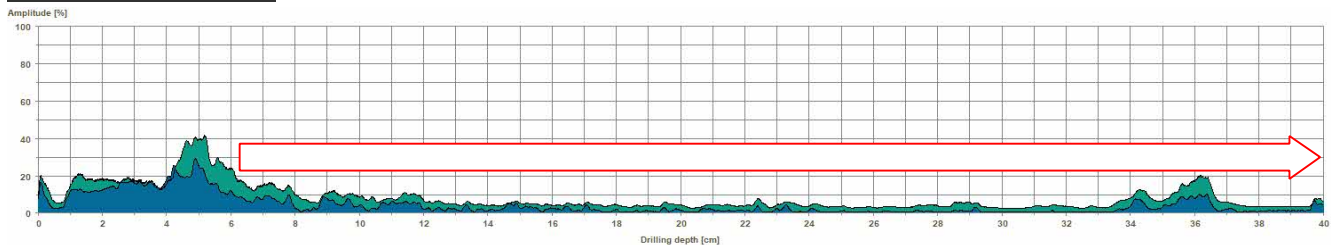
## Drill Trace 13 – West

The drill trace indicates an area of incipient decay is forming from c.5cm through to c.8cm where it becomes more extensive in nature with decay/hollowing being present through to the end of the assessment
