Tim Ellis

Heritage Impact Assessment (including Design and Access Statement)

Goddards Green
Angleley Road, Cranbrook TN17 3LR

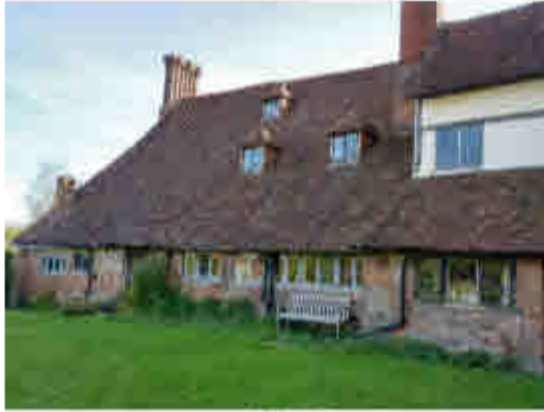
North-west elevation catslide and kitchen window range. North-west elevation projecting West end range.

- 3.06 The kitchen window range, as illustrated by drawing GGC/0124/04, consists of curious simple mullions with chamfered corners but the sashes are plain and crude being completely devoid of mouldings; the square edged glazing bars are a distinctly incongruous feature. Frames have small rebates suggesting that this range of windows was originally fitted with leadlights.

The frames are to be retained but the sashes replaced with authentic period mouldings (slender glazing bars) and fitted with double glazed units. The request to use double glazed units is to reduce the risk of condensation given that this is the kitchen where relative humidity can be high due to cooking. The double-glazed units would be a 'Slimlite' type product fitted within proper glazing bars. Thicker sashes, required for double glazed units, can be rebated so that the historic frames do not need to be modified.

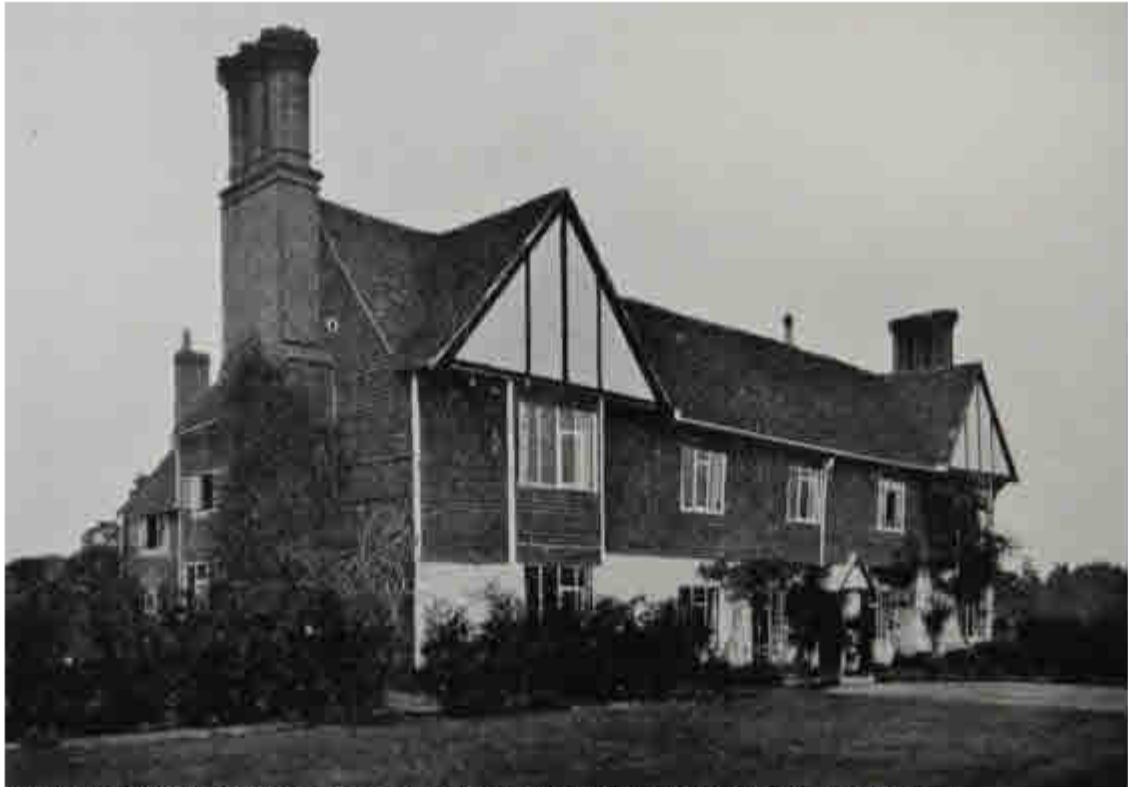
Late C19th/early C20th photograph showing the front (Southeast) and flank (South-west) elevations.

The historic photograph of the house clearly indicates that dormer windows to the front elevation have been added. Hanging tiling, protecting the timber frame, is now only retained in the areas noted in item 1.03.

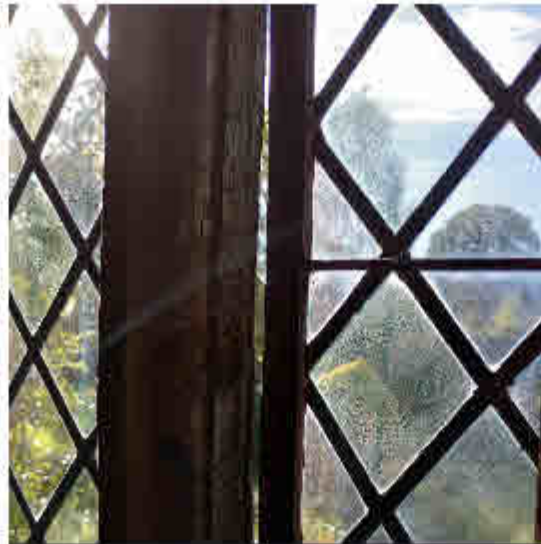
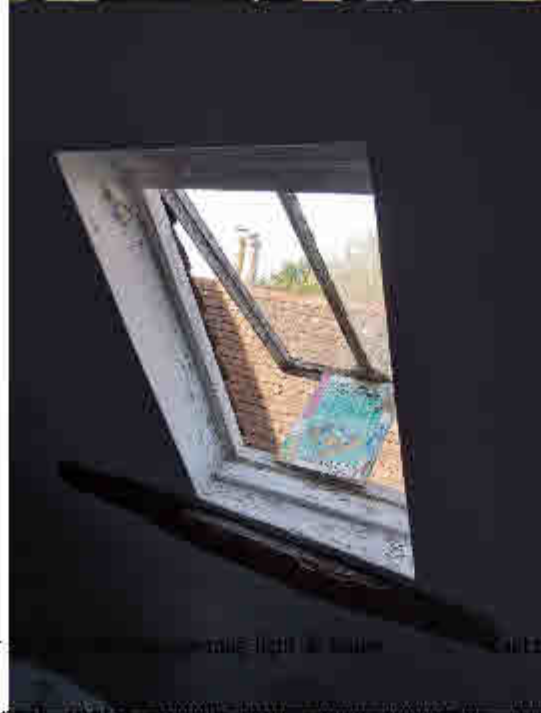
- 2.04 To the rear slope of the main roof, a C19th cast iron rooflight provides daylight and ventilation to the attic bathroom.
- 2.05 External ground floor doors comprise a mixture of historic and C20th doors – the glazed C20th door (joinery item 18 in the Dolmen condition survey) is to be replaced.

Window from rooflight to attic bathroom.

Secondary glazing is also to be fitted to the attic bathroom which is illuminated by a cast iron rooflight. Here, a glazed panel set in a timber frame is to be fitted to the coved ceiling. The panel will be hinged to allow access to the rooflight so that it may be opened.
