Goddards Green Survey Report

Summary Survey Report August 2023

Goddards Green Survey Report	DOLMEN

Date: 25/07/23	CONSERVATION & JOINERY

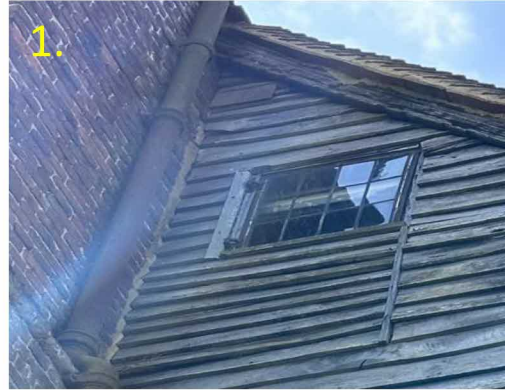
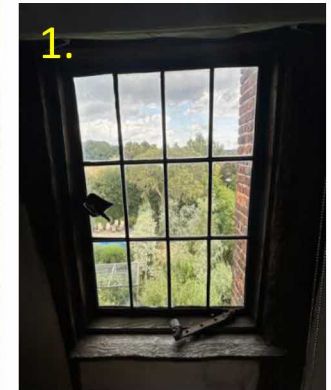
Item Number 1 **Condition** Poor **Description**
Window Casement and feather edge cladding

- Oak frame repairs as required
- Leaded lights x2 for overhaul
- Replacement of surrounding feather edge boarding
- Replacement of detailed barge board
- Visual survey of timber frame behind featheredge to be undertaken.

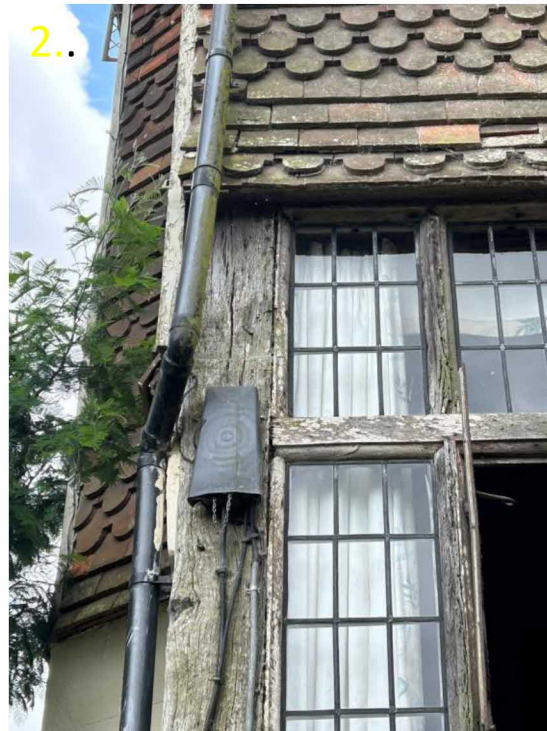
Item Number 2 **Condition** Poor- Fair
Description Ground floor TV room 3 Over 3 with
1 opener

- Glazing overhaul
- Metal casement overhaul
- Jambs of the window frame to be repaired or replaced where needed

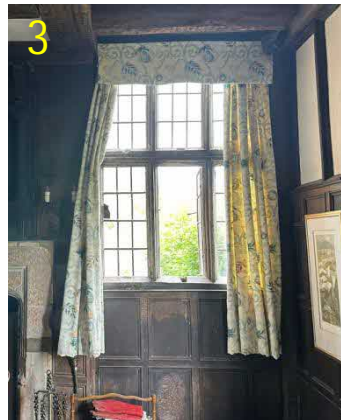
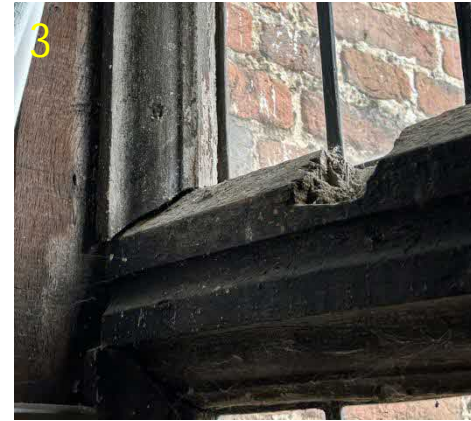
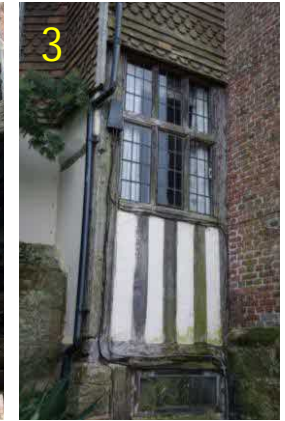
Item Number 3 **Condition** Good -Fair
Description

- Cill to be repaired/replaced

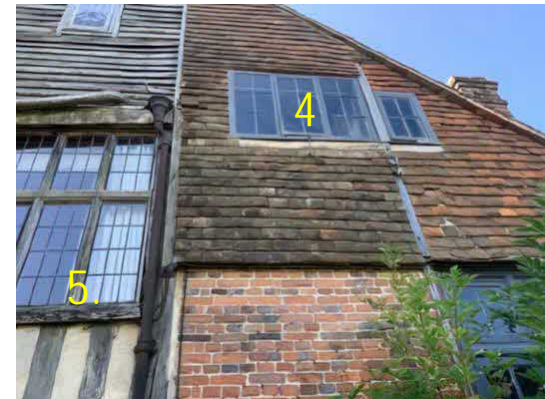
Item Number 4 **Condition** Poor
Description

- Removal to joinery workshop
- Localised repairs
- Refitting to frame
- Glazing bars to be repaired, re-using existing glass
- Re-glazing of entire window
- Painted finish to be renewed

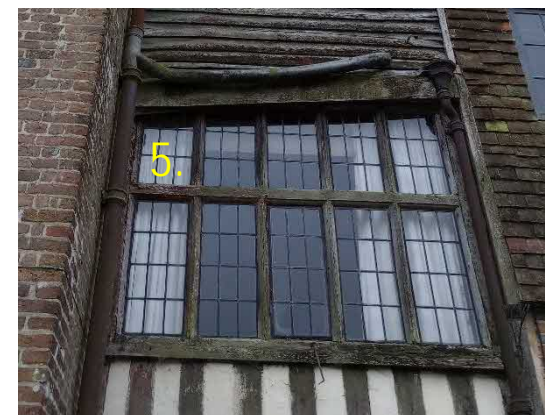
Item Number 5 **Condition** Poor, decay to cill Possible compromise to structural integrity of the frame due to the decay.

Description Large oak frame mullioned window

- Removal of frame and casements to joinery workshop
- Repair to cill and abutments
- Refitting on site

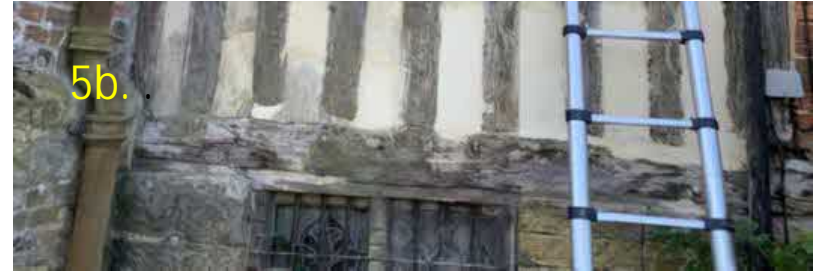
Item Number 5b.

Condition Poor

Description Exterior rail in poor condition, soft in places

- Repair localised guttering
- Opening up works required to investigate level of decay and make appropriate recommendations for repair

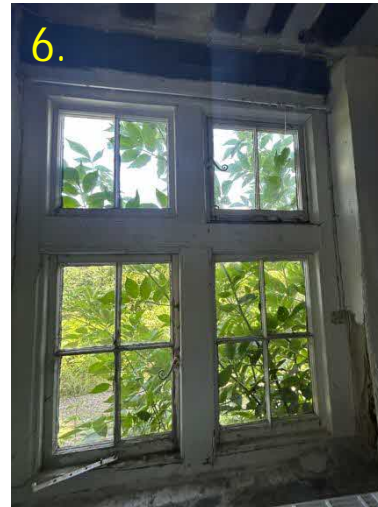
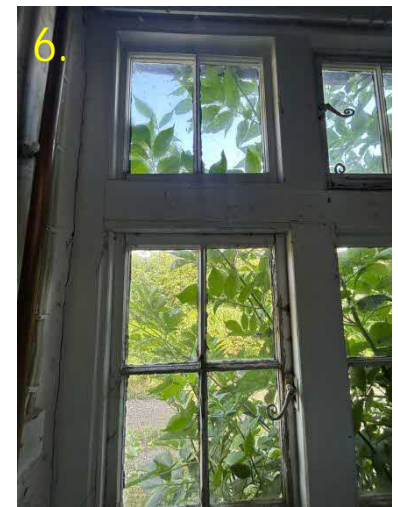
Item Number 6

Condition Poor-Fair

Description Pantry Northeast Elevation

- Re-glaze to cease water ingress , re-using existing glass where possible

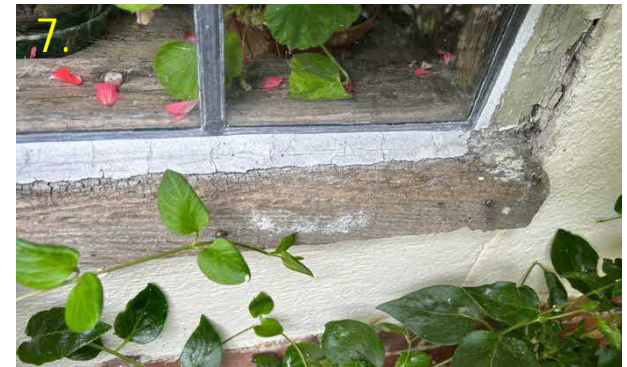
Item Number 7 **Condition** Poor
Description Hallway Cupboard and bathroom 2 rooms 1 window.

- All leaded lights to be overhauled and re-glazed, re-using existing glass where possible
- Frame to be overhauled in workshop
- Hinges to be overhauled
- Oak Casement to be repaired

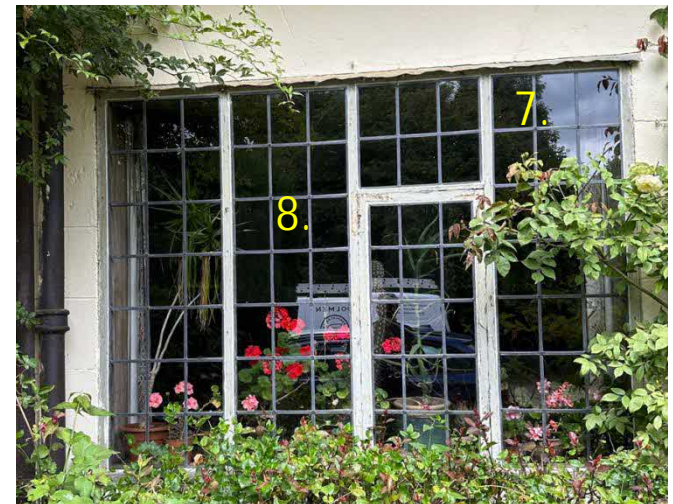
Item Number 8 **Condition** Good-Fair

Description Main Hall, 3 with 1 Opener

- Easing of closing side of Oak casement

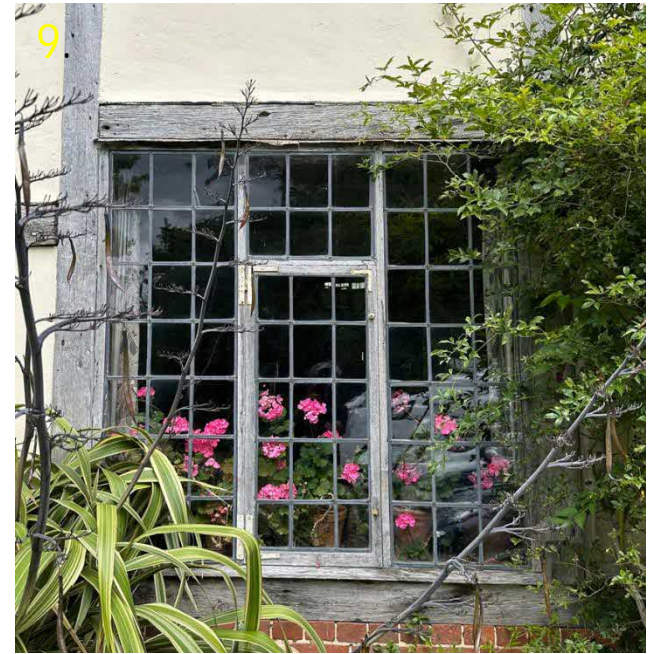
Item Number 9 **Condition** Poor-Fair
Description Main hall, 3 with 1 opener

- Oak casement bottom rail replacement,
- Cill to be de-frassed and condition accessed for repair
- Transom repair and re-fix

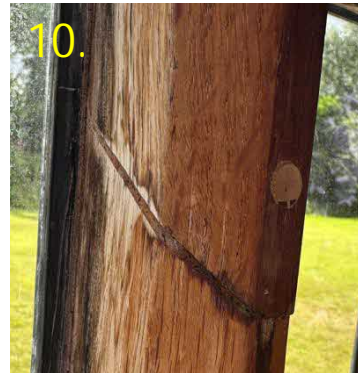
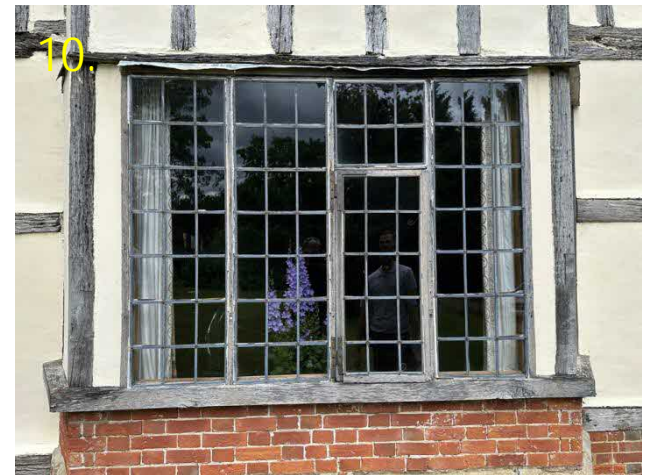
Item Number 10 **Condition** Poor
Description Music room/drawing room 4 with 1 opener

- Casement repairs on bottom rail and stile ends
 - Rehang casement to ensure correct fitting
 - Leaded lights to be overhauled and re-glazed, re-using existing glass where possible
 - 1 broken pane on RHS
- *note that the existing mullion repairs are angled into building, they should be the opposite.

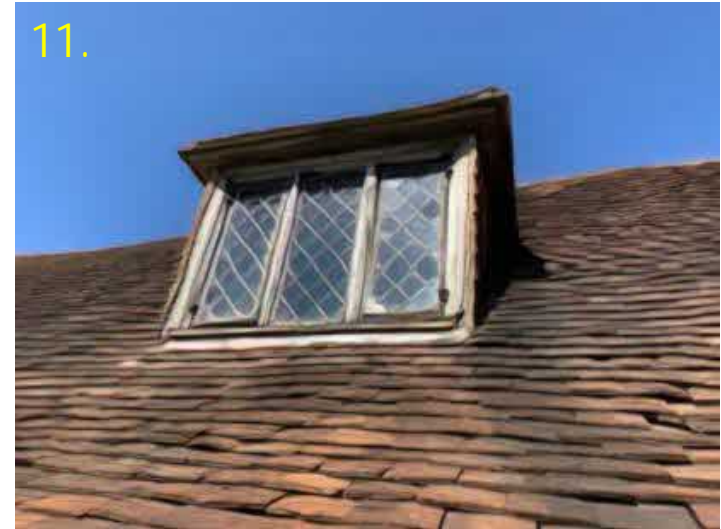
Item Number 11 **Condition** Poor- Fair
Description Upper Floor Dormer (West)

- Repairs to both jambs required
- Stay pin replacement
- Adjustment of casement
- Replacement of both cover boards
- Re-fitting of all leaded lights
- Casement pintels tightening
- Repair or replacement of cill

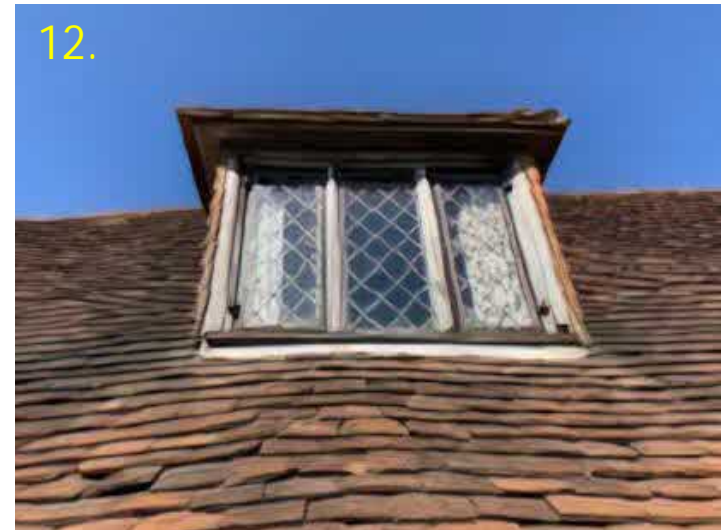
Item Number 12 **Condition** Poor-Fair
Description Upper Floor Dormer (East)

- Tightening of pintels
- Local repairs/replacement of cill
- Replacement of casement stay pin
- Repair of moulded cover boards to be repaired
- Securing of middle leaded lights

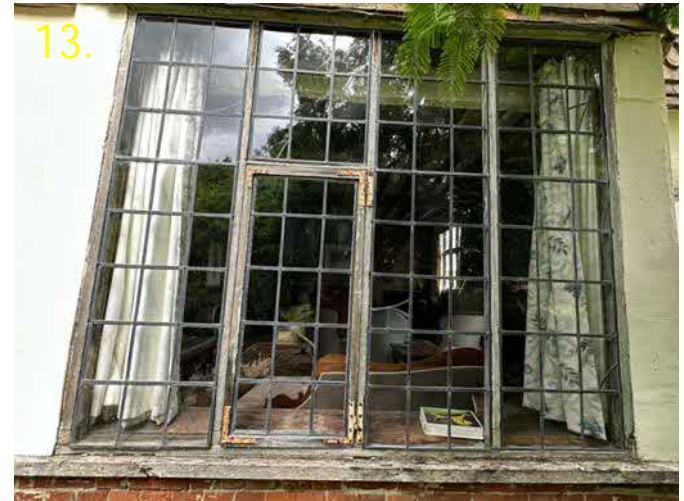
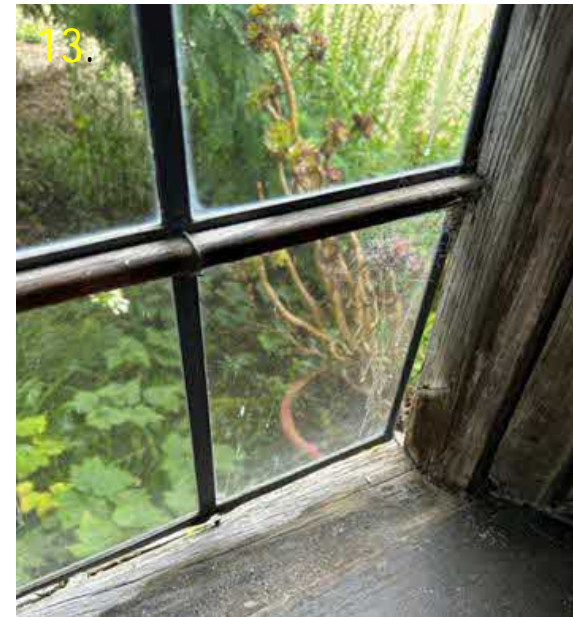
Item Number 13

Description TV Room large 4 pane 1 opener
South East Elevation

- Ironmongery overhaul including 2 hinges
- RHS leded light overhaul
- 1 cracked pane to be replaced
- All leded lights need to be removed and refitted to frames
- Re-pointing under the cill
- Cill repairs where needed
- Transom re-fixed as its loose

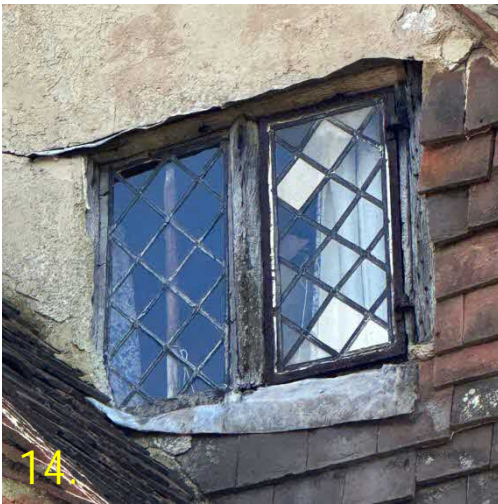
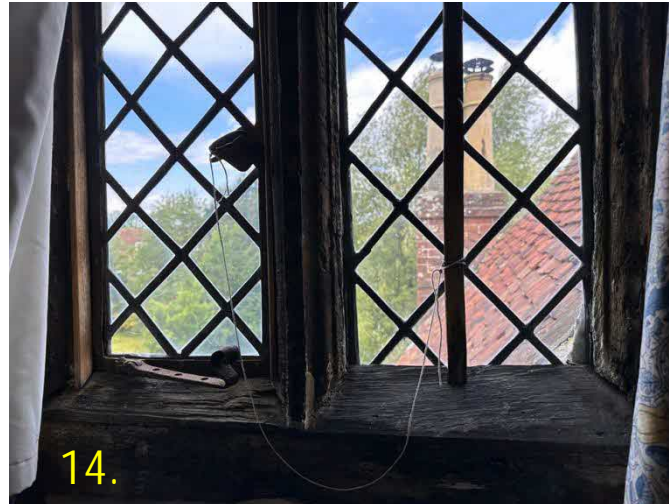
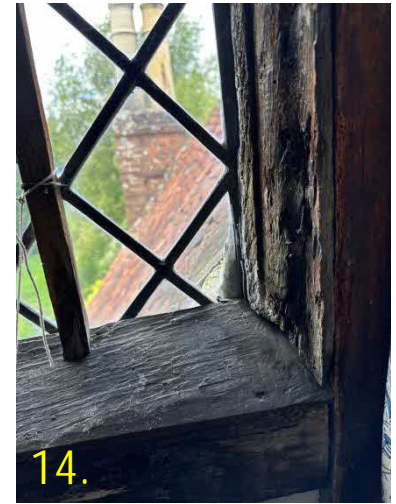
Item Number 14

Condition Poor Cill has holes through it causing water ingress Exterior plaster blown and in a poor state. Lead-work under the window is failing and not secure

Description Top floor window. 2 with one opener.

Window will need to be removed and worked on in the workshop, local repairs and component replacement, Oak frame rail the window sits on is wet and will need further investigation to assess condition.

- Re-glaze, utilising existing glass where possible and overhaul leaded lights
- The bottom of this window is covered by the roof line, potential to increase efficient weather detail

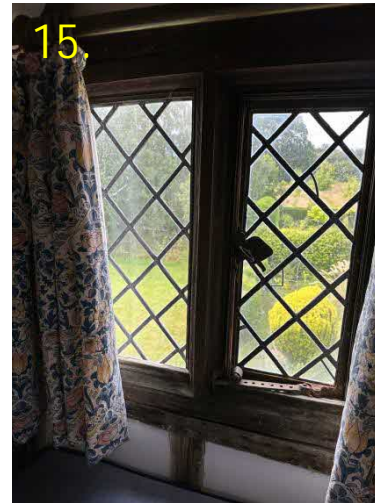
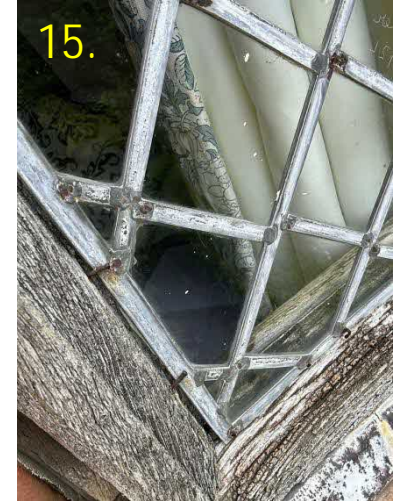
Item Number 15

Condition Poor

Description Top floor RHS of chimney breast 2 with 1 opener

remove windows to workshop

- Cill replacement
- Leaded lights overhaul
- 2 panes broken to be replaced
- Jamb and mullion end repairs on 3
- Secondary draught strips to be re-made and fitted
- Iron casement to be assessed for repair or replacement

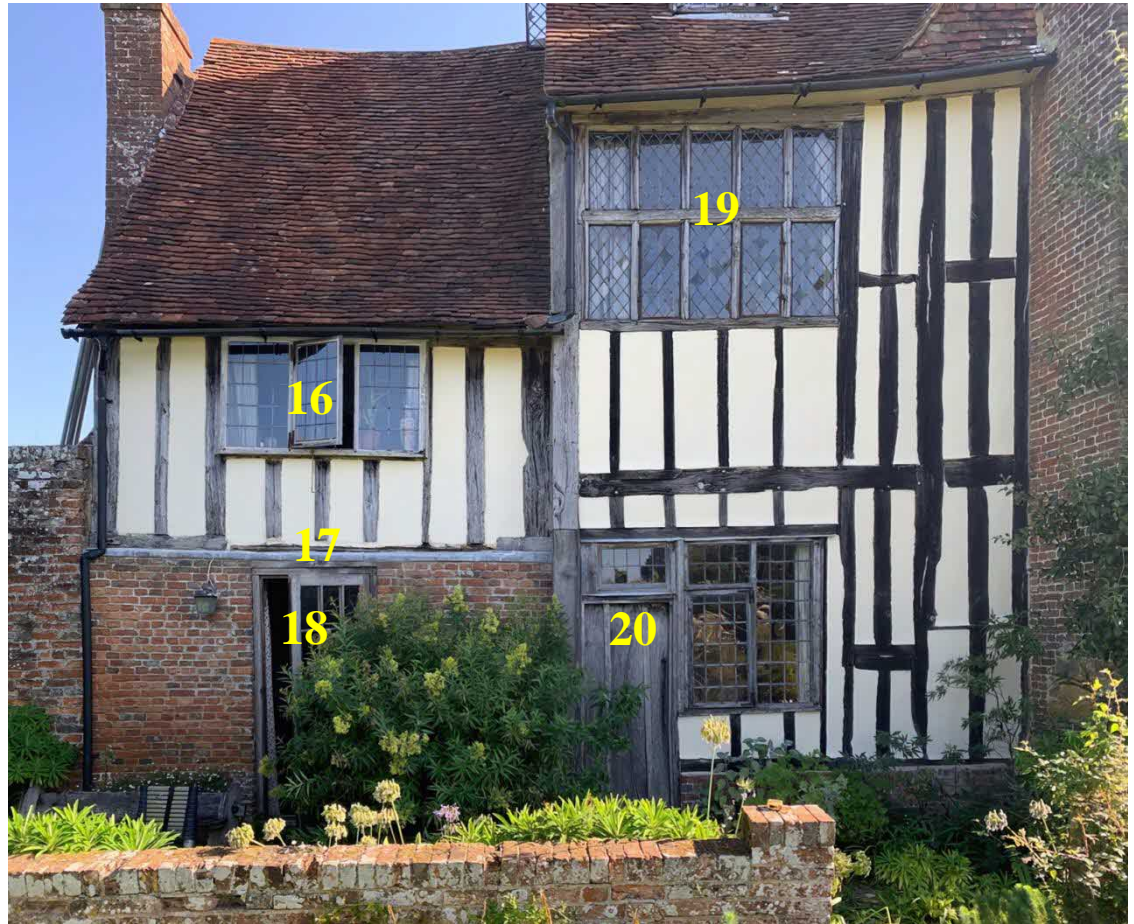
Item Number 17

Poor

Description Structural mid rail and base of 5 studs connected

- Removal of decayed timber and replacement with dry oak to match existing dimensions
- Removal of decayed material on stud feet and replacement with dry oak to match dimensions and conversion. New joints to be cut connection studs and mid rail reflecting the original carpentry
- Where insufficient structurally sound timber is found then the members may require replacement

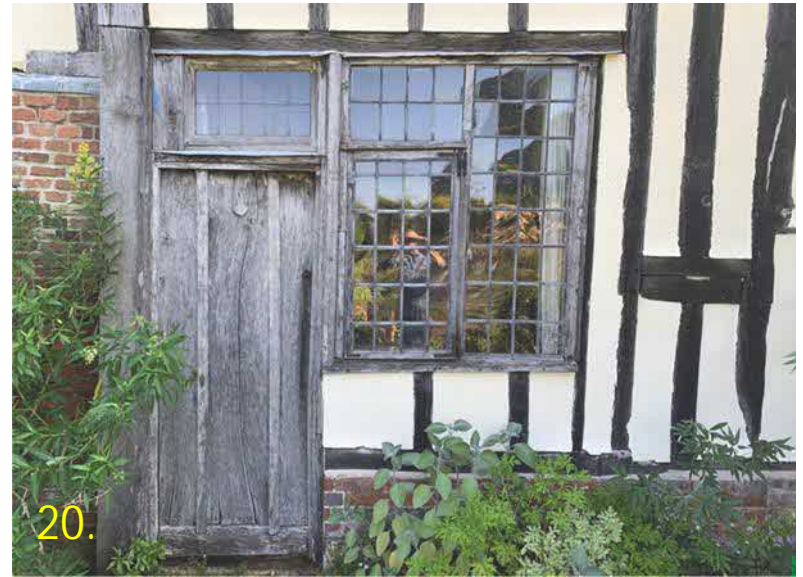
Item Number 20

Condition Poor Fixed sash in poor

condition, racked and fractured door leaf, decay to door frame

Description Door and windows

- Repair of fixed sash
- Repair to door leaf and frame
- Renewal or repair of cills, jambs and mullions

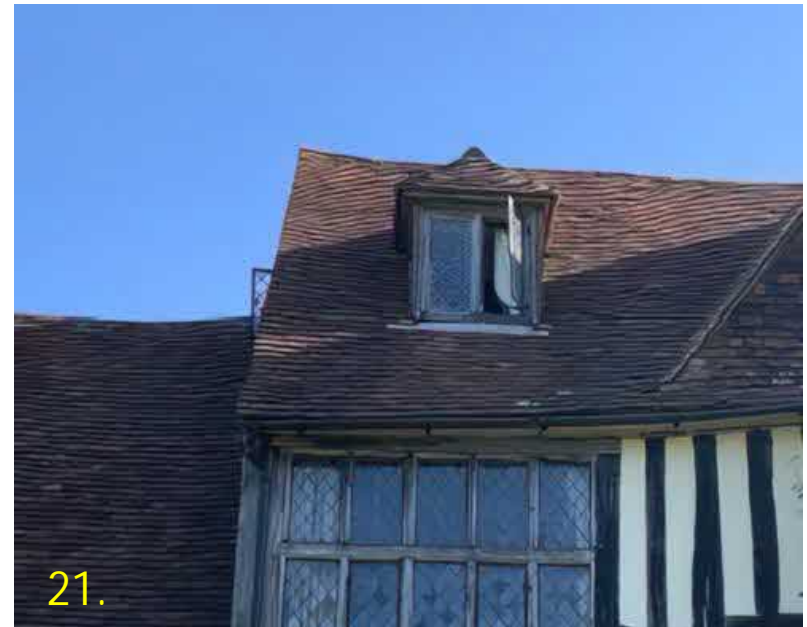
Item Number 21

Condition Poor

Description Upper Dormer

- Repair or replace timber elements where required
- Full service in joinery workshop

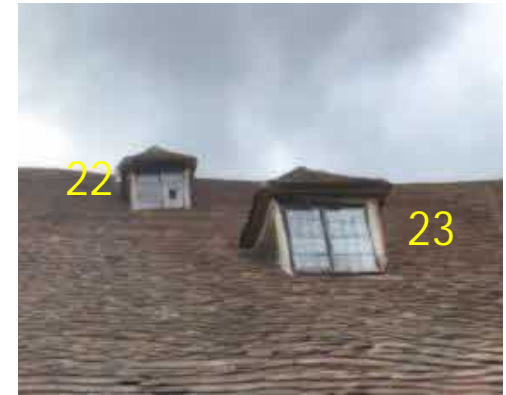
Item Number 22 **Condition** Poor, structure leaning caused by structural instability due to decay

Description Upper Dormer Window

- Further investigation in to cause of failure required
- Repair to cill
- Replacement of pane of glass
- Replacement of pintel
- Refitting of casement#

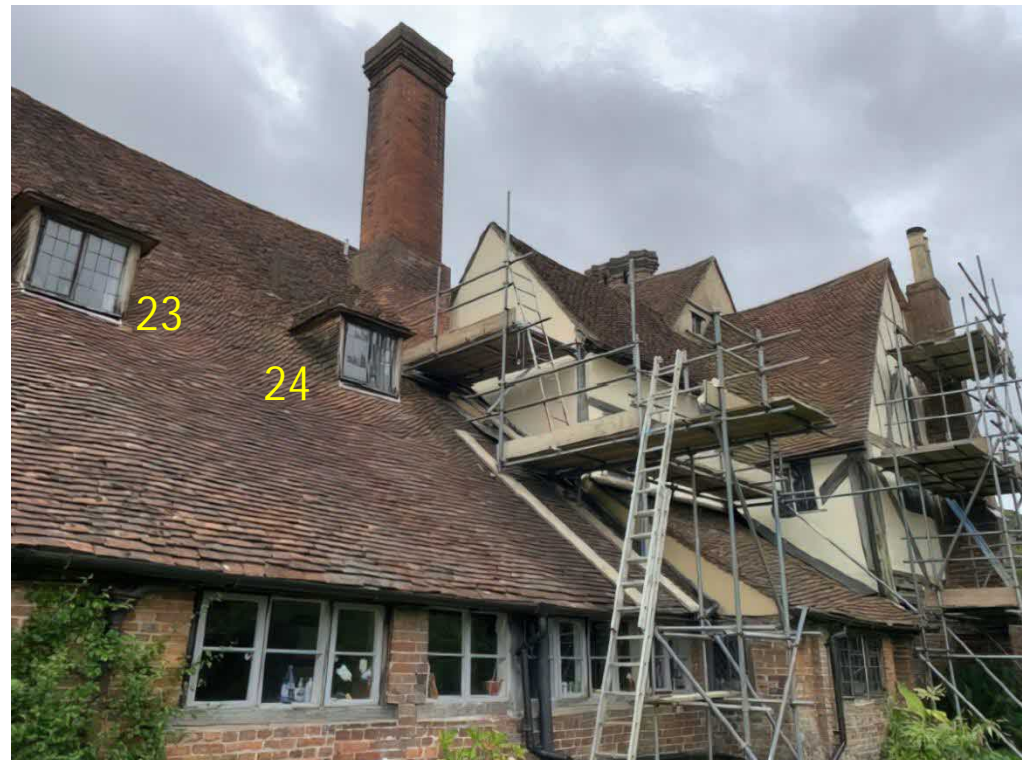
Item Number 24 **Condition** Poor

Description Bathroom Dormer

- Replacement of pintel
- Repair/renew cill
- Latch repair to central mullion
- Replacement of covering boards
- Refitting of stay pin
- Refitting of lead lights

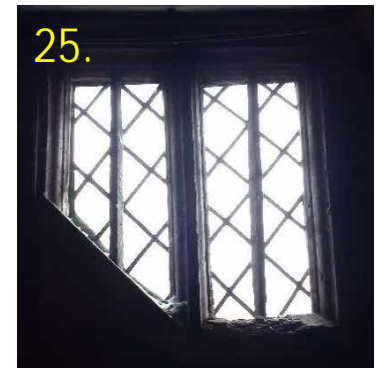
Item Number 25**Condition** Poor**Description** Small studio window**Recommended Works**

Replacement of the window matching dimensions and design

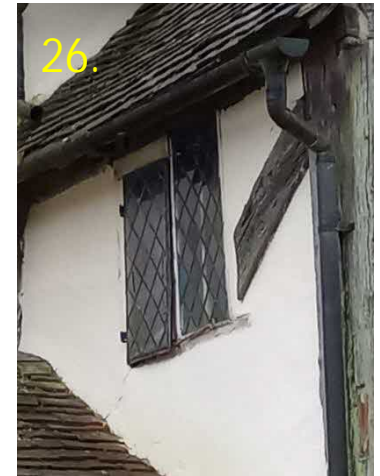
**Item Number 26****Condition** Poor**Description** Stairwell window**Recommended Works**

- Repair or replacement of cill and effected areas
