Heritage Impact Assessment  
(including Design and Access Statement)

Goddards Green  
Angley Road, Cranbrook TN17 3LR

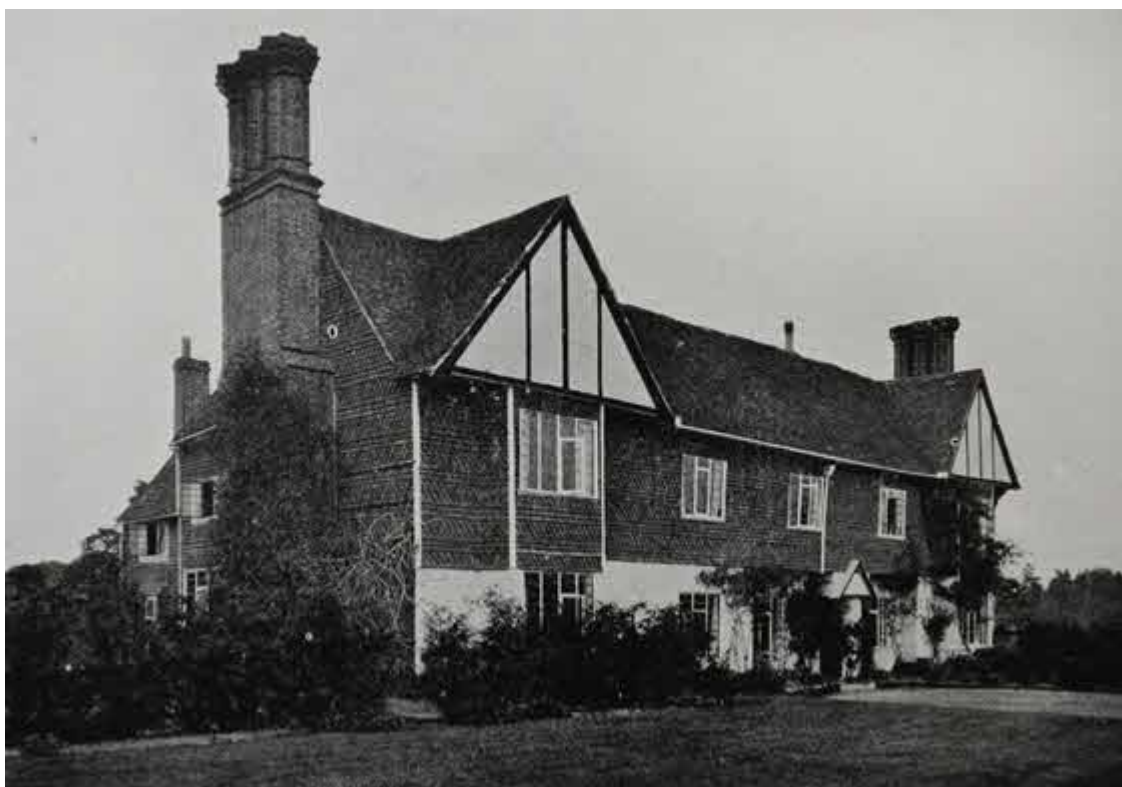
Late C19th/early C20th photograph showing the front (Southeast) and flank (South-west) elevations.

The historic photograph of the house clearly indicates that dormer windows to the front elevation have been added. Hanging tiling, protecting the timber frame, is now only retained in the areas noted in item 1.03.

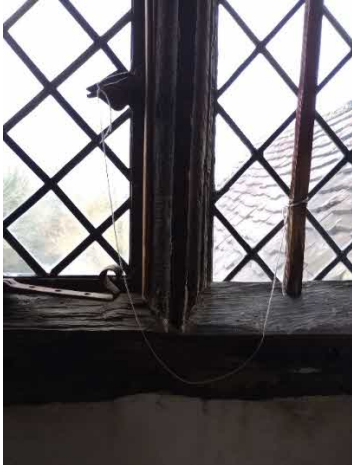
Window 14

- 3.01 The proposed works involve the repair and restoration of damaged/tired leadlights where there are gaps between both fixed and opening lights and their frames, distortion and damage to the quarries.

Leadlight panels are to be re-made and the historic glass will be re-used.

- 3.02 Repairs to window frames are also to be implemented (see Dolmen Schedule) with any scarfing angled to the exterior of the building such that any water entering the repair joint is inclined to drain outwards rather than to the building interior.

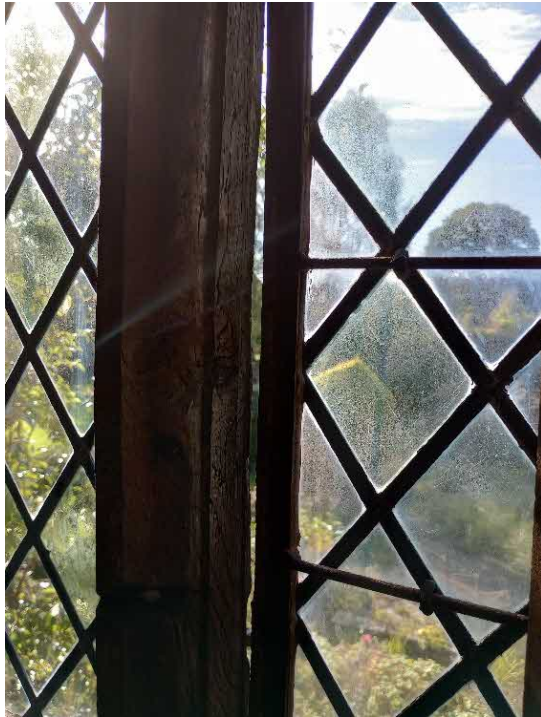
1.05 The house is currently extremely draughty and difficult to heat during the Winter months. Gaps are visible where opening lights close against frames and some fixed lights are distorted such that there are gaps between them and their window frames.

Window 19: gap between opening light & frame

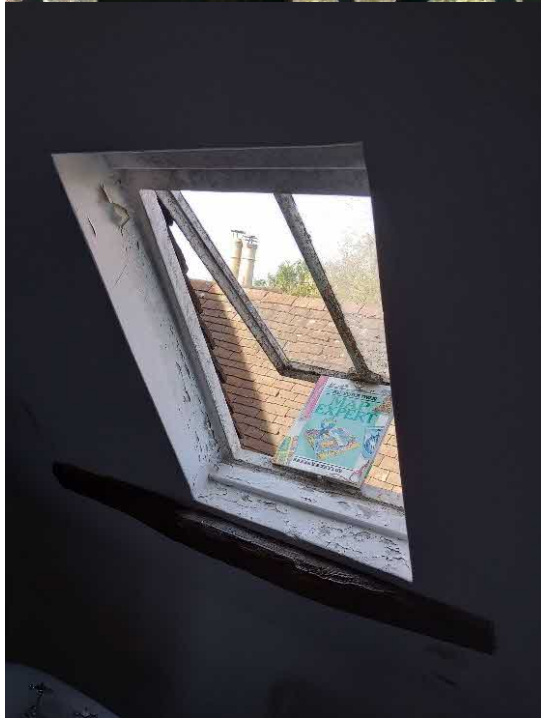
- 2.04 To the rear slope of the main roof, a C19th cast iron rooflight provides daylight and ventilation to the attic bathroom.
- 2.05 External ground floor doors comprise a mixture of historic and C20th doors – the glazed C20th door (joinery item 18 in the Dolmen condition survey) is to be replaced.

Cast iron rooflight to attic bathroom.

Secondary glazing is also to be fitted to the attic bathroom which is illuminated by a cast iron rooflight. Here, a glazed panel set in a timber frame is to be fitted to the coved ceiling. The panel will be hinged to allow access to the rooflight so that it may be opened.
