Tree Condition Report Arboricultural Impact Assessment Method Statement and Tree Protection

Land at 22 Hawthorn Road, Shrewsbury

Site Visit: 30th January 2024

Written by: Zoe Adlington MSc, MArborA

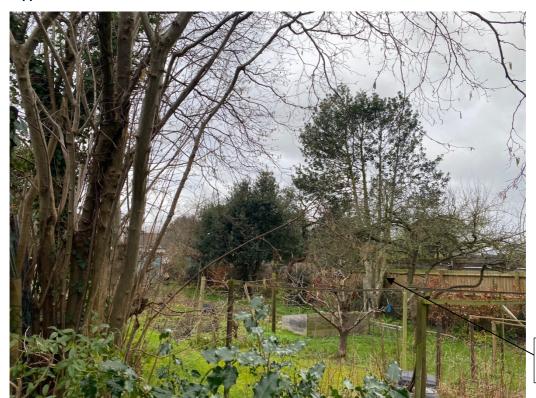
G1- on neighbouring property

Root: no visual evidence of soil movement. **Stem:** crowns lifted over the garden.

Crown: No evidence of recent breakouts or significant dieback.

Install section of Heras fence barrier positioned as indicated on the tree protection plan.
 Specification as recommended in BS5837 (2012) fig.3 appended

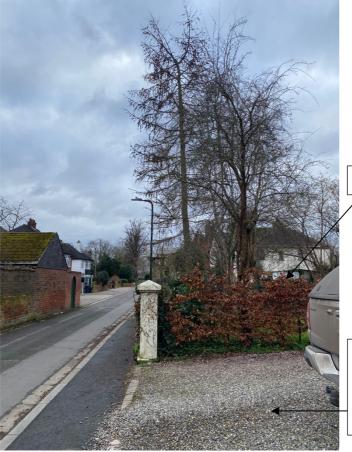
Н2

Existing driveway will provide ground protection during the construction. Vehicles will still require this for parking.

- Install section of Heras fence barrier positioned as indicated on the tree protection plan. Specification as recommended in BS5837 (2012) fig.3 appended.
- The existing driveway will provide adequate ground protection during the construction
 of the extension. Parking for the owners will still be required during the construction, as
 there is no parking available along the road side.
