DJC/DS/6166

25 August 2023

### **JAMES STIFF COTTAGES, ROUGHAM – STRUCTURAL INSPECTION REPORT**

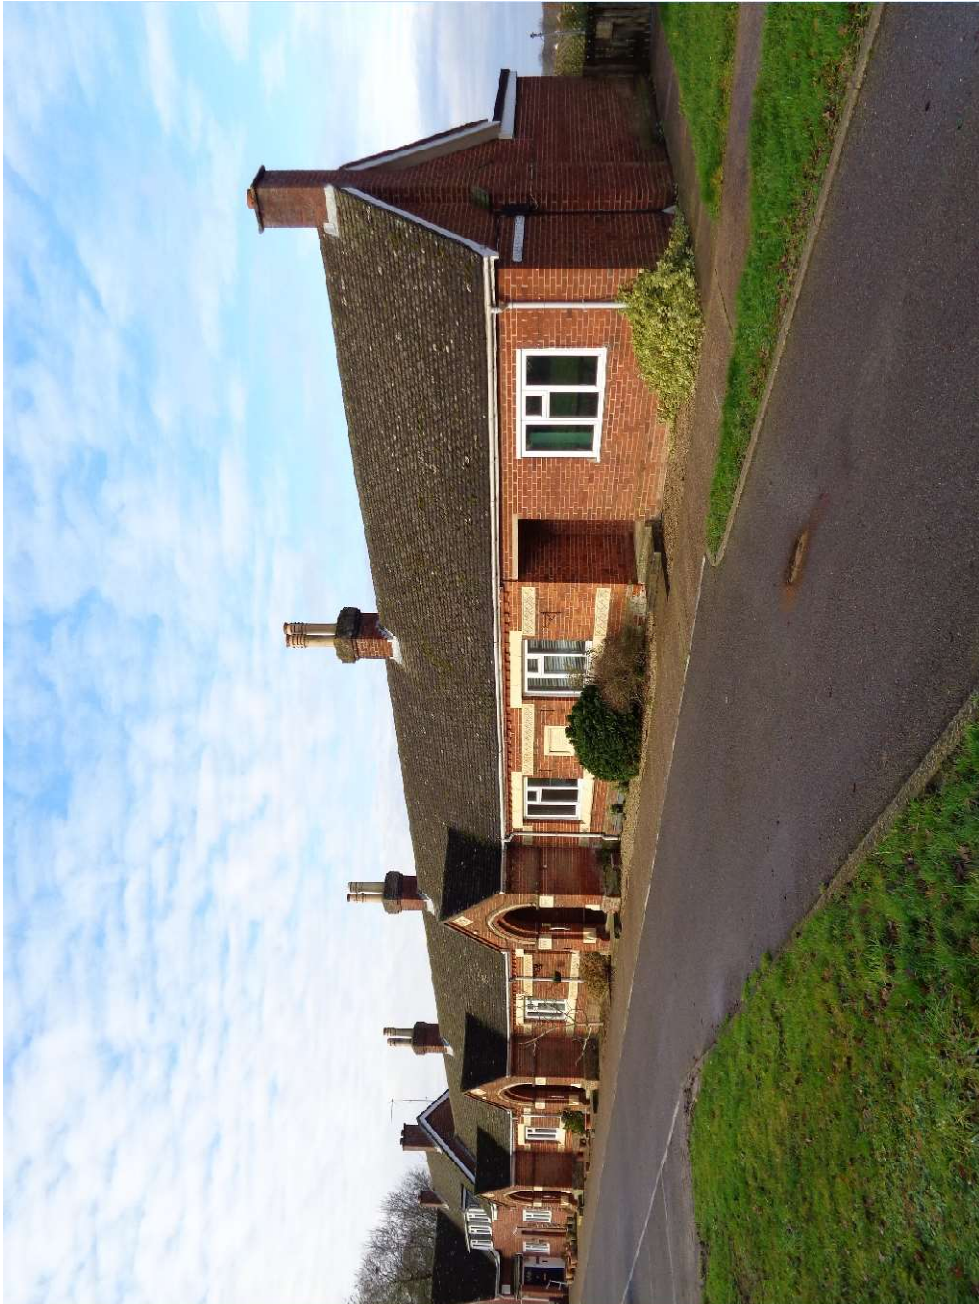
#### Photograph 1

The terrace of single storey Alms Houses was constructed in 1876 from solid masonry with a raised collar pitched roof overclad in clay tiles. The eastern property was constructed in the 1970s in a similar style, with cavity masonry and a cut rafter and purlin roof overclad in clay tiles. To the rear of the terrace, a single storey flat roof extension forms the kitchens and bathrooms. See Photograph 1.

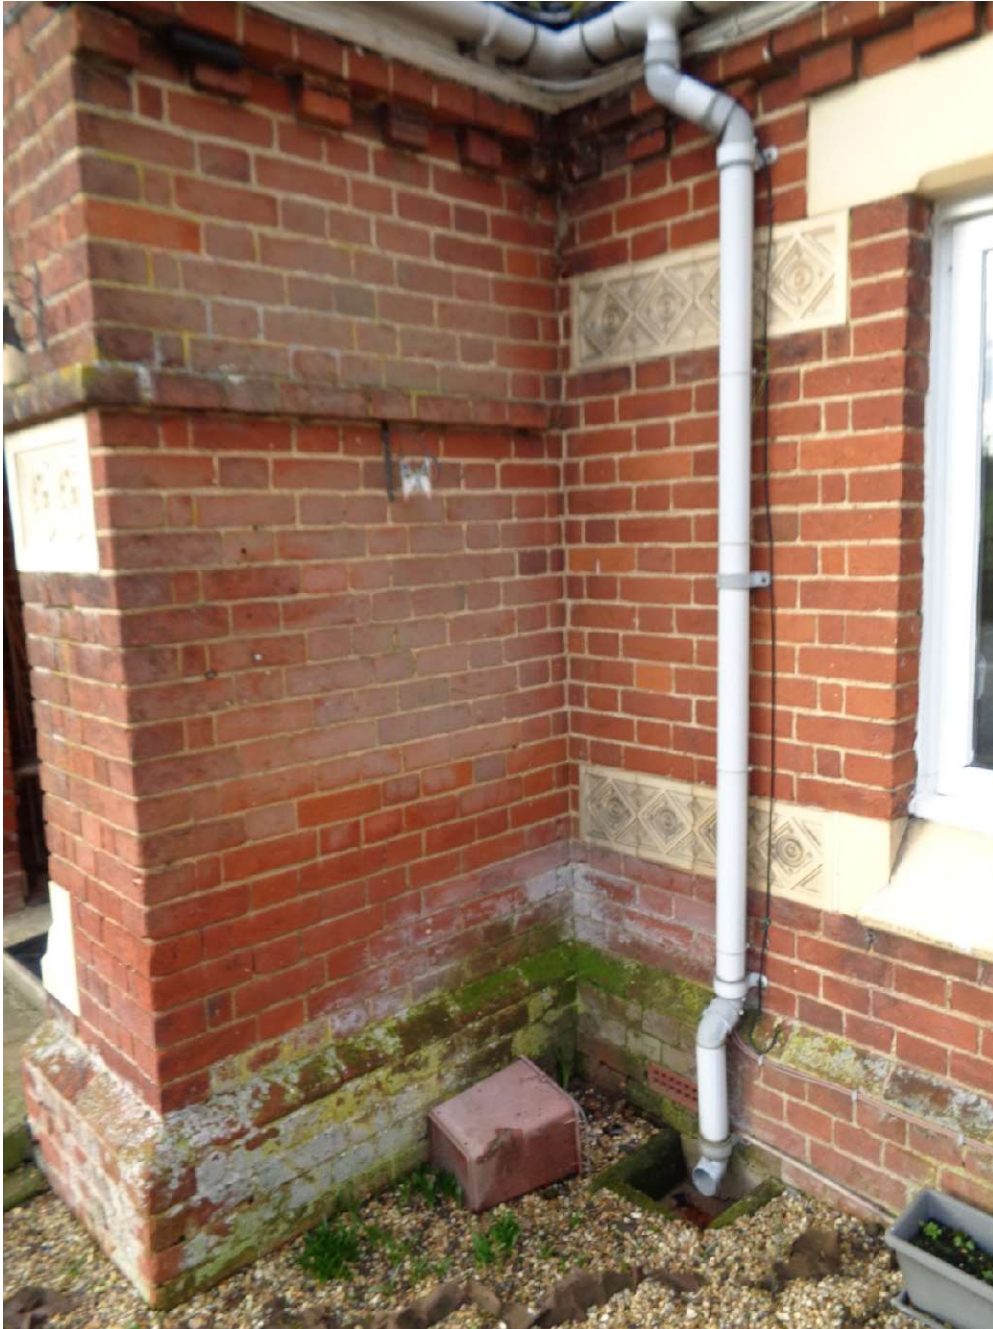
#### Photograph 2

An inspection of the front elevation generally reveals no significant damage, with washout of the lime mortar occurring in two locations – probably associating with historic leaking of rainwater goods that has now been repaired. See Photograph 2.

The historic properties have been constructed using traditional masonry and lime mortar, which generally appears to be in good condition. Small areas of mortar washout have occurred in two locations and this should be repointed with a sympathetic material.

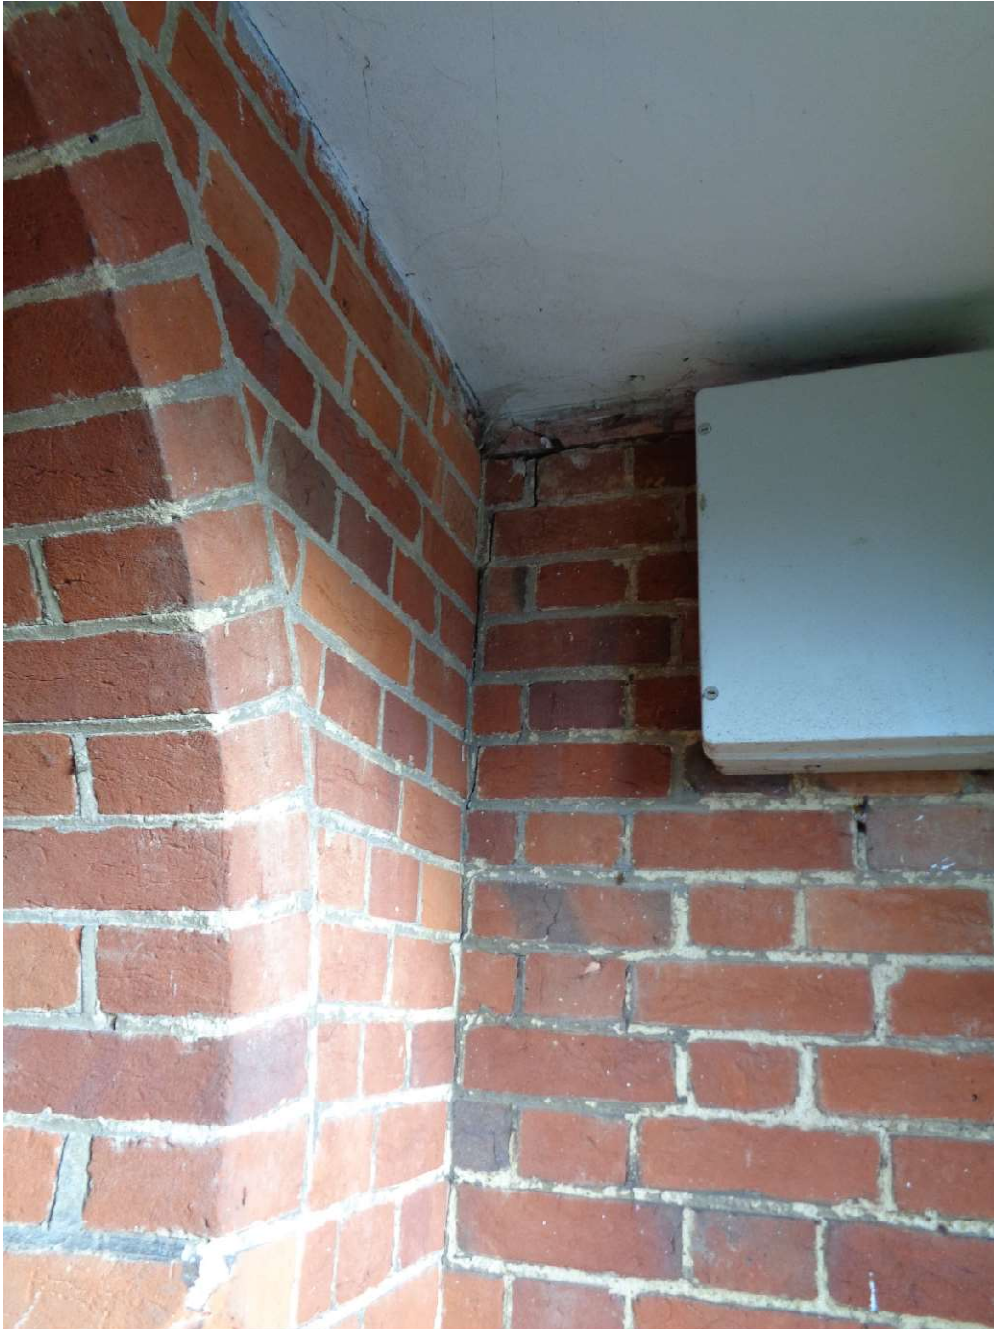
#### Photograph 3

Access to each pair of properties is through an archway structure. Generally, these appear to be in good condition, however there is evidence that there is slight differential movement between the arch and the main property which took the form of vertical tapered cracking up to 1mm wide. See Photograph 3 Within the central arch, delaminating between the brick coursing has occurred leading to a crack up to 1mm wide. See Photograph 4.

We consider that the crack damage noted to the entrance arches is due to minor differential settlement between the entrance arch and the main building. We would recommend that helibar reinforcement is installed at 450mm centres vertically to prevent further movement and the damage repaired using traditional stitching.
