## APPENDIX A – Structural Reports Referred

ISSUED FOR INFORMATION	By	LRS	Date	07.06.23	Rev.	P1
<b>ISSUED FOR INFORMATION</b>						
Title <b>PLAN SHOWING INITIAL CONDITION ASSESSMENT - SHEET 3 of 3</b>						
Project <b>MTR PROJECT MADEIRA TERRACES, BRIGHTON</b>						
Client <b>BHCC</b>						
<b>HOP</b>		HOP House, 41 Church Road Hove, East Sussex BN3 2BE www.hop.uk.com ask@hop.uk.com +44 (0)1273 223900				
Drawing No. <b>MTR-HOP-01-XX-DR-S-S003</b>						Status <b>S2</b>
						Rev. <b>P1</b>

<b>PROJECT:</b>		Project No:	12719-6
Madeira Terraces		Site Visit No:	14
<b>SUBJECT:</b>			
Visit to Cast Iron Welding Services to review Grit Blasting Trail			
Date of Visit:	2 <sup>nd</sup> May 2023	Arrival Time:	10.30
Record prepared by:	Nigel Hosker	Departure Time:	15.30
Weather conditions:	Generally dry and sunny		
Site visited by:	Nigel Hosker (NJH)	Representing:	HOP Consulting Limited (HOP)
Visitor accompanied by:	Neil King (NK) – Purcell; Lian Harter (LH) – Purcell; Ian Graham (IG) - B&HCC CIWS Hosted the visit at their Offices and other facilities.		
<p>The purpose of the visit was to visit Cast Iron Welding services yard to meet the team and review grit blasting of components already

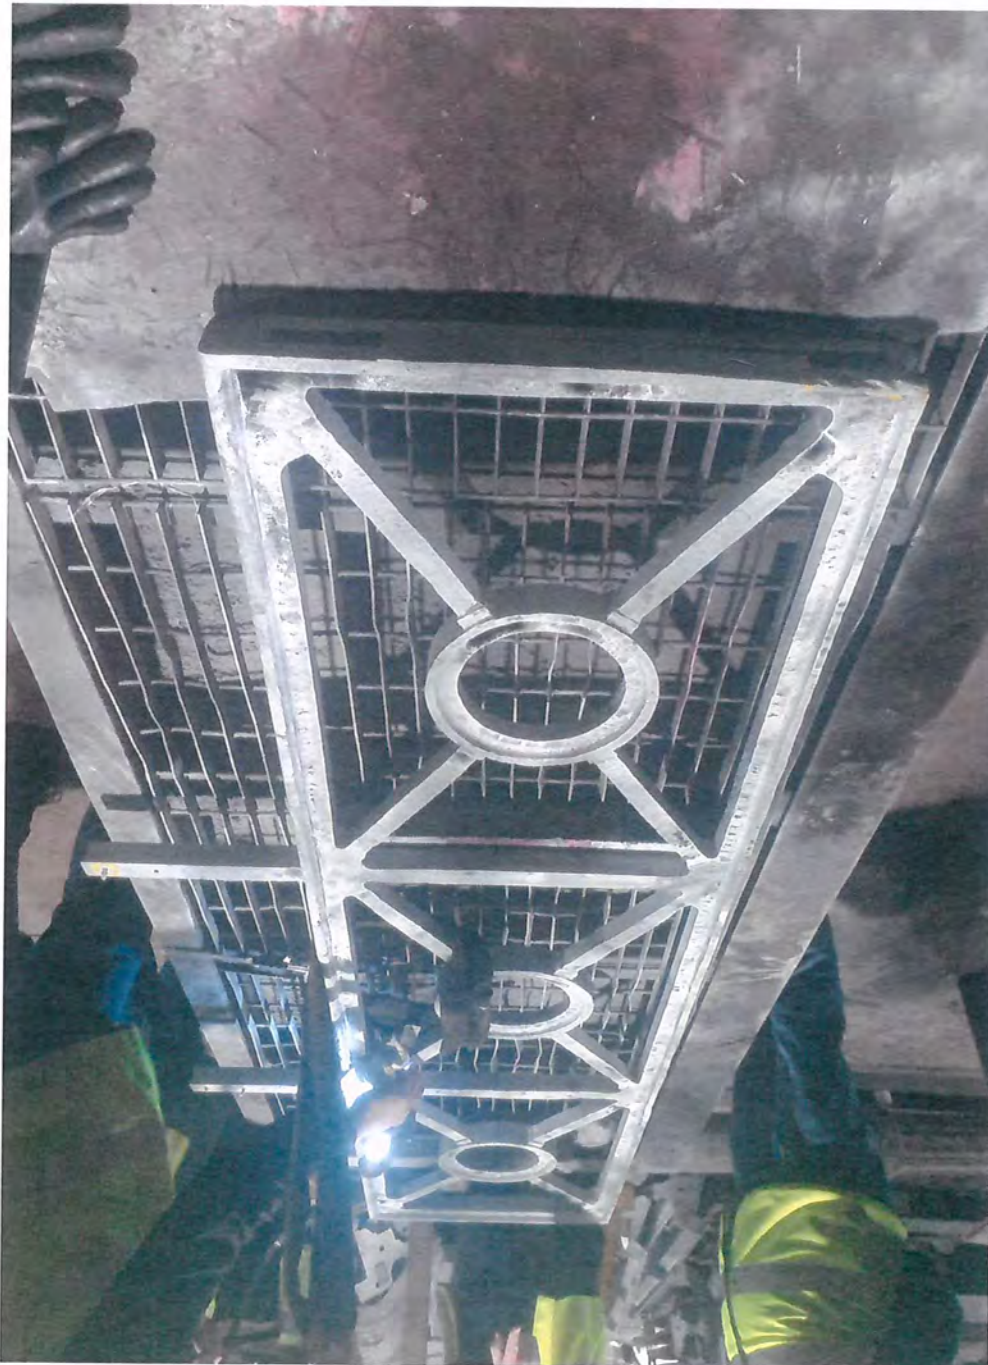
Photo 1 indicating Existing infill recovered to bench test  
Note variable geometry and 2 No. horizontal members  
spanning nominally 2.4m (transom)

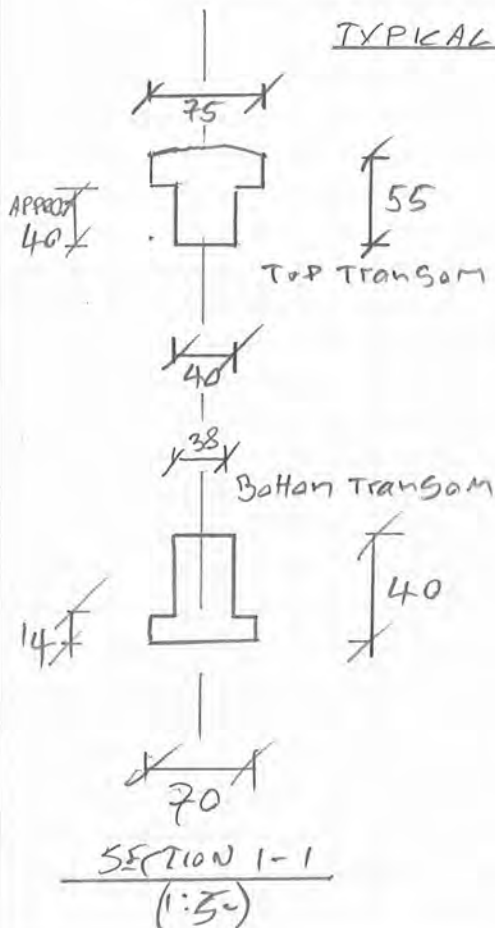
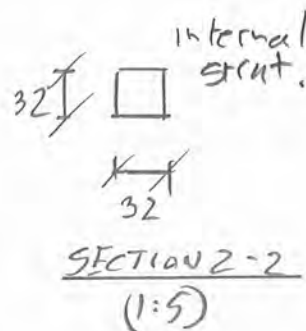
TYPICAL BALUSTRADE ARRANGEMENT

NOTE ALL SECTION SIZES HIGHLY VARIABLE WITH LOCALISED NECKING NOTED FROM CRIT BLAST INSPECTION AT CIWS YARD

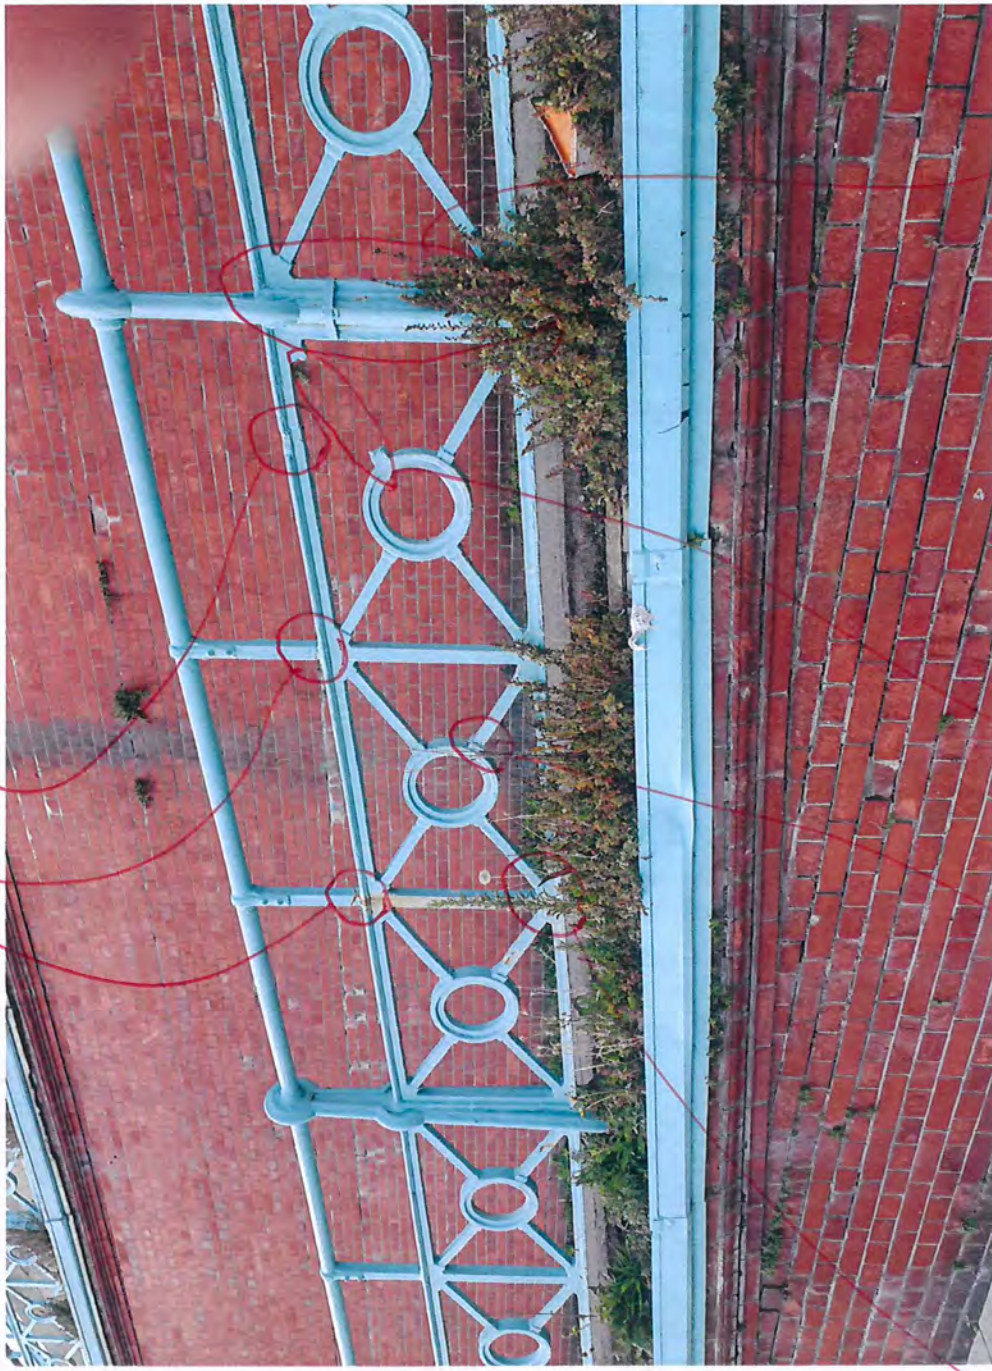
Diagonal strut fails brittle failure check (Note also supported by visual failures evident) Ref photo 2 over

Ref: 324 photo 2 typical Defect evident.

FRacture unlikely due to flexible top rail  
DISCONTINUITY TOP TRANSOM

SEPARATION  
OF IN FULL  
STRAPPED

DIAGONAL STEEL FRACTURE  
TYPICAL DEFECTS (photo 2)

CASTING DEFECTS  
IDENTIFIED TO NODES  
DURING CIWS INSPECTION

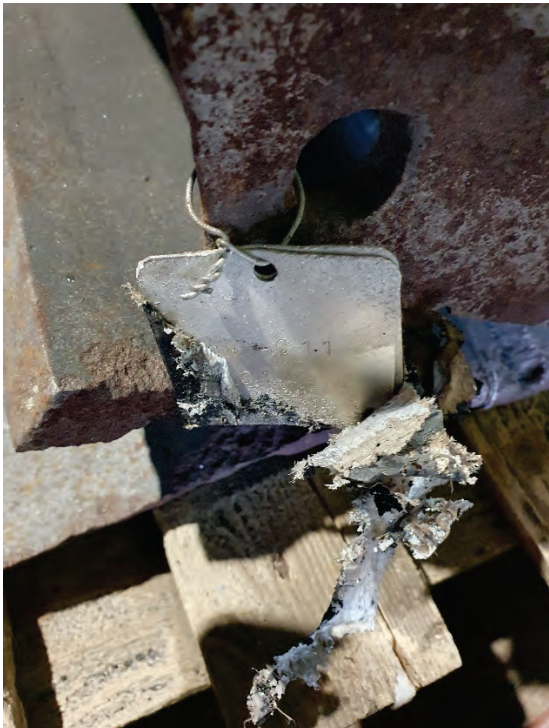
<p><i>Photograph 1 indicating metal tags used to identify artifacts.</i></p>

It is proposed all artifacts are tagged with metal tags with a unique referencing such that artifacts would be auditable [1].

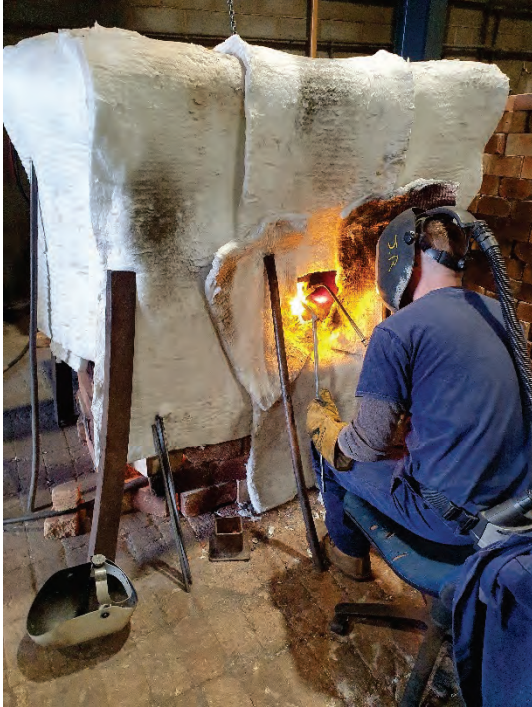
*Photograph 2, indicating fusion welding process where component is locally heated and insulated then welded with oxyacetylene touch electrode and flux. CIWS noted the important of matching the grade of cast iron the parent metal metallurgy which is informed by sampling in their yard.*

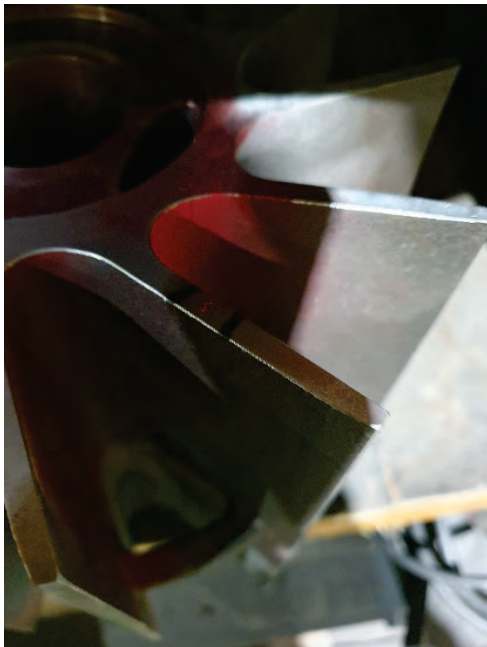
*Photograph 3, indicating an example of a casting defect in a new casting that was to be remedied by fusion welding to achieve full specification.*

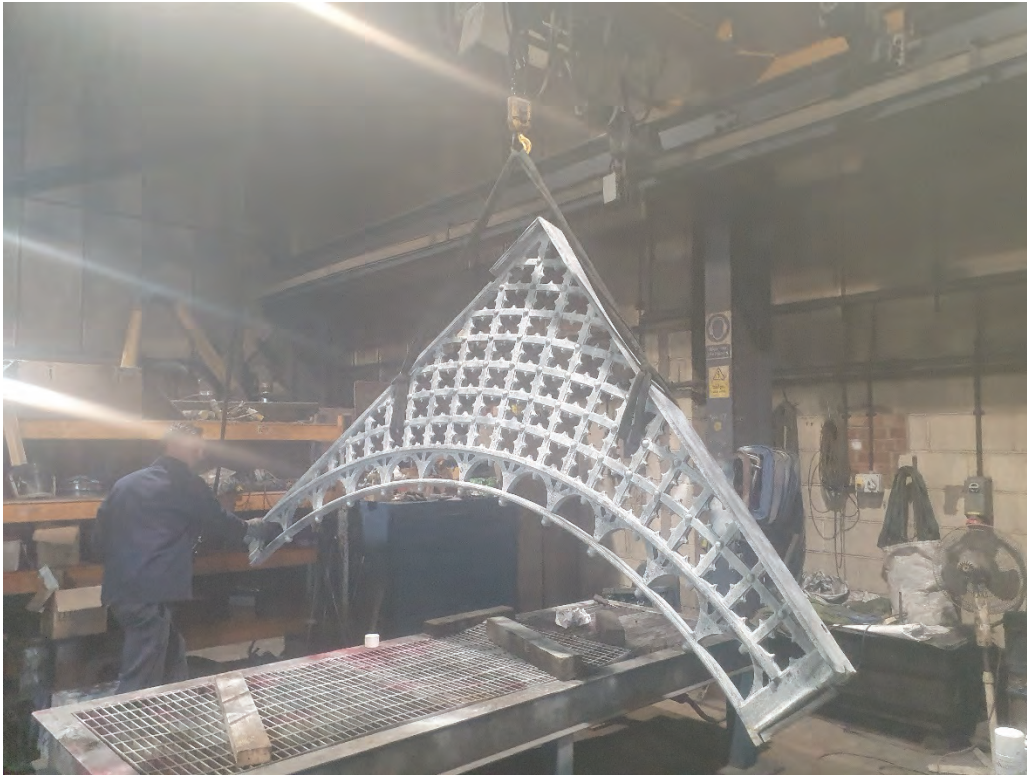
*Photograph 4, indicating 1 of 2 grit blasted spandrel panels awaiting inspection and non-destructive testing on the bench. Note the spandrel has been painted white in preparation for MPI inspection. In general, the grit blasting process had removed many years of paint layers and the intricate detailing and features of the original casting were far more evident.*

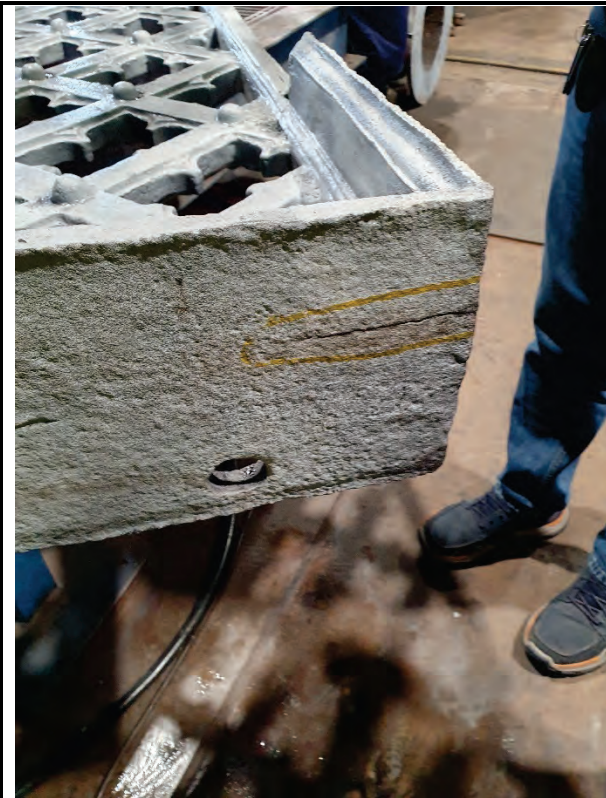
*Photograph 5 indicating fracture to spandrel haunch zone note does not initiate or propagate to a bolt hole.*

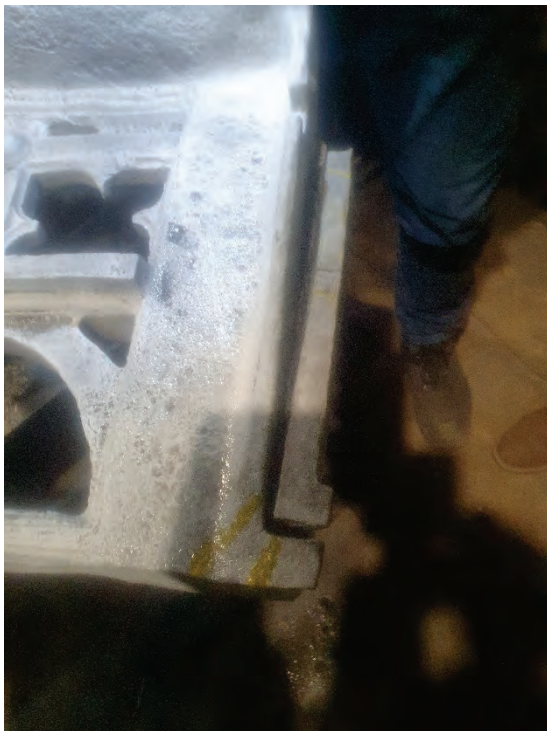
*Photograph 6, indicating fracture to key stone (voussoir) bottom note the residual key stone component had not become free from the grit blasting preparation. This was investigated and it was found that the keystone section was extensively corroded, seized and partly fused into the groove in which it locates. CIWS operative managed to carefully tap this out with mallet and chisel exposing the original casting groove.*

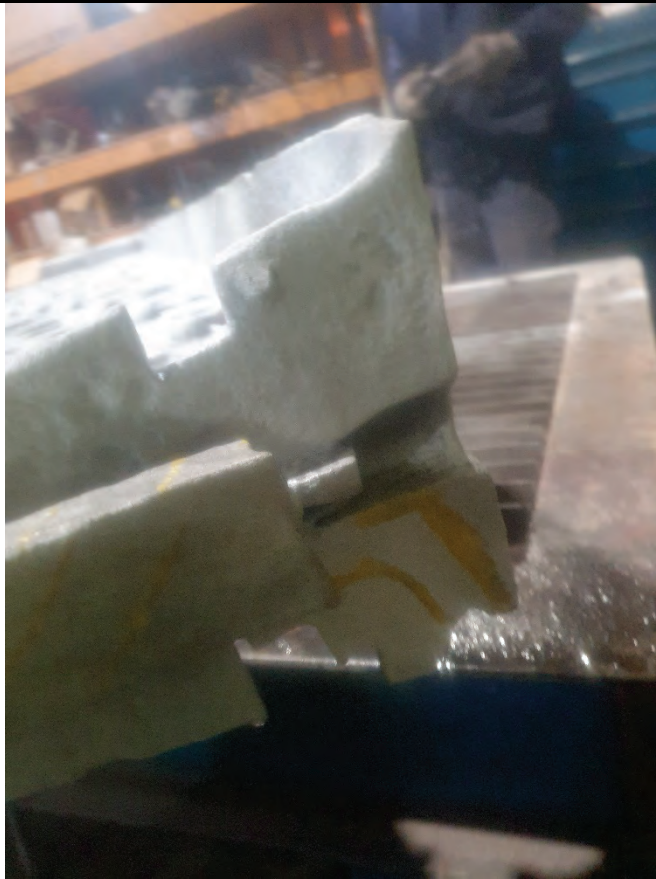
*Photograph 7 indicating fracture to keystone top.*

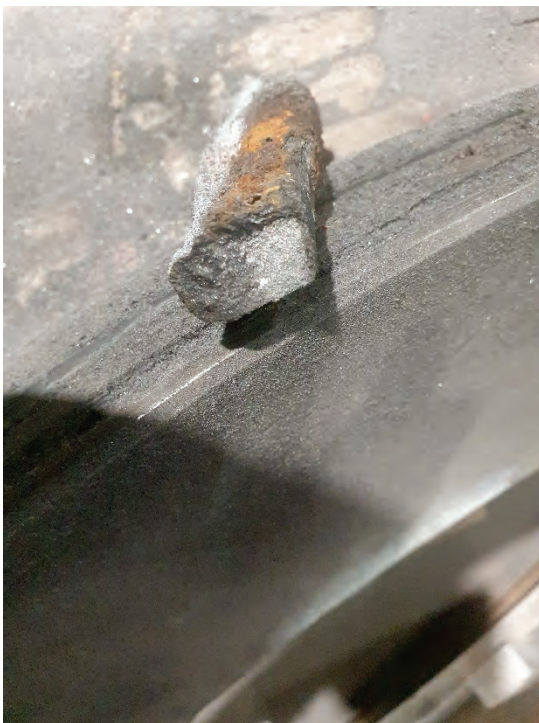
*Photograph 8, extracted section of keystone that had fused with the locating groove, note the shiny fracture surface perhaps an indication graphitic corrosion.*

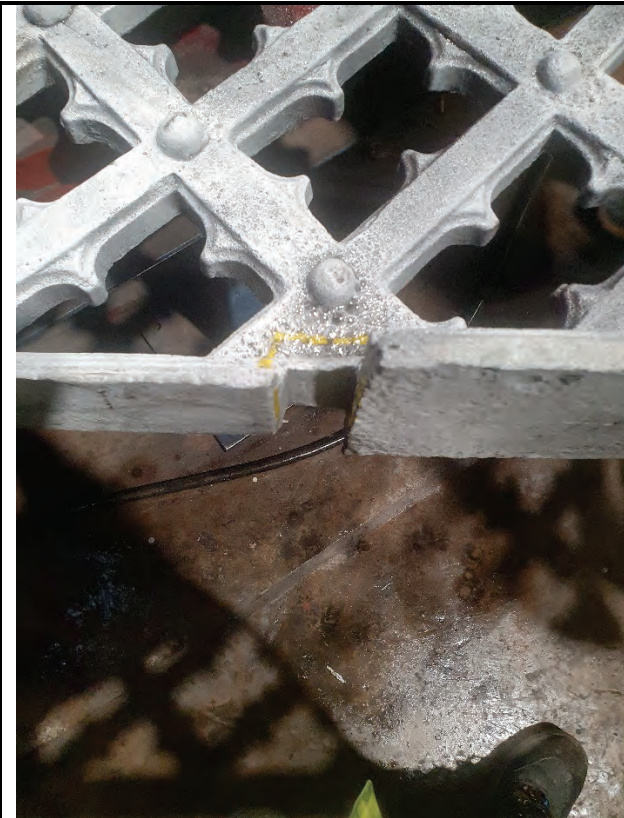
*Photograph 9, indicating fracture to spandrel haunch at the location where section properties curtail abruptly likely a stress concentration.*

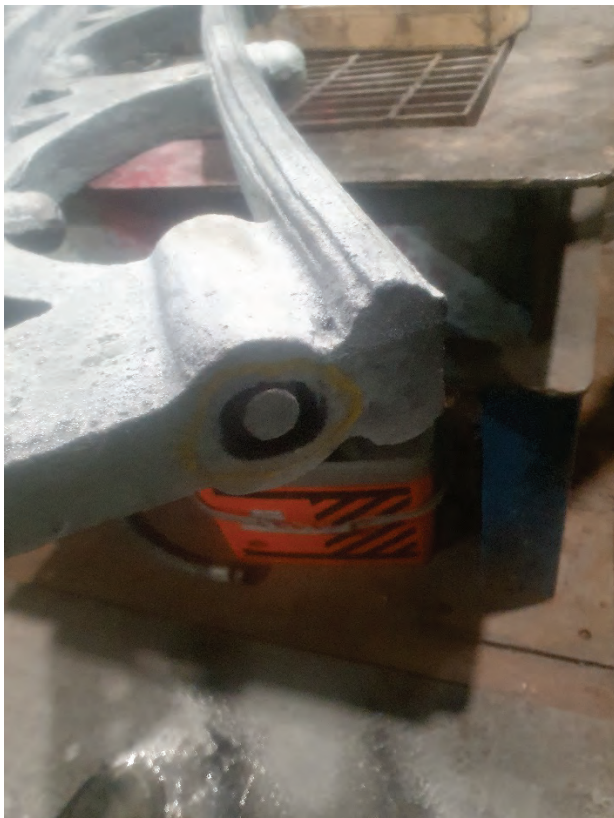
*Photograph 10, seized bolt to corbel / spandrel connection. Bolt could not be readily removed without heat.*

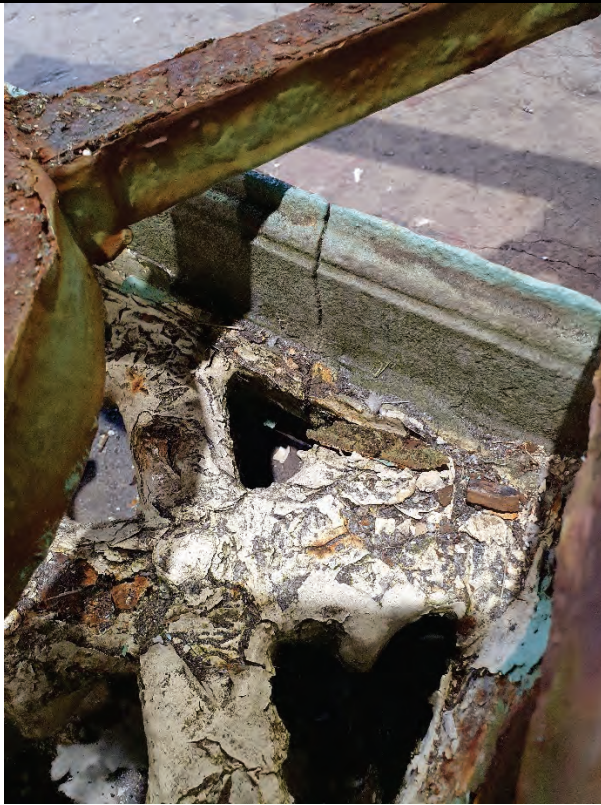
*Photograph 11, indicating 2<sup>nd</sup> spandrel half which had not been grit blasted at the time of the visit though a significant full depth fracture was noted to the haunch propagating full depth through the entire shoulder of the spandrel. No bolt holes in the vicinity of the fracture.*

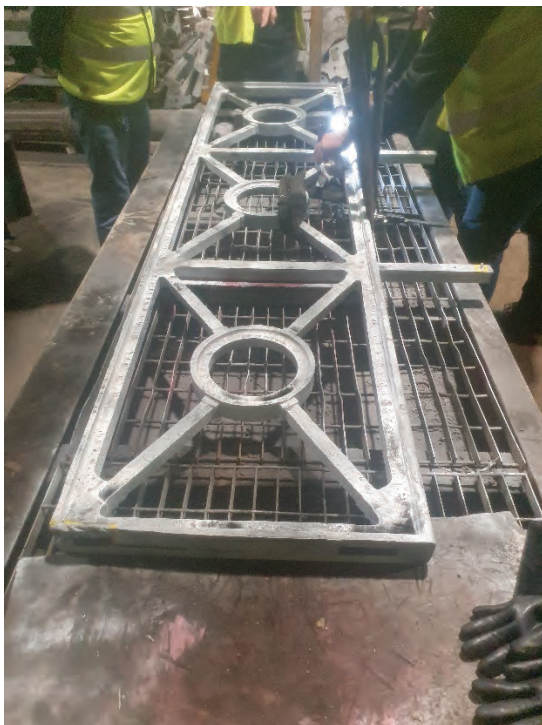
*Photograph 12, infill panel after grit blasting during MPI inspection.*

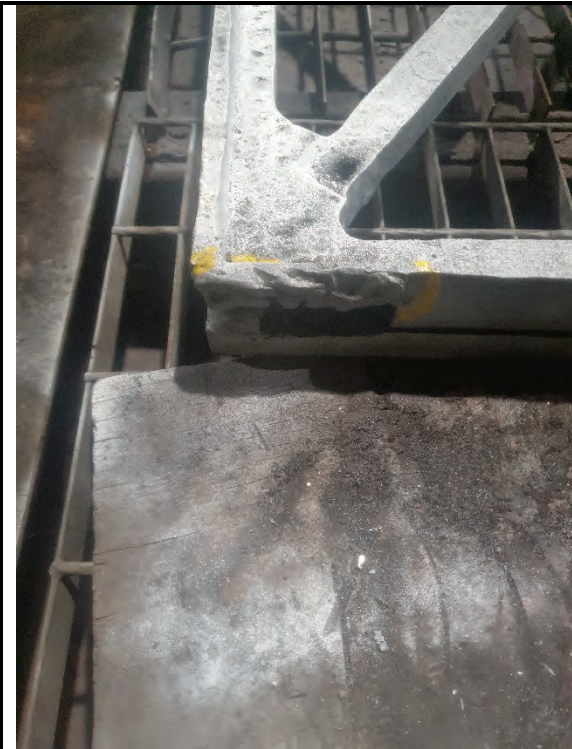
*Photograph 13, indicating bottom corner of balustrade infill, note historical in situ attempts have been made to weld the panel forming an ad hoc repair. Weld quality was of poor quality. It is likely this was done to counter the balustrade panel joints which are generally reported to open up.*

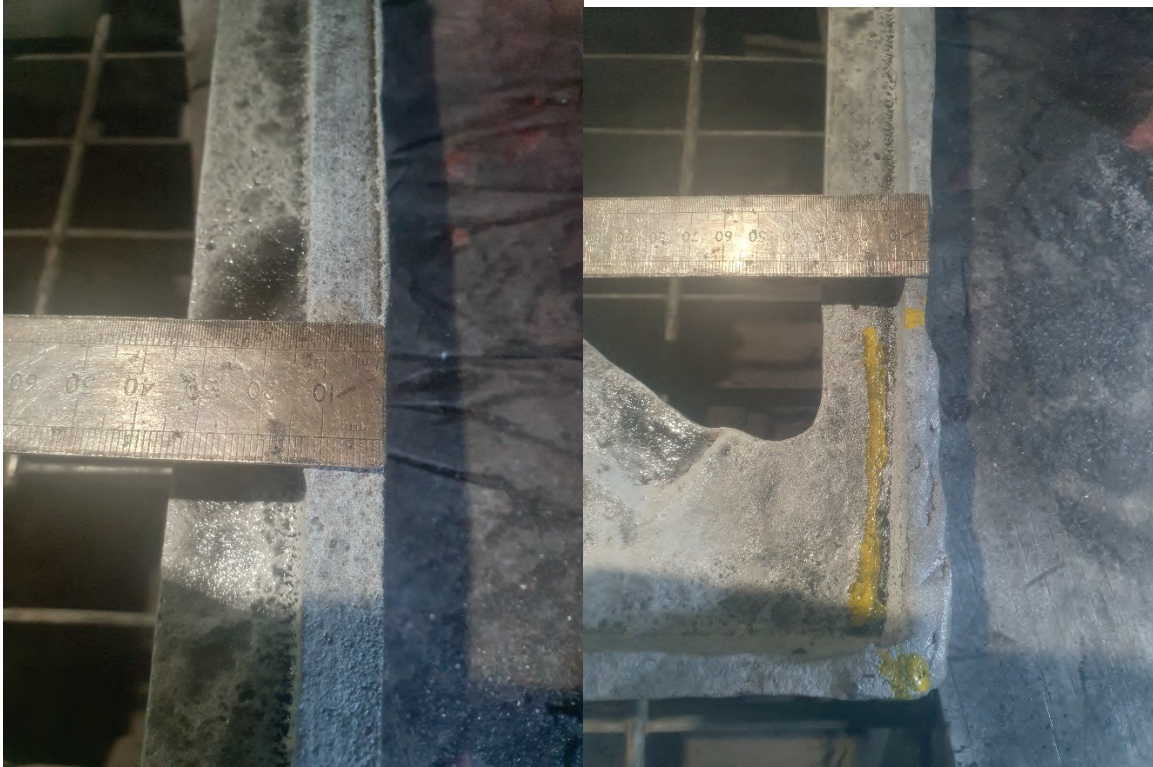
*Photograph 14 & 15, indicating the balustrade infill panel at its junction with standard. Note the necing of the section left (no necking approx. 12mm) and right (necking 7mm).*

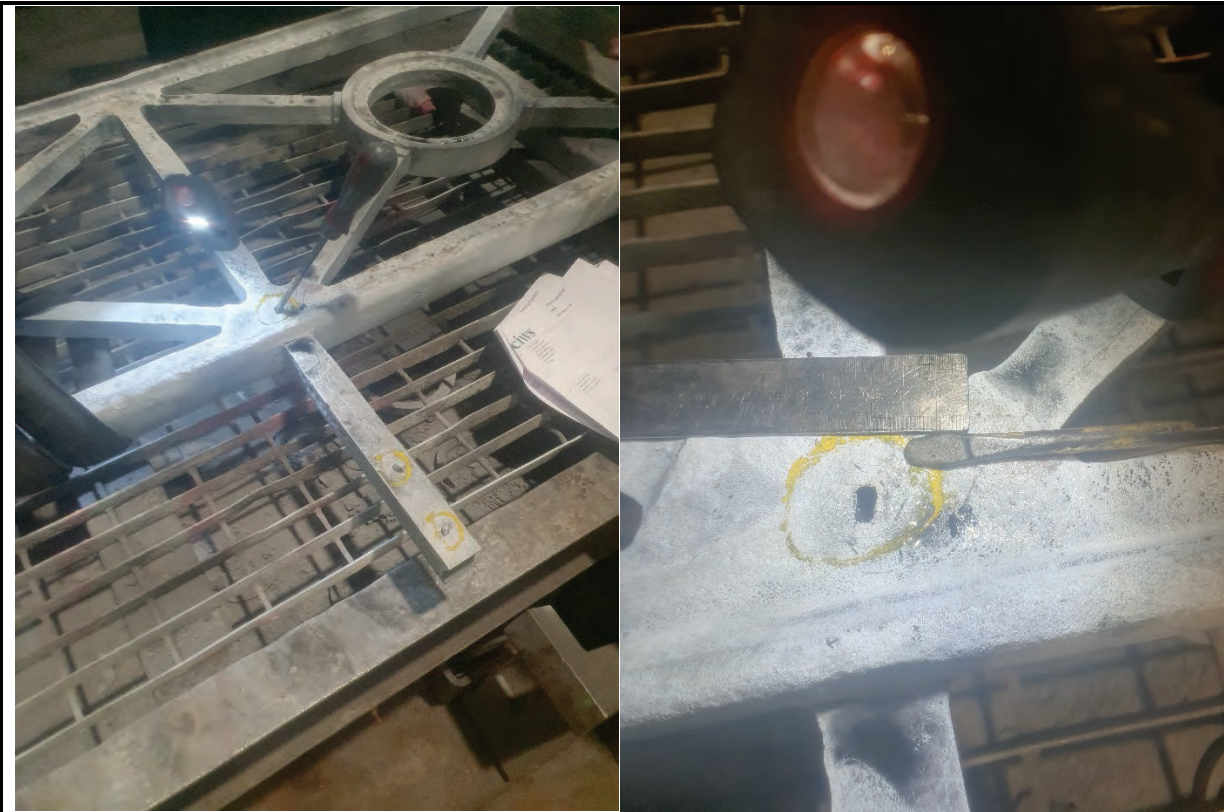
*Photograph 16 & 17, indicating blow hole / casting defect to balustrade infill at 1/3 span of 1 of 2 transoms. The hole was probed with a screwdriver and found to be 'lobster pot' shaped as indicated by the orientation of the screwdriver. Hole depth was measured as 20mm with overall section of 35mm hence this is a significant defect resulting in a localise reduction in iron thickness of 15mm. CIWS are to prepare and expose the defect to establish significance. We discussed how this could be the located where molten iron entered the patten and hence all to mindful that this could be a consistent defect if this was how it was caused.*

NOTE CASTING DEFECTS WILL SIGNIFICANTLY REDUCE STRUCTURAL CAPACITY! THIS CHECK NOTES BOTTOM TRANSOM IS WORKING AT PERMISSIBLE STRESS HIGHLIGHT TO CLIENT IF EXISTING CAST IRON INFILLS ARE TO BE ADOPTED THIS CARRIES RISK. RECOMEND RECAST IN SG IRON TO ECIMINATE RISK.
