# MADEIRA TERRACES REFURBISHMENT, BRIGHTON

## IRON REUSE STRATEGY REPORT

31 OCTOBER 2023

Ref: MTR-HOP-ZZ-XX-D2-6003

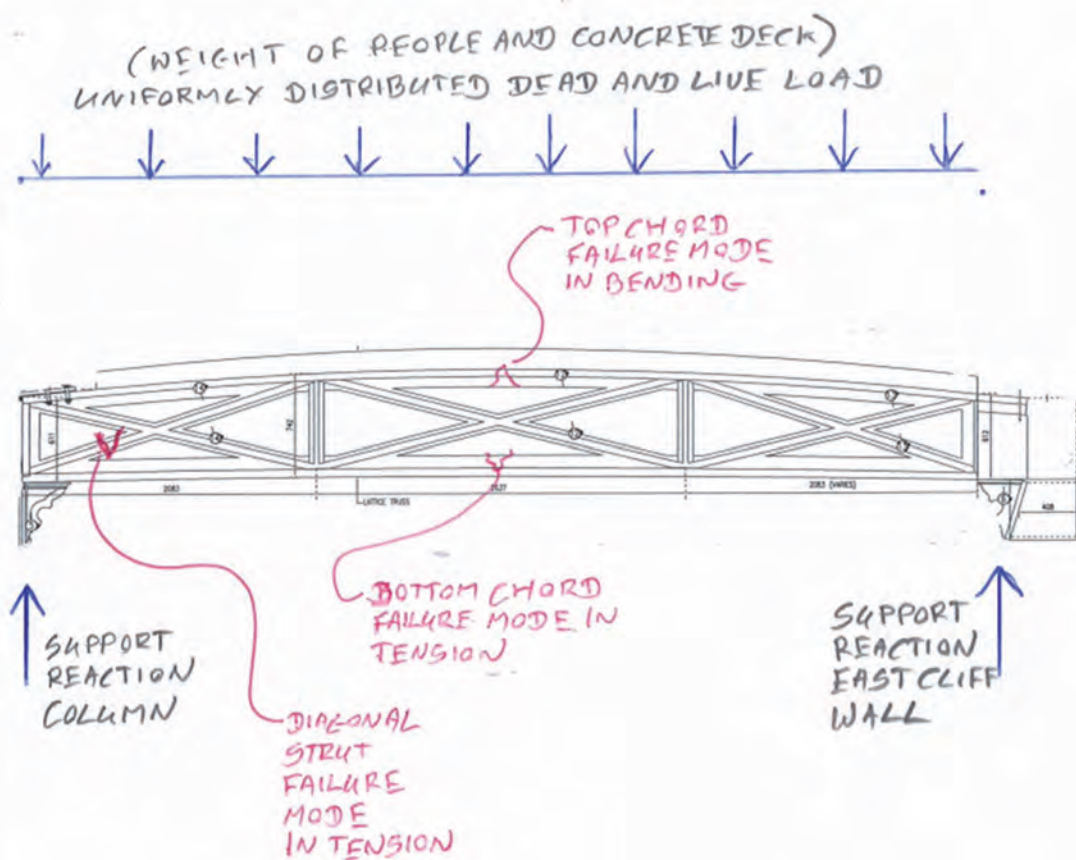
The assessment of the overall capacity of a truss requires identification of the various failure modes. Figure 5 below indicates the principal failure modes of consideration with the Diagonal Strut failure mode identified as governing overall truss load carrying capacity. This conclusion is also supported by others that have modelled the structure historically.

Figure 5 – Indicating principal failure modes of consideration with the Diagonal Strut mode identified as governing overall truss capacity.

Ultimately until more confidence in the tensile strength of the material from which trusses are formed (actual truss specific testing), the assessment process of a truss cannot be concluded.

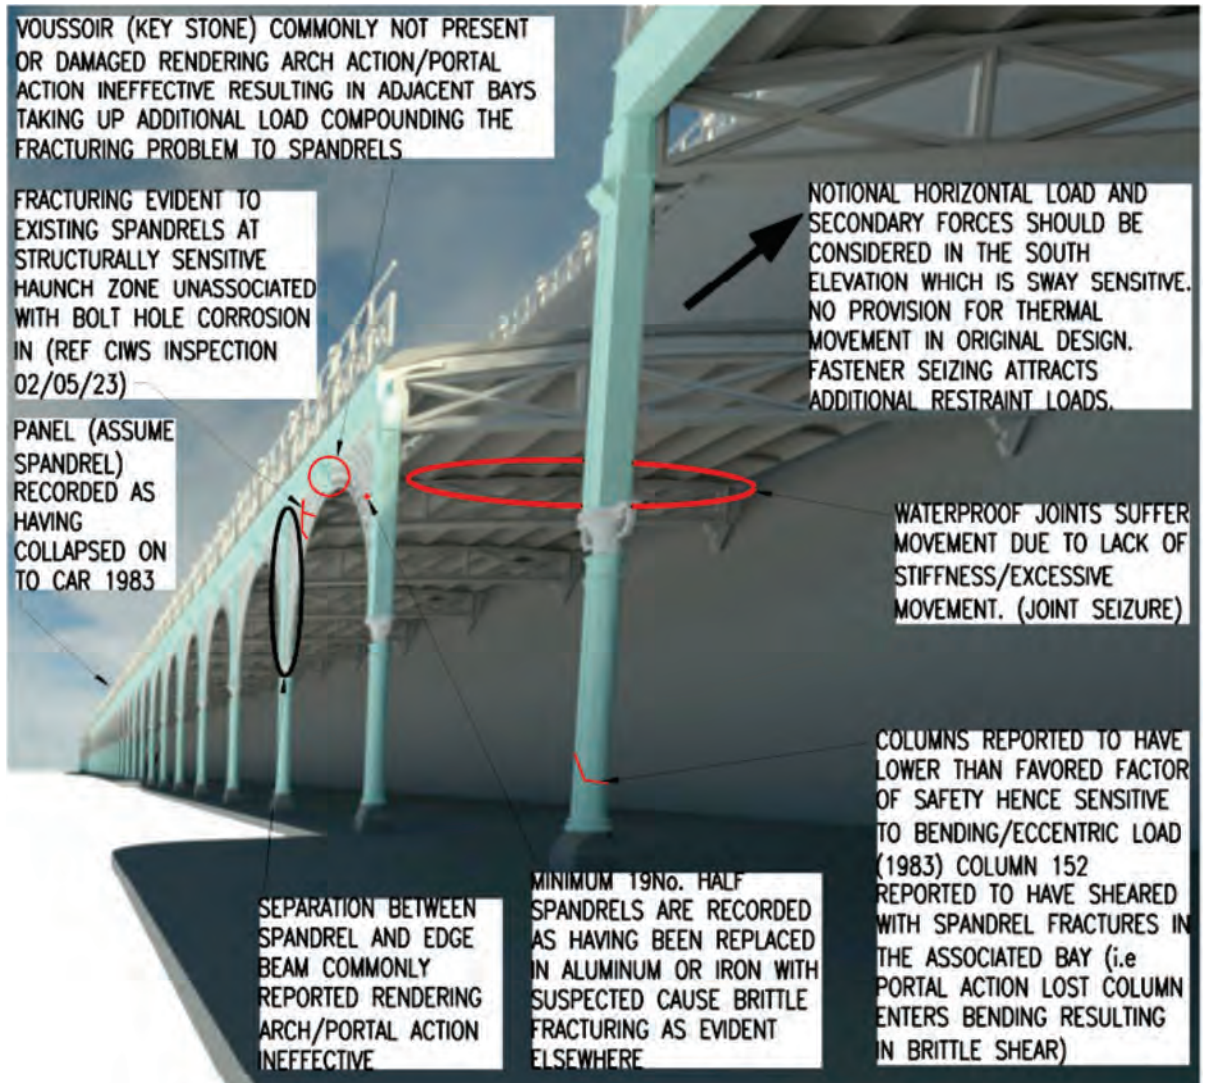
- vii) Separation between Spandrel and edge beams are commonly reported rendering arch / portal action ineffective / unreliable.

Figure 6 – Sketch summarising existing structural problems with the south (Spandrel) elevation.

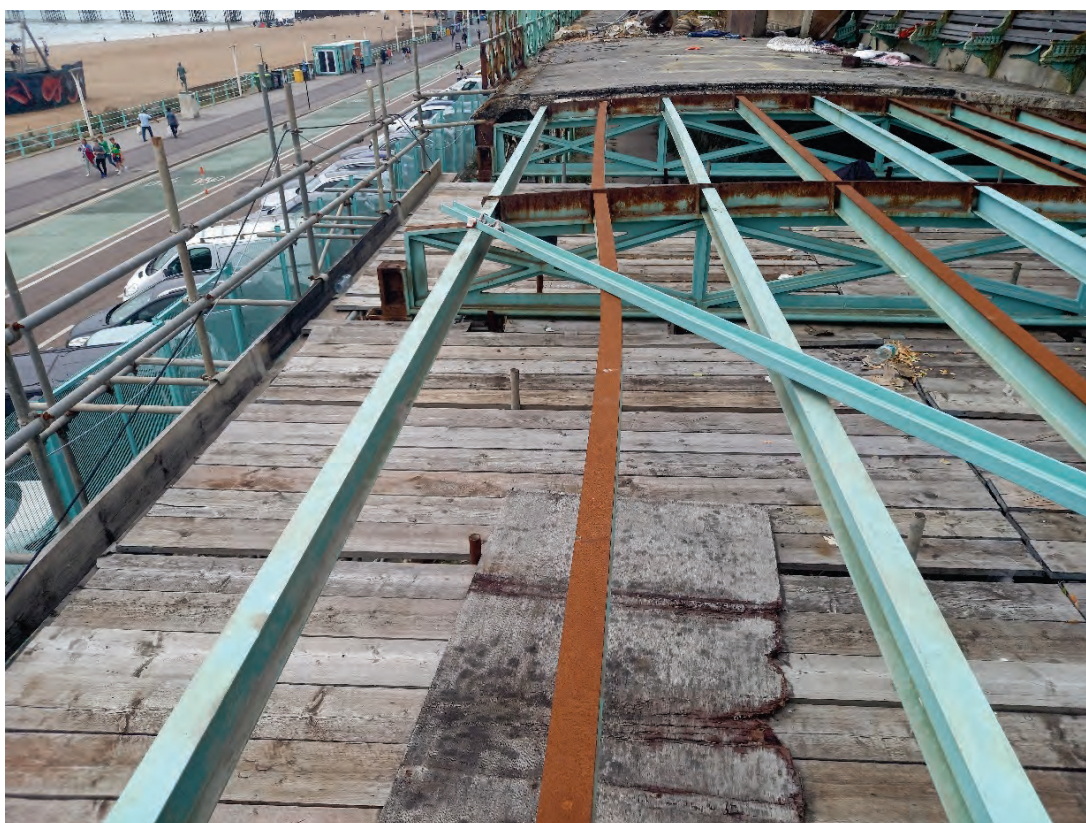
- 4.8.7 As and when historical interventions have been implemented in the past e.g. replacement of columns or spandrels, it is considered that these interventions are likely to change the movement regime again i.e. a previously seized connection may be renewed or replaced resulting in increased provision for movement locally to the intervention. Photograph 3 below indicates this process where 2No. bays had been removed in 2014 releasing the area and attracting movement.

*Photograph 3 - indicating 2014 trial bays following removal of spandrels forming a 'release' to the structure. Note how steel beam has buckled in the weak axis where insufficient capacity is available to resist restraint forces to horizontal movement.*

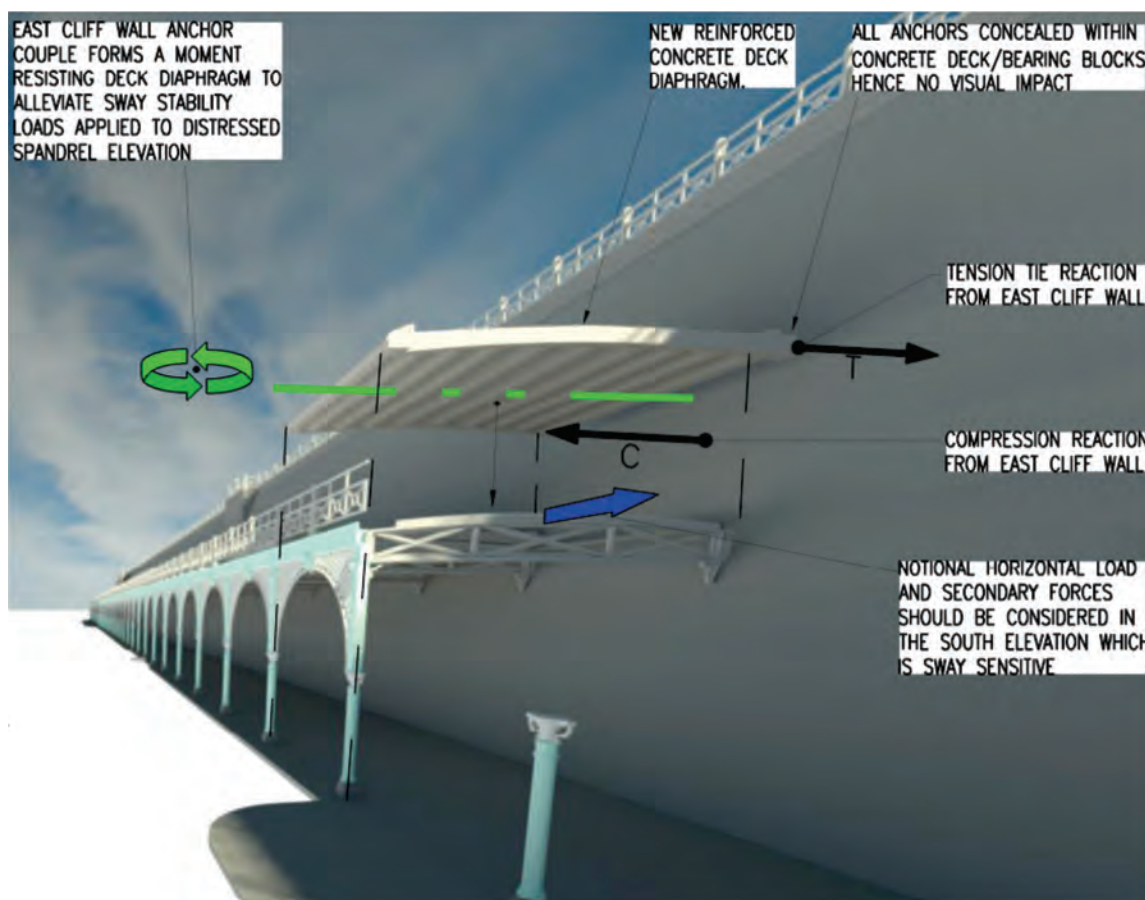
Figure 7 – Sketch indicating structural reasoning for introduction of deck diaphragm tying action

positive connection into the east cliff wall. This intervention will be largely concealed from view and incorporated into the reinforced concrete deck at truss bearing blocks. This approach maximises the opportunity to reuse existing spandrels. Further it reduces bending action applied to columns thereby enhancing opportunities for column reuse also.

4.8.12 Figure 7 below summarises the tying proposal:
