Validation Letter

Date: 6 October 2023

Our Ref: M41977-JNP-XX-XX-RP-G-0020-P01

Re: Former Sunninghill Gas Works – Validation of Capping Layer for Plots 13 - 26 (Block C)

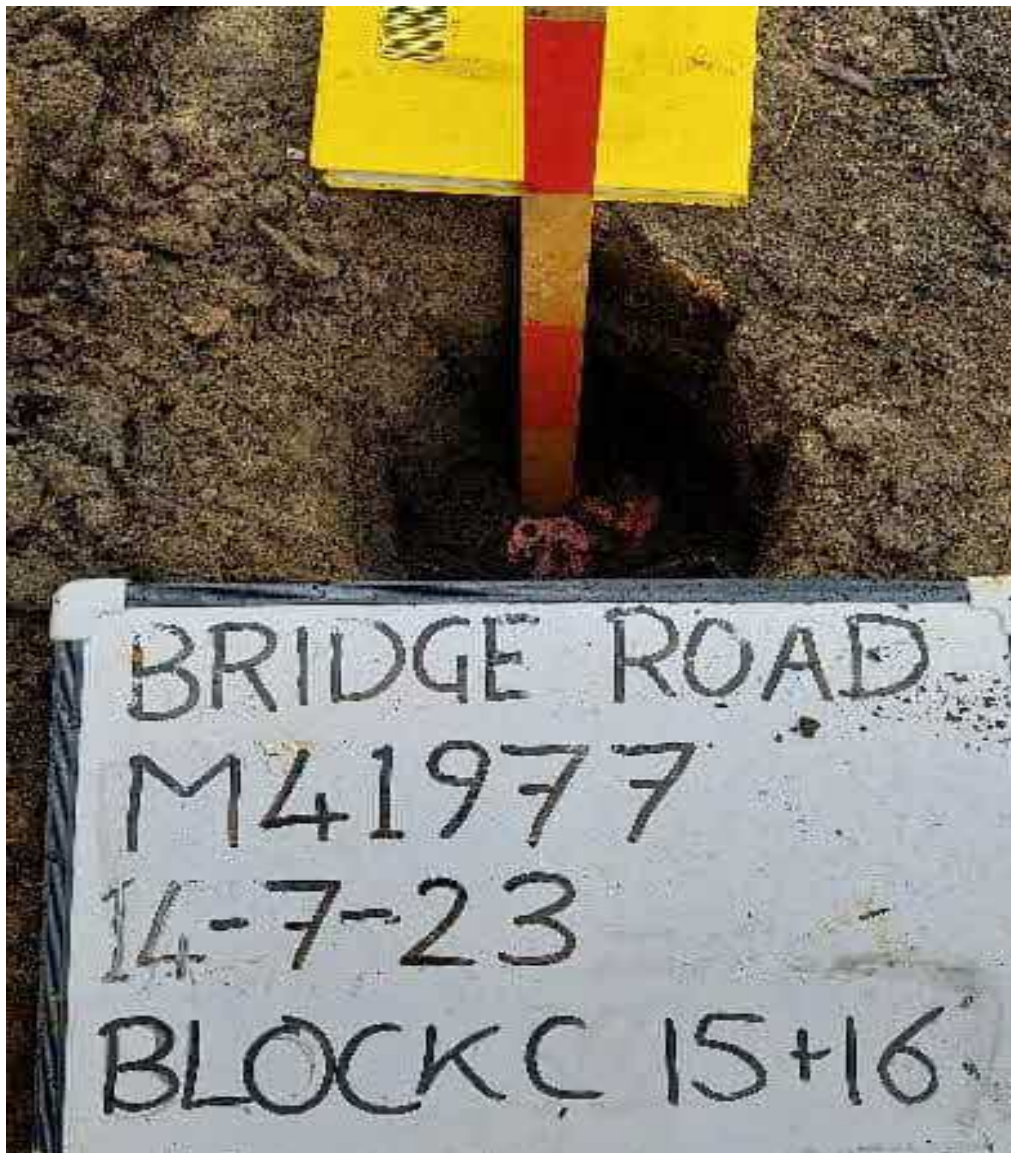
Topsoil was present to a depth of 300mm below which lay the geotextile membrane. The topsoil consisted of dark brown loamy slightly gravelly sandy SILT. The topsoil material was sourced from Warfield.

The topsoil material was generally free of any deleterious material (e.g. wire, glass, plastics, treated wood or textiles). Photographs taken from the plots are also given in Appendix B to this letter.

Photograph 1: Block C Landscaping Area Validation Pit

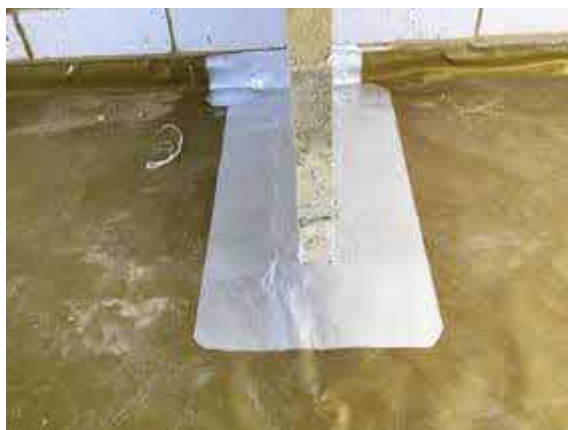
Plot 3 retro fit detail over the damaged membrane that is under the internal block work wall.

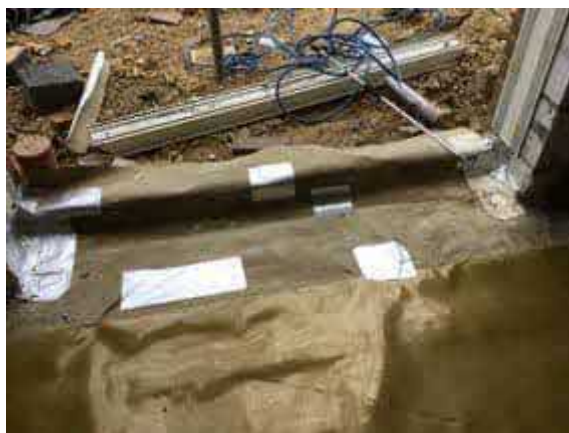
Plot 75 repaired damaged membrane using SAGM.

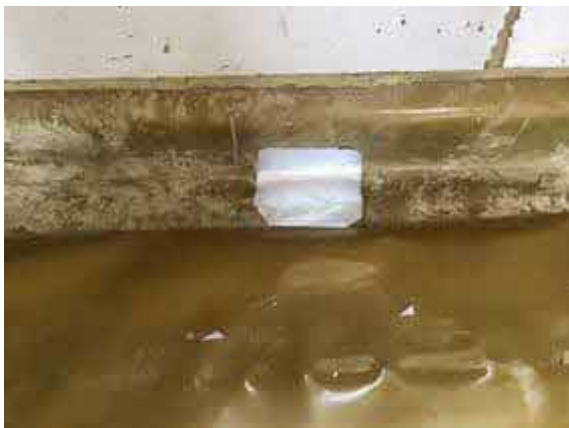
Plot 7 patch repair using SAGM.

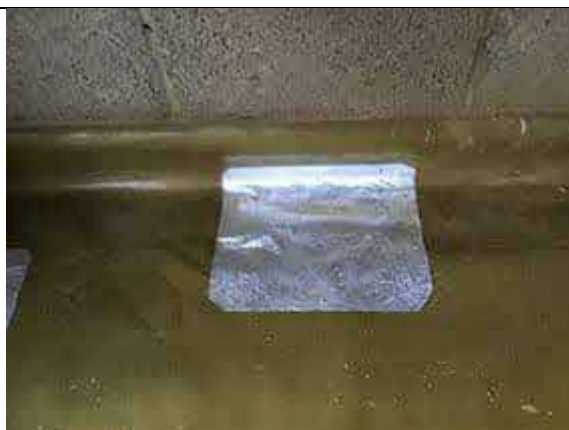
Repaired damaged perimeter membrane using SAGM to plot 39.

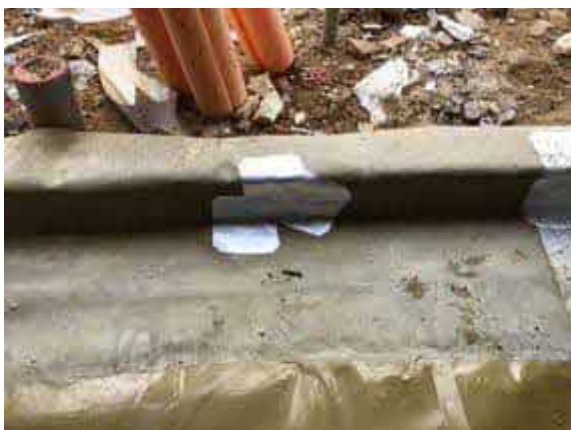
Patch repairs to damaged perimeter membrane using SAGM.
