PROJECT  
 5 Farleigh Road, Norton St Philip

DRAWING TITLE  
 Existing window WG.02

DRAWING NO. REV.  
 72-D-02

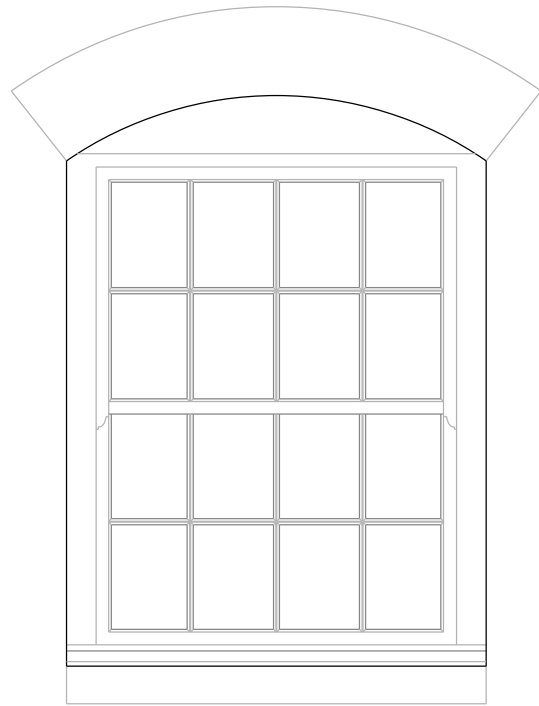
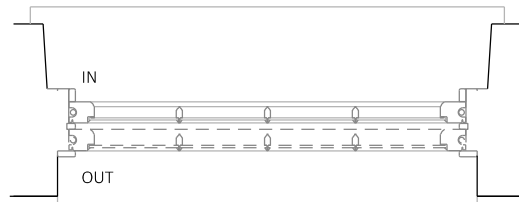
WG.02

Painted timber, single glazed, vertical sliding sash window, with horn detail, fitted as part of the later conversion works. Ovolo moulded frame and slim ovolo glazing bars, putty glazed. The timber sill is raised slightly above the stone sill and has weathered better than WG.01 & 03. The timber sill and lower vertical portion of the outer frame are showing signs of deterioration.

The proposal is to repair the timber sill and lower sections of the outer fixed frame, areas of rot and damp timber to be cut back to sound wood, new matching timber sections to be pieced in and the entire window painted white to match the existing finish. Existing panes of glass retained. Extent of repairs to be agreed with specialist joiner.

To be fitted with new magnetically fixed secondary glazing and draught strip, see detail drawing 72-D-12

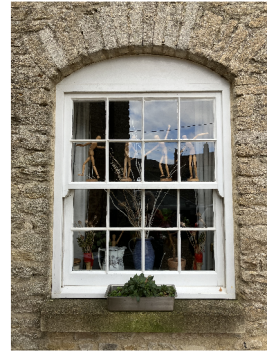
WG.02 sill and outer lining to frame show signs of deterioration

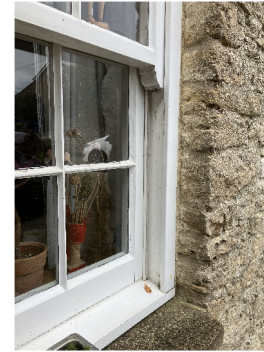
WG.02 sill and outer lining to frame show signs of deterioration

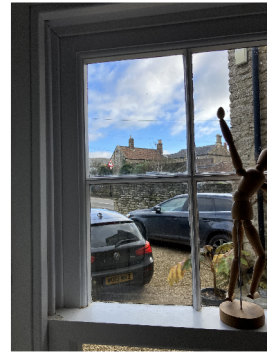
WG.02 internal frame, glazing bar and meeting rails detail

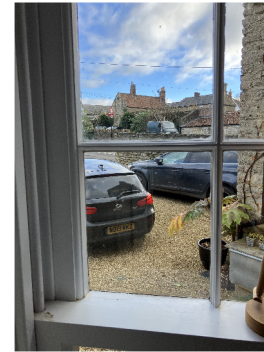
WG.02 internal frame, glazing bar and meeting rails detail
