WG.01 & WG.03

PROJECT
 5 Farleigh Road, Norton St Philip

DRAWING TITLE
 Existing windows WG.01 & 03

DRAWING NO. REV.
 72-D-01

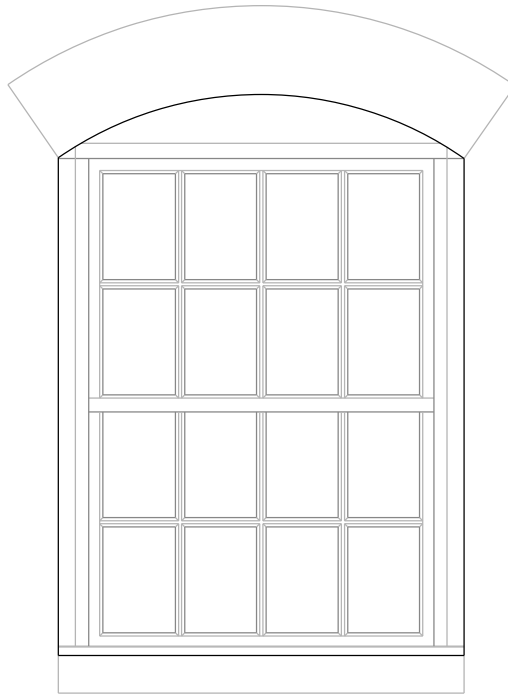
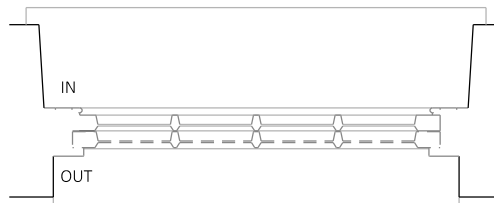
Painted timber, single glazed, vertical sliding sash windows, fitted as part of the earlier conversion works. Simple chamfered glazing bars with rounded corners, no moulding details, putty glazed. The sill sits directly on the stone sill, the timber sill and lower horizontal and vertical portion of the frames are showing signs of rot and deterioration.

The proposal is to replace the timber sill sections and repair the frame and casements, areas of rot and damp timber to be cut out back to sound wood, new matching timber sections to be pieced in and the entire window painted white to match the existing finish. Existing glass panes retained. Extent of repairs to be agreed with specialist joiner.

To be fitted with new magnetically fixed secondary glazing and draught strip, see detail drawing 72-D-12

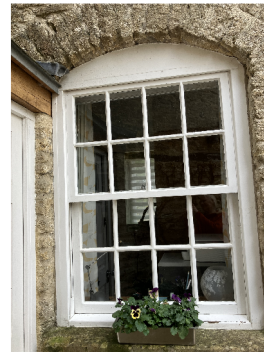
WG.01 sill and outer lining to frame show signs of rot

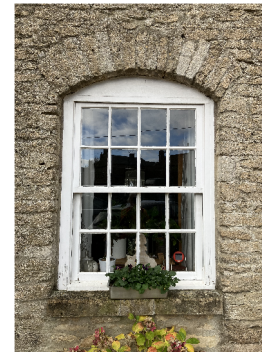
WG.03 sill and outer lining to frame show signs of rot

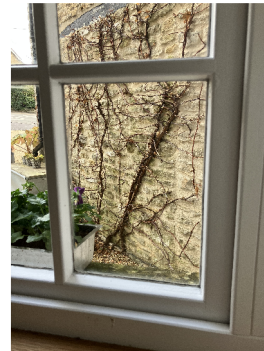
WG.01 internal frame and glazing bar detail (WG.03 matches)

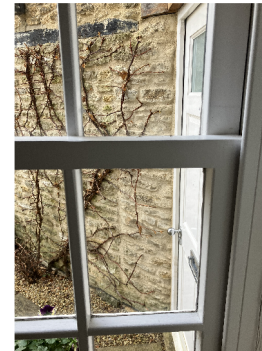
WG.01 internal frame and meeting rail detail (WG.03 matches)

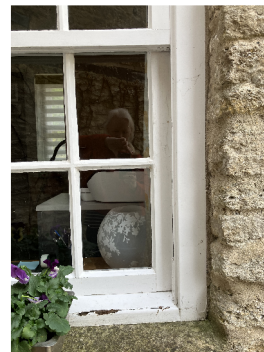
WG.01 sill and outer lining to frame show signs of rot

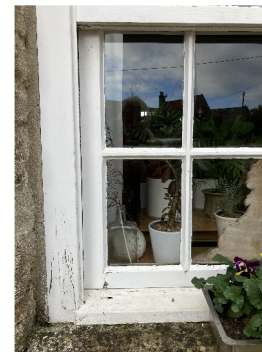
WG.03 sill and outer lining to frame show signs of rot
